Amendment C205 to the Hume Planning Scheme – Lindum Vale PSP

Statement of Evidence

Satterley Property Group Pty Ltd

12 February 2018

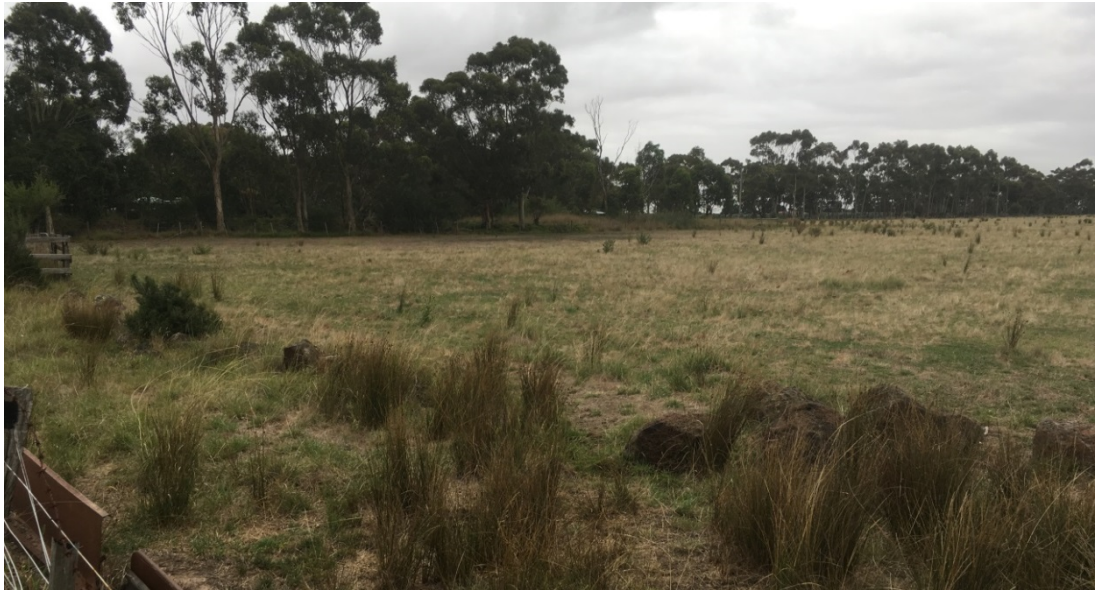
- DSW1 is characterised as being Rating 2 by Stevens. Instead, given its very poor condition, it is my opinion that this section of wall should not be considered as being of higher than Rating 1 (and therefore not marked for retention in the PSP) – this conclusion is also drawn by EHP (2017); and
- DSW3 was characterised as Rating 2 by Stevens, whilst wall DSW2 was assigned Rating 3. Instead, it is my opinion that the former (DSW3) should be considered of equal if not higher significance. In other words, DSW3 should be considered one of the best preserved walls in the PSP, if not the best.

Figure 4 – Looking northwest across Stevens’ wall DSW1. (Source: Extent Heritage)

As shown in Figure 4, DSW1, which I agree with EHP (2017) clearly represents a continuation to the west of DSW2, is in extremely poor condition and no longer comprises a continuous line of stones, much less a structure. On the basis of its possible original form, EHP determine that the remnants fall somewhere between Rating 1 and 2, but more closely Rating 1 given its condition. I agree with the EHP conclusion in this respect.

It is therefore considered that it should not be required that wall DSW1 be retained in the PSP.

The PSP's Plan 5 Image, Character and Housing, should be amended to remove Stevens' wall DSW1 from the category 'Dry stone walls to be retained and repaired – rating 2-3 (moderate-high value)'.

This would be to reflect that it should actually be considered a Rating 1 wall under the system employed, and therefore it should not be earmarked for retention under Guideline G11.

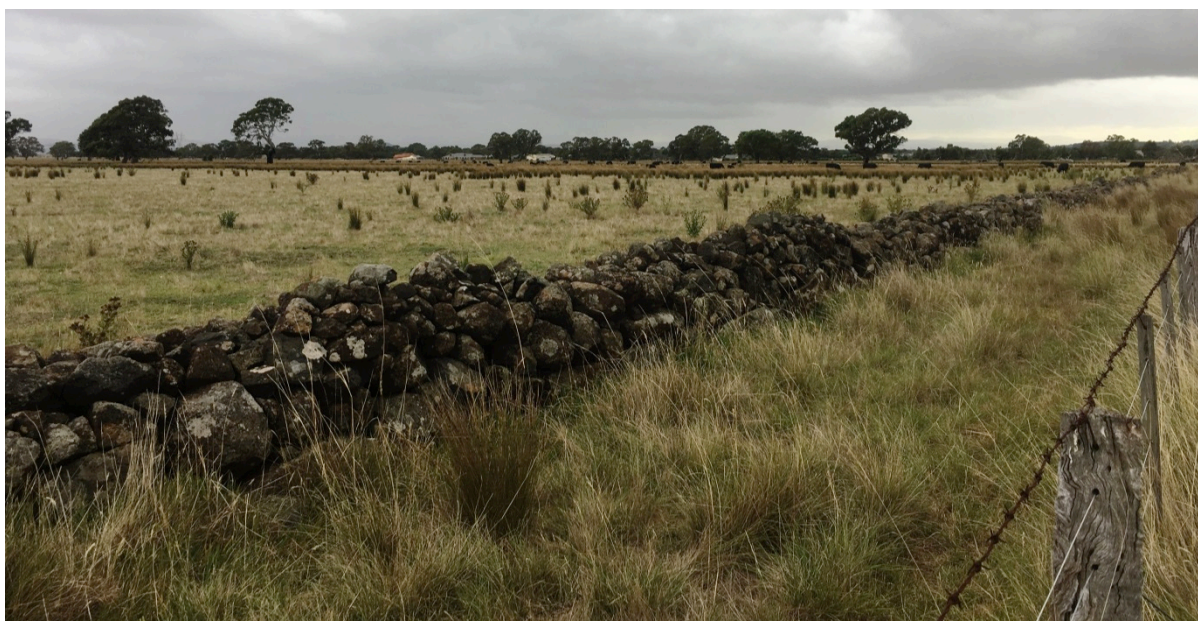
Wall DSW2 (Figure 5) comprises two ‘skins’ with hearting stone between and it retains a consistent A-shape profile. There is relatively little coursing of stones in the skins, although this is possibly symptomatic of the irregular shape of the stones at the site. The stones do however appear to be roughly graded, with larger stones toward the bottom of the wall, and plugging stones are present. Aside from some sections which appear to be more eroded than others, this structural form is fairly consistent throughout the wall, and although EHP (2017) separate the wall into two sections (DSW2-1 & DSW2-2), I would be inclined to attribute this whole section with the same relatively high rating (Rating 3).

Figure 5 - Looking north east along wall DSW2, February 2018. (Source: Extent Heritage)

It is not considered that the holistically considered heritage significance of wall DSW2 demands its retention in situ. It is also considered that retention of the whole wall would be impractical.

It is therefore recommended that, notwithstanding the blanket retention of Rating 2 and Rating 3 walls envisaged under Guideline G11 (reworded and made a Requirement of the PSP at the request of Hume City Council), allowance be made for all or part of wall DSW2 to be removed. The heritage value of the feature should be mitigated through one of the approaches described under 3.3.1 above, through discussion with the responsible authority.

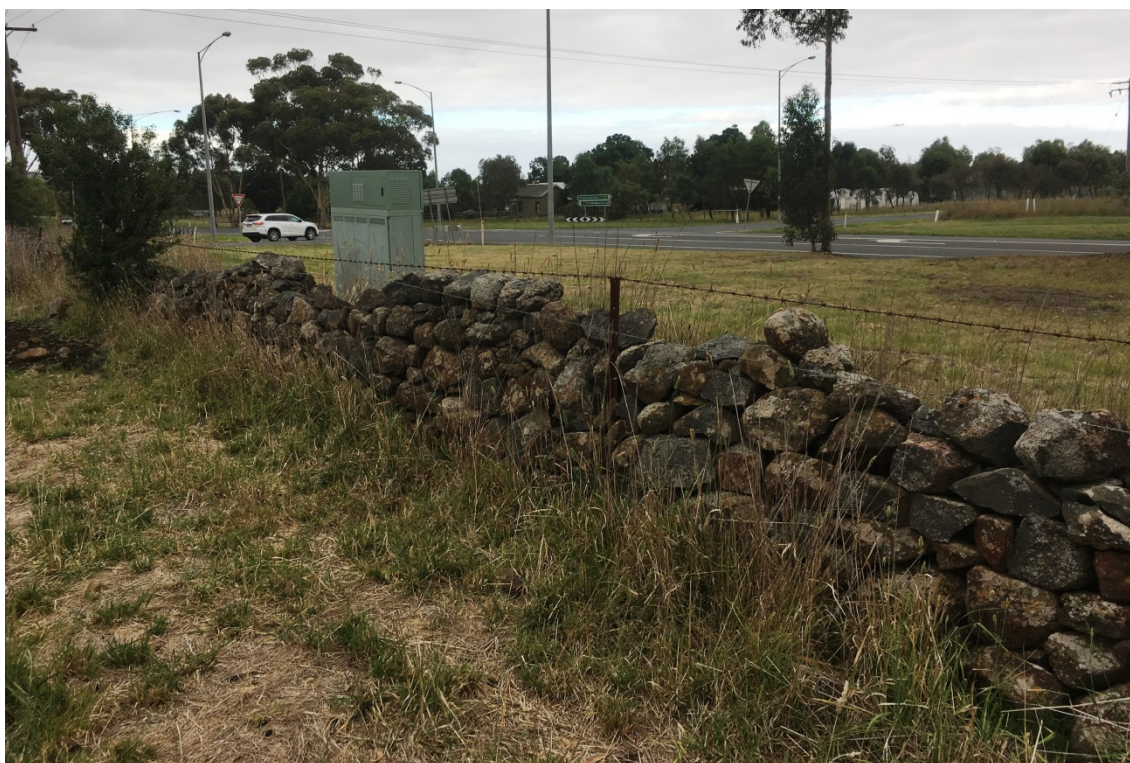
As with wall DSW2, wall DSW3 (Figure 6) comprises two 'skins' with hearting stone between and retains a consistent A-shape profile. There is again relatively little coursing of stones in the skins, symptomatic of the irregular shape of the stones at the site, but there appears to be generally more consistent grading of stone size through the wall, and plugging stones are present. The northern section of the wall is more eroded and has been supplemented by inserted post and wire fencing and a dense hedgerow. Further to the south the structure retains greater integrity, and some sections retain coping stones. Although not as consistent in structure and condition as wall DSW2, it is my conclusion that the whole of this wall is relatively superior to the other walls in the PSP.

Figure 6 - Section of wall DSW3, looking southwest towards the junction of Mickleham Road and Mt Ridley Road. (Source: Extent Heritage)

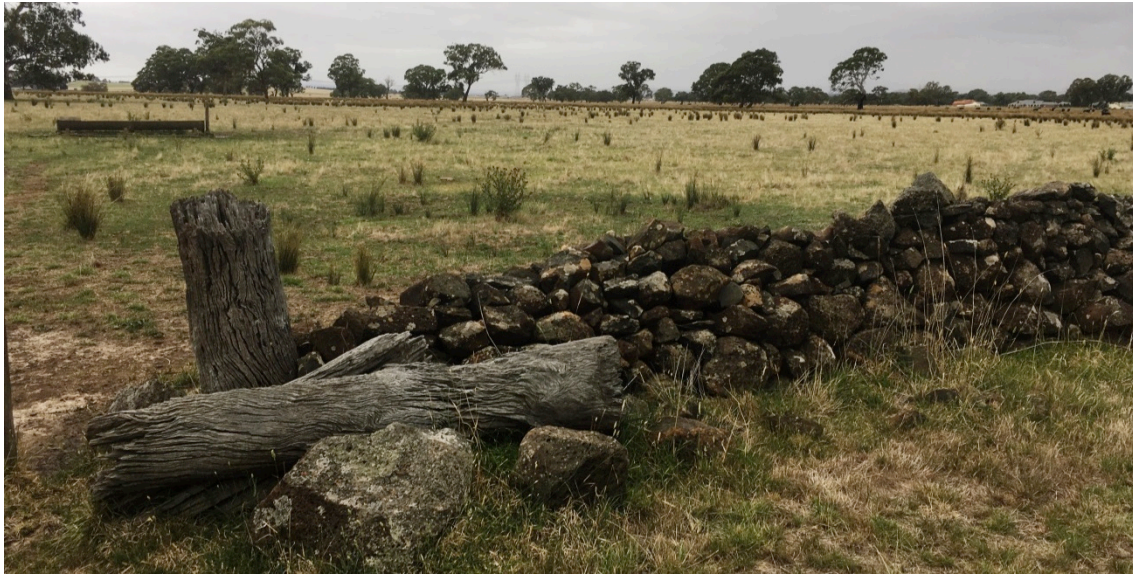
At both the western and eastern ends of DSW2 there are timber posts marking gateways (Figure 8 and Figure 9). The walls at these interstices are not structured stone wall ends but instead taper off, in the case of the western end, and abut the wooden post at the eastern end. The impression is that the wall is either in poorer condition at the west end and has been repaired against the post at the eastern, or that the gateways are relatively recent openings created since the wall was constructed.

Figure 8 – Western end of wall DSW2, showing the tapering wall and wooden post. (Source: Extent Heritage)

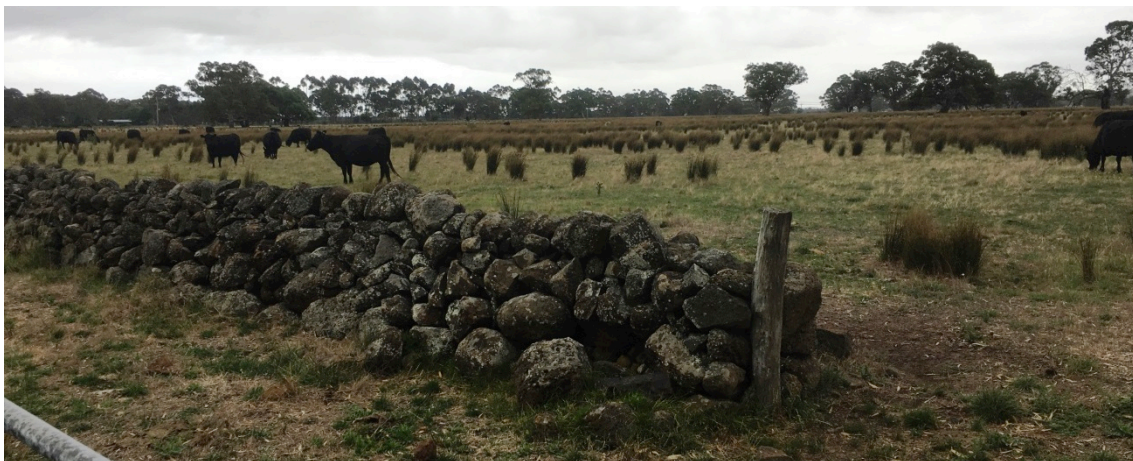
Figure 9 – Eastern end of wall DSW2, showing wall abutting wooden post. (Source: Extent Heritage)

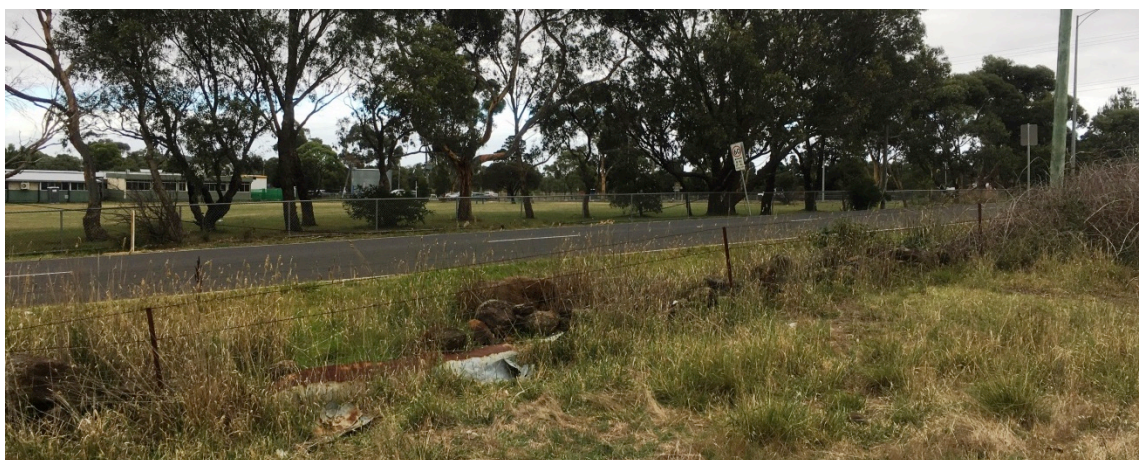
Some wall survives along Mt Ridley Road, running east from its junction with Mickleham Road and also marking a historic property boundary, but this is in a very fragmented state (Rating 1 under Stevens' assessment) (see Figure 10). Although essentially an interpretive act, given the greater prominence of the location and a greater audience along the road corridor, it is considered that restoring wall along this boundary would represent a much more effective approach to communicating the historic character of the area.

Figure 10 – Fragmentary wall remnants along Mt Ridley Road. (Source: Extent Heritage)

In line with Requirements 12 and 13 of the PSP, a representative section (to be agreed with the responsible authority) of wall DSW2 could be reconstructed elsewhere in the PSP.
