**National Pacific Properties Pty Ltd**

**Preliminary Site Investigation for National Pacific Properties** 1625 Ballarto Road, Clyde Victoria

November 2010

T&T Ref: 1917/0

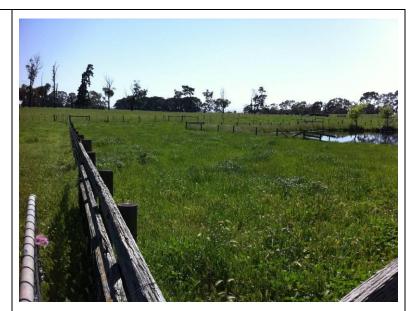
Photograph 5

Photo taken from centre of site looking north west.

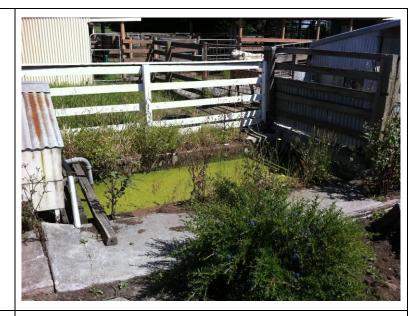
Photograph 8

Stock bore in paddock to the west of the farm house, north of the houses at the corner of Twyfold and Ballarto roads.
