Arboricultural Assessment and Report

River Red Gum trees Kororoit Creek, Melton East PSP

Prepared for Victorian Planning Authority

5 May 2023

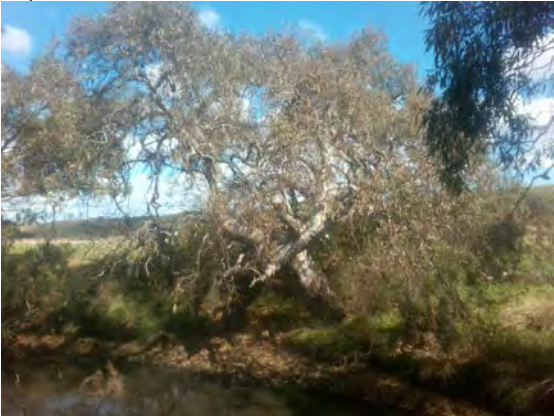
Tree ID: 29. *Eucalyptus camaldulensis* (River Red Gum), Maturing, Indigenous. Arb. Rating: Mod.A. Water's edge, habitat hollows, trunk decay.
DBH: 90 cm. TPZ rad 10.8 m radius. Permit req'ment: ESO 2&5, 52.17.
Map ref: 1

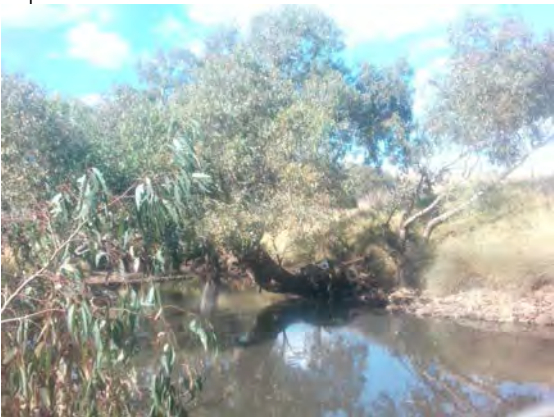
Tree ID: 31. *Eucalyptus camaldulensis* (River Red Gum), Maturing, Indigenous. Arb. Rating: High.
DBH: 90 cm. TPZ rad 10.8 m radius. Permit req'ment: ESO 2&5, 52.17.
Map ref: 1

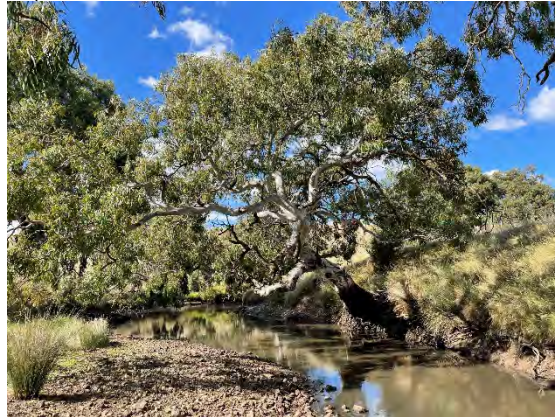
Tree ID: 33. *Eucalyptus camaldulensis* (River Red Gum), Maturing, Indigenous. Arb. Rating: High. Habitat hollows, past limb failure.
DBH: 127 cm. TPZ rad 15 m radius. Permit req'ment: ESO 2&5, 52.17.
Map ref: 1

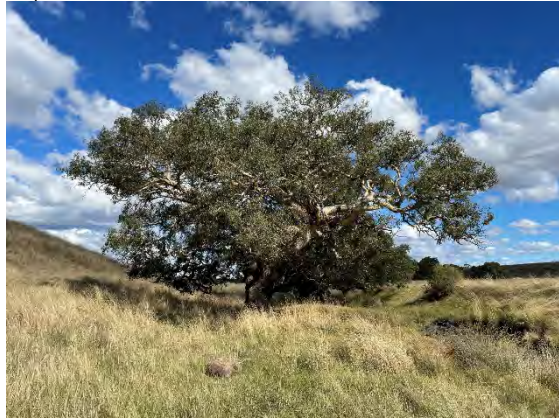
Tree ID: 47. *Eucalyptus camaldulensis* (River Red Gum), Maturing, Indigenous. Arb. Rating: Mod.B. Water's edge, previous failures. Exposed buttress. DBH: 80 cm. TPZ rad 9.6 m radius. Permit req'ment: ESO 2&5, 52.17. Map ref: 2

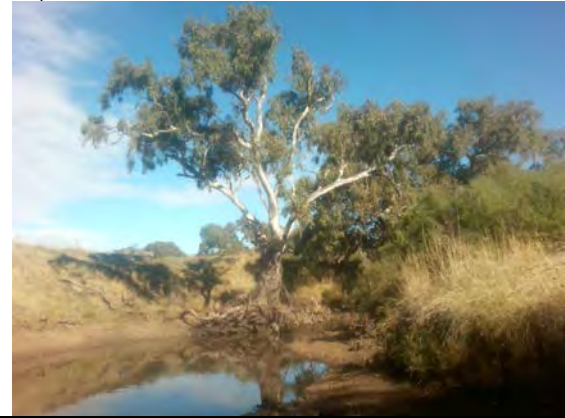
Tree ID: 41. *Eucalyptus camaldulensis* (River Red Gum), Maturing, Indigenous. Arb. Rating: High. Habitat hollows. DBH: 125 cm. TPZ rad 15 m radius. Permit req'ment: ESO 2&5, 52.17. Map ref: 1,2

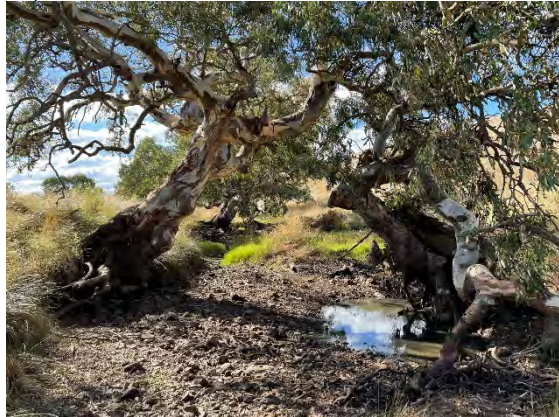
Tree ID: 48. *Eucalyptus camaldulensis* (River Red Gum), Maturing, Indigenous. Arb. Rating: High. Water's edge, past limb failure. DBH: 90 cm. TPZ rad 10.8 m radius. Permit req'ment: ESO 2&5, 52.17. Map ref: 2

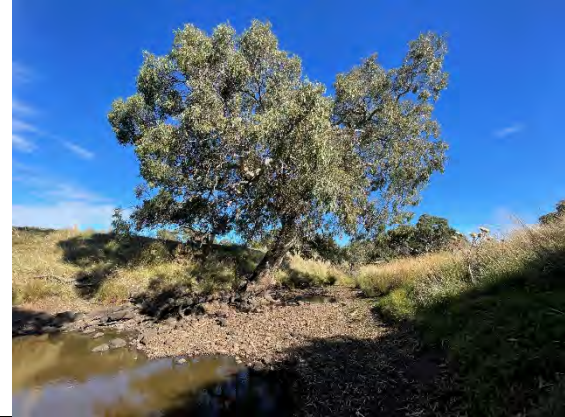
Tree ID: 45. *Eucalyptus camaldulensis* (River Red Gum), Maturing, Indigenous. Arb. Rating: High. Habitat hollows. DBH: 145 cm. TPZ rad 15 m radius. Permit req'ment: ESO 2&5, 52.17. Map ref: 2

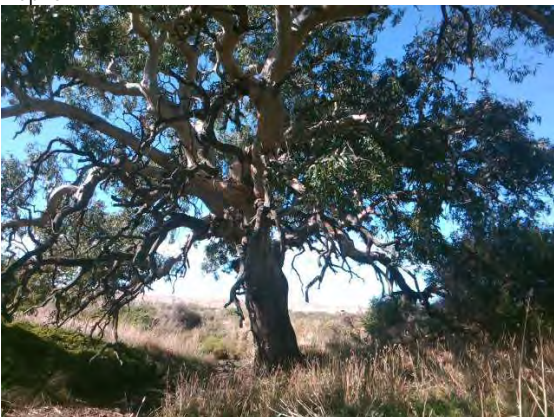
Tree ID: 61. *Eucalyptus camaldulensis* (River Red Gum), Over-mature, Indigenous. Arb. Rating: Low. Dead burnt stump. DBH: 75 cm. TPZ rad 9 m radius. Permit req'ment: ESO 2&5, 52.17. Map ref: 2

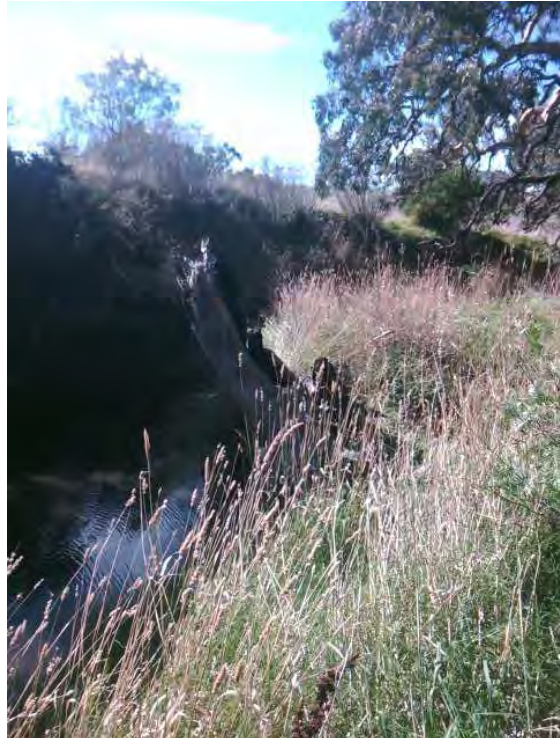
Tree ID: 64. *Eucalyptus camaldulensis* (River Red Gum), Maturing, Indigenous. Arb. Rating: Mod.A. Partly suppressed - crown bias, over-extended limbs developing-. West. DBH: 77 cm. TPZ rad 9.2 m radius. Permit req'ment: ESO 2&5, 52.17. Map ref: 2

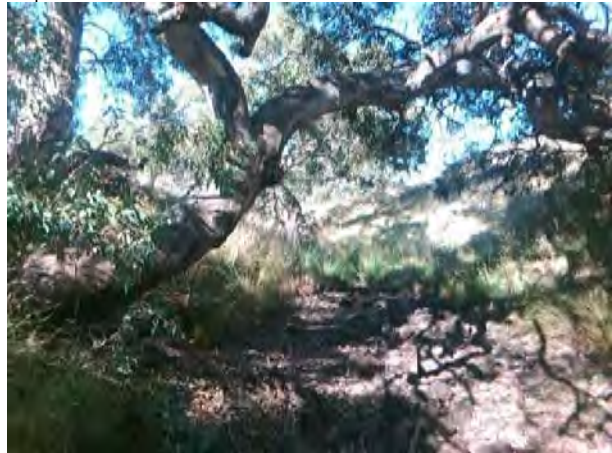
Tree ID: 65. *Eucalyptus camaldulensis* (River Red Gum), Maturing, Indigenous. Arb. Rating: Mod.A. Leaning trunk, past limb failure. Lean to Sth.
 DBH: 112 cm. TPZ rad 13.4 m radius. Permit req'ment: ESO 2&5, 52.17.
 Map ref: 2

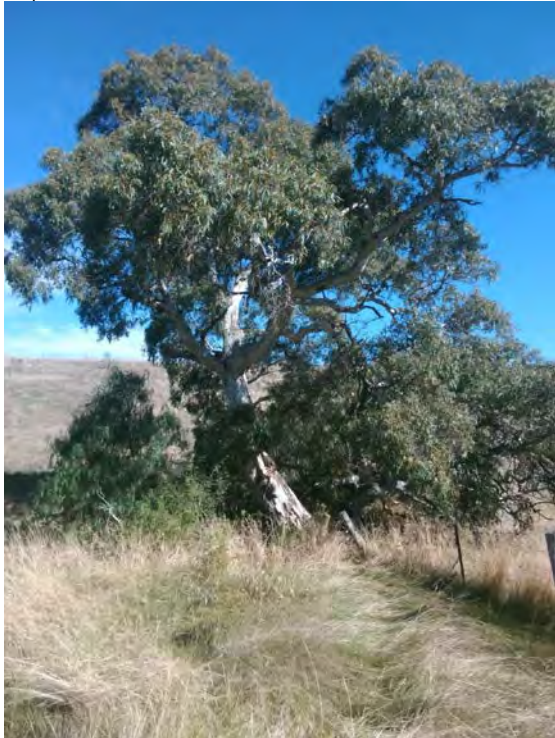
Tree ID: 67. *Eucalyptus camaldulensis* (River Red Gum), Maturing, Indigenous. Arb. Rating: Mod.B. Deadwood >50mm, habitat hollows, leaning trunk, crown bias w.
 DBH: 135 cm. TPZ rad 15 m radius. Permit req'ment: ESO 2&5, 52.17.
 Map ref: 3

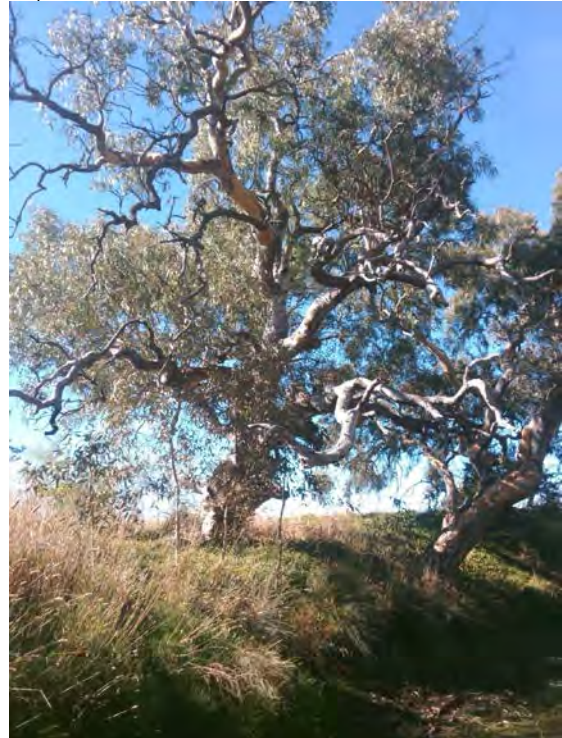
Tree ID: 66. *Eucalyptus camaldulensis* (River Red Gum), Maturing, Indigenous. Arb. Rating: Mod.B. Trunk cavity, habitat hollows, past limb failure.
 DBH: 146 cm. TPZ rad 15 m radius. Permit req'ment: ESO 2&5, 52.17.
 Map ref: 2,3

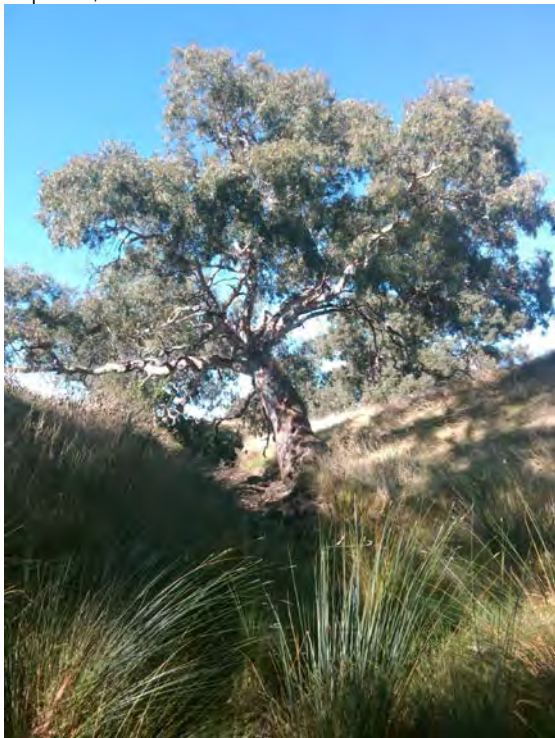
Tree ID: 68. *Eucalyptus camaldulensis* (River Red Gum), Maturing, Indigenous. Arb. Rating: Mod.B. Past limb failure, partly suppressed - crown bias sth.
 DBH: 105 cm. TPZ rad 12.6 m radius. Permit req'ment: ESO 2&5, 52.17.
 Map ref: 3

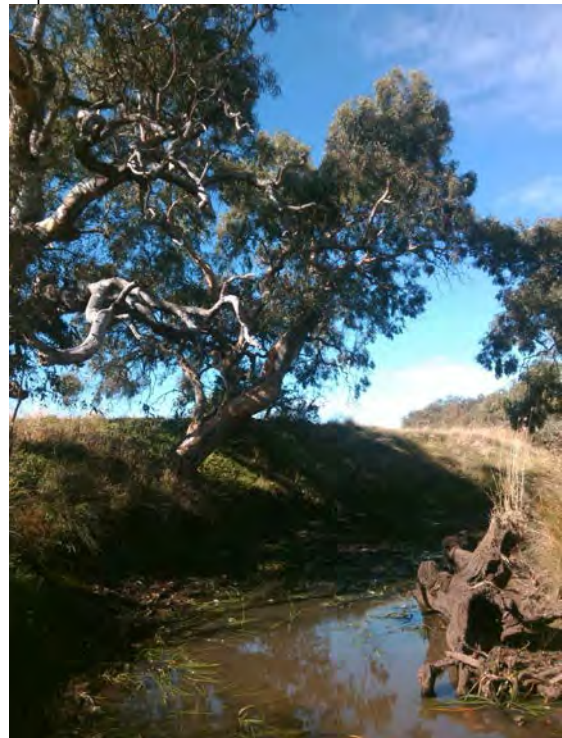
Tree ID: 69. *Eucalyptus camaldulensis* (River Red Gum), Maturing, Indigenous. Arb. Rating: Mod.A. Over-extended limbs.
 DBH: 129 cm. TPZ rad 15 m radius. Permit req'ment: ESO 2&5, 52.17.
 Map ref: 3

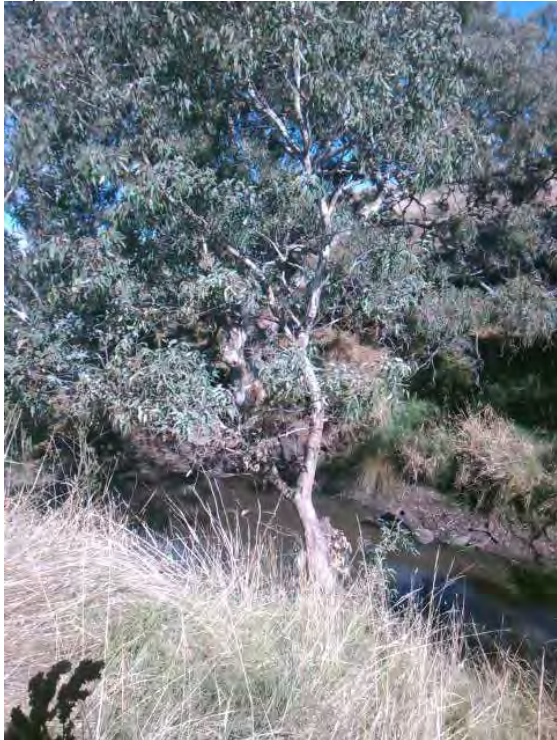
Tree ID: 71. *Eucalyptus camaldulensis* (River Red Gum), Maturing, Indigenous. Arb. Rating: Mod.A. Habitat hollows, incipient decay, past limb failure, over-extended limbs developing-. NW.
 DBH: 95 cm. TPZ rad 11.4 m radius. Permit req'ment: ESO 2&5, 52.17.
 Map ref: 3

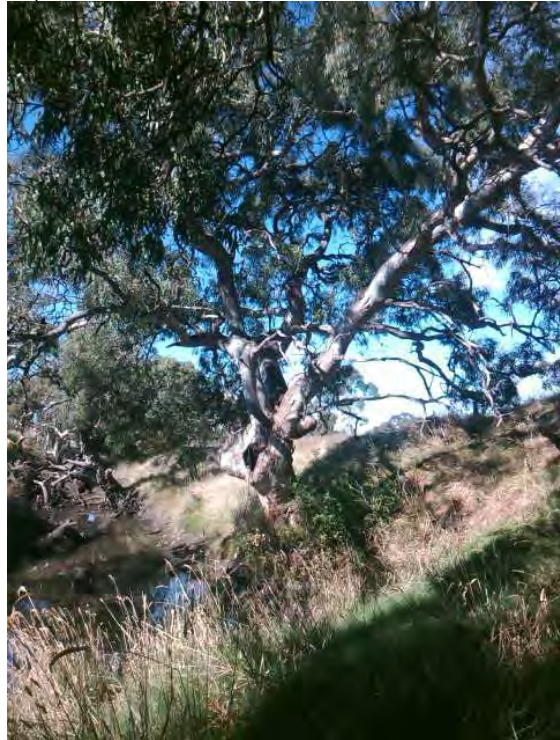
Tree ID: 73. *Eucalyptus camaldulensis* (River Red Gum), Maturing, Indigenous. Arb. Rating: Mod.B. Waters edge, habitat hollows, trunk decay.
 DBH: 65 cm. TPZ rad 7.8 m radius. Permit req'ment: ESO 2&5, 52.17.
 Map ref: 3

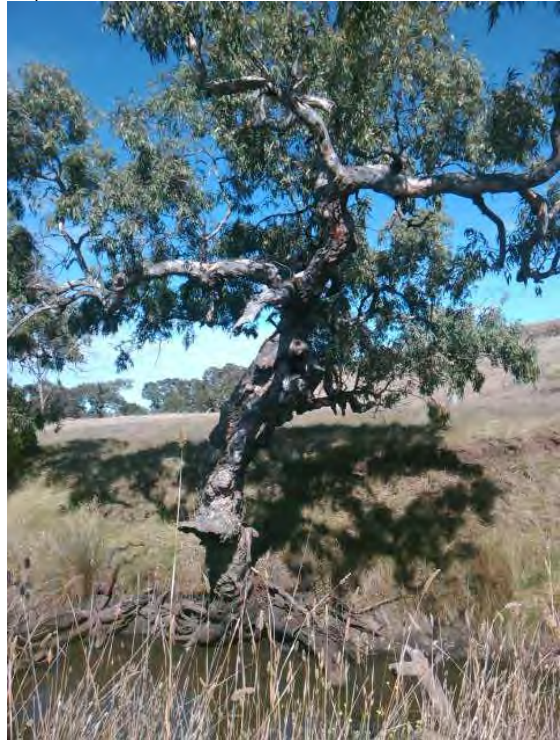
Tree ID: 74. *Eucalyptus camaldulensis* (River Red Gum), Maturing, Indigenous. Arb. Rating: Mod.B. Not accessed-In creek line w debris & failed trees.
DBH: 80 cm. TPZ rad 9.6 m radius. Permit req'ment: ESO 2&5, 52.17.
Map ref: 3

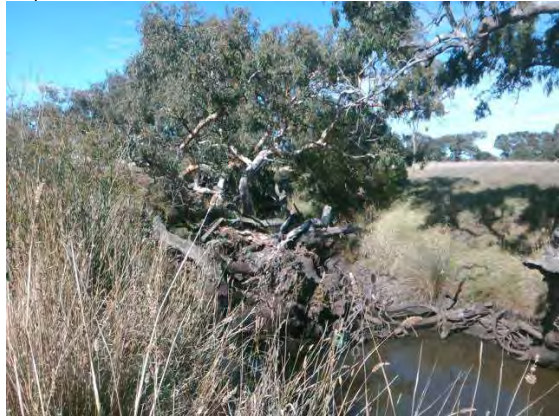
Tree ID: 75. *Eucalyptus camaldulensis* (River Red Gum), Maturing, Indigenous. Arb. Rating: Mod.B. Waters edge, leaning trunk, over-extended limbs developing-. Nth. Lower trunk obscured by flood debris to 2.5m.
DBH: 120 cm. TPZ rad 14.4 m radius. Permit req'ment: ESO 2&5, 52.17.
Map ref: 3

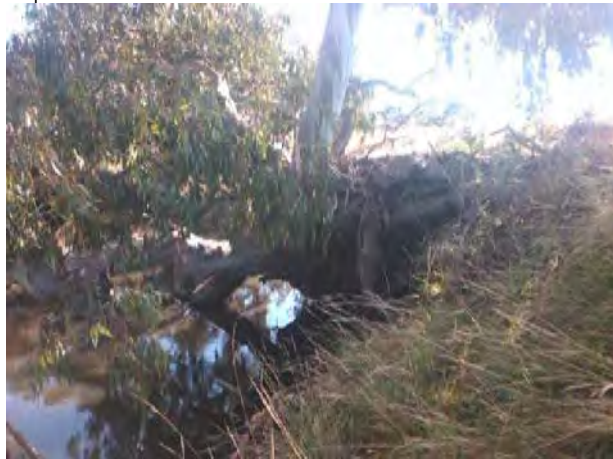
Tree ID: 76. *Eucalyptus camaldulensis* (River Red Gum), Maturing, Indigenous. Arb. Rating: Mod.B. Waters edge, incipient decay, limb wounds, past limb failure, over-extended limbs developing-. West.
DBH: 85,85 cm. TPZ rad 14.4 m radius. Permit req'ment: ESO 2&5, 52.17.
Map ref: 3

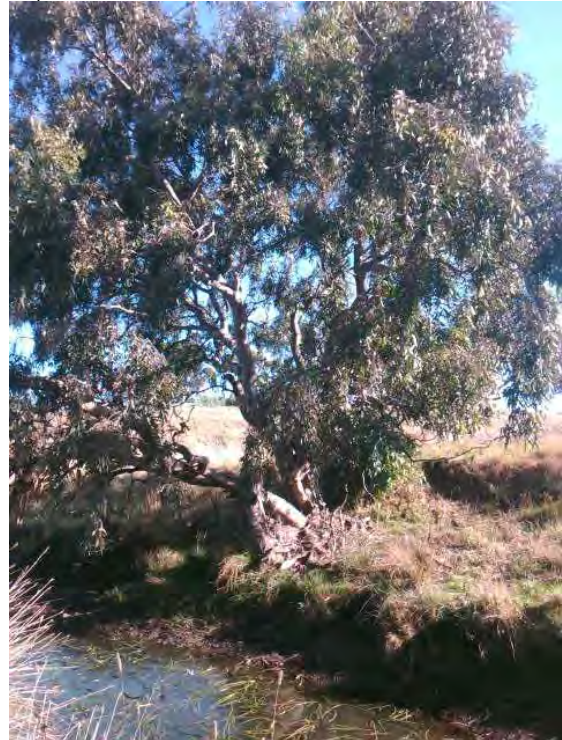
Tree ID: 101. *Eucalyptus camaldulensis* (River Red Gum), Maturing, Indigenous. Arb. Rating: Mod.A. Water edge, exposed roots, past branch failure. DBH: 110 cm. TPZ rad 13.2 m radius. Permit req'ment: ESO 2&5, 52.17. Map ref: 3

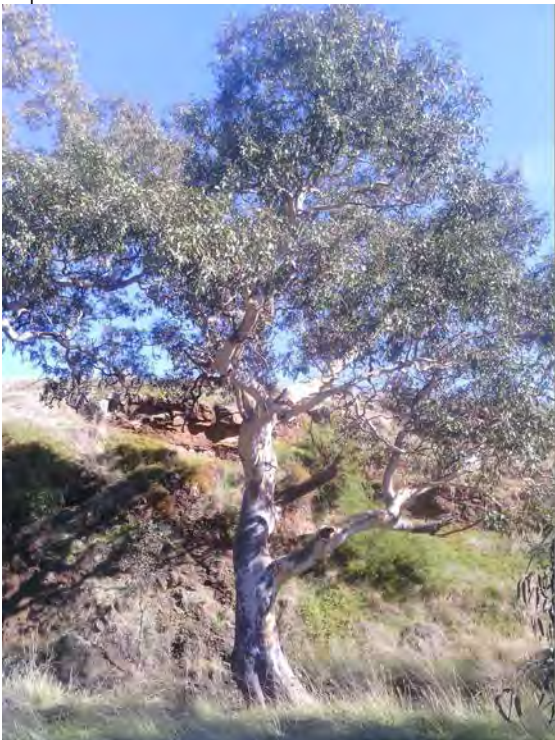
Tree ID: 119. *Eucalyptus camaldulensis* (River Red Gum), Over-mature, Indigenous. Arb. Rating: Low.
 DBH: 130 cm. TPZ rad 15 m radius. Permit req'ment: ESO 2&5, 52.17.
 Map ref: 4

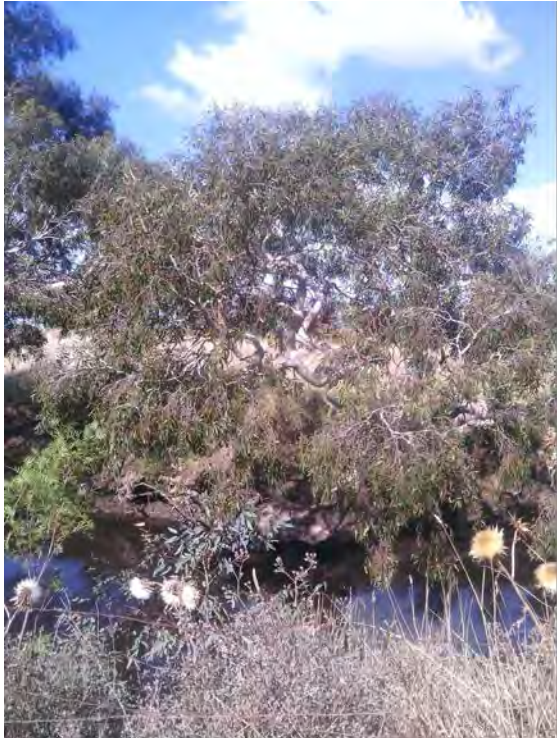
Tree ID: 148. *Eucalyptus camaldulensis* (River Red Gum), Maturing, Indigenous. Arb. Rating: Mod.A. Past branch failure. DBH: 75 cm. TPZ rad 9 m radius. Permit req'ment: ESO 2&5, 52.17. Map ref: 5

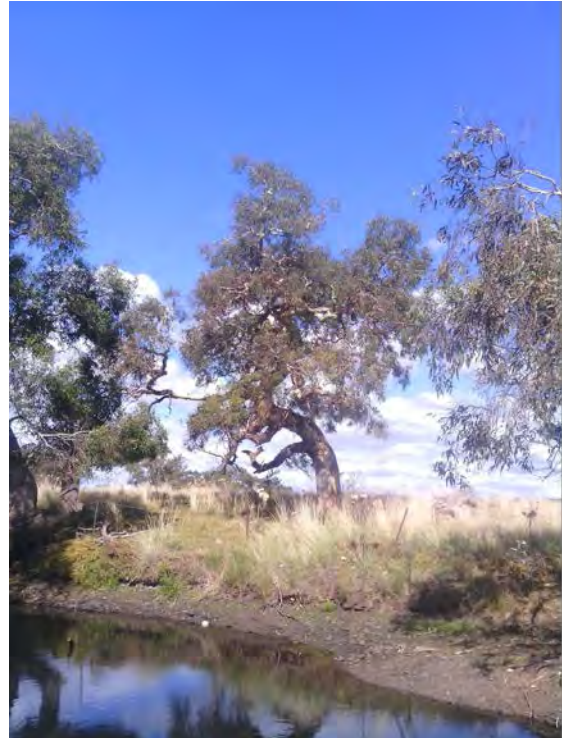
Tree ID: 146. *Eucalyptus camaldulensis* (River Red Gum), Maturing, Indigenous. Arb. Rating: High. DBH: 55, 30, 30 cm. TPZ rad 8.3 m radius. Permit req'ment: ESO 2&5, 52.17. Map ref: 5

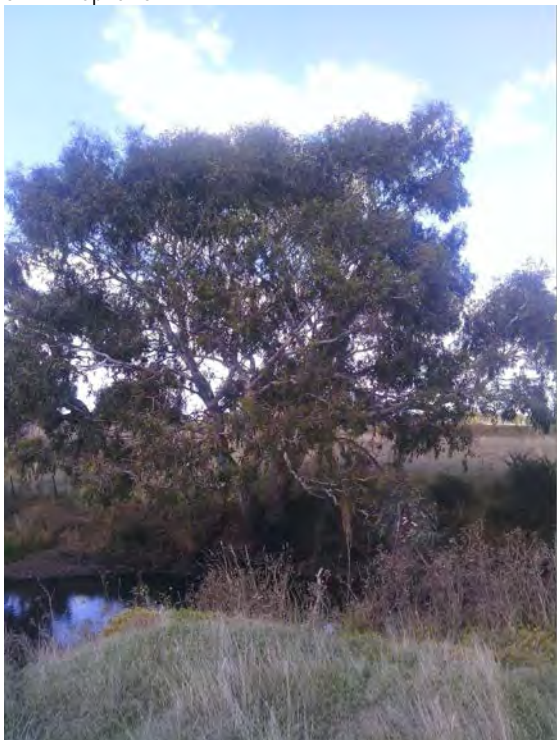
Tree ID: 149. *Eucalyptus camaldulensis* (River Red Gum), Maturing, Indigenous. Arb. Rating: Mod.A. Water edge, exposed roots, past branch failure. DBH: 50, 30 cm. TPZ rad 7 m radius. Permit req'ment: ESO 2&5, 52.17. Map ref: 5

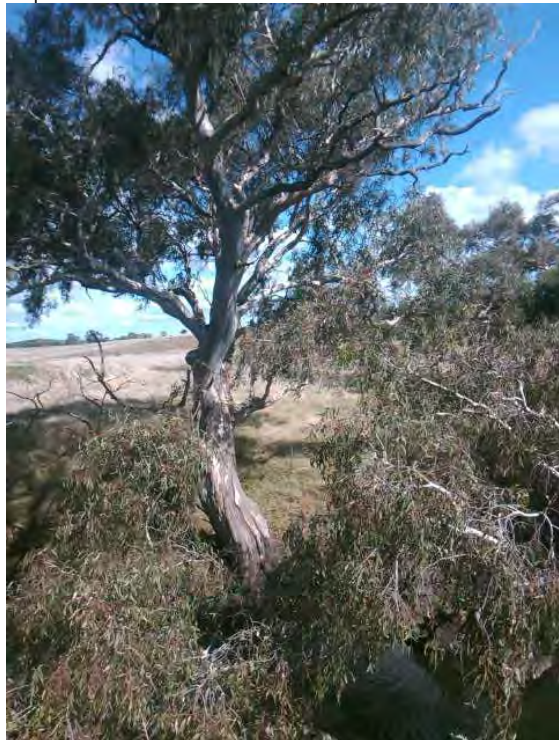
Tree ID: 155. *Eucalyptus camaldulensis* (River Red Gum), Early-mature, Indigenous. Arb. Rating: Mod.B. Waters edge, past limb failure. DBH: 60 cm. TPZ rad 7.2 m radius. Permit req'ment: ESO 2&5, 52.17. Map ref: 5

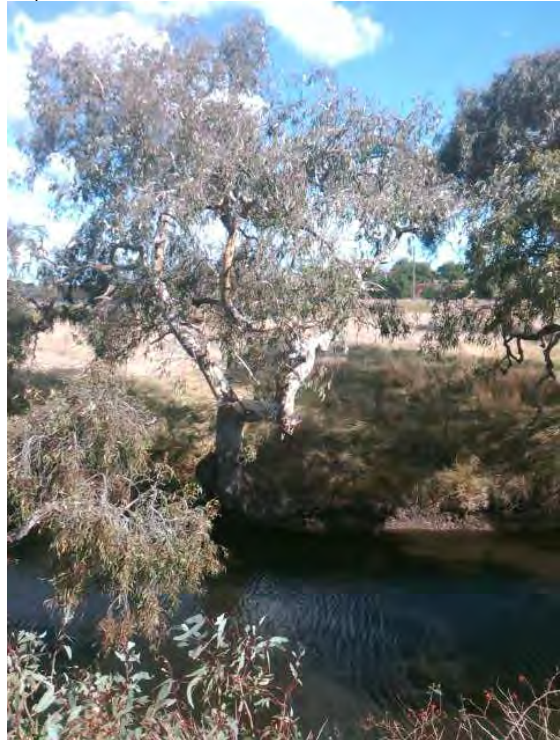
Tree ID: 156. *Eucalyptus camaldulensis* (River Red Gum), Early-mature, Indigenous. Arb. Rating: Mod.B. Waters edge, abnormal lean. Trunk extends west over creek.
 DBH: 54 cm. TPZ rad 6.5 m radius. Permit req'ment: ESO 2&5, 52.17.
 Map ref: 5

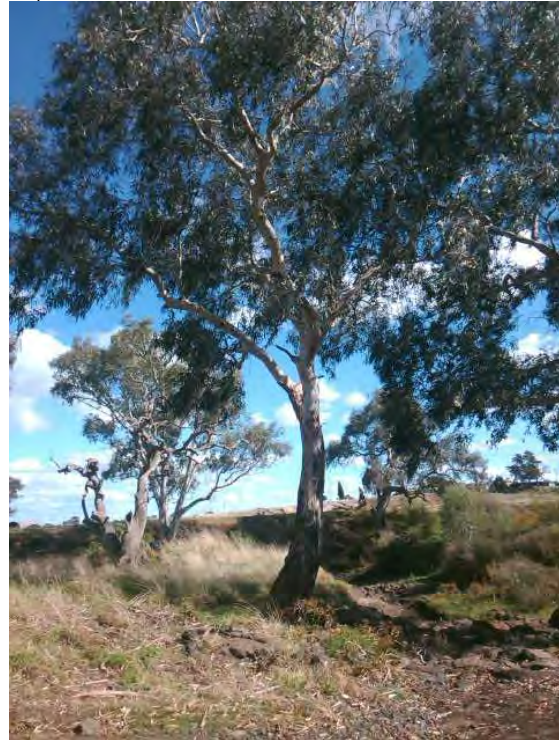
Tree ID: 165. *Eucalyptus camaldulensis* (River Red Gum), Early-mature, Indigenous. Arb. Rating: Mod.B. Past limb failure, crown bias south, growing in rock at creek crossing.
 DBH: 65 cm. TPZ rad 7.8 m radius. Permit req'ment: ESO 2&5, 52.17.
 Map ref: 5,6

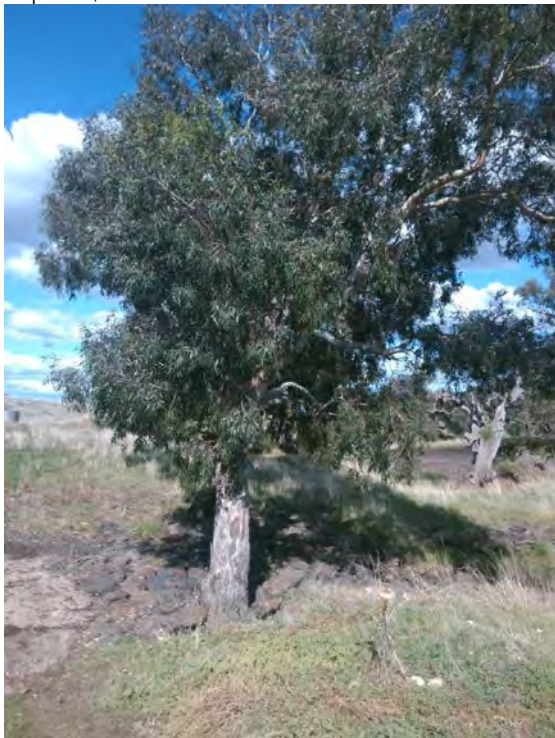
Tree ID: 167. *Eucalyptus camaldulensis* (River Red Gum), Maturing, Indigenous. Arb. Rating: Mod.B. Waters edge, undermined by floods.
 DBH: 82 cm. TPZ rad 9.8 m radius. Permit req'ment: ESO 2&5, 52.17.
 Map ref: 5,6

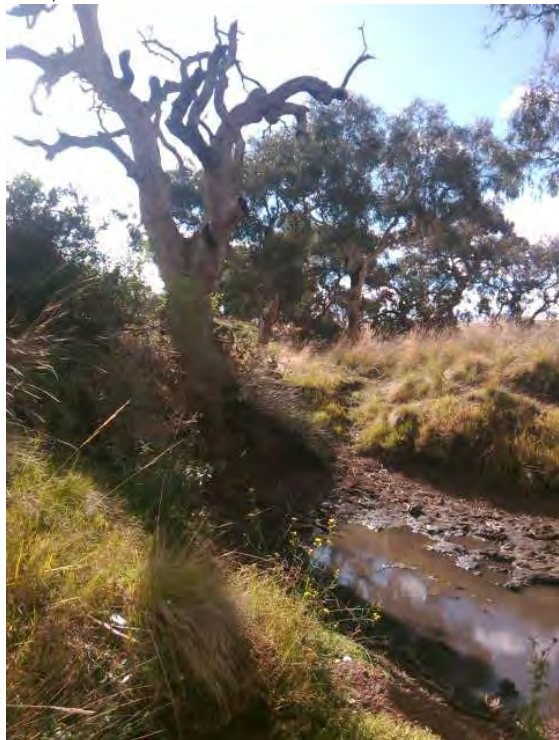
Tree ID: 171. *Eucalyptus camaldulensis* (River Red Gum), Maturing, Indigenous. Arb. Rating: High. Deadwood >50mm, past limb failure, over-extended limbs developing-. Sth.
DBH: 179 cm. TPZ rad 15 m radius. Permit req'ment: ESO 2&5, 52.17. Map ref: 6

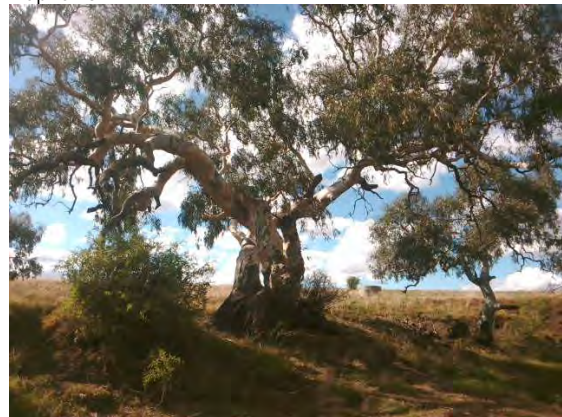
Tree ID: 172. *Eucalyptus camaldulensis* (River Red Gum), Maturing, Indigenous. Arb. Rating: Mod.B. Exposed roots, undermined by floods, over-extended limbs developing-. West, in creekline, trunk leaning SE.
DBH: 104 cm. TPZ rad 12.5 m radius. Permit req'ment: ESO 2&5, 52.17. Map ref: 6

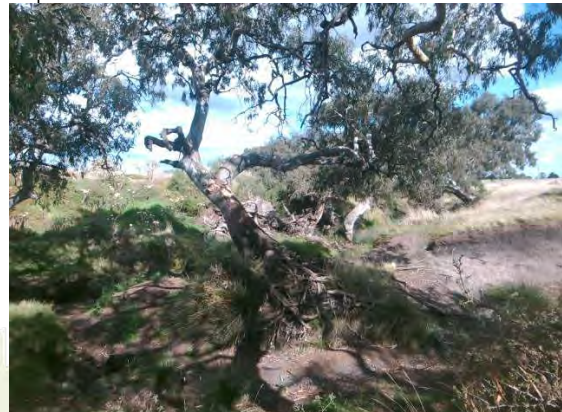
Tree ID: 173. *Eucalyptus camaldulensis* (River Red Gum), Early-mature, Indigenous. Arb. Rating: Mod.B. Waters edge, flush cut, incipient decay, trunk wounds.
 DBH: 65 cm. TPZ rad 7.8 m radius. Permit req'ment: ESO 2&5, 52.17.
 Map ref: 6

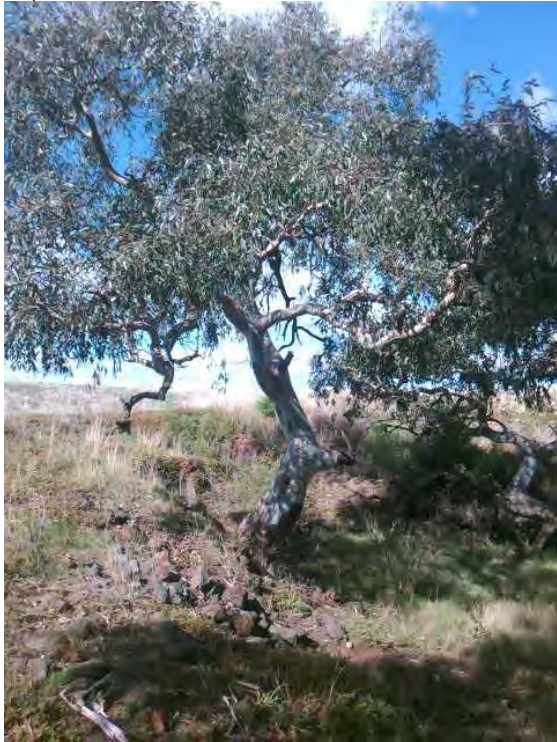
Tree ID: 175. *Eucalyptus camaldulensis* (River Red Gum), Maturing, Indigenous. Arb. Rating: Mod.B. Waters edge. Tree collapsed into creek under weight of other collapsed tree, growing up again, large trunks washed up against base.
 DBH: 59 cm. TPZ rad 7.1 m radius. Permit req'ment: ESO 2&5, 52.17.
 Map ref: 6

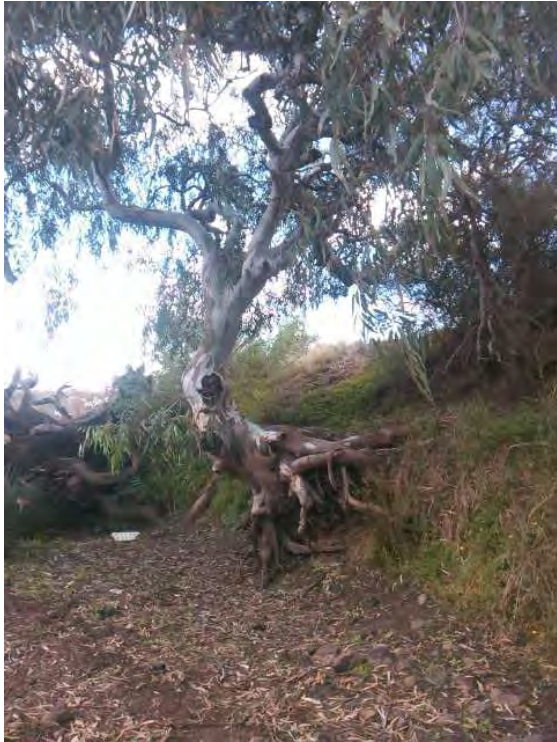
Tree ID: 179. *Eucalyptus camaldulensis* (River Red Gum), Maturing, Indigenous. Arb. Rating: Mod.C. Deadwood >50mm, past stem failure, weed infested.
DBH: 105 cm. TPZ rad 12.6 m radius. Permit req'ment: ESO 2&5, 52.17. Map ref: 6

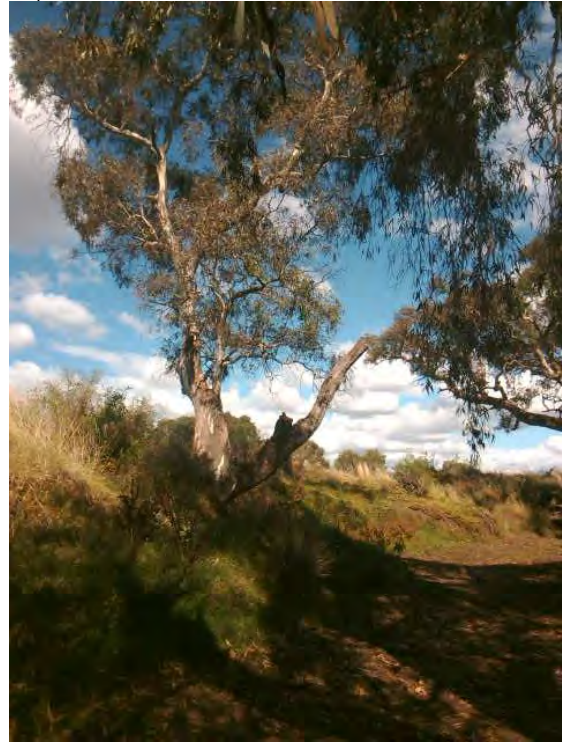
Tree ID: 178. *Eucalyptus camaldulensis* (River Red Gum), Maturing, Indigenous. Arb. Rating: Mod.C. Exposed roots, undermined by floods, incipient decay, past limb failure, trunk wounds.
DBH: 100 cm. TPZ rad 12 m radius. Permit req'ment: ESO 2&5, 52.17. Map ref: 5,6

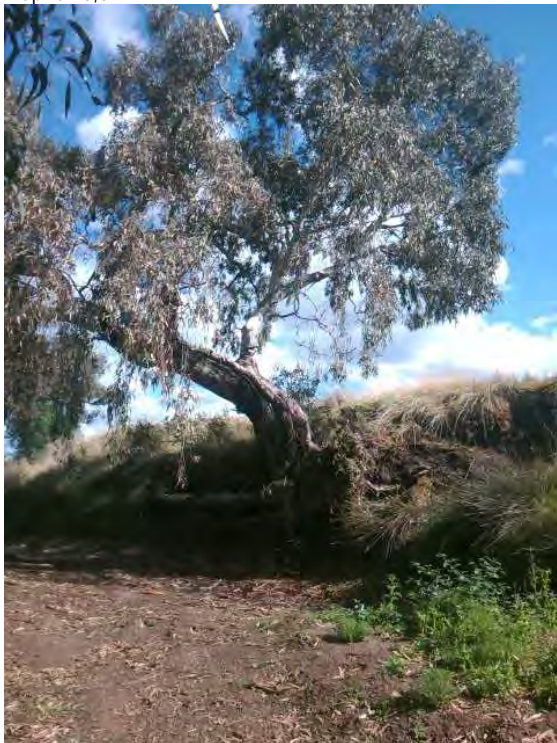
Tree ID: 180. *Eucalyptus camaldulensis* (River Red Gum), Maturing, Indigenous. Arb. Rating: Mod.B. Waters edge, exposed roots. Undermined by floods.
DBH: 130 cm. TPZ rad 15 m radius. Permit req'ment: ESO 2&5, 52.17. Map ref: 6

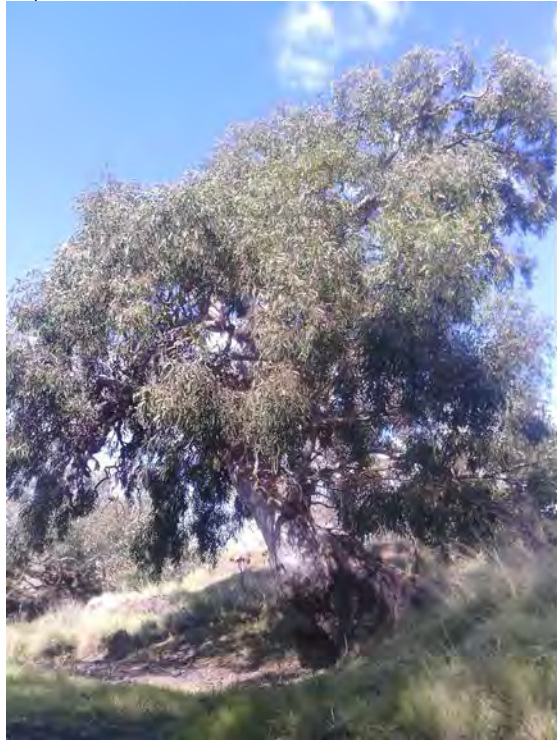
Tree ID: 188. *Eucalyptus camaldulensis* (River Red Gum), Maturing, Indigenous. Arb. Rating: Mod.A. Water edge, bee hive, exposed roots, past branch failure, trunk wounds. DBH: 90 cm. TPZ rad 10.8 m radius. Permit req'ment: ESO 2&5, 52.17. Map ref: 6

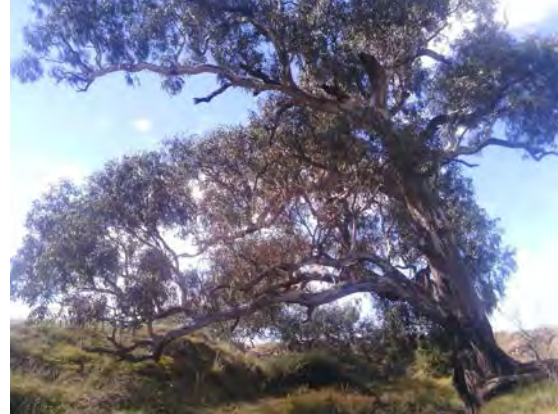
Tree ID: 189. *Eucalyptus camaldulensis* (River Red Gum), Maturing, Indigenous. Arb. Rating: High. DBH: 90 cm. TPZ rad 10.8 m radius. Permit req'ment: ESO 2&5, 52.17. Map ref: 6

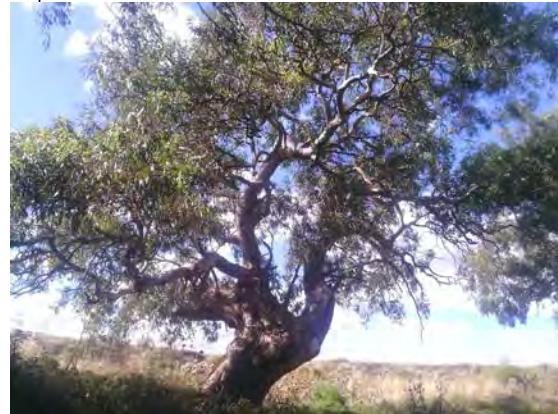
Tree ID: 187. *Eucalyptus camaldulensis* (River Red Gum), Maturing, Indigenous. Arb. Rating: Mod.C. Water edge, epicormic shoots, exposed roots, reduced foliage density, trunk decay. DBH: 80 cm. TPZ rad 9.6 m radius. Permit req'ment: ESO 2&5, 52.17. Map ref: 6

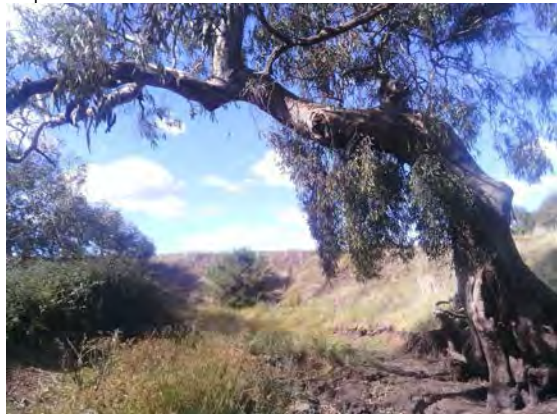
Tree ID: 196. *Eucalyptus camaldulensis* (River Red Gum), Maturing, Indigenous. Arb. Rating: High. Water edge.
 DBH: 120 cm. TPZ rad 14.4 m radius. Permit req'ment: ESO 2&5, 52.17.
 Map ref: 6,7

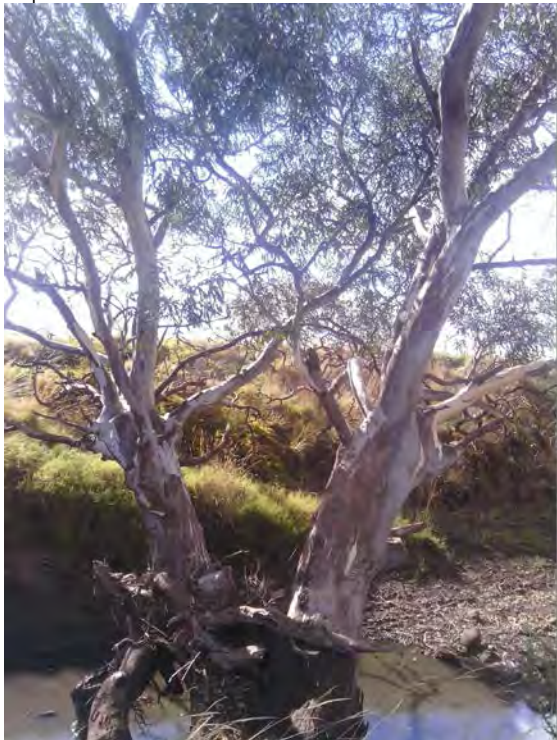
Tree ID: 200. *Eucalyptus camaldulensis* (River Red Gum), Maturing, Indigenous. Arb. Rating: Mod.A. Water edge, past limb failure. DBH: 80 cm. TPZ rad 9.6 m radius. Permit req'ment: ESO 2&5, 52.17. Map ref: 7

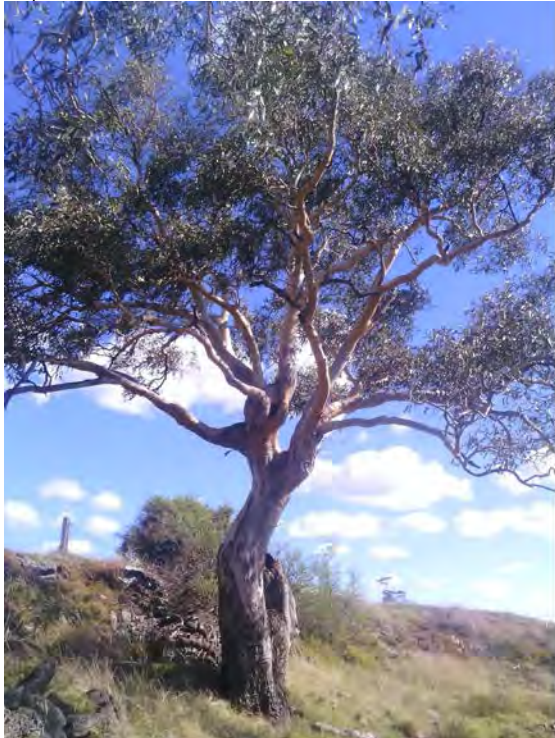
Tree ID: 202. *Eucalyptus camaldulensis* (River Red Gum), Maturing, Indigenous. Arb. Rating: Mod.A. Water edge, basal decay, exposed roots. DBH: 75 cm. TPZ rad 9 m radius. Permit req'ment: ESO 2&5, 52.17. Map ref: 7

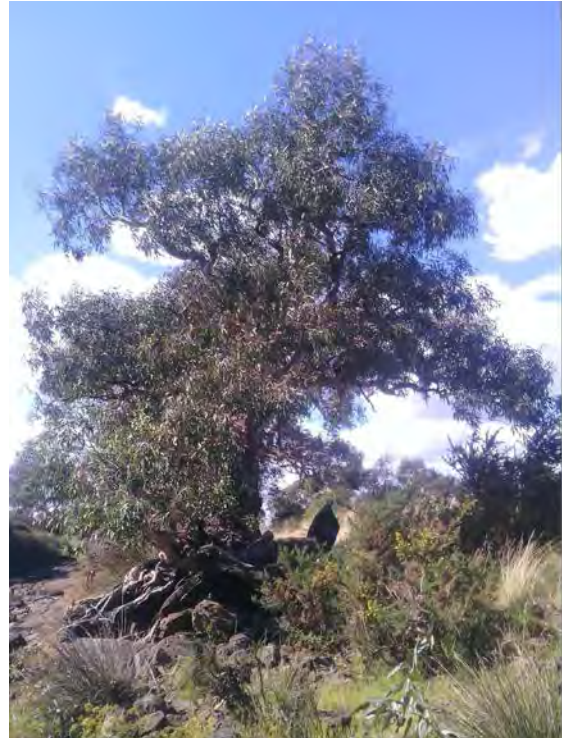
Tree ID: 201. *Eucalyptus camaldulensis* (River Red Gum), Maturing, Indigenous. Arb. Rating: Mod.A. Past branch failure. Canopy is made up from young branches. DBH: 85 cm. TPZ rad 10.2 m radius. Permit req'ment: ESO 2&5, 52.17. Map ref: 7

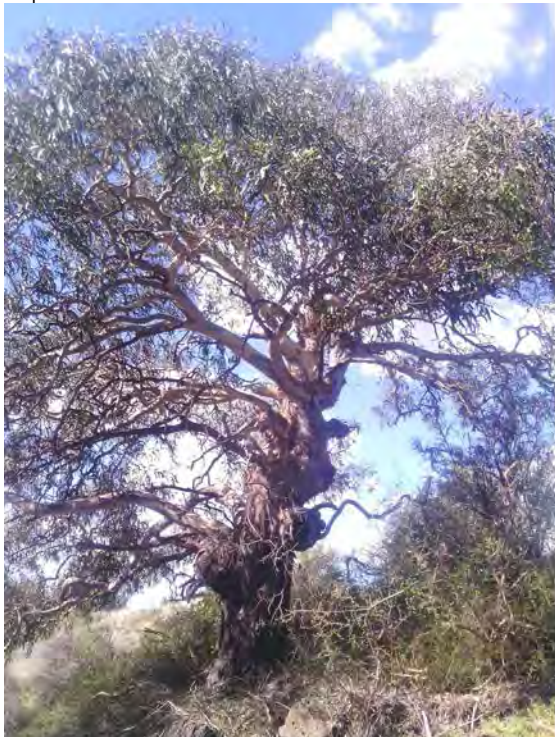
Tree ID: 203. *Eucalyptus camaldulensis* (River Red Gum), Maturing, Indigenous. Arb. Rating: High. Deadwood >50mm, past branch failure. DBH: 135 cm. TPZ rad 15 m radius. Permit req'ment: ESO 2&5, 52.17. Map ref: 7,8

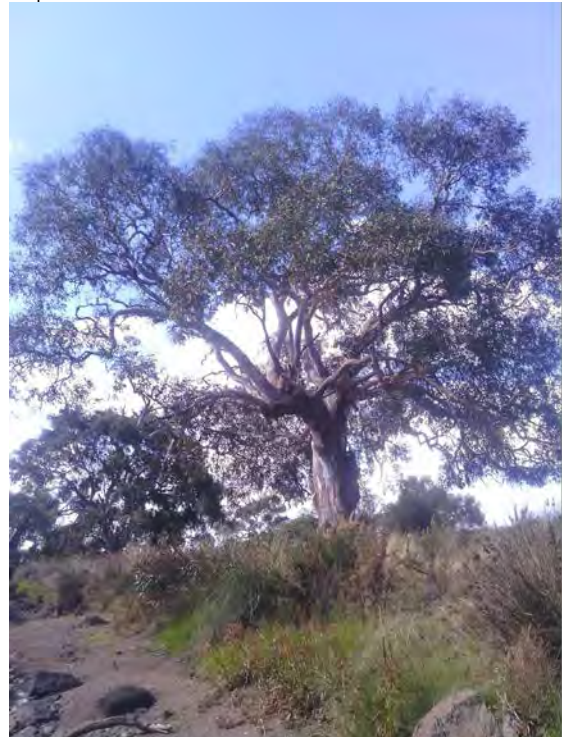
Tree ID: 205. *Eucalyptus camaldulensis* (River Red Gum), Maturing, Indigenous. Arb. Rating: Low. Water edge, epicormic crown, exposed roots, past limb failure, trunk cavity, trunk hollows. DBH: 70 cm. TPZ rad 8.4 m radius. Permit req'ment: ESO 2&5, 52.17. Map ref: 8

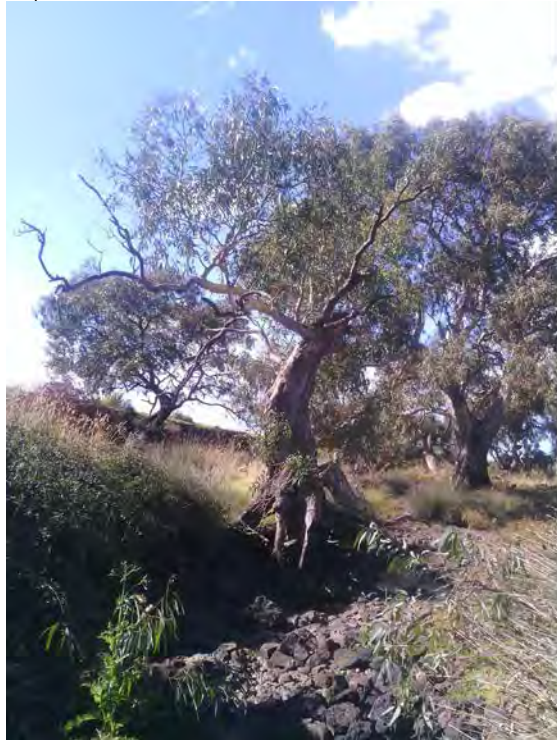
Tree ID: 212. *Eucalyptus camaldulensis* (River Red Gum), Semi-mature, Indigenous. Arb. Rating: Mod.C. Water edge, leaning trunk. DBH: 20 cm. TPZ rad 2.4 m radius. Permit req'ment: ESO 2&5, 52.17. Map ref: 8

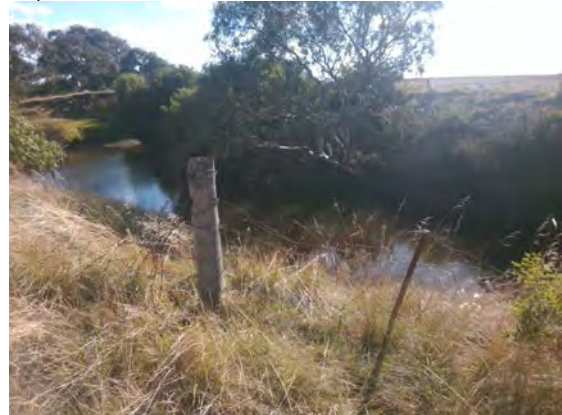
Tree ID: 224. *Eucalyptus camaldulensis* (River Red Gum), Maturing, Indigenous. Arb. Rating: Mod.B. Past branch failure, weed infested.
DBH: 90,80 cm. TPZ rad 14.4 m radius. Permit req'ment: ESO 2&5, 52.17. Map ref: 8

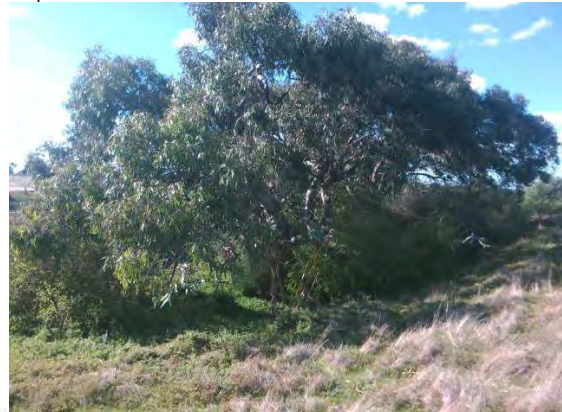
Tree ID: 225. *Eucalyptus camaldulensis* (River Red Gum), Maturing, Indigenous. Arb. Rating: Mod.B. Deadwood >50mm, trunk wounds, weed infested.
 DBH: 85 cm. TPZ rad 10.2 m radius. Permit req'ment: ESO 2&5, 52.17.
 Map ref: 8
