Environmental Conditions Summary

East Village Precinct, Bentleigh East

19 September 2017

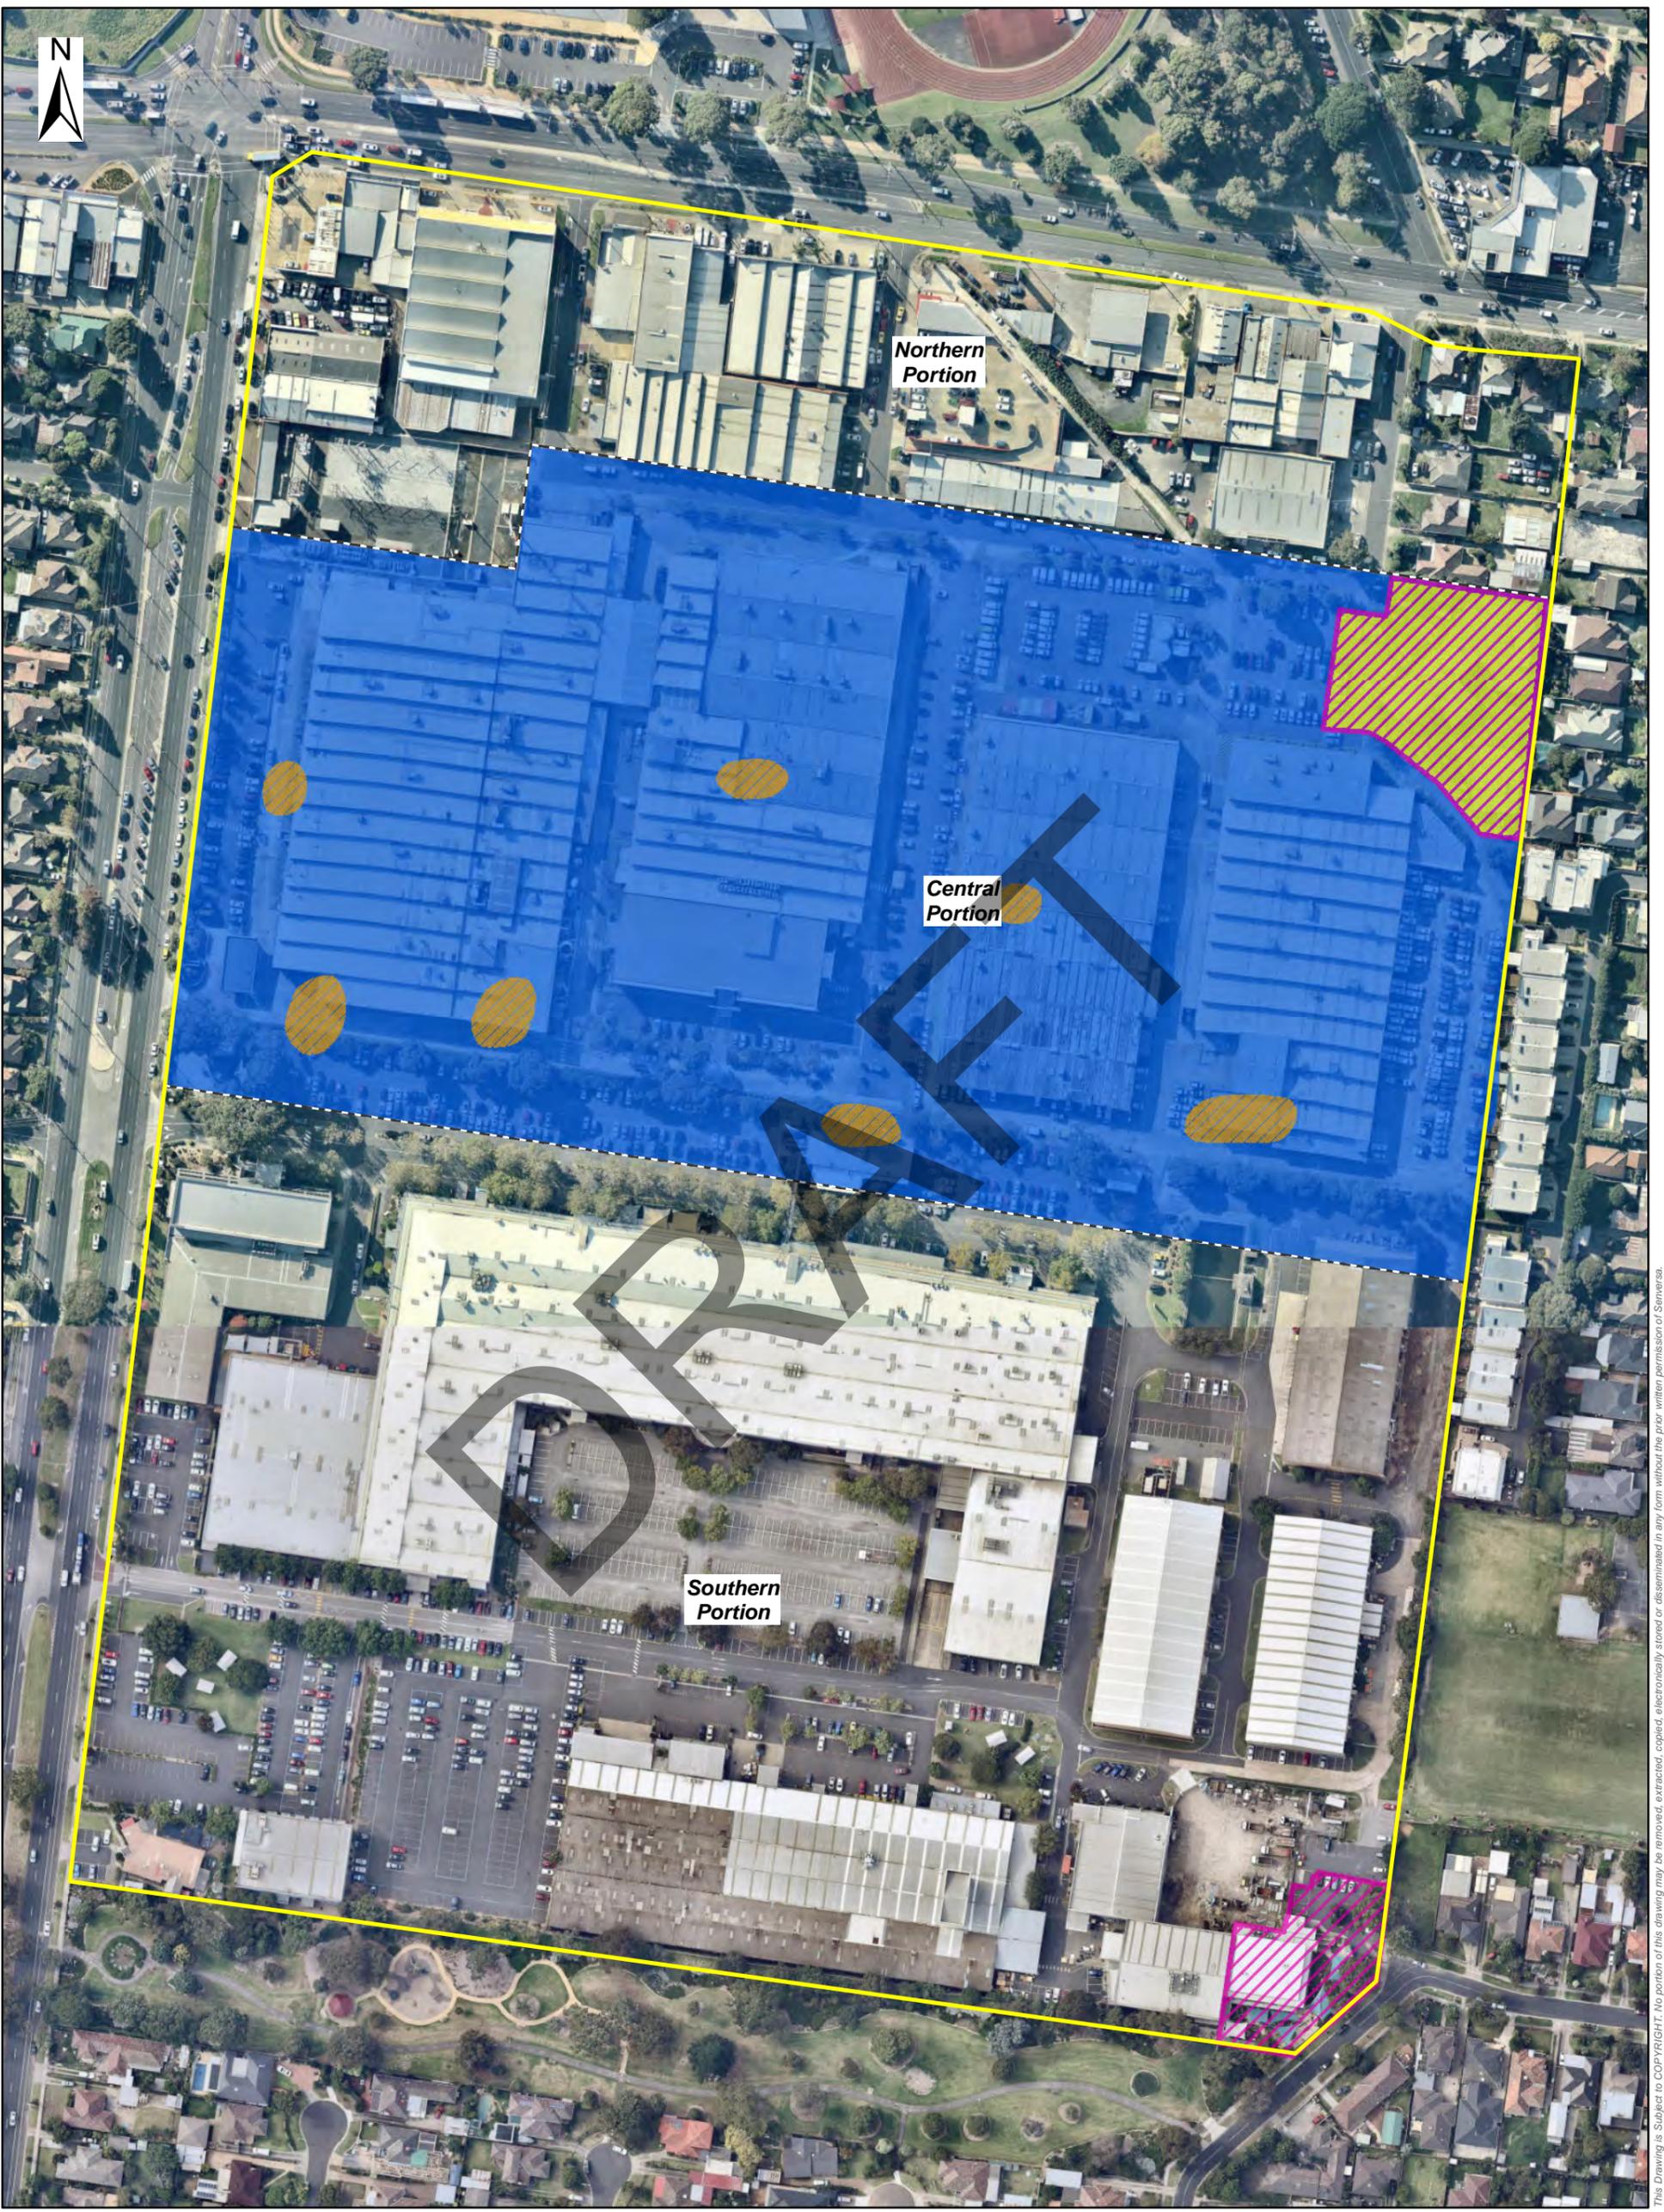
Figure 1: Summary of Environmental Conditions

The most recent available environmental report undertaken on Plants 1 and 2 (western half of the central portion) (Senversa, 2016), identified five areas of impacted soils with elevated chlorinated and petroleum hydrocarbon concentrations that represent a potential ongoing source of groundwater contamination and therefore would likely require management should the Precinct be redeveloped (see **Figure 1**). A groundwater investigation also largely delineated the extent of chlorinated hydrocarbon concentrations exceeding adopted criteria protective of beneficial uses, that would likely require management or remediation should the Precinct be redevelopment into a more sensitive use. An environmental management plan and groundwater quality and management plan is currently in place to manage potential risks that may be associated with identified impacts in soil and groundwater.

For Plants 3 and 4 (eastern half of the central portion) the most recent available environmental report (Environmental Risk Sciences, 2012) reported that two areas of impacted soils with elevated chlorinated hydrocarbon concentrations represent a potential ongoing source of groundwater contamination and therefore would likely require management should the Precinct be redeveloped (see **Figure 1**). Elevated concentrations of chlorinated hydrocarbons in groundwater were also reported to be exceeding adopted criteria protective of beneficial uses on the Precinct.

Groundwater beneath the former Plant 5 was found to be polluted by elevated concentrations of petroleum hydrocarbons, ammonia, metals (arsenic, beryllium, total chromium, cobalt, copper, nickel, iron, manganese and zinc), nitrate, sulphate, and pH.

For the remainder of the southern portion of the Precinct the Phase 2 ESA report (LWM, 2015b) reported soil conditions to be below adopted investigation for human health and ecological criteria with the exceptions of elevated concentrations of benzo(a)pyrene and nickel exceeding adopted ecological criteria in one location each.

In conjunction with this, elevated concentrations of chlorinated and petroleum hydrocarbons exceeding adopted investigation criteria were identified on the western portion of the boundary between the central and southern portions of the Precinct underneath the carpark. These elevated concentrations would likely required clean up or management should the Precinct be redeveloped for a more sensitive use.

Soil and groundwater remediation in the form of in situ chemical oxidation (ISCO) has previously been undertaken in areas of soil and groundwater found to be the most heavily impacted by chlorinated solvents in former Plants 1, 2, and 4 in the central portion of the Precinct. Measurable decreases in chlorinated hydrocarbon concentrations were measured in groundwater following the ISCO remedial attempts, however these decreases did not generally persist and further remediation of the seven impacted soil areas and groundwater within the central portion of the Precinct (as shown on **Figure 1**) will be required as a part of the redevelopment of the Precinct.

For the identified impacted soil and groundwater area shown on **Figure 1**, potential management / remediation measures that may be able to be employed (potentially more than one) to manage potential risks the future development include one or more of the following:
