Environmental Conditions Summary

East Village Precinct, Bentleigh East

19 September 2017

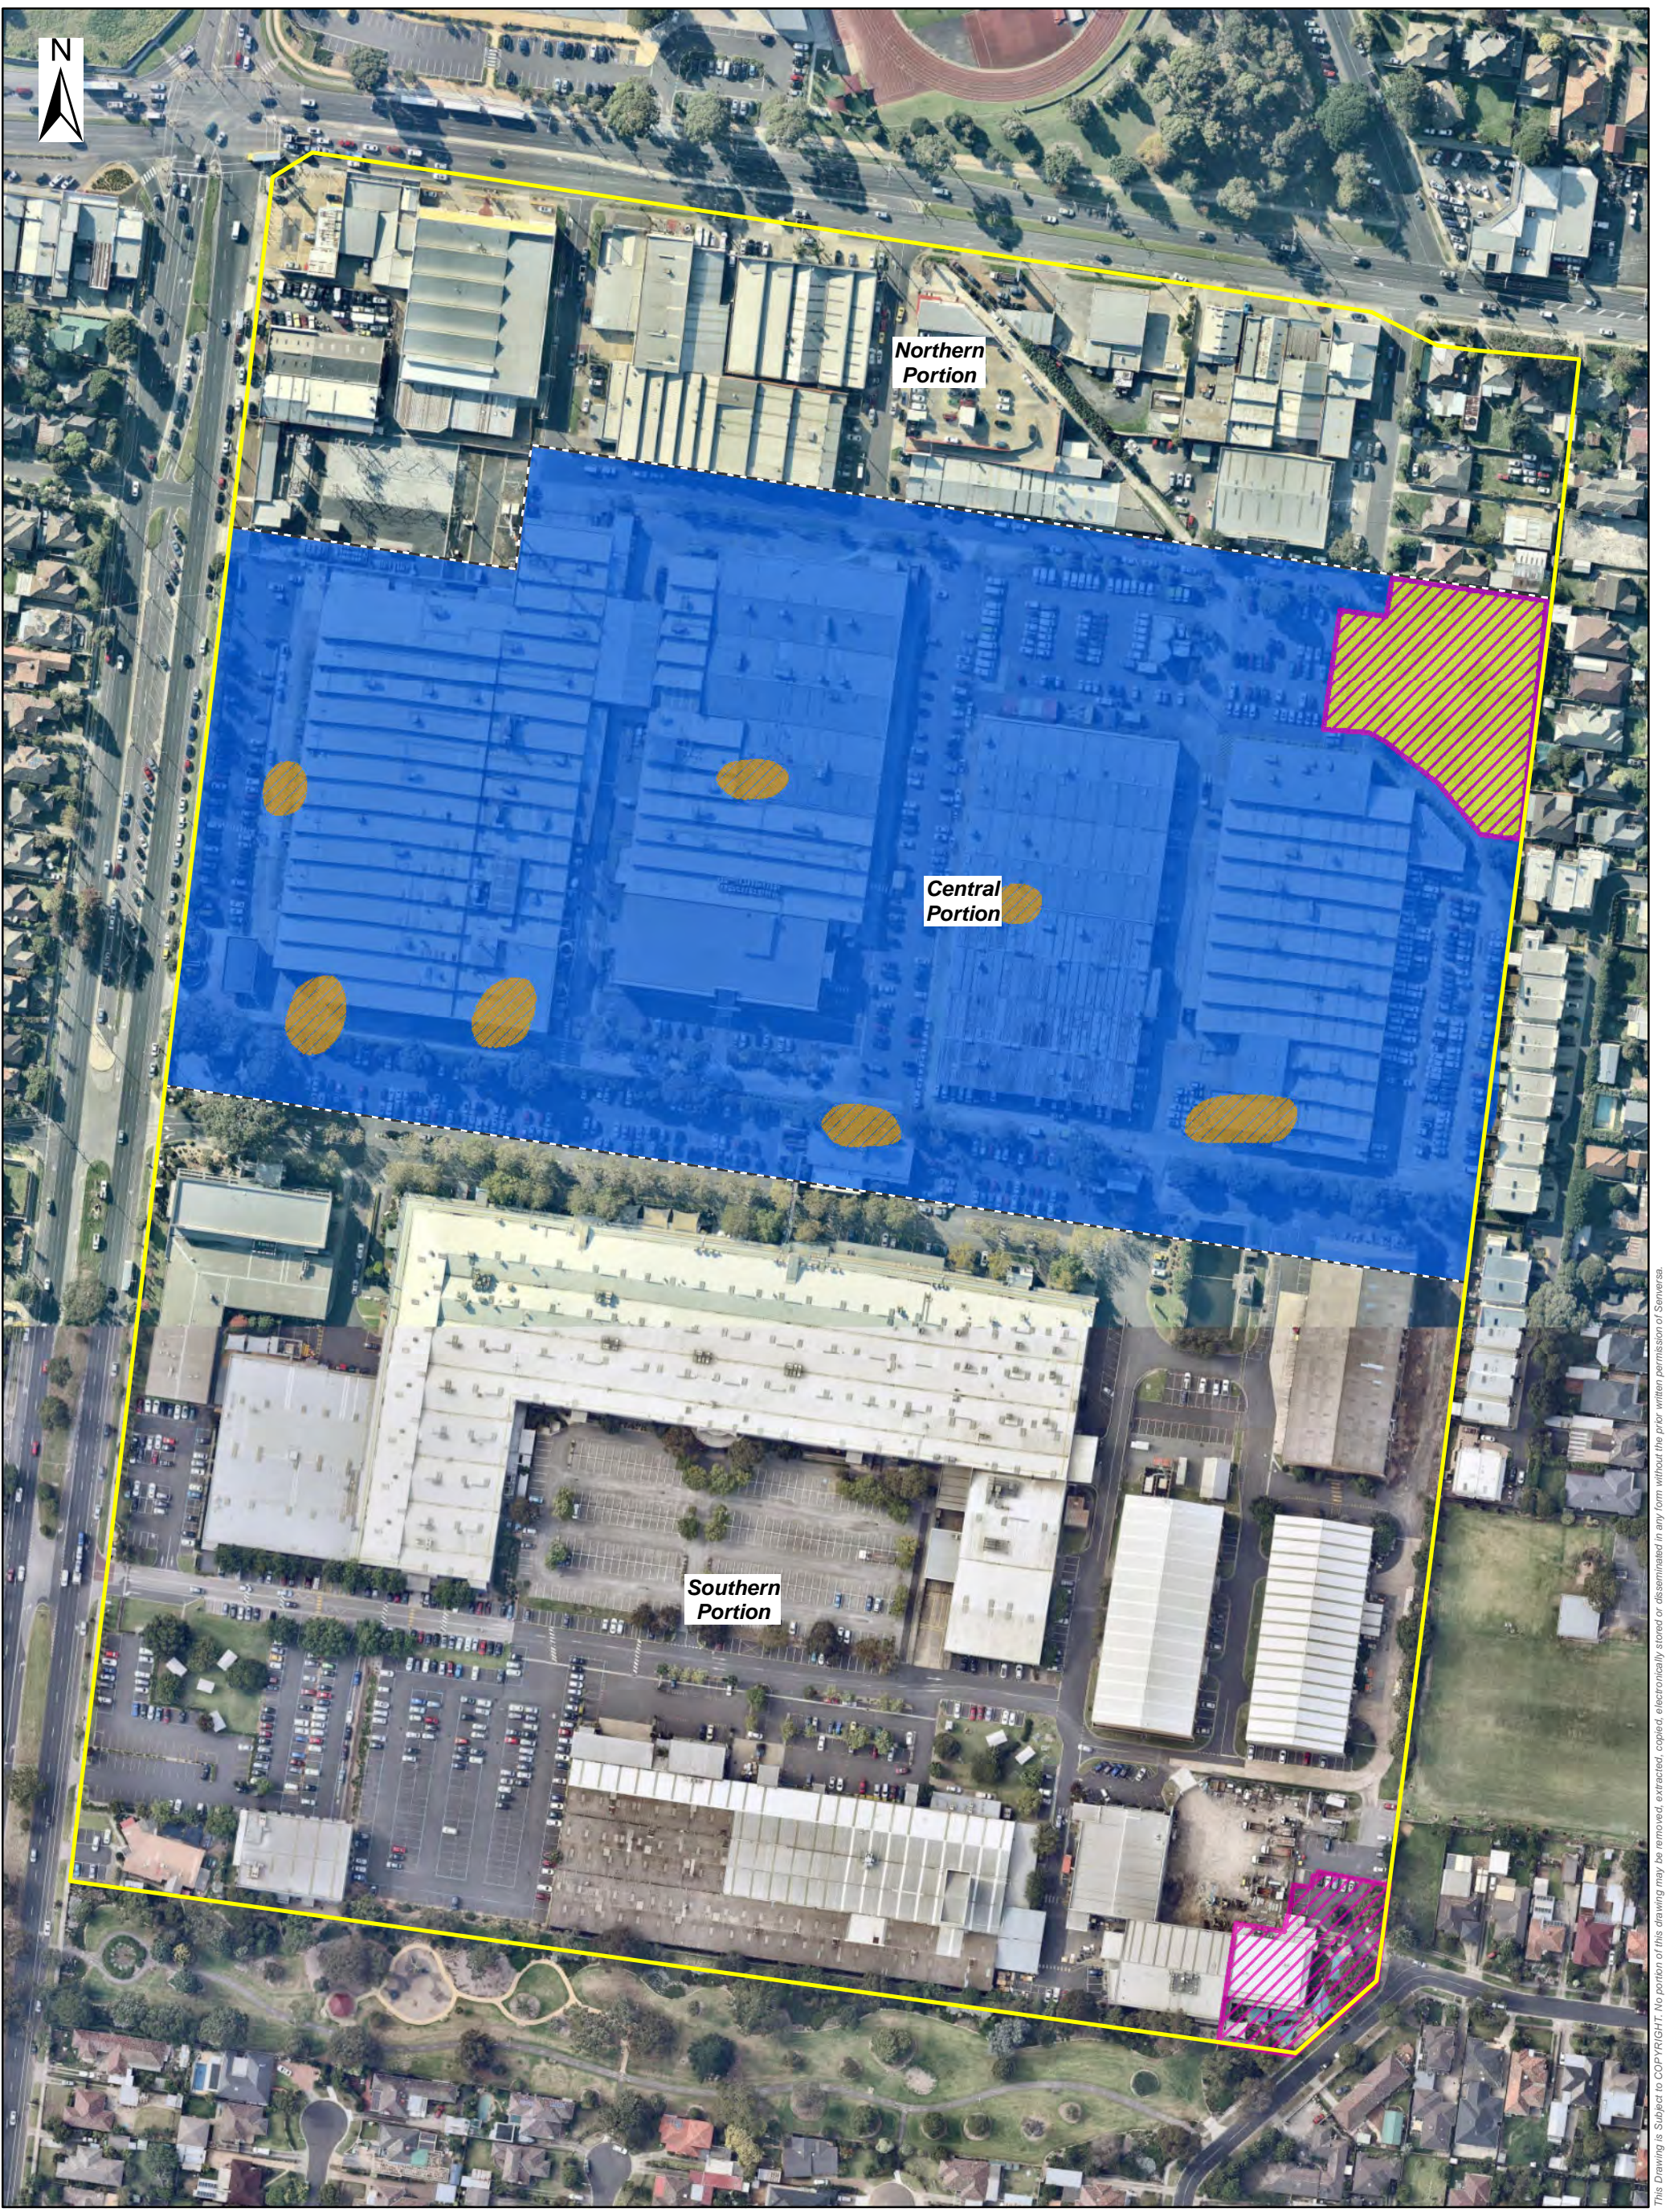
Figure 1: Summary of Environmental Conditions

Soil and groundwater remediation in the form of in situ chemical oxidation (ISCO) has previously been undertaken in areas of soil and groundwater found to be the most heavily impacted by chlorinated solvents in former Plants 1, 2, and 4 in the central portion of the Precinct. Measurable decreases in chlorinated hydrocarbon concentrations were measured in groundwater following the ISCO remedial attempts, however these decreases did not generally persist and further remediation of the seven impacted soil areas and groundwater within the central portion of the Precinct (as shown on **Figure 1**) will be required as a part of the redevelopment of the Precinct.

For the identified impacted soil and groundwater area shown on **Figure 1**, potential management / remediation measures that may be able to be employed (potentially more than one) to manage potential risks the future development include one or more of the following:

- Soil source remediation – Excavation, off-site disposal and emplacement of carbon source amendment.
- Soil source remediation – Soil mixing and emplacement of carbon source amendment.
- Enhanced groundwater bioremediation with carbon source amendment.
- Enhanced groundwater bioremediation with microbial augmentation.
- Monitored natural attenuation with source remediation.
- Permeable reactive barrier.
- Hydraulic control.
