2 May 2018

155 Dore Road Pakenham tree assessment

Our ref: Matter 27511

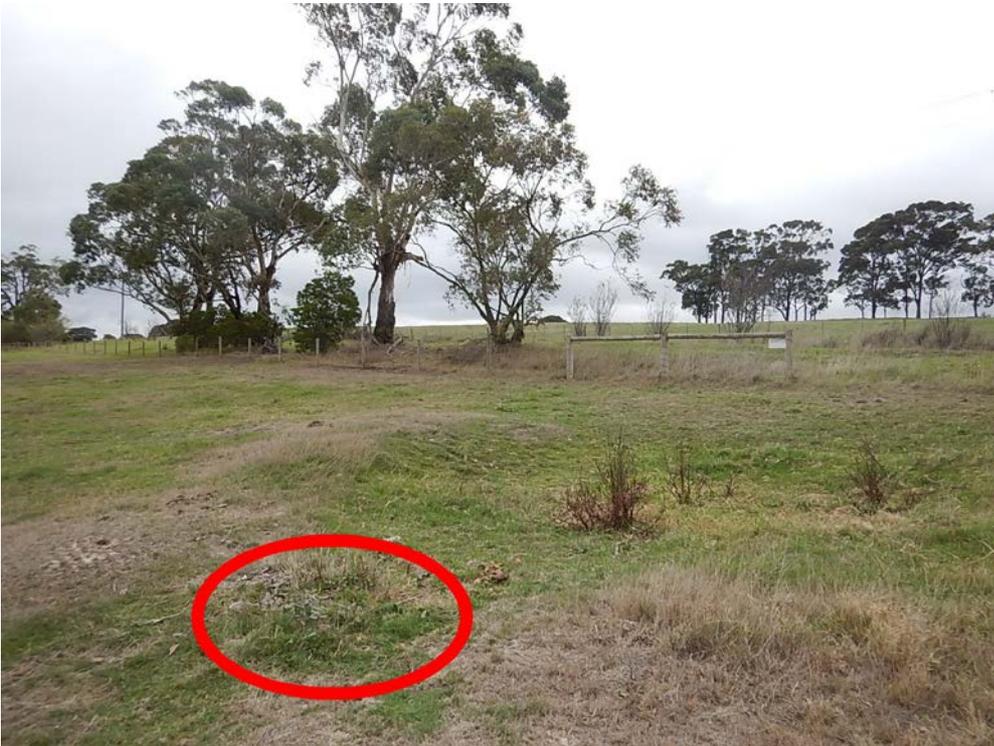
Tree ID	Species	Condition	Value for fauna	Ecological value	Photo
141	Dead Stag	No longer present. The landholder informed us that this tree fell over several years ago and was subsequently cleaned up and removed from the site.	None	None	1
142	Dead Stag	No longer present. The landholder informed us that this tree fell over in the last few years and was subsequently cleaned up and removed from the site.	None	None	2

Photo 1 Mapped location of tree 141. Depression in soil of original tree base indicated in red.

The three trees no longer present (141, 142 and 145) should be removed from the NVPP. These may not contribute to the offsets required under the NVPP and do not provide any current ecological values.

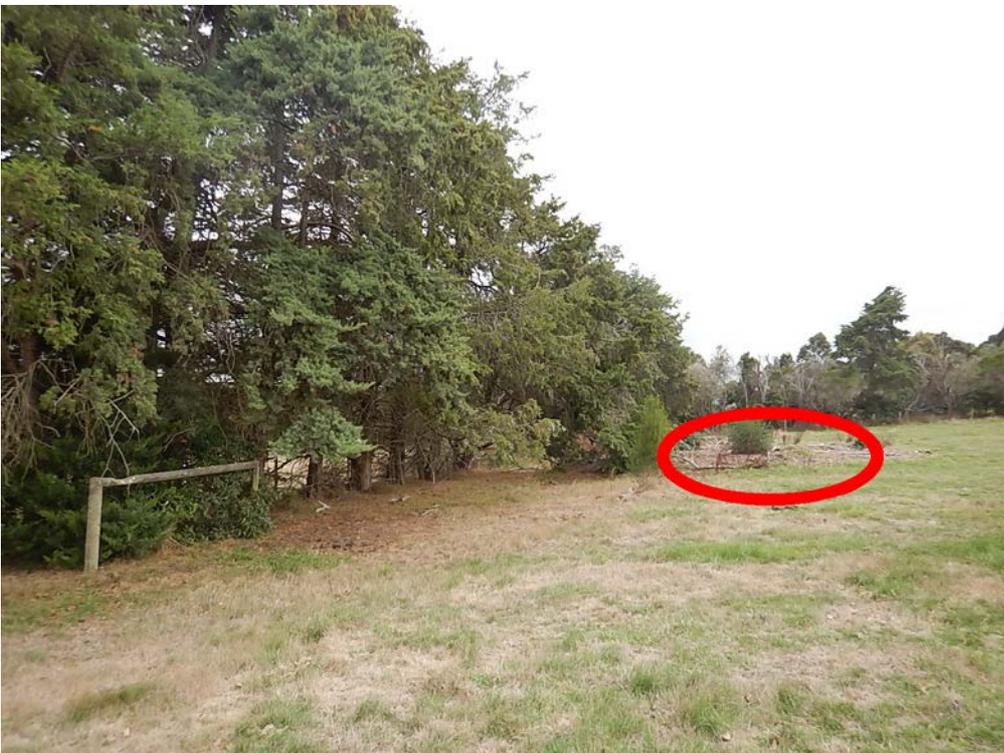
Photo 2 Mapped location of tree 142 (indicated in red).

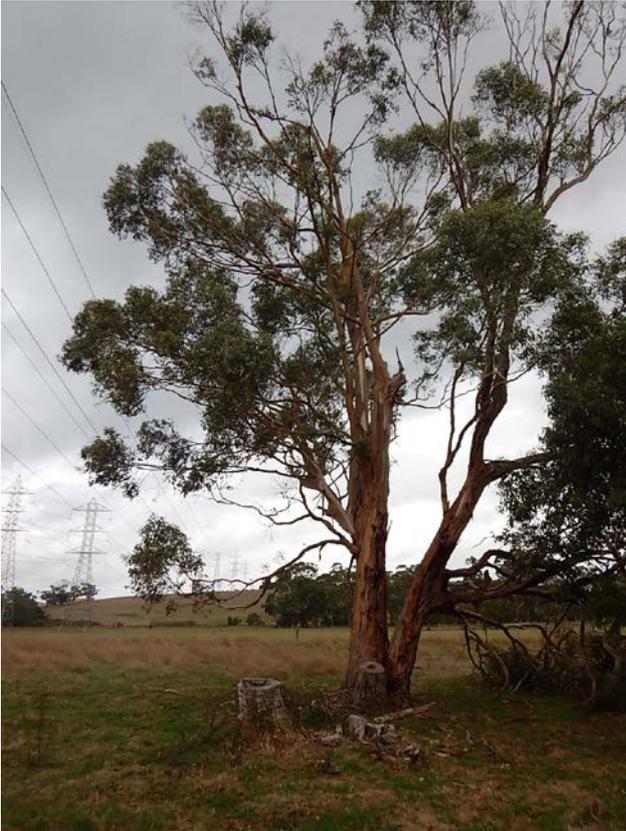
Photo 3 Mapped location of tree 145 (stump in foreground with tree 147 in background).

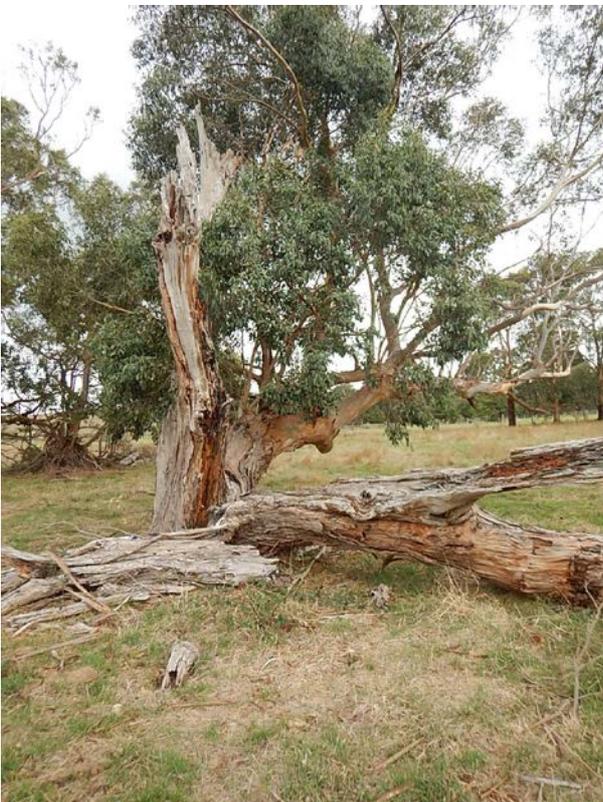
Photo 4 Tree number 143.

Tree ID	Species	Condition	Value for fauna	Ecological value	Photo
143	<i>Eucalyptus ovata</i>	Poor. This tree has undergone significant limb loss. The largest limb has broken off the tree. The remaining limb is cracked at the base and the trunk of this tree is split through the middle. It is likely that the last living limb of this tree will snap off in the coming years.	Limited. No hollows located in the tree. It may provide occasional foraging habitat for common bird and possum species. The fallen limb is providing potential habitat for reptiles but this is insignificant in a landscape context and overall of low ecological value.	Limited. The tree is not connected to any habitat corridors and the long term value of retaining this tree is limited as all other trees in the vicinity are also in poor condition and subject to ongoing maintenance associated with the high voltage powerline.	4, 5

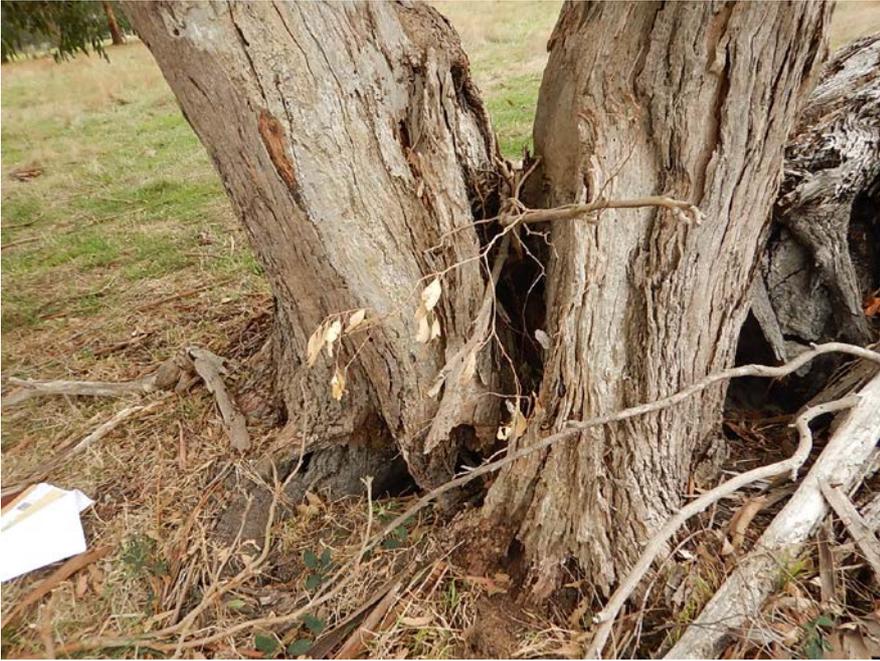
Photo 5 Tree number 143, depicting large split in trunk.

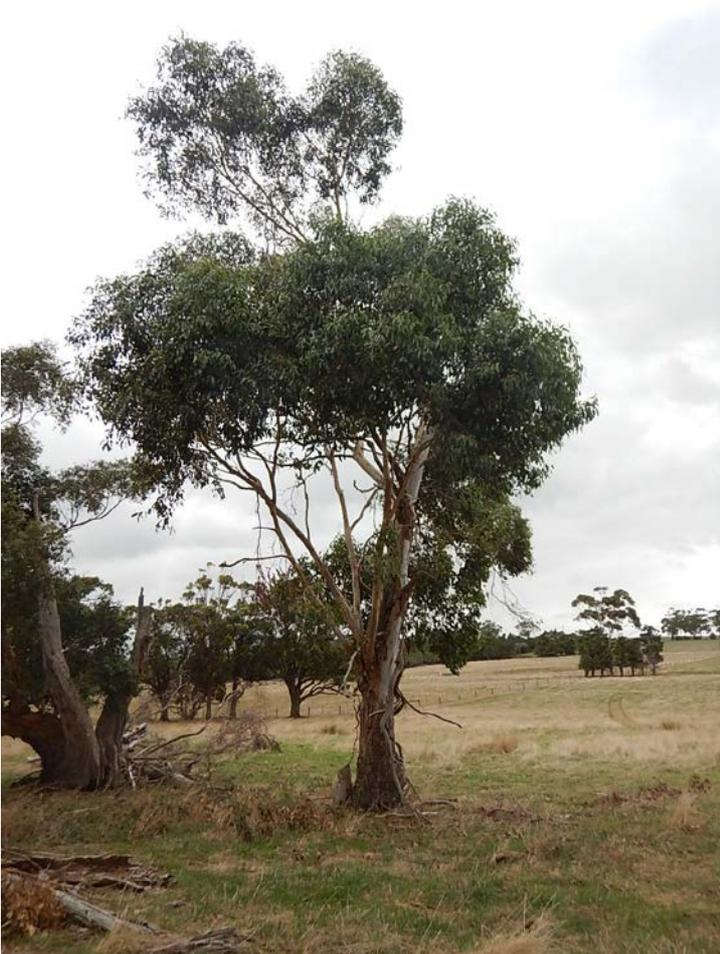
Photo 6 Tree number 144.

144	Swamp Gum <i>Eucalyptus ovata</i>	Moderate. This tree has undergone and will continue to undergo extensive canopy lopping due to its proximity to powerlines. The existing branches and canopy appears to be in good health.	Limited. No hollows located in the tree. It may provide occasional foraging habitat for common bird and possum species.	Limited. The tree is not connected to any habitat corridors and the long term value of retaining this tree is limited as all other trees in the vicinity are also in poor condition and subject to ongoing maintenance associated with the high voltage powerline.	6, 7
145	Swamp Gum	No longer present. The landholder informed us that this tree was removed by the power management company as it was deemed a risk to the adjacent high voltage powerlines. All material from this tree has been removed from site.	None	None	3
146	Swamp Gum	Moderate/ Poor. There is evidence that the original main branch of this tree broke off in the past. The current form of the tree is multiple small coppiced branches that appear weak and are currently under stress from fallen branches from the adjacent tree 147. Canopy appears to be in good health.	Limited. No hollows located in the tree. It may provide occasional foraging habitat for common bird and possum species.	The tree is not connected to any habitat corridor and the longer term value of retaining this tree is limited as all other trees in the vicinity are also in poor condition and subject to ongoing maintenance associated with the high voltage powerline.	8

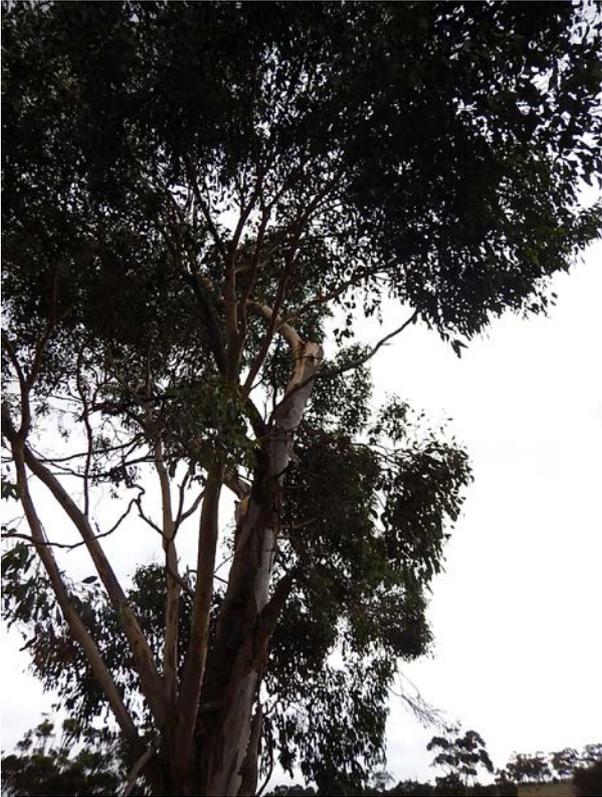
Photo 7 Tree number 144, depicting where canopy had been previously lopped.

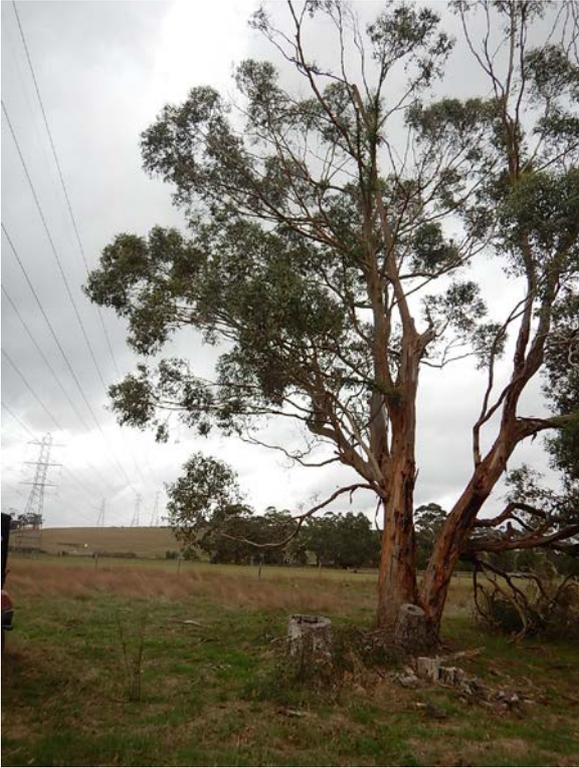
Photo 9 **Tree number 147.**

147	Swamp Gum	Moderate/ Poor. This tree undergoes lopping for maintenance of the adjacent high voltage powerlines. It currently appears stressed and has dropped limbs.	Limited. No hollows located in the tree, the tree may provide occasional foraging habitat for common bird and possum species.	The tree is not connected to any habitat corridor and the long term value of retaining this tree is limited as all other trees in the vicinity are also in poor condition and subject to ongoing maintenance associated with the high voltage powerline.	9,10

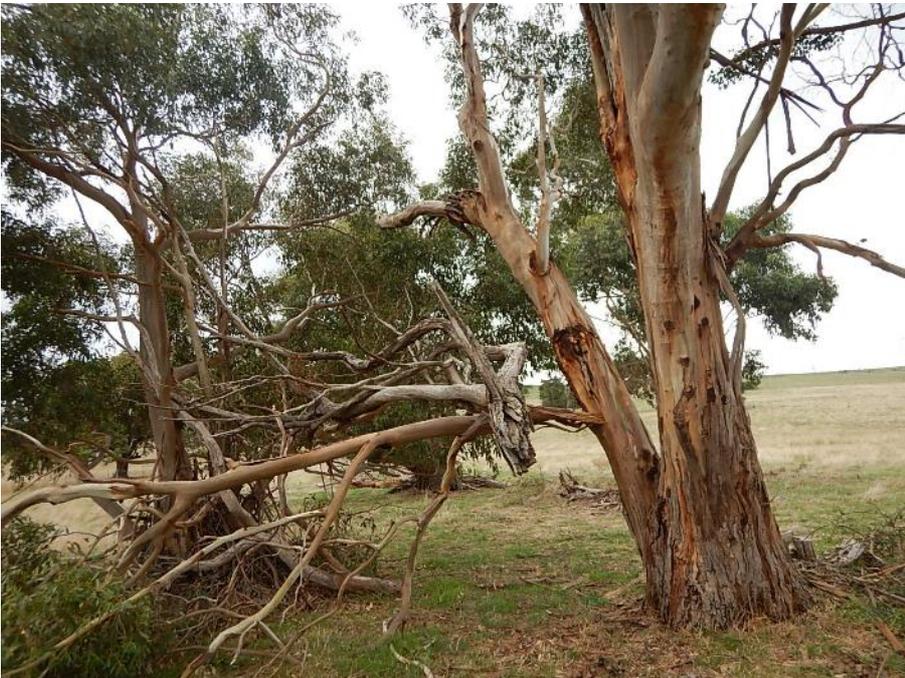
Photo 10 **Limb loss on tree number 147.**
