## Lindum Vale Dry Stone Wall Historic Heritage Assessment

CLIENT: MAB Corporation

FINAL DATE: 12 April 2016

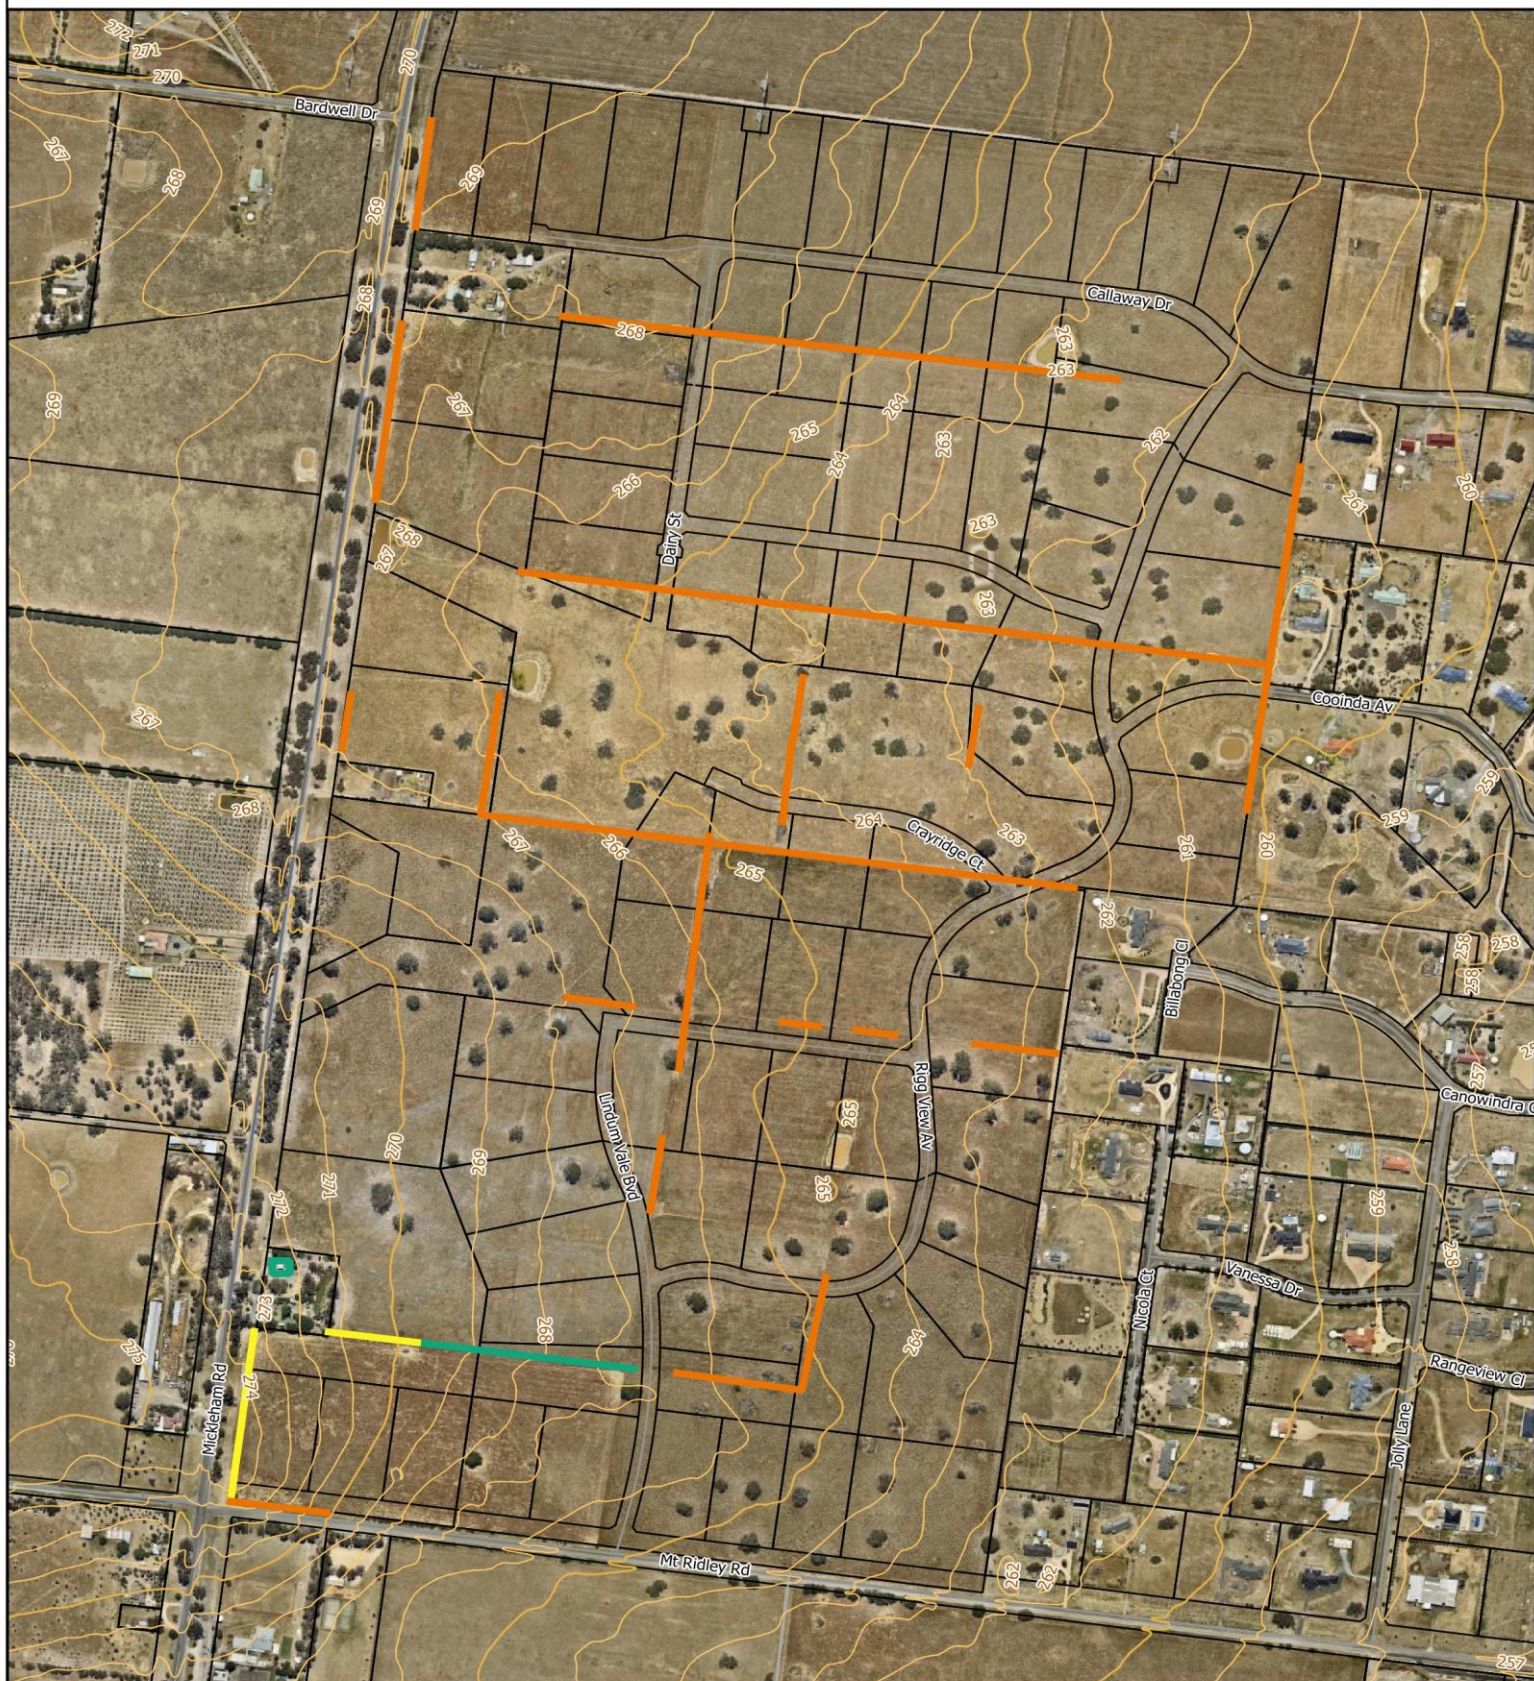
# Lindum Vale Dry Stone Walls Distribution and Condition Rating

There is approximately 4.3 km of linear or semi-linear stone occurrences across the Lindum Vale PSP area (Map 1); however, only 496 metres of this distance comprises occurrences that are two stones or higher. This measurement includes a square DSW compound within the bluestone homestead complex. The remaining 3804 comprises semi-linear or scattered rocks that are considered to have been too heavy and cumbersome to have been used by wallers for the purposes of constructing DSW (Plates 1-2). These correspond to all stone occurrences in the 'Rating 1' category on Map 1 and Table 2.

The 496 metres of walls greater than two stones high includes 281 metres of Rating 2 DSW that are two stones or higher or less than 40%, but more the 20% of their original height. Rating 2 DSW are indicated in yellow on Map 1 and include the immediate area at the rear of the bluestone homestead running in an easterly direction into the PSP area and the immediate area from the south boundary of the homestead running in a southerly direction to the corner of Mt. Ridley and Mickleham Roads. Rating 3 DSW comprises a total length of 215 metres; however, approximately 41 metres of this distance comprises the 100% intact DSW compound within the bluestone homestead complex indicated in aqua on Map 1. Rating 3 DSW are defined by full height walls of between 1.1 – 1.3 metres or less than 80% but more than 60% this height and retain their structural and functional integrity.

Aside from the DSW compound in the grounds of the homestead, the Rating 3 DSW in the PSP area is also at the rear of the homestead and adjoins the rating 2 DSW which runs in an easterly direction through the PSP area. This section of DSW is indicated in aqua on Map 1.

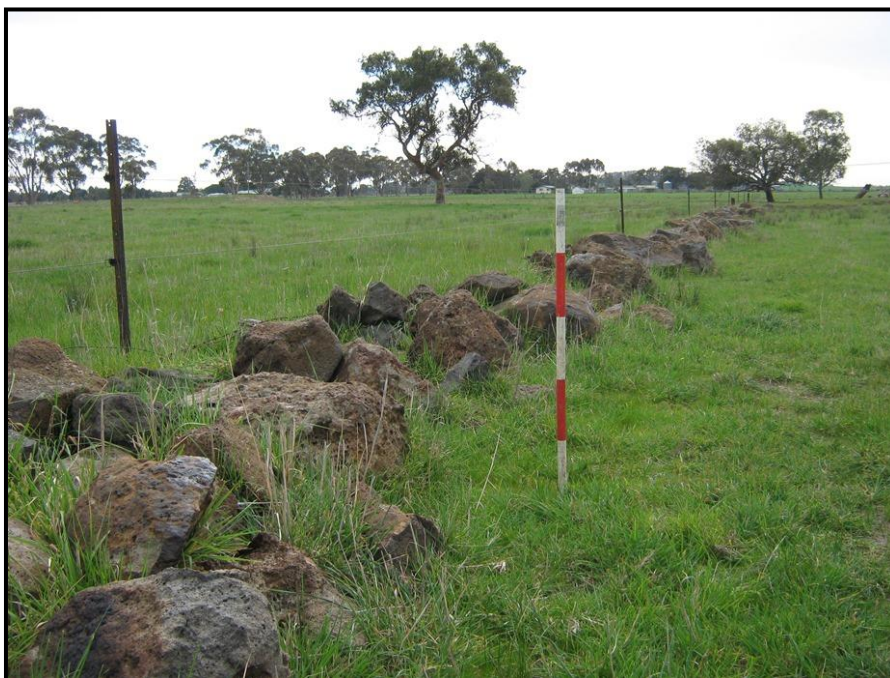
*Plate 1: Example of rating 1 stone occurrence in the northern section of the Lindum Vale PSP. Note scattered nature and large basaltic floaters.*

All Rating 1 stone occurrences can be removed from the PSP area. They are a product of land clearance practices and are not associated DSW development.

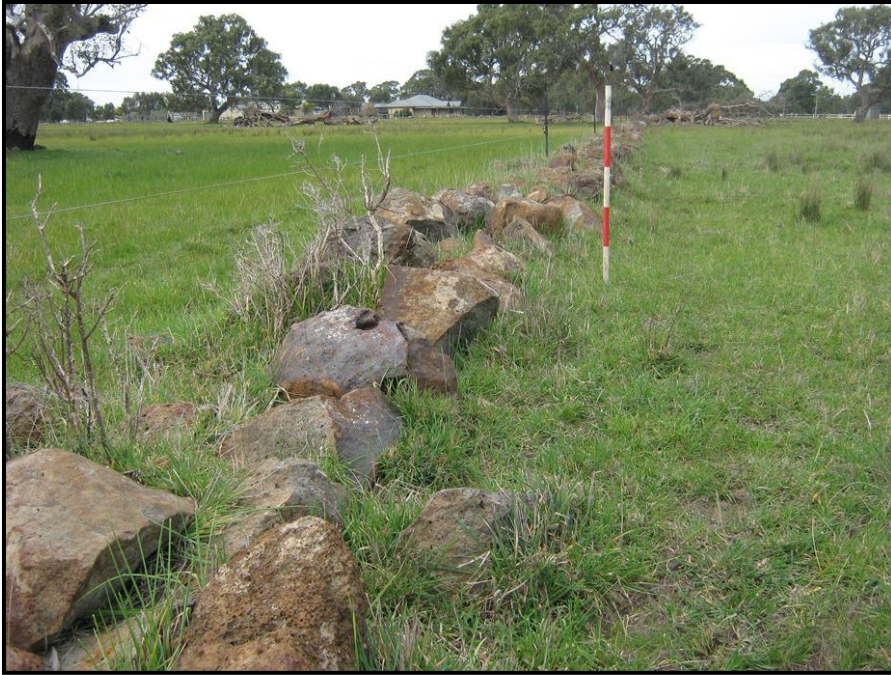
*Plate 2: Example of Rating 1 stone in the eastern section of the Lindum Vale PSP area. This occurrence comprises a haphazard semi-linear row of stones consisted with land clearance practices.*

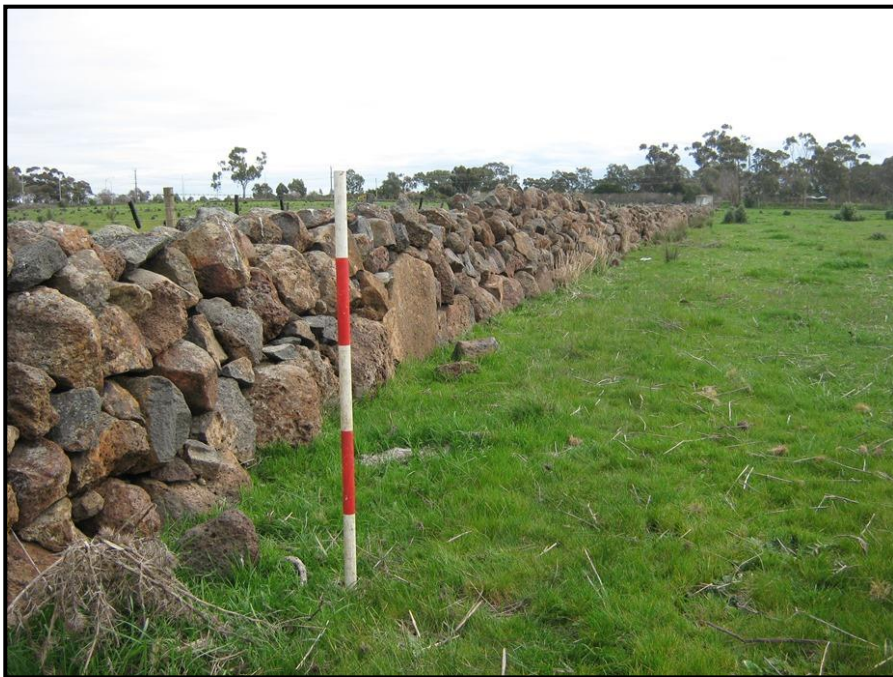
*Plate 3: Example of Rating 3 DSW in the PSP area. The Rating 2 DSW can be seen in the background of the image.*

The only visual changes made to the original structure over the years is the top two layers of coping stones have been removed from the Rating 3 DSW and half or approximately 40-60% of the DSW has been removed from the Rating 2 DSW.

It is recommended that options for removal and reconstruction of DSWs be considered by MAB in areas of open space.

The Rating 3 DSW in the PSP is an extension of the Rating 2 DSW heading in an easterly direction from the rear of the homestead. The Rating 3 DSW comprises walls that are less than 80% and more than 60% intact with all coping stones removed. Rating 3 DSW in the PSP area are highly degraded and, due to their height and degraded nature, may pose public safety risks. It is recommended that DSW be repaired and / or dismantled and re-established in open space.

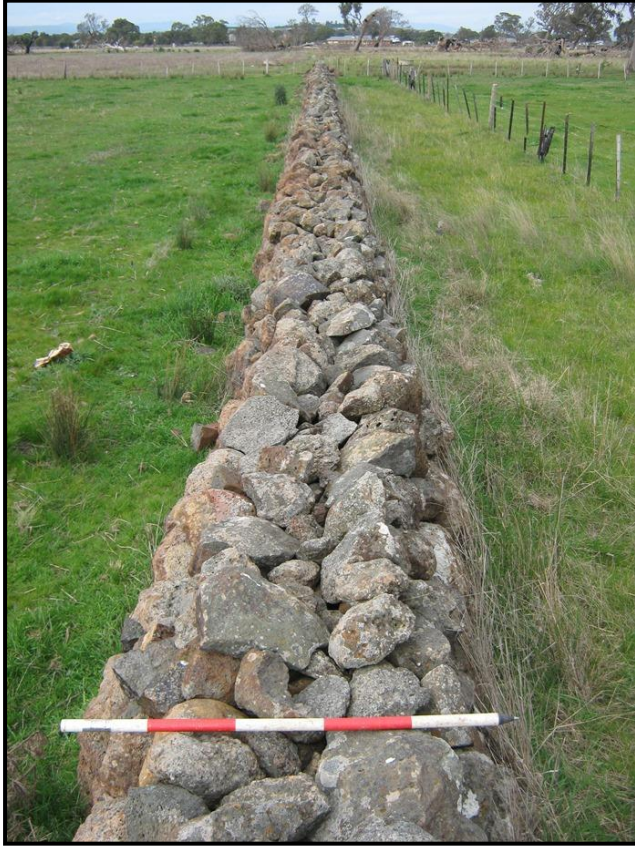
*Plate 4: Overview of the Rating 3 DSW in the PSP area showing breadth of construction.*

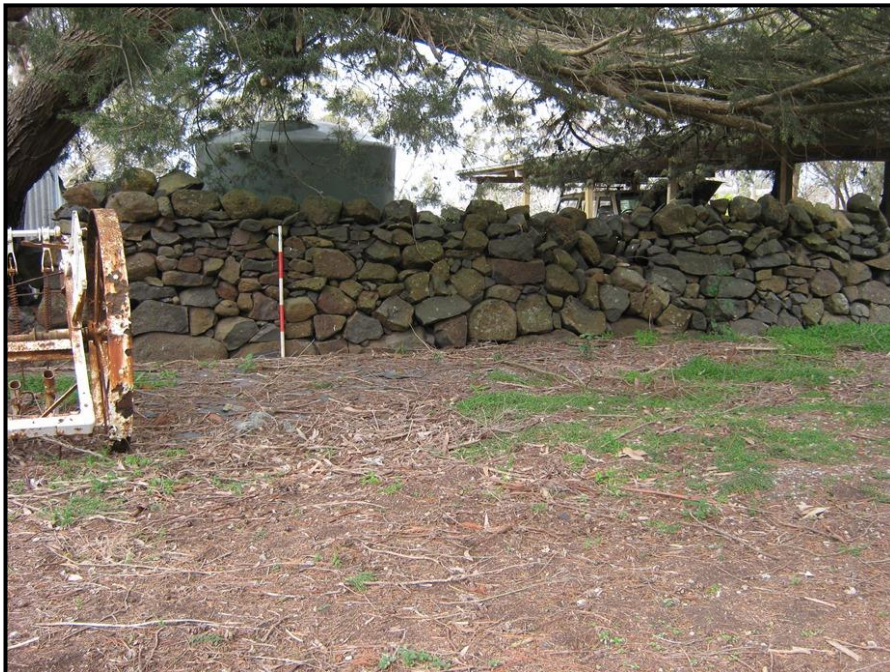
The bluestone homestead bounding the PSP area is a coursed bluestone cottage with a DSW located to the north of the dwelling. The DSW around the dwelling are substantial full DSW; although it appears they have collapsed in places and been reconstructed in a non-professional style.

*Plate 5: The full DSW compound in the grounds of the homestead.*
