1 Introduction

Hansen Partnership have been engaged by Cardinia Shire Council to prepare a Landscape Assessment to inform the development of a Precinct Structure Plan for the Pakenham East Precinct.

pakenham east precinct landscape assessment | study area and surrounds

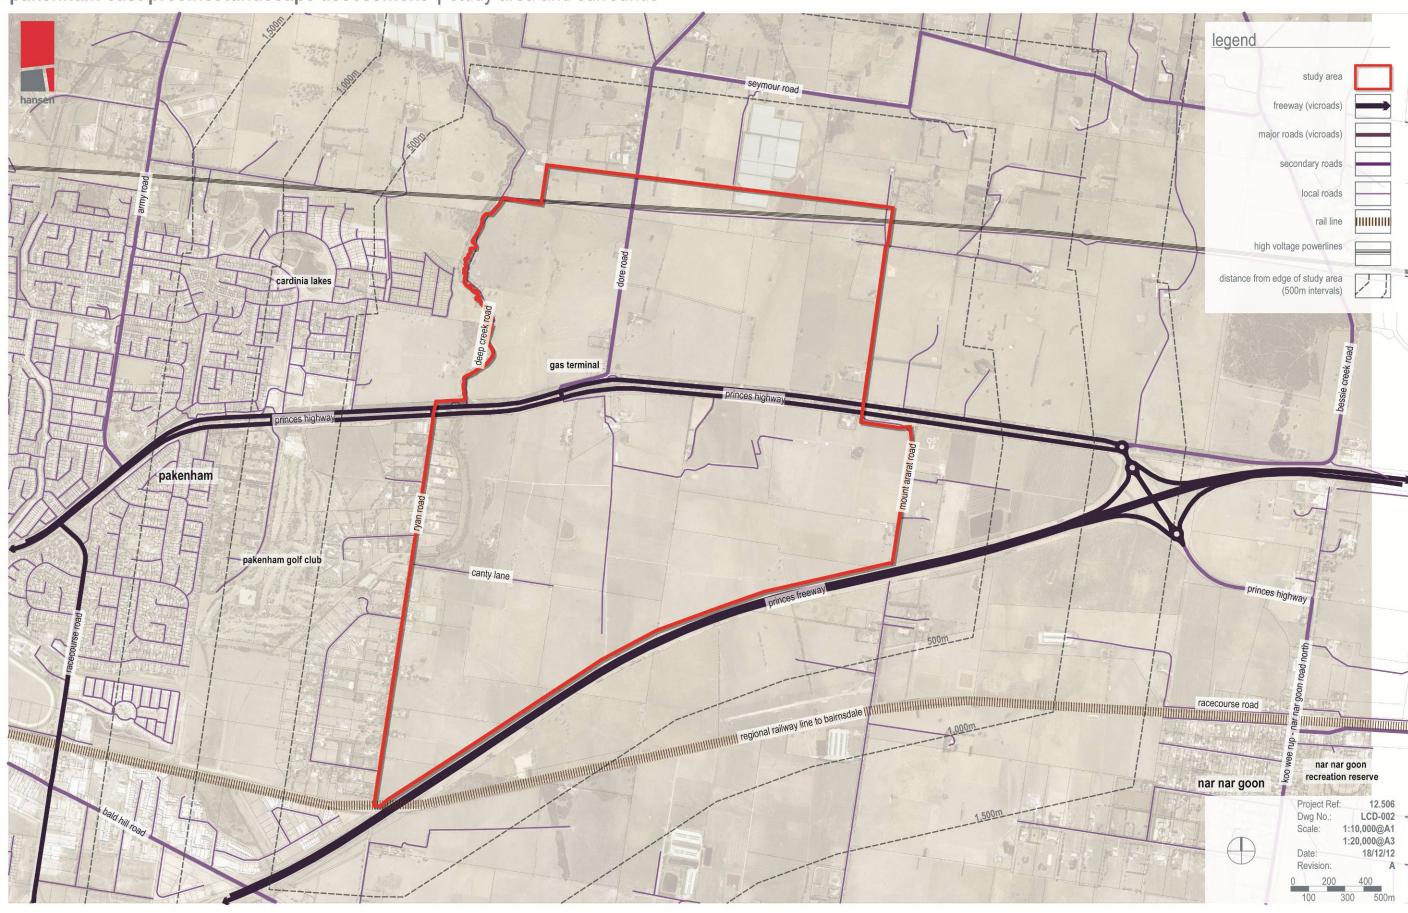
The Princes Freeway is a primary road way located along the southern study area boundary and runs in a generally east west direction.

The Princes Highway is a primary road way which runs through the centre of the study area in an east west direction connecting Pakenham in the west to the Princes Freeway intersection approximately 1.45km to the east.

The eastern residential fringe of Pakenham is located to the west of the study area in the form of the Cardinia Lakes Residential development. Pakenham Golf Club is located approximately 350m to the west of the study area. Ryan Road and associated residential property abuts the south west boundary of the study area. The study area boundary then follows the alignment of Deep Creek which continues to the north west corner of the study area.

An existing transmission line is located within the northern part of the study area and running in a generally east west direction.

Dore Road is a secondary road which intersects with the Princes Highway running in a north south direction from the centre of the study area at the intersection with the Princes Highway and connecting to the rural land to the north.

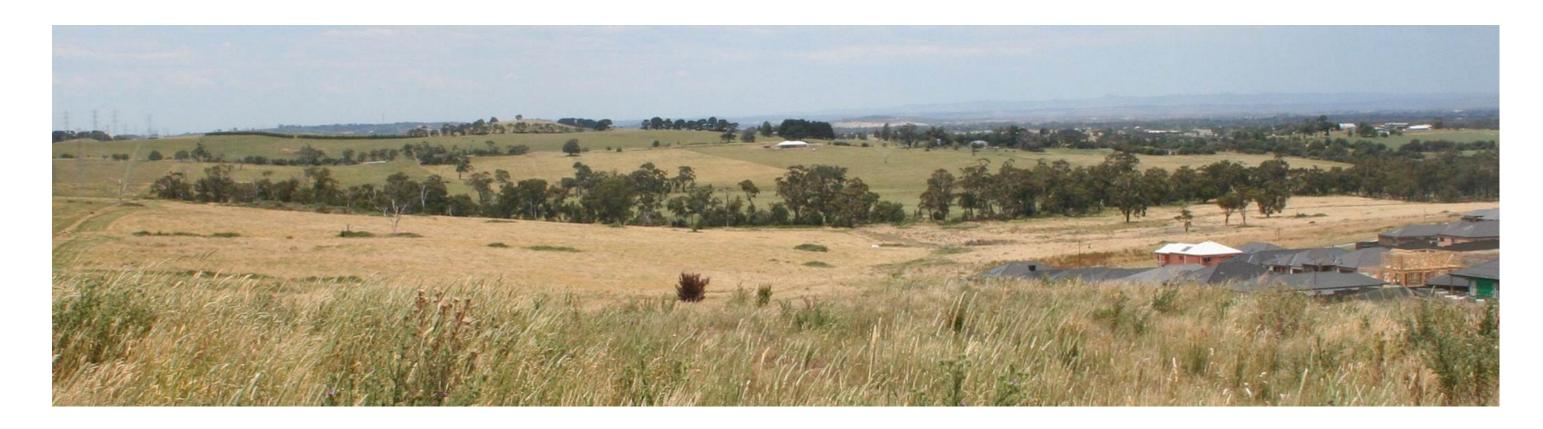
pakenham east precinct landscape assessment | topographical analysis

The study area topography falls generally from undulating terrain in the north to the valley floor in the south. This pattern of land topography is part of a broader land formation of foothills and valleys characteristic of the southern extents of the Dandenong Ranges.

A clearly defined ridgeline formation of elevated land is located in the centre of the study area extending down from the northern boundary towards the low lying land adjacent to the Princes Highway.

The Princes Highway is an engineered major road which, in most locations, has been raised above the surrounding landscape with embankments either side of the road reserve. Towards the centre of the site, the road passes through the central ridgeline described above and the terrain has been excavated to accommodate the road grading. This has resulted in the formation of steep embankments either side of the westbound lanes of the Princes Highway.

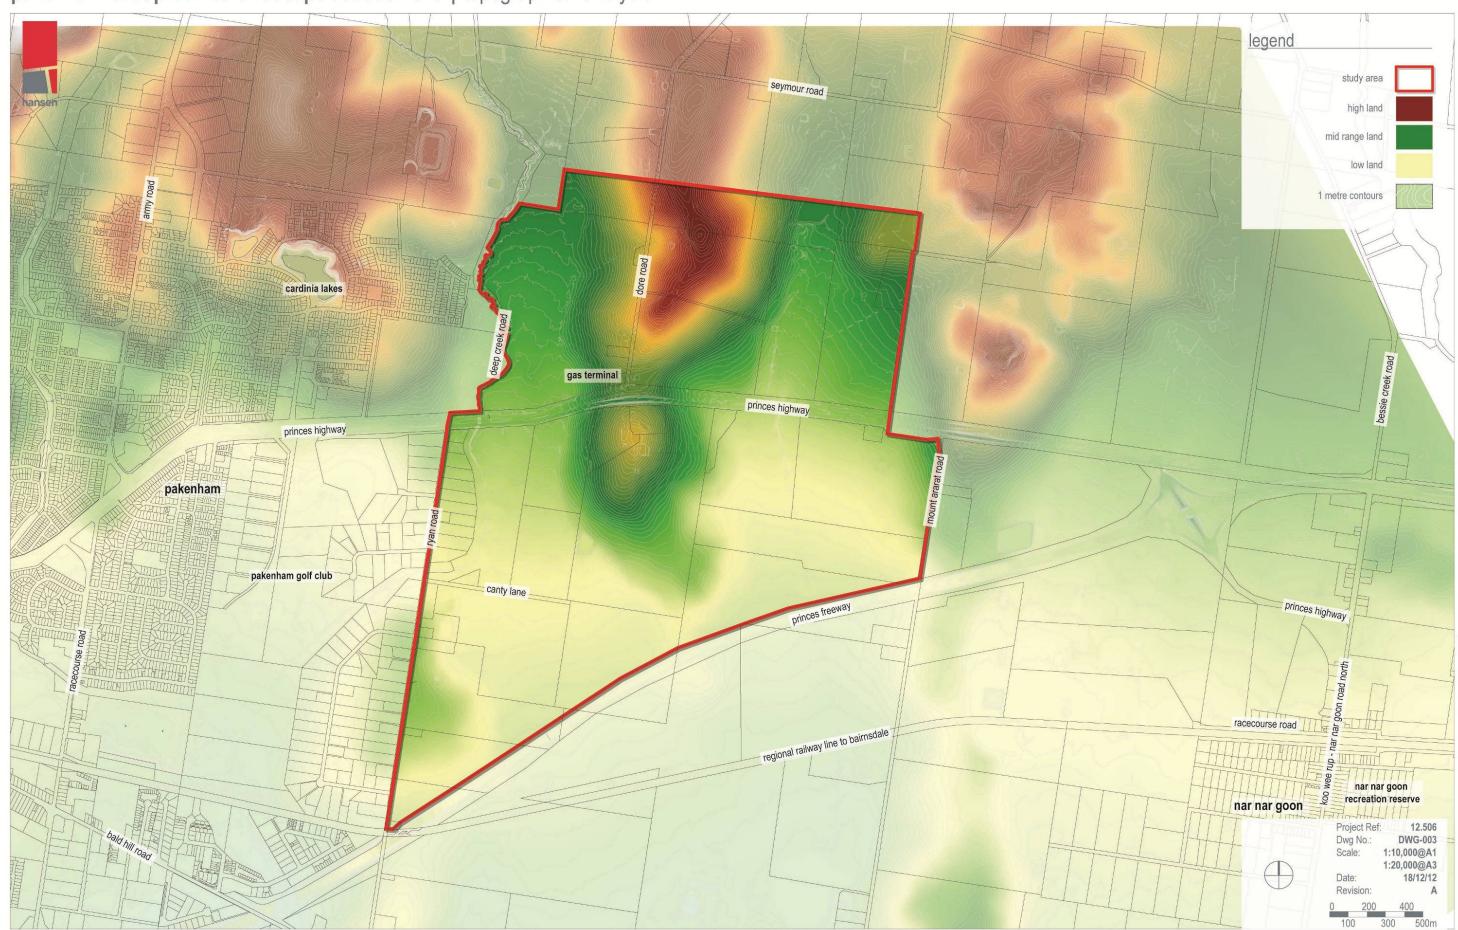
The north east corner of the site is also elevated and reflects the southern extents of a greater ridgeline formation located beyond the study area to the north and east.

A valley of lower lying land is located to the east and west of the central ridgeline with a drainage line running from north to south along Deep Creek adjacent to Deep Creek Road.

The southern portion of the site to the south of the Princes Highway consists of predominantly lower lying terrain.

A small patch of land in the south west corner of the site is slightly elevated above the surrounding land.

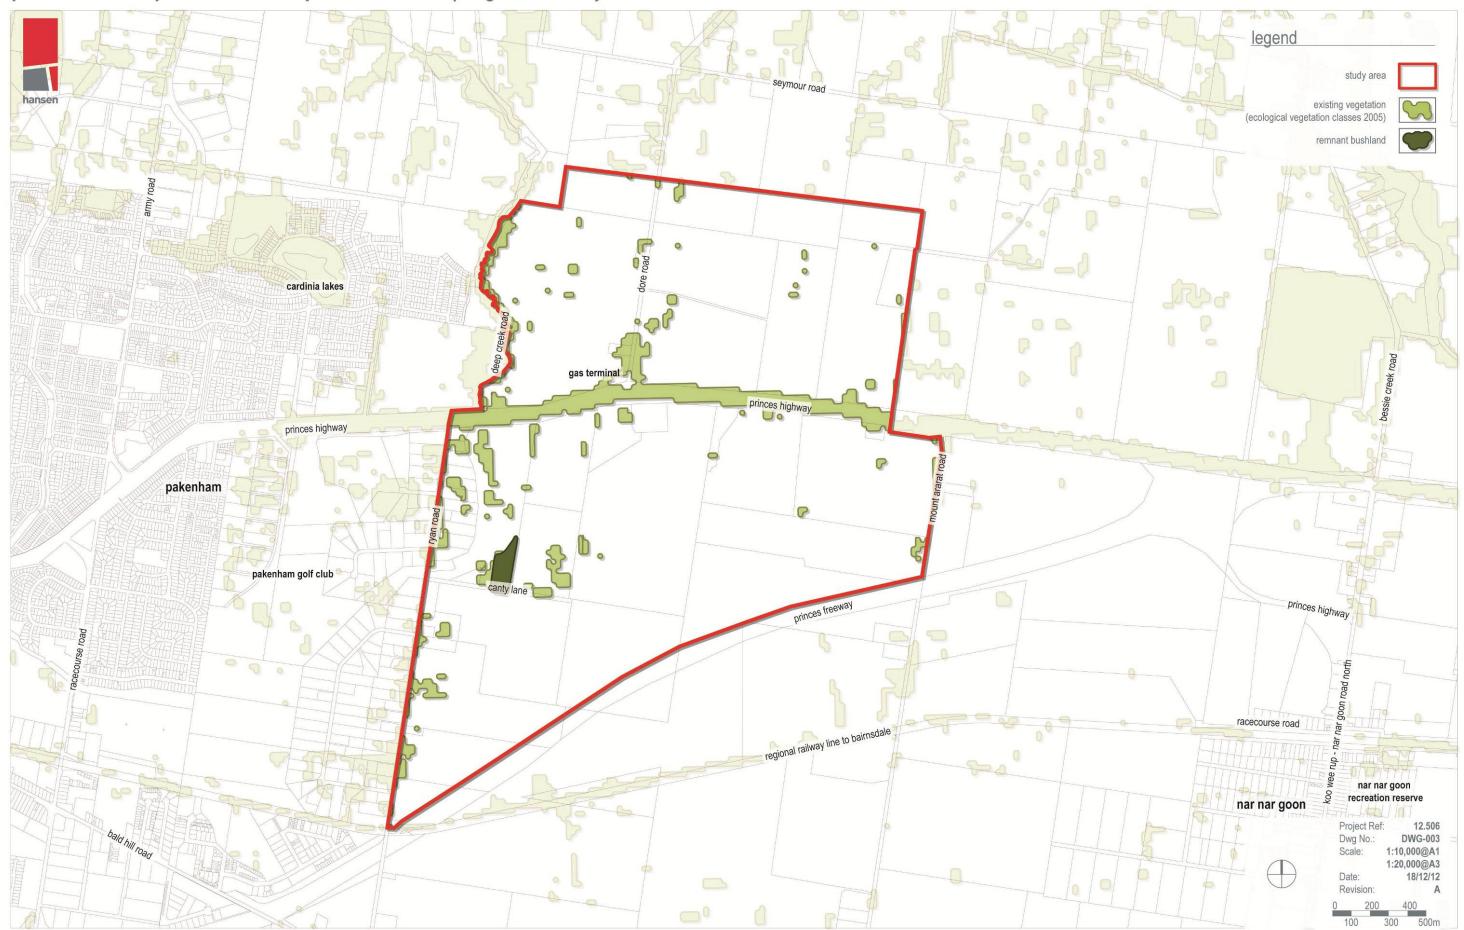
pakenham east precinct landscape assessment | vegetation analysis

The vegetation analysis map opposite provides an overview of the extent of existing vegetation located within the study area based on 2005 EVC cadastre data provided by Cardinia Shire Council. As shown the study area is largely cleared pasture land and is predominantly devoid of vegetation.

Scattered native and exotic trees and shrubs are located along fence lines, driveways and around existing farm settlements most likely acting as wind breaks for local residents and livestock.

The majority of the existing tree vegetation is located along road sides and Deep Creek. Road side vegetation is visible along Dore Road with a patch of more dense coverage located towards the centre of the site at the southern end of the Dore Road.

Extensive road side vegetation exists along either side of the majority of the Princes Highway road reserve and within the wide central median. This vegetation is densely planted for the most part but some gaps occur in localised areas.

Dense predominantly native vegetation including mature native trees lines the embankments either side of Deep Creek as well as within the road reserve of Deep Creek Road on the western study area boundary.

Vegetation exists within the road reserve of Ryan Road along the south west boundary of the site and within the private rural residential properties located between the Princes Highway and Canty Lane.

The mapping also shows a dense patch of suspected remnant bushland vegetation located within a private property in the south west part of the site on Canty Lane.

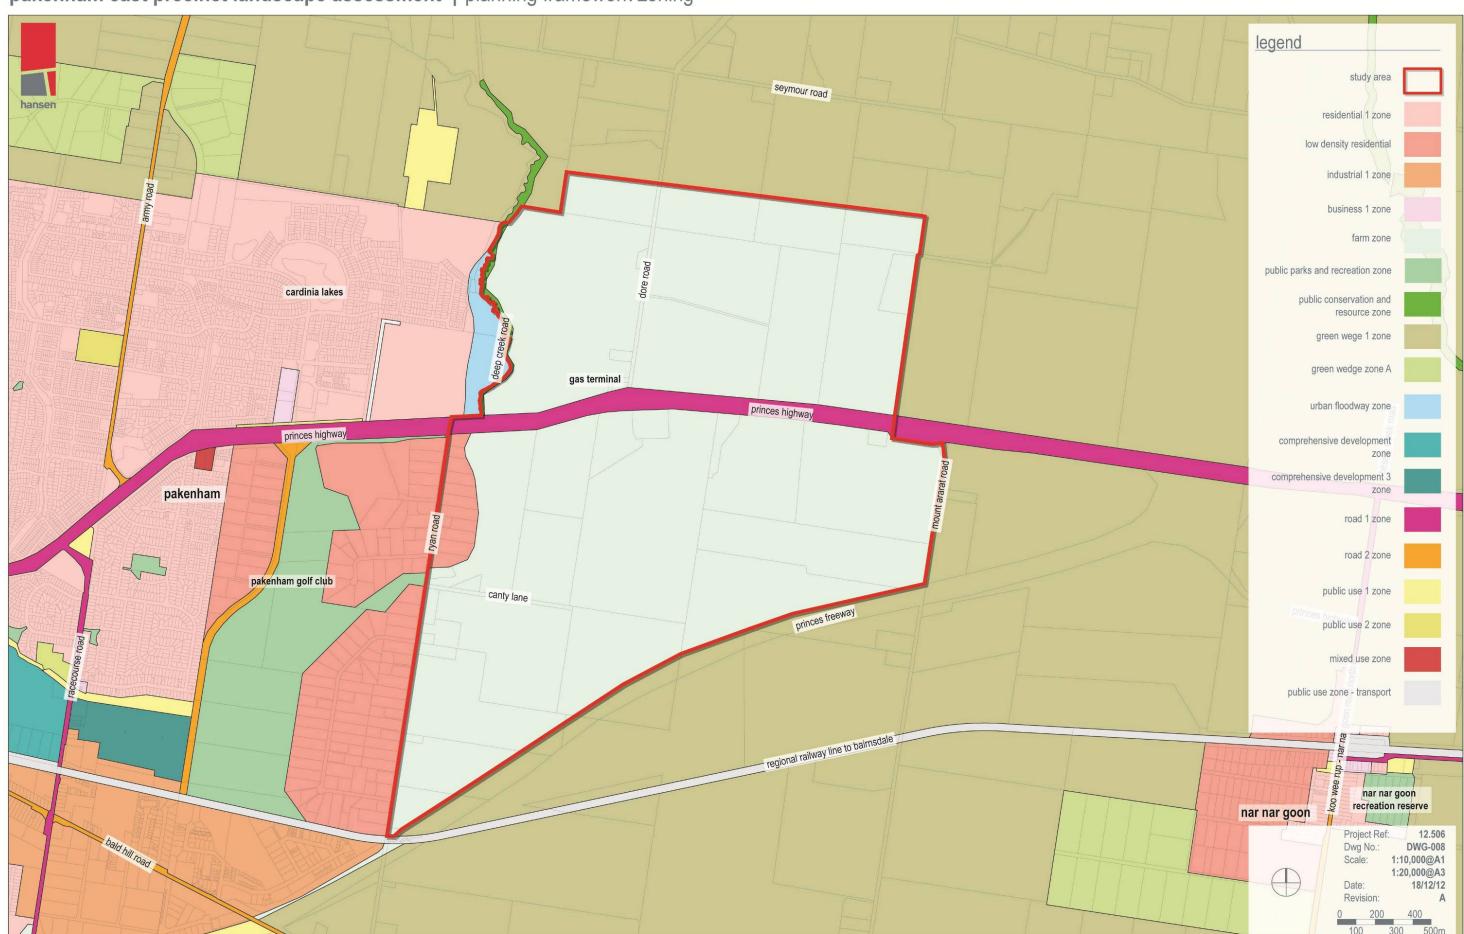
pakenham east precinct landscape assessment | planning framework zoning

The Planning zone diagram opposite provides a graphic summary of the existing planning zones that apply to the study area and the immediate surrounding land.

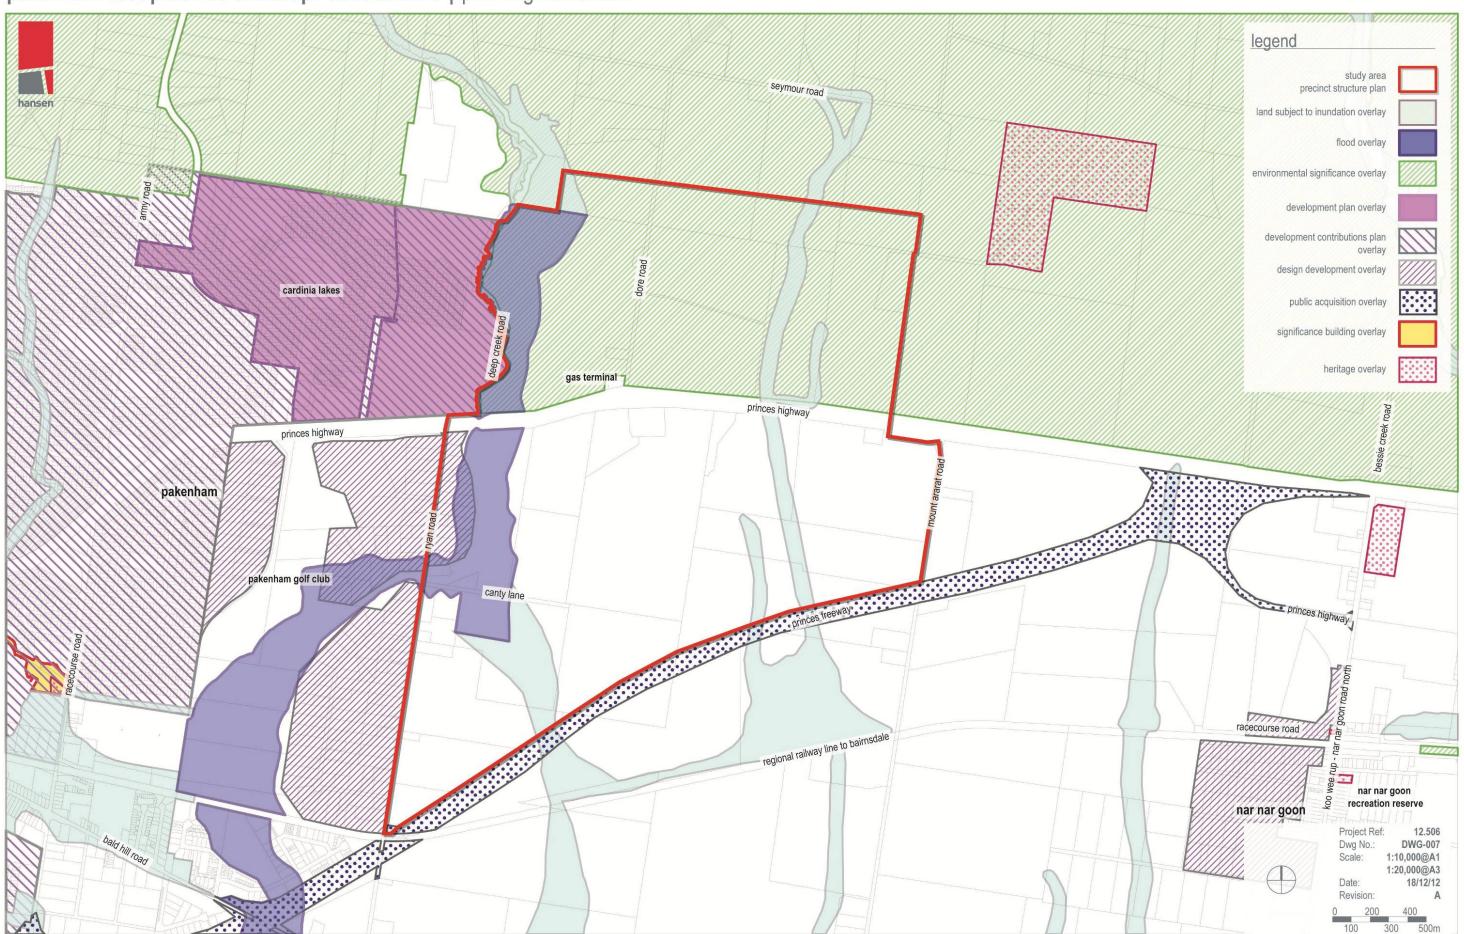
pakenham east precinct landscape assessment | planning framework

The Planning overlays diagram opposite provides a graphic summary of the existing overlays that apply to the study area.

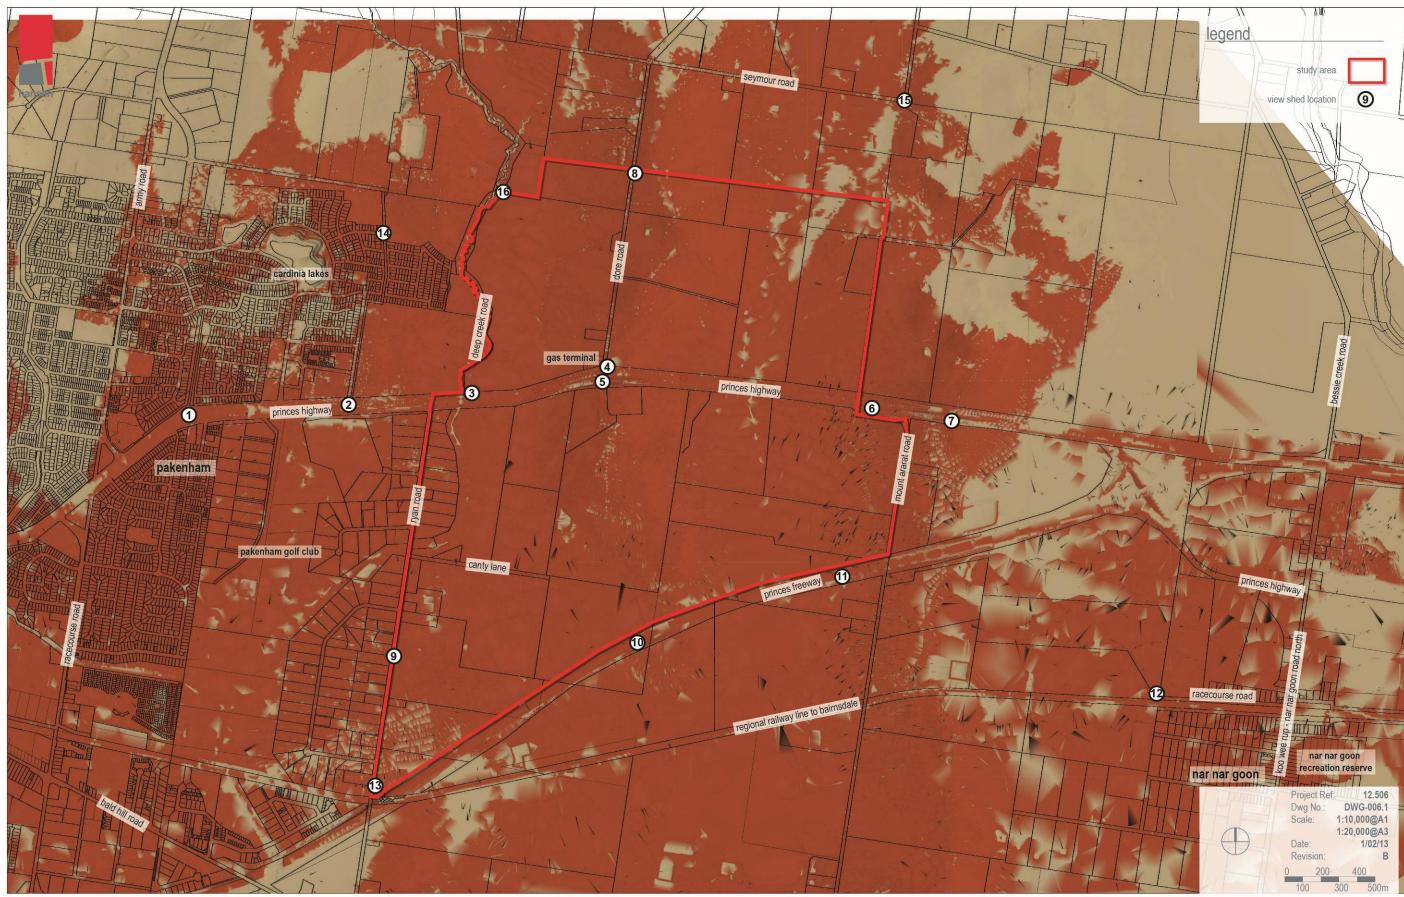
pakenham east precinct landscape assessment | view shed - visual exposure from all view shed locations combined

Each viewpoint has also been assessed through field work to review the outcomes of the viewshed analysis. This process is necessary in order to account for the potential screening and filtering effect on views caused by existing vegetation and built form.

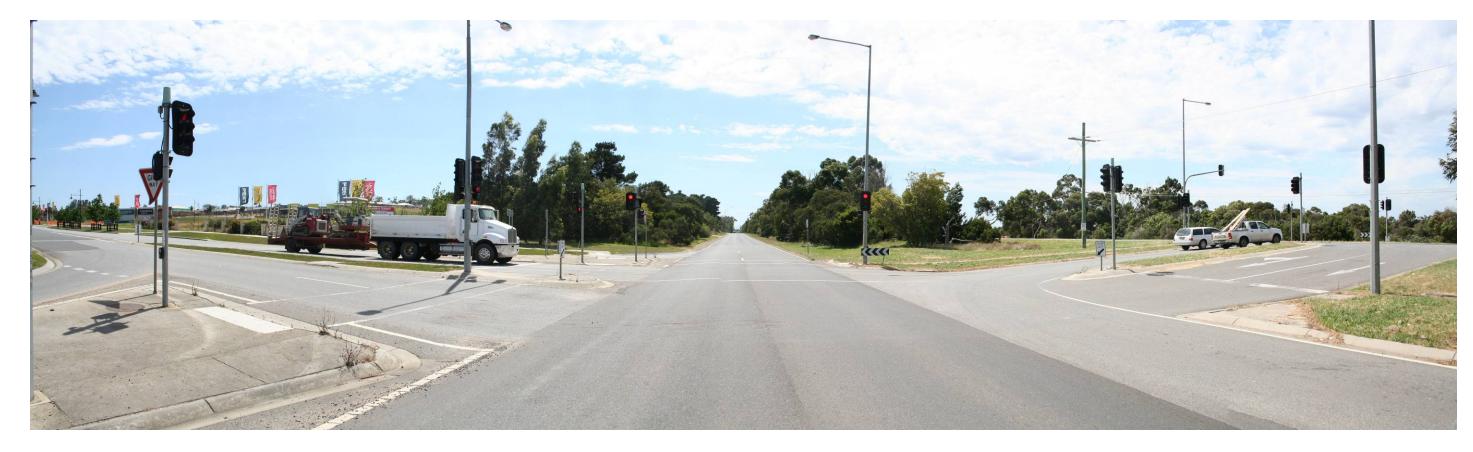
Princes Highway looking east

This 'on ground' assessment of the view from this location confirms that the large patch of potentially visible land shown in the viewshed analysis map opposite is not an issue for further consideration.

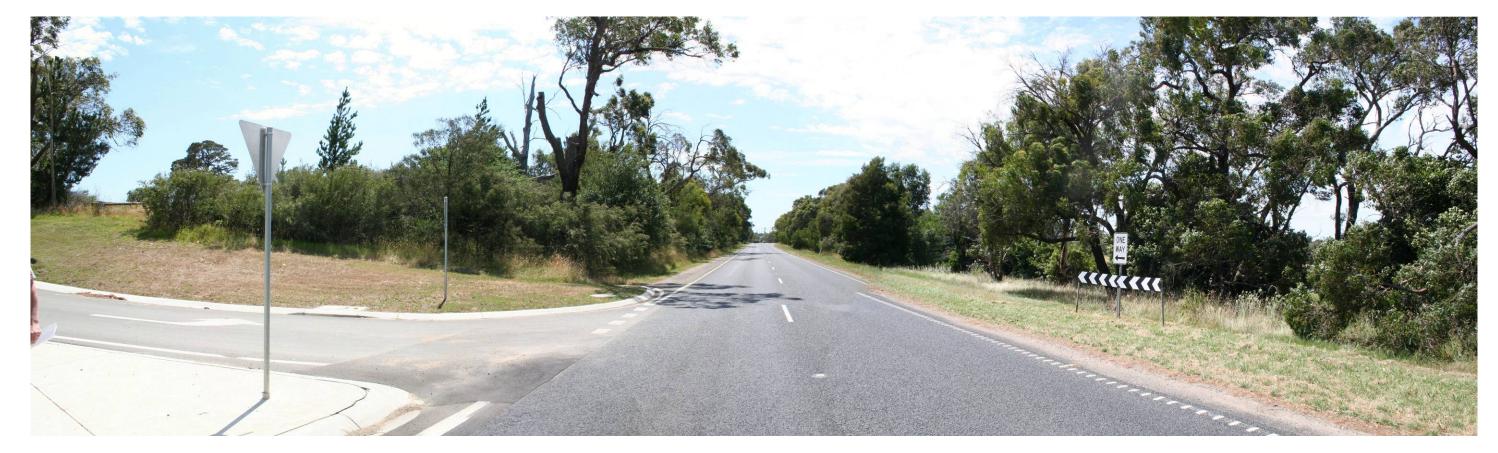
Princes Highway looking east

This confirms that when existing vegetation is taken into consideration, the large areas of the study area shown on viewshed analysis map opposite can be disregarded.

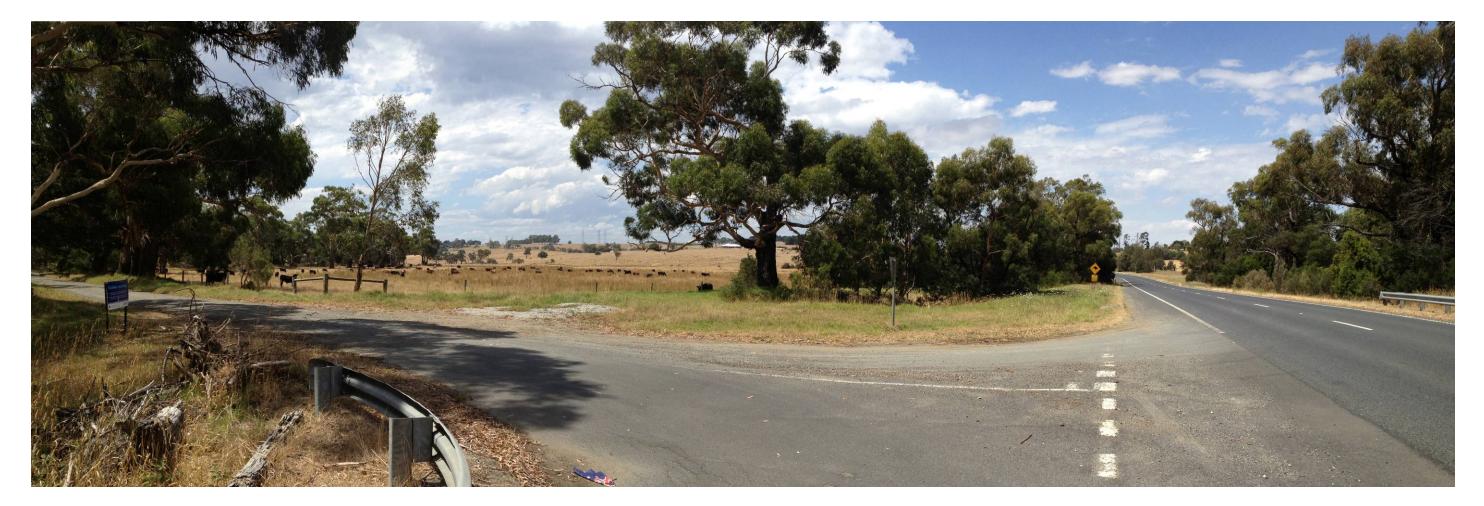
Princes Highway looking east

Views to the south are screened by the dense existing vegetation located within the Princes Highway road reserve.

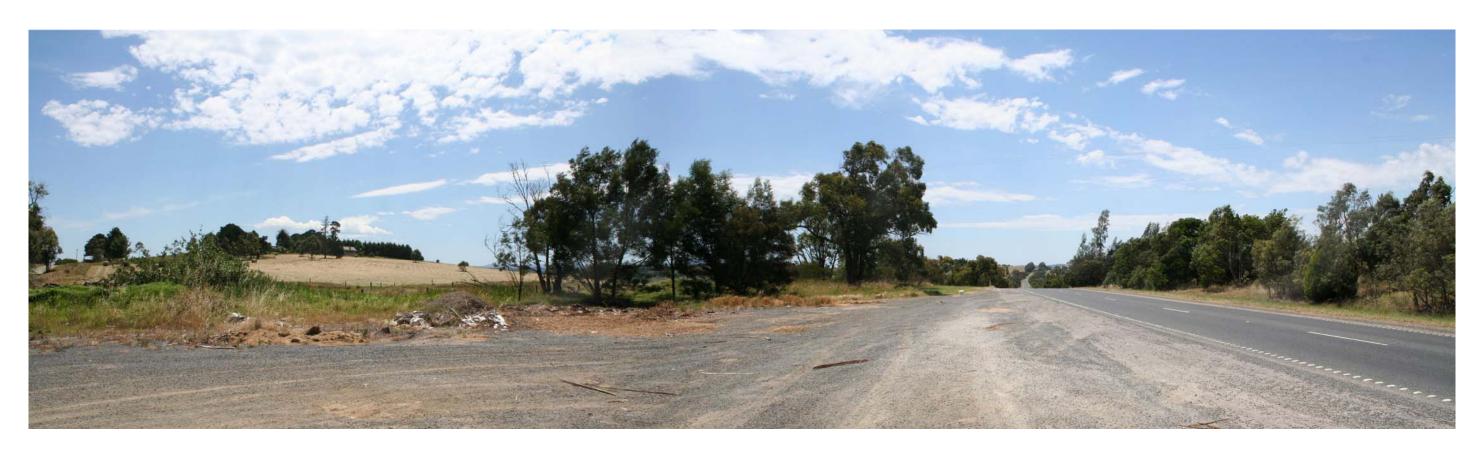
Princes Highway looking east

This assessment confirms that when existing vegetation is taken into consideration, the areas identified as potentially visible from this location can be largely disregarded with the exception of the elevated land along Dore Road and a narrow view contained by the existing road reserve vegetation.

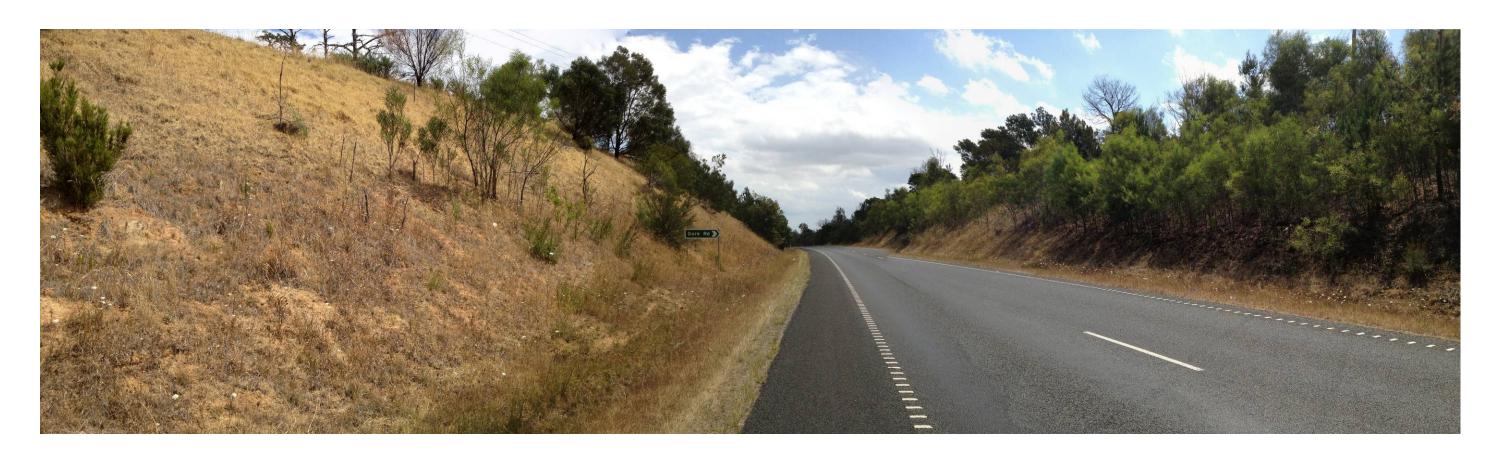
Princes Highway looking west

This confirms the results of the viewshed mapping analysis as shown opposite.

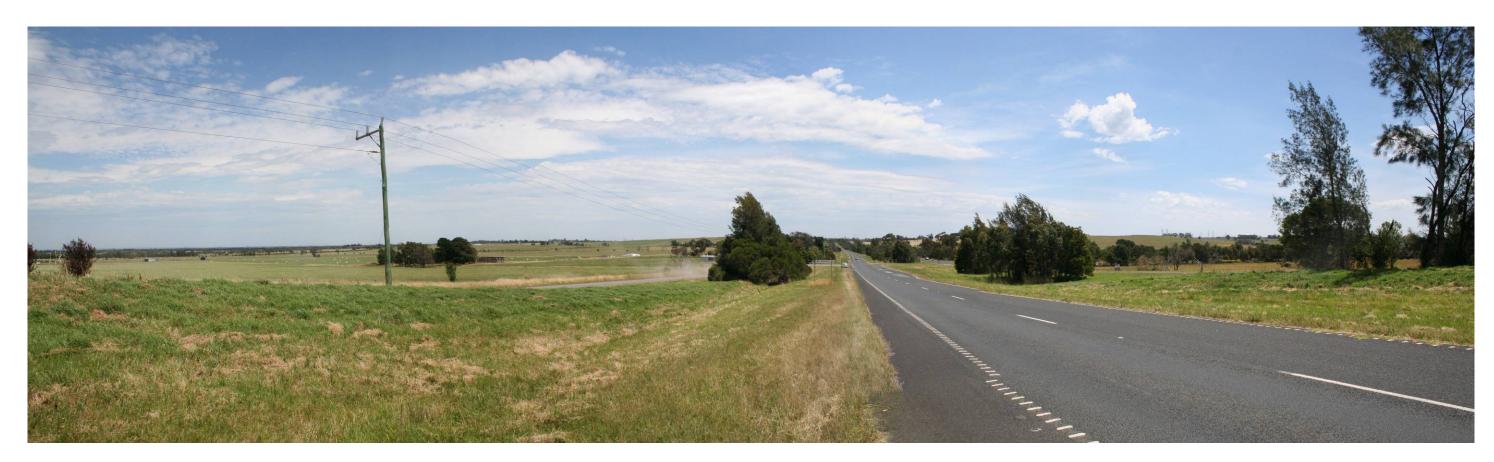
Princes Highway looking west

This assessment shows that there are wide and largely unobstructed views to the low lying land to the south, as indicated in the viewshed mapping opposite. The views to the west and north west are, in part, screened by road side vegetation in the foreground. However, the upper most portion of the ridgeline at the centre of the site protrudes above the foreground vegetation in some places and is prominent within the view.

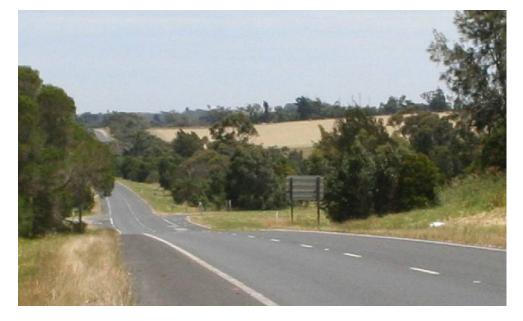
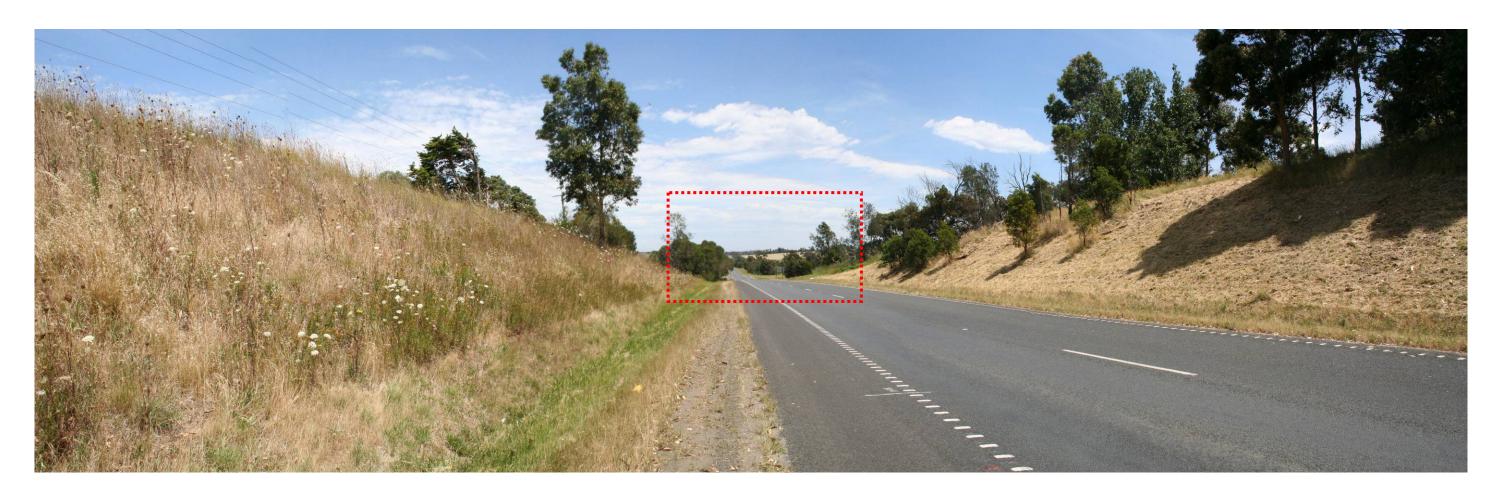
The background of this view shows the elevated terrain beyond the study area to the west. The horizon line comprises the canopy of trees associated with the roadside vegetation along Abrehart Road.

This assessment confirms the viewshed mapping shown opposite although views to the lower lying topography either side of the Princes Highway are generally screened by existing vegetation located within the road reserve. This is also the case for the land associated with Cardinia Lakes beyond Abrehart Road which is screened by the existing vegetation along the road reserve

Blow up of highlighted area, Princes Highway looking west

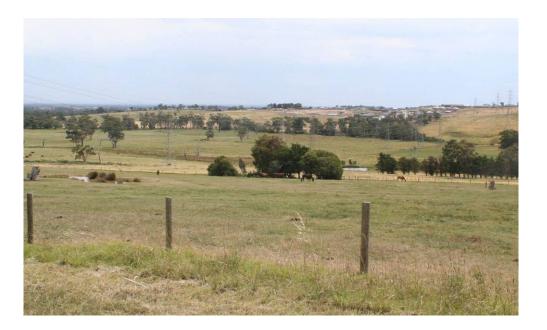
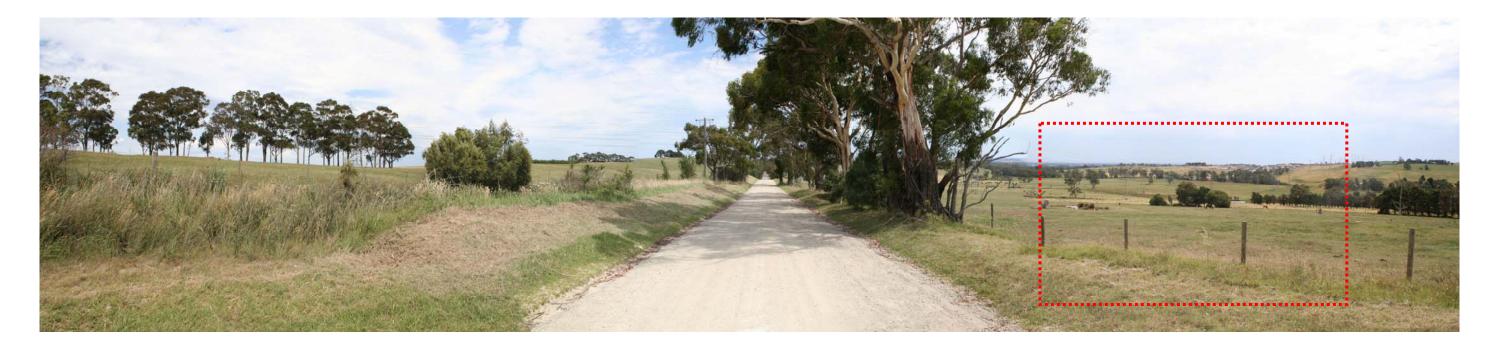
Dore Road looking south

The existing transmission line is prominent in the view as it runs east to west across the study area.

With the inclusion of factors such as existing vegetation, this assessment shows that the area potentially visible identified by the viewshed analysis is reduced in part. The land to the south of the Princes Highway is certainly obscured or in some cases screened from view, mostly as a result of the existing vegetation along Dore Road.

Blow up of highlighted area

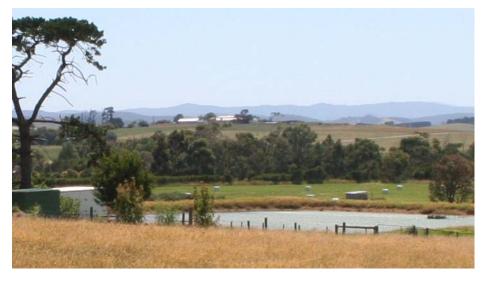
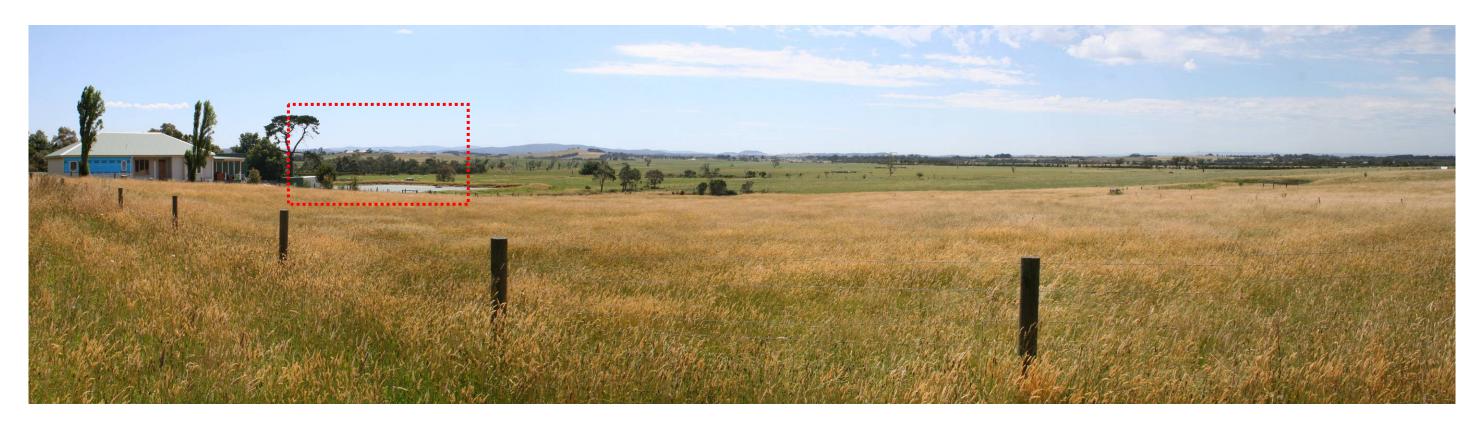
Ryan Road looking north east

An elevated ridgeline land form is also visible from this location marked by the existing rural settlement located at 2686 Princes Highway. This settlement is located on elevated land that continues to the north of the Princes Highway in the form of a ridgeline located towards the centre of the study area.

The horizon line is defined by the undulating foothills of the Dandenong Ranges which are located beyond the northern boundary of the study area. This is a prominent feature in the wider regional landscape.

Blow up of highlighted area

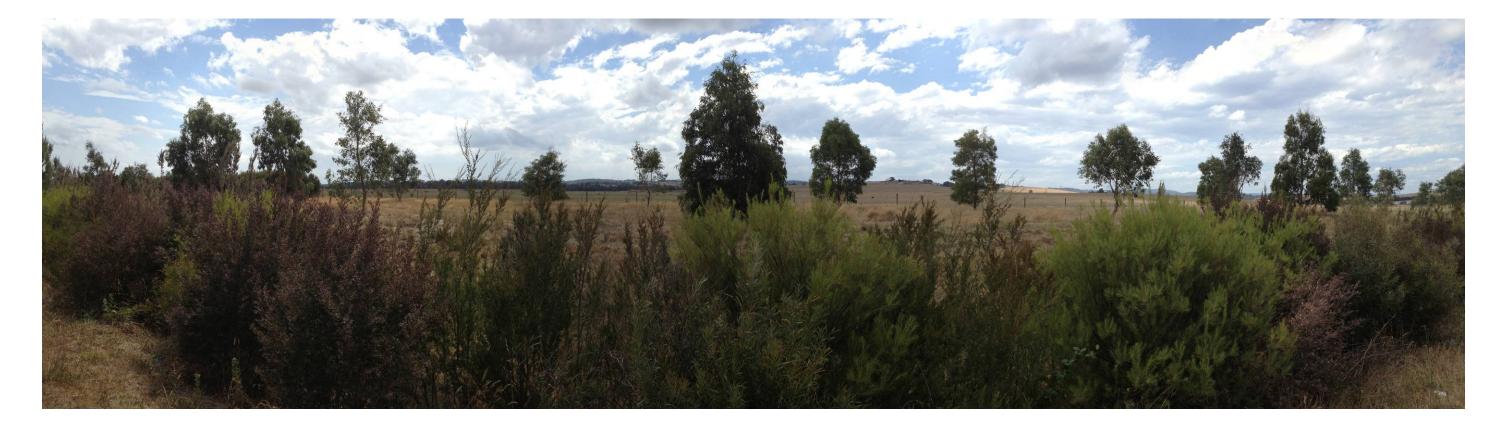
Princes Freeway looking north

The road reserve is elevated above the adjoining low lying pasture within the study area affording wide views across the study area from this location. It is noted also that the relatively recently installed road side planting is likely to screen views to the study area once it reaches maturity.

The background and horizon is defined by the undulating and vegetated hills of the Dandenong Ranges.

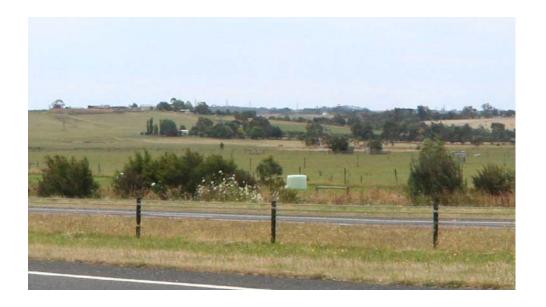
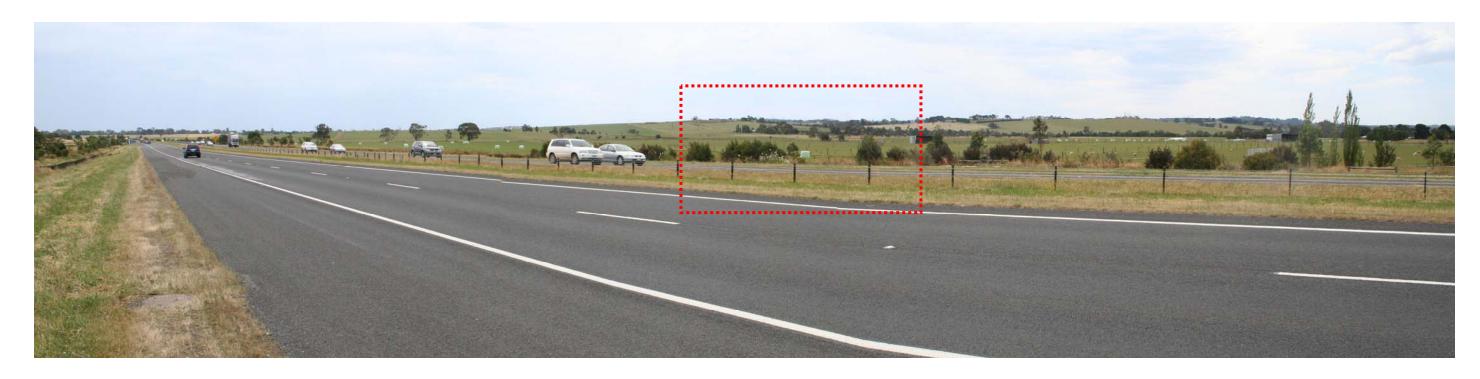
Princes Freeway looking north west

The ridge line land form and vegetation obscures views to the study area to the west of Dore Road.

This assessment generally confirms the extent of visible areas shown in the viewshed map opposite.

Blow up of highlighted area

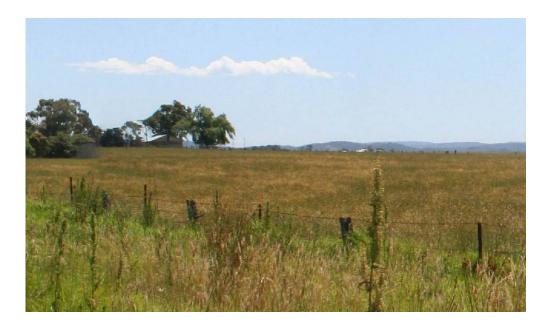
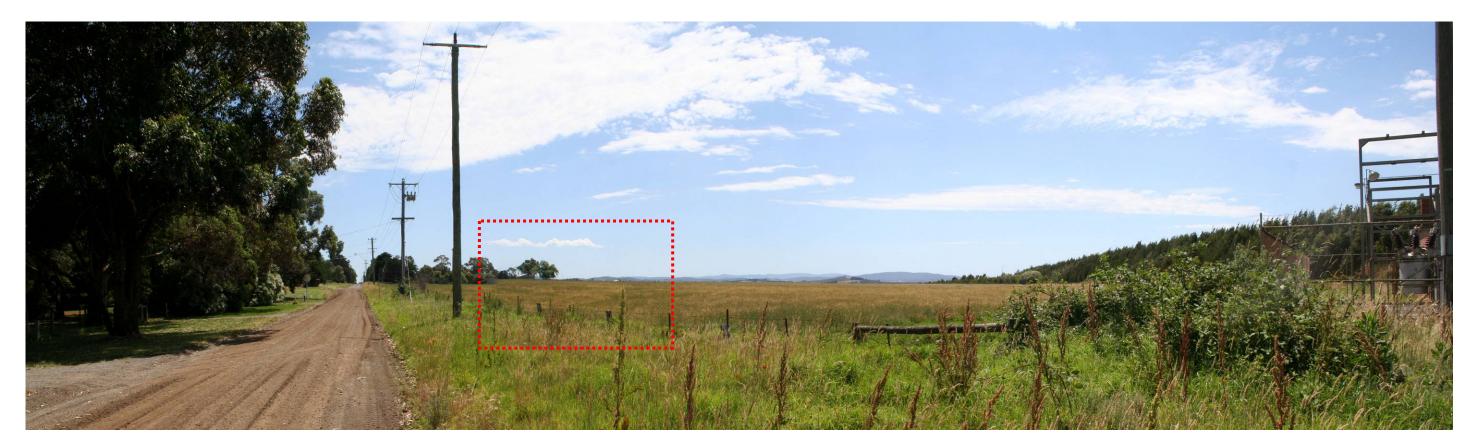
Ryan Road looking g north east

The undulating hills of the broader Dandenong Ranges landscape to the north of the study area are visible within the background line of the image.

For the reasons described above, the portion of study area adjacent to Dore Road indicated on the viewshed map, approximately 3.5km away, is barely discernable from this location and can therefore be discounted.

Blow up of highlighted area

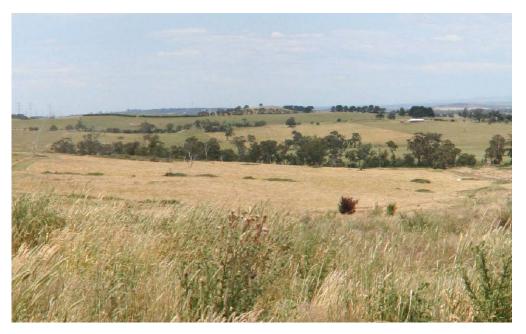
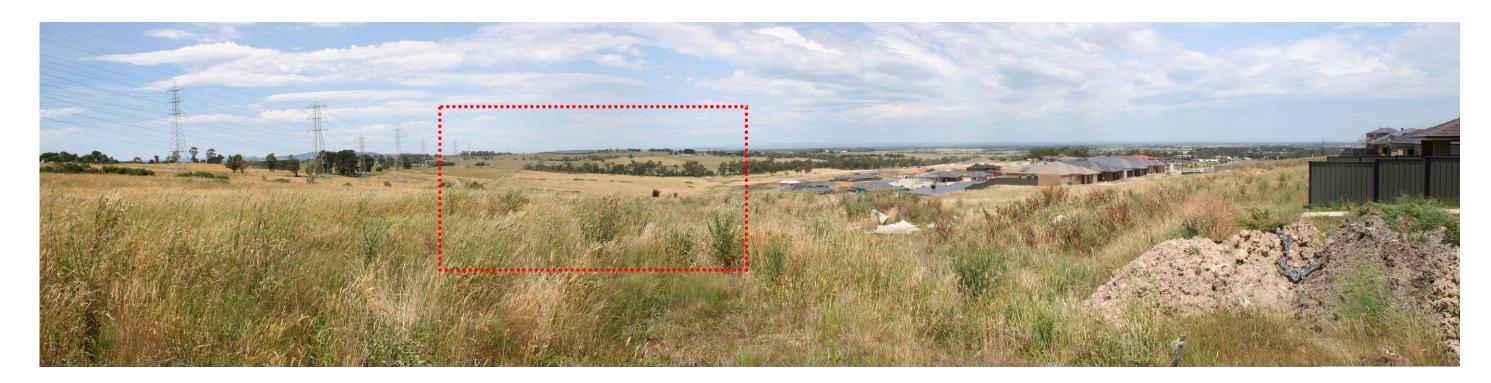
Tahoe Court looking east and south east

The ridge line which runs through the centre of the study area in the vicinity of Dore Road is also visible in the background of the image. The existing vegetation along Dore Road and adjoining rural settlements contributes positively to the landscape and breaks up the sequence of cleared rural pasture land.

The bands of vegetation along Deep Creek, Dore Road and the ridgelines and properties to the east reinforces the scene in the middle and background as a series of undulating ridgelines, including the ridgeline at the centre of the study area, with the wider hills of the Dandenong Ranges lining the horizon.

Blow up of highlighted area

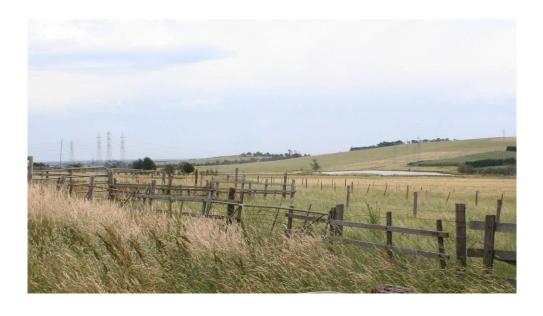
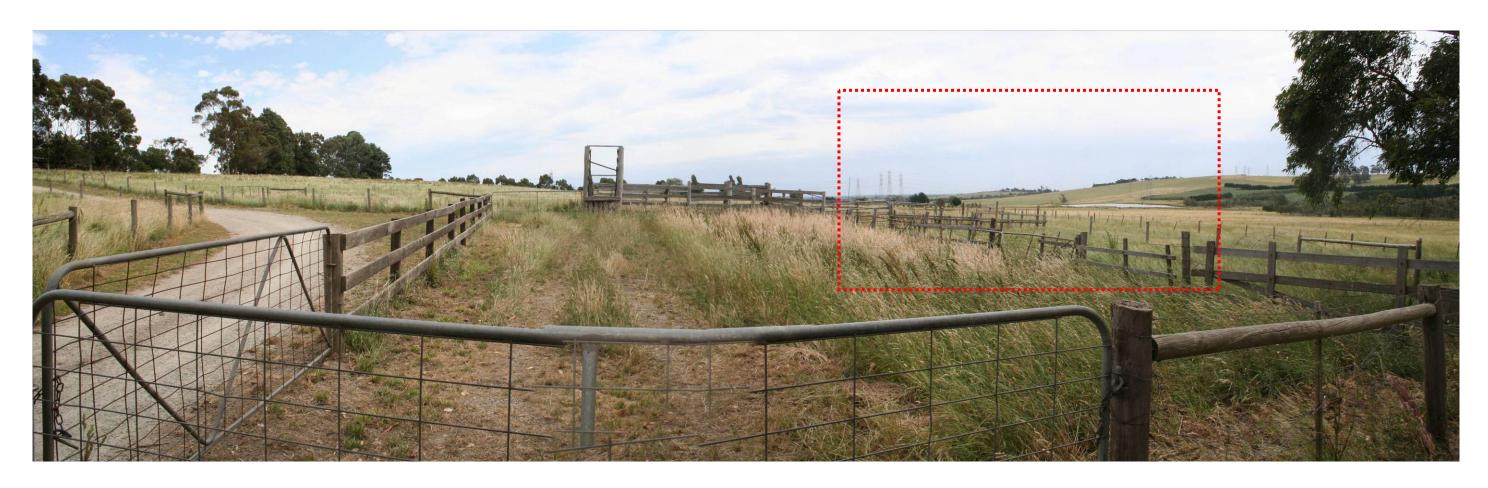
Seymour Road looking south and south west

A glimpse of the existing rural settlement and associated wind break vegetation is visible on the elevated ridge located to the south of the Princes Highway in the far distance. This property is approximately 2.3km from this location.

The existing transmission line located within the study area breaks the horizon line.

Blow up of highlighted area
