1 Introduction

Hansen Partnership have been engaged by Cardinia Shire Council to prepare a Landscape Assessment to inform the development of a Precinct Structure Plan for the Pakenham East Precinct.

pakenham east precinct landscape assessment | study area and surrounds

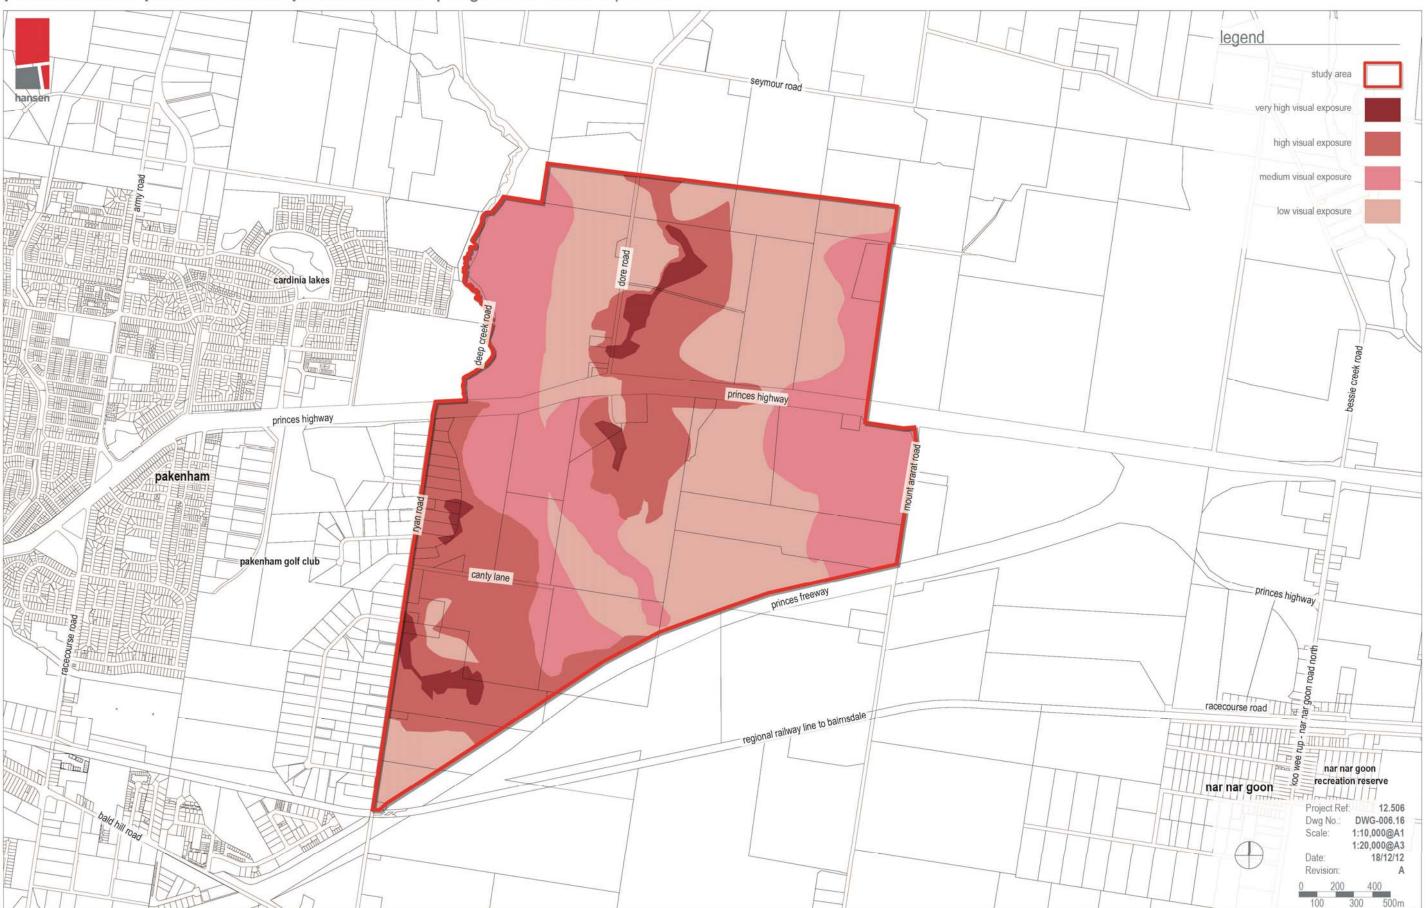
pakenham east precinct landscape assessment | degrees of visual exposure

Through a detailed analysis of each viewshed location accompanied by on ground assessment we have been able to assemble an overall picture of the relative visual exposure of the study area from a range of views both surrounding the study area and from key roads.

The analysis shows that areas of very high visual exposure are consistently found on the upper extents of the ridgeline located towards the centre of the site. This area is a relatively narrow band of terrain which runs in a north south direction from the northern boundary to a location approximately 500m south of the Princes Highway.

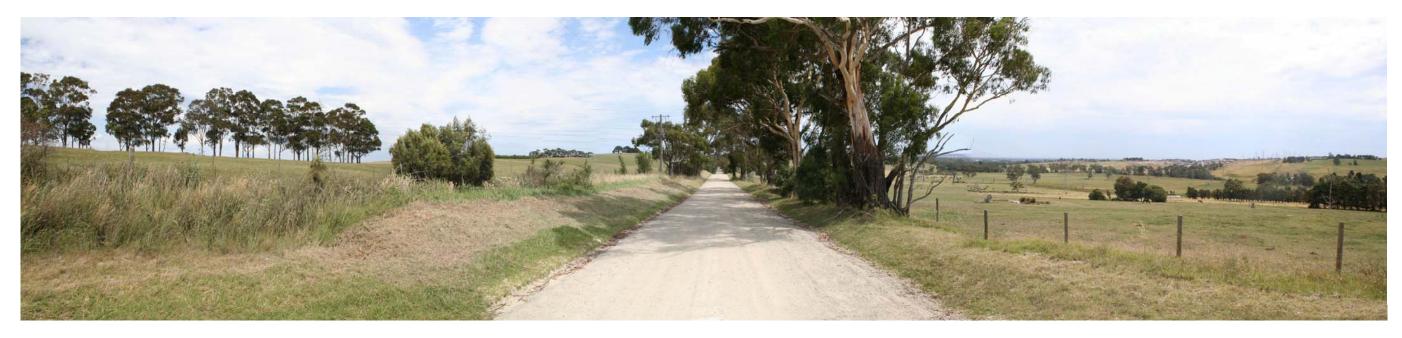
Gaps between existing road reserve vegetation along Dores Road afford expansive, long views to the south and east across cleared pasture land. The views to the west are restricted to the cleared pasture within the foreground due to the rising land formation located beyond the western study area boundary.

An existing power line which runs along the northern study area boundary is also characteristic of the Elevated Pasture landscape.

Elevated Pasture landscape character, Dore Road looking south towards the study area

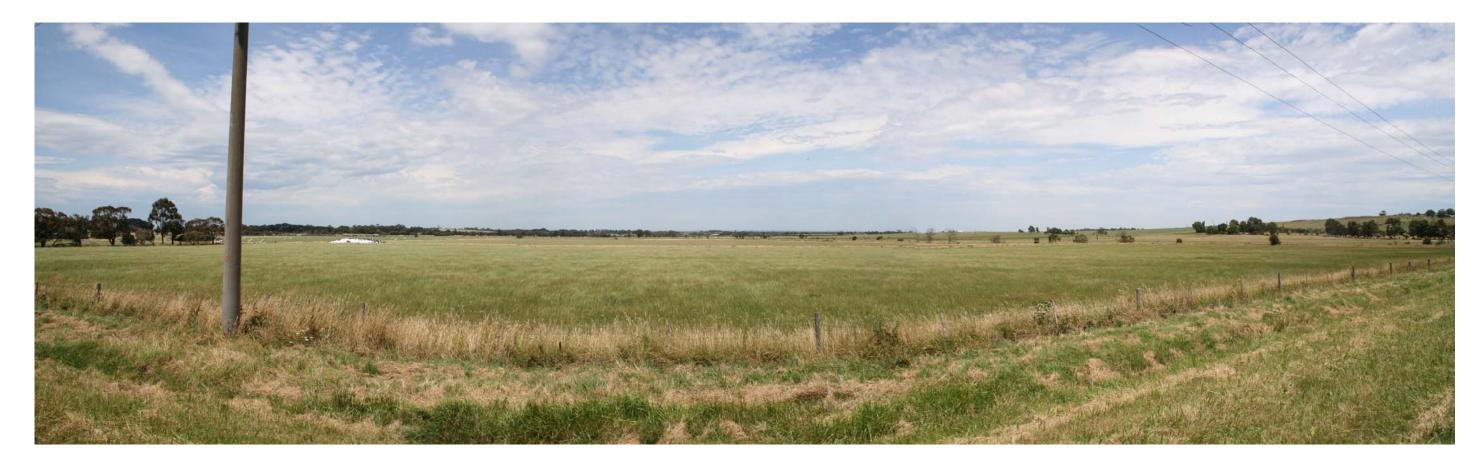
This unit is characterised by long views across cleared pastureland. Scattered buildings and farm infrastructure contribute to the character of this part of the study area.

Low Lying Pasture is also characterised by scattered existing native and exotic vegetation located around existing dwellings, along fence lines and road reserves.

Low Lying Pasture landscape character, view looking south from Princes Highway

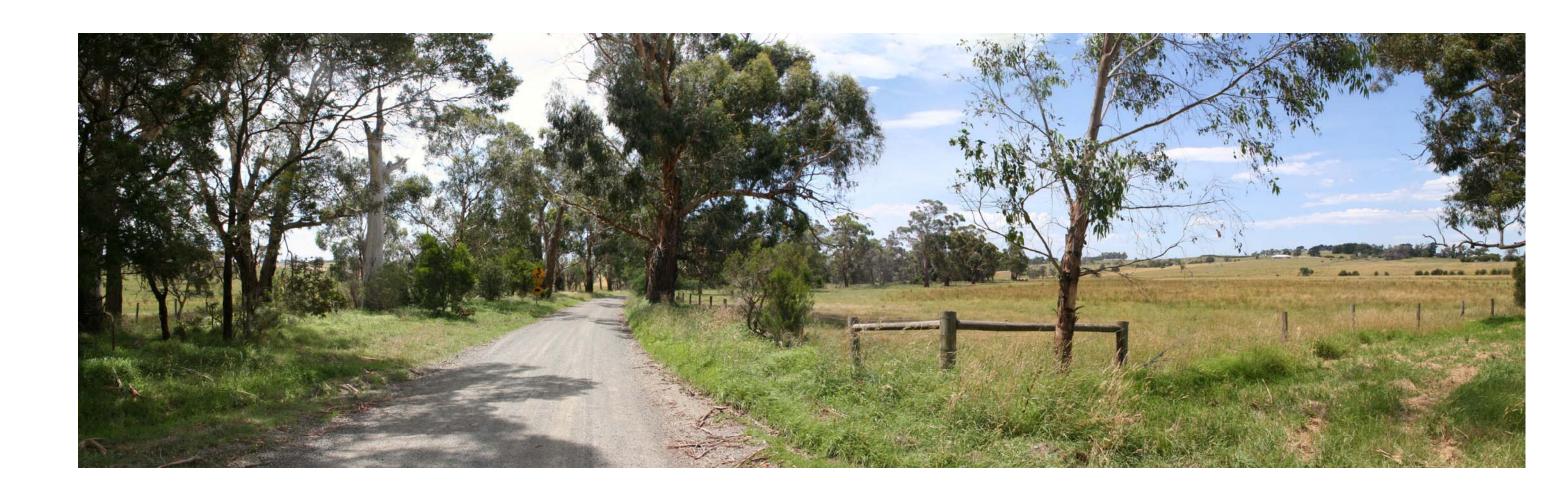
pakenham east precinct landscape assessment | landscape character - riparian

Existing exotic and native vegetation (predominantly native) located along the banks of Deep Creek and within the Deep Creek Road reserve creates a more enclosed landscape experience and restricts some views to the surrounding landscape to the east and west. It should be noted that this varies along the length of Deep Creek Road and, at some locations along the road, breaks in the vegetation allow views across pastureland to the east and west.

At the time of inspection, Deep Creek was a relatively minor water body which had cut into the landscape through the ongoing effect of erosion. Views to the actual water are limited to glimpses from the top of the embankment and are generally not attainable from Deep Creek Road.

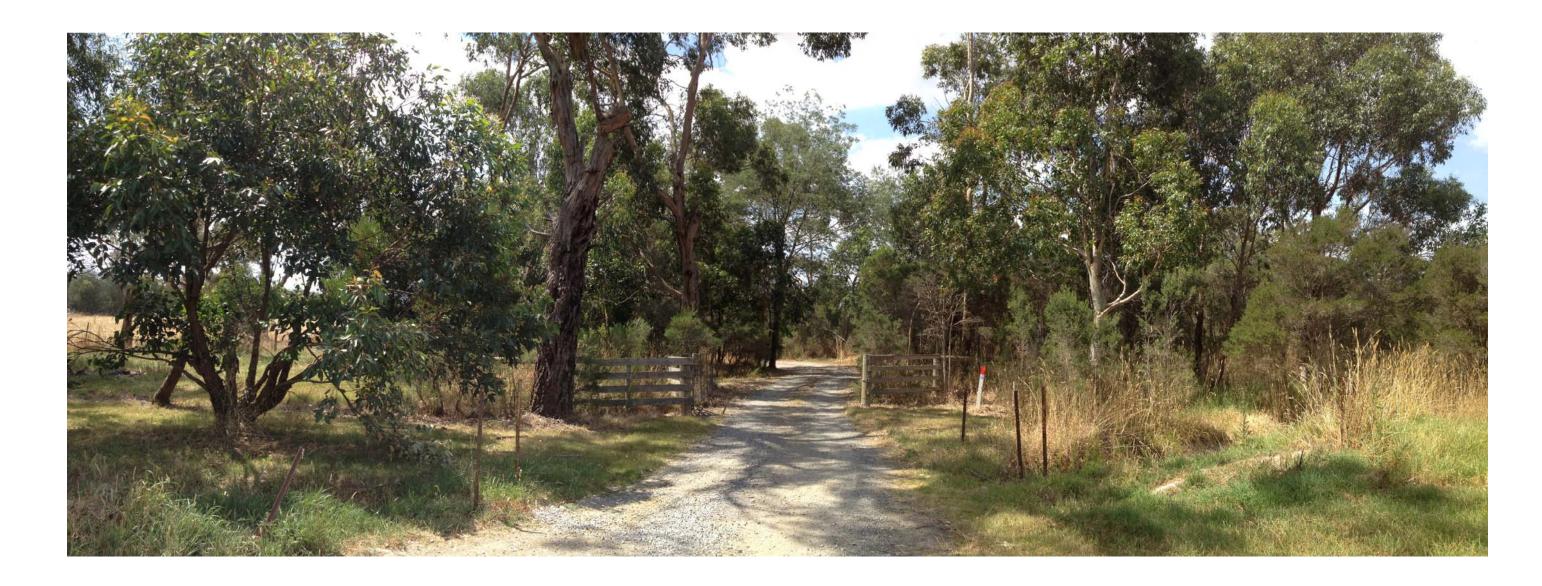
pakenham east precinct landscape assessment | landscape character - remnant bushland

A relatively small patch of what is likely to be at least in part remnant bushland interplanted with younger trees as part of a revegetation strategy. This area is located in the south west corner of the study area within a private property accessed via a long unsealed driveway off Canty Lane.

The landscape character of this area is defined by dense native vegetation and tree canopies which restrict views to the surrounding landscape and the study area.

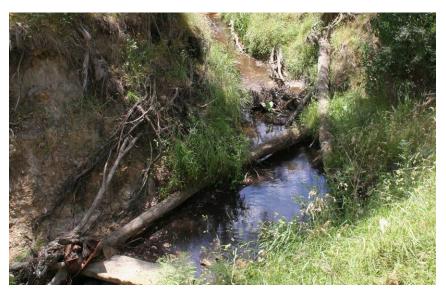
- Eroded Deep Creek embankment
- Weeds and dead trees located within the road reserve and embankment landscape.

It should be noted that this area is by no means a pristine landscape. Elements such as the eroded creek embankment, some weed infestation within the road reserve and a number of dead or dying trees are not particularly desirable.

Although the eroded embankment means that the water body is not visible from the road, the Riparian landscape has feature of some landscape merit.

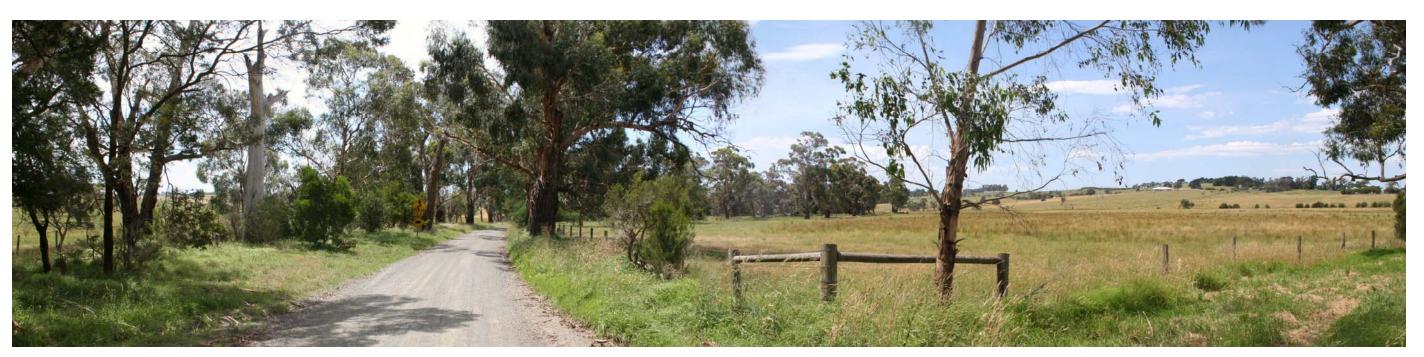
The Riparian landscape is located in the vicinity of the Deep Creek water way and the more densely vegetated landscape located along Deep Creek Road. Deep Creek Road is an unsealed road that meanders along the western boundary of the study area generally following the creek alignment.

The vegetation creates a pleasant sense of shade and enclosure when travelling along Deep Creek Road, with gaps allowing views to the cleared land to the east.

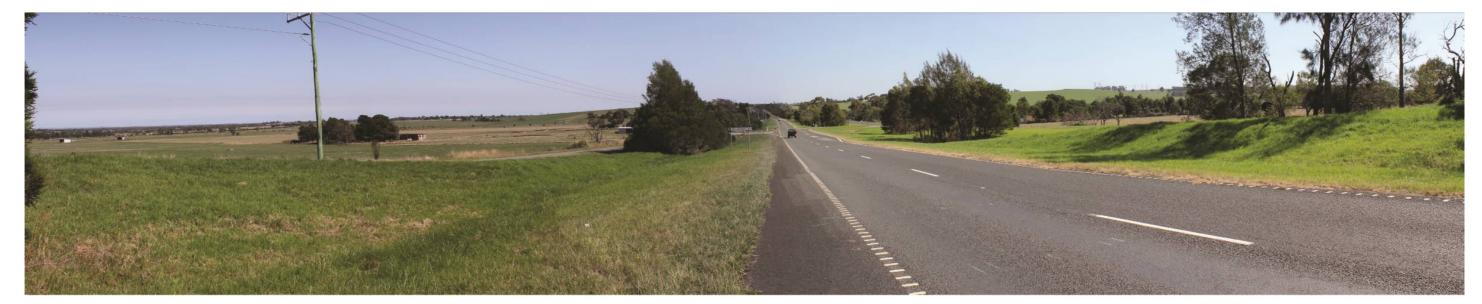
Figure 7.1 Viewpoint Location 6 – Princes Highway Westbound – Existing View

Figure 7.1 below shows a series of merged digital photographs capturing the view looking towards the study area from this location.

- Development should not obstruct views to RL90m and above in land north of the Princes Highway.
- Development should not obstruct views to RL62m and above in land south of the Princes Highway.

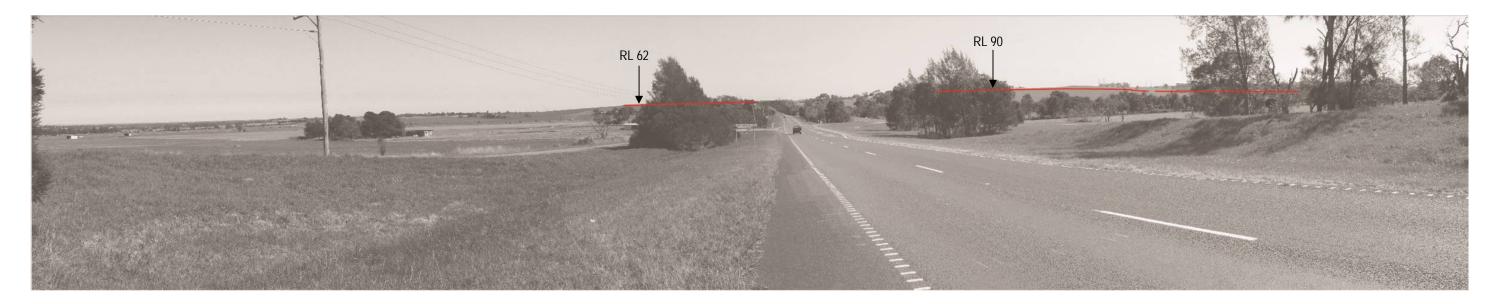
7.4 Viewpoint Location 6 – black & white photograph showing red contours RL 62 south of the Princes Highway & RL90 north of the Princes Highway

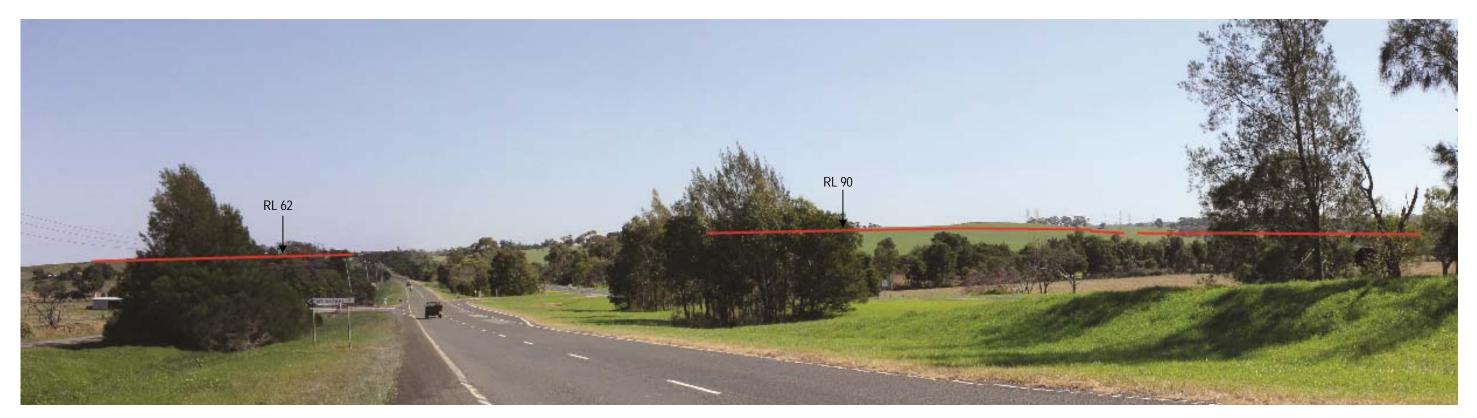
7.5 Viewpoint Location 6 – Photomontage showing the existing view overlaid with red contours RL 62 south of the Princes Highway & RL90 north of the Princes Highway

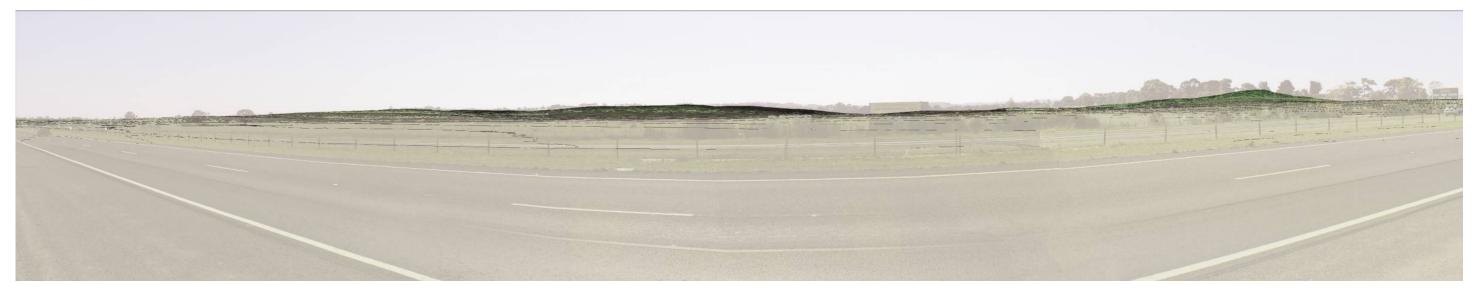
7.8 Viewpoint Location 11–3D Terrain Overlaid over photograph

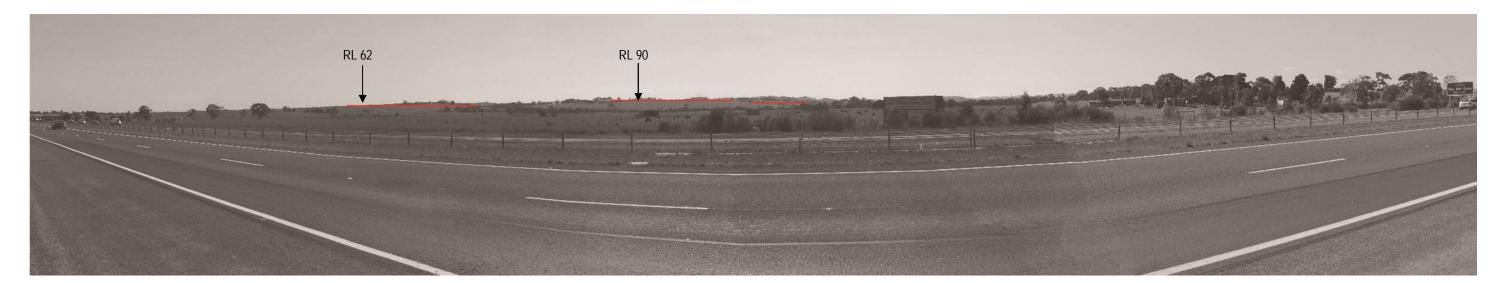
7.10 Viewpoint Location 11 – black & white photograph showing red contours RL 62 south of the Princes Highway & RL90 north of the Princes Highway

Development should not obstruct views to RL90m and above in land north of the Princes Highway.

Development should not obstruct views to RL62m and above in land south of the Princes Highway

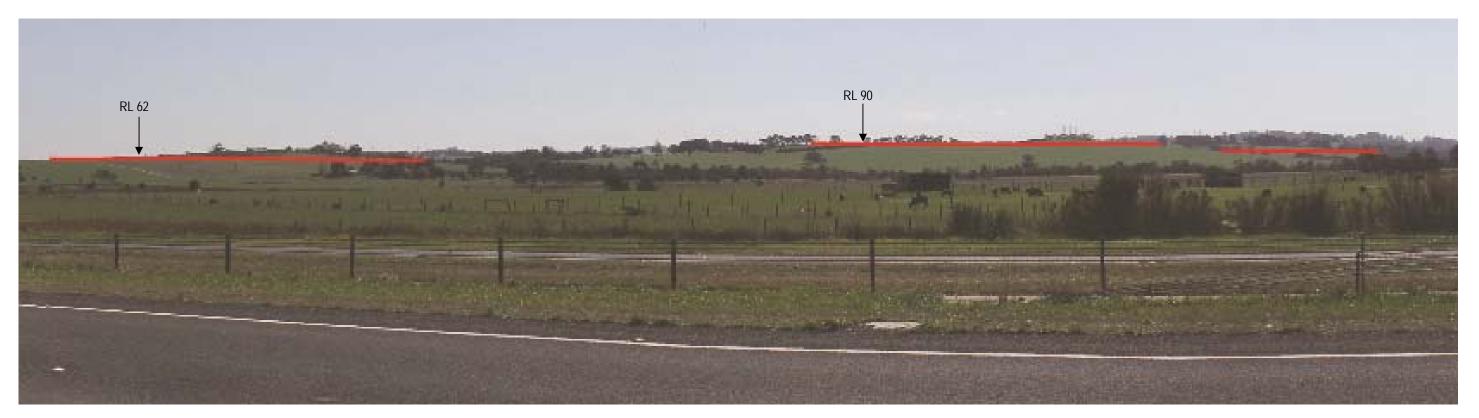
7.11 Viewpoint Location 6 – Photomontage showing the existing view overlaid with red contours RL 62 south of the Princes Highway & RL90 north of the Princes Highway

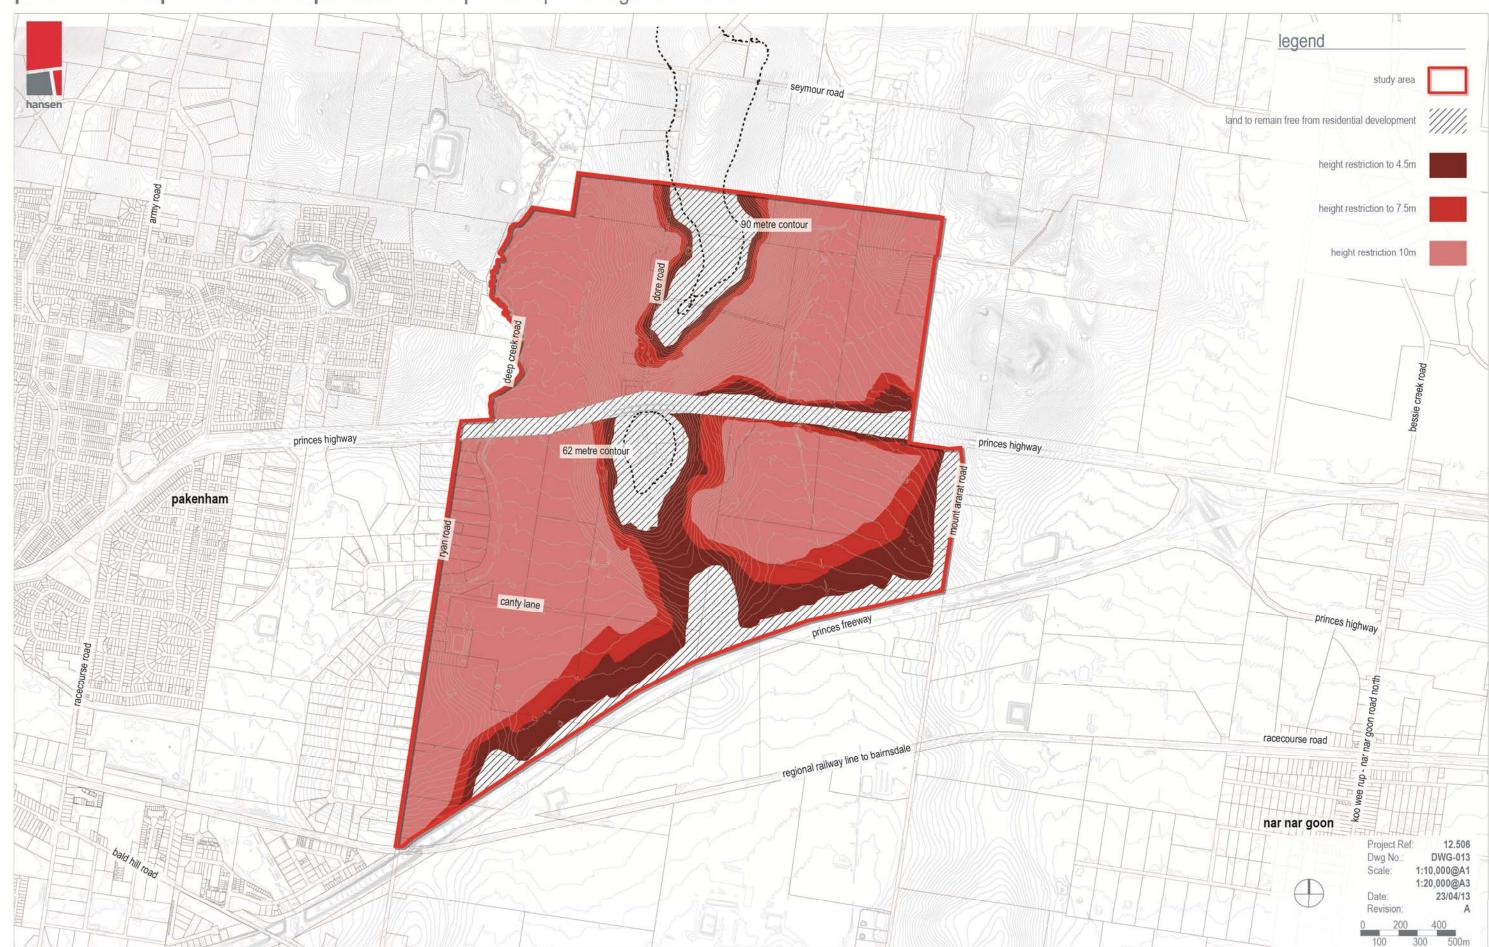
pakenham east precinct landscape assessment | landscape management framework

The resulting distribution of development height zones has been mapped and is shown on the page opposite.
