PRELIMINARY CONTAMINATION ASSESSMENT WITHOUT SOIL SAMPLING & DESKTOP HYDROGEOLOGICAL REVIEW

1425 POUND ROAD & 2100 THOMPSONS ROAD, CLYDE NORTH

Reference: M005387

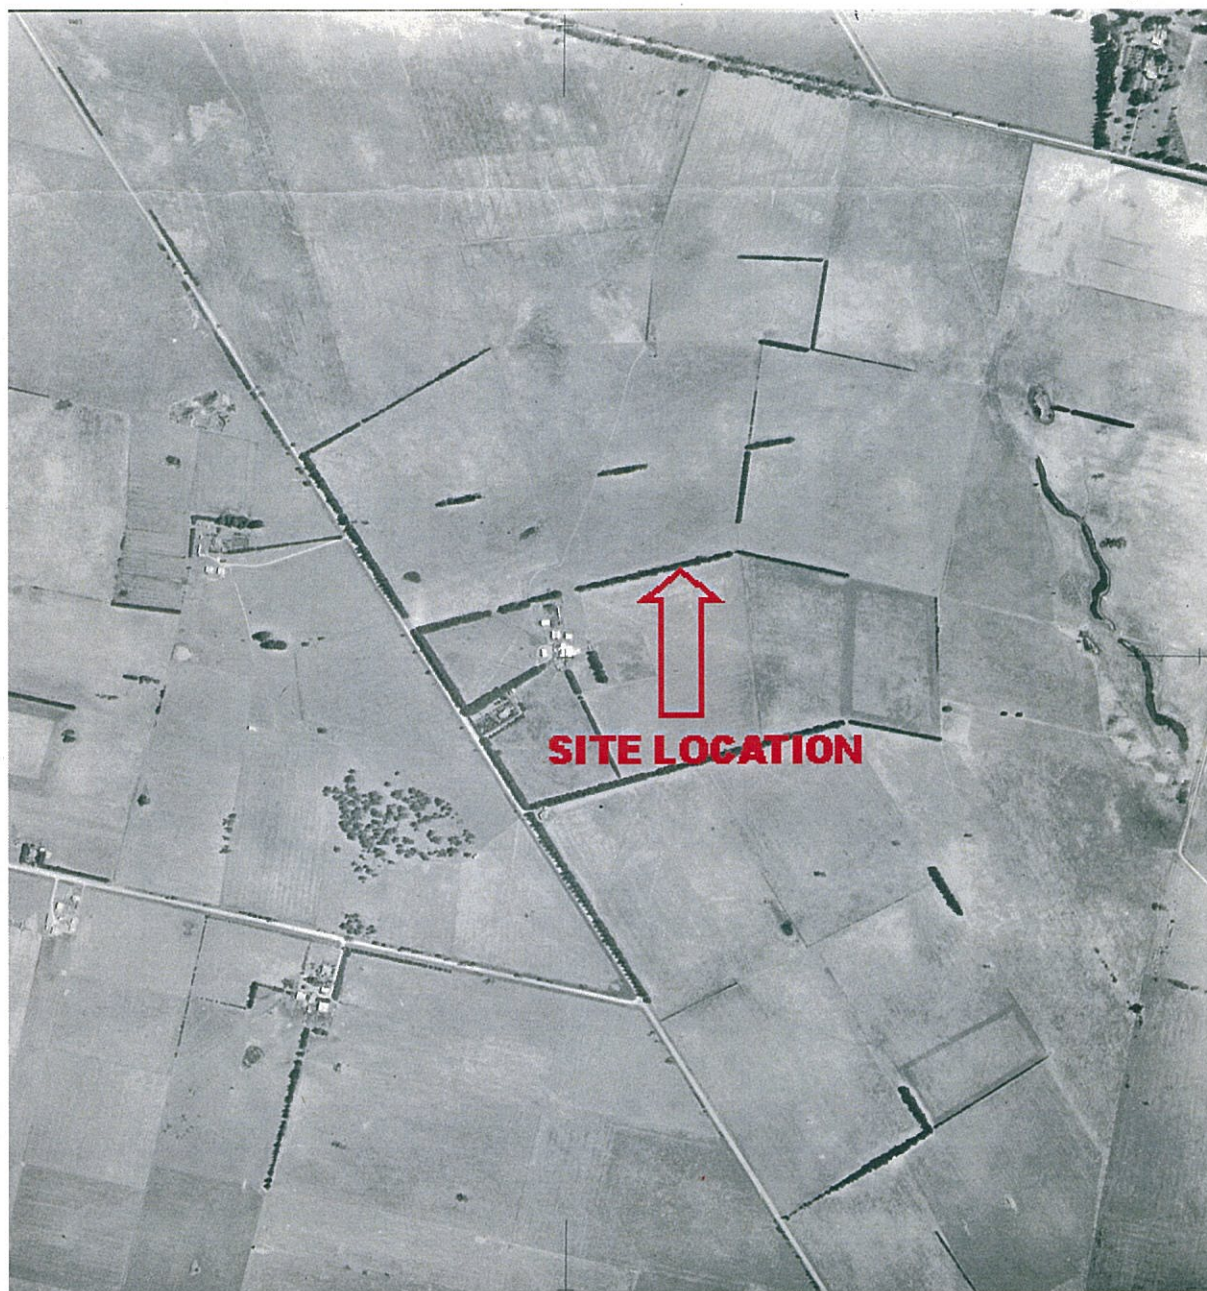
Year: 1960

Year	Scale	Summary
1960	1:9,600	<p>The site appears to be cleared of vegetation and used for grazing or cropping. There are several large farm buildings located in the south west portion of the site. There appears to be two dams located near the buildings. A water course on the eastern side of the site looks to have been dammed. There appears to be a large dam located to the north of the possible dammed water course. There are several vegetated fence lines within the site boundary. There appears to be two man-made drainage channels entering the site near the north west corner and near Soldiers Road and traversing towards the small dam in the east portion of the site. There appears to be small holding yards to the south of the buildings near the south boundary.</p> <p>The surrounding area appears to be used for grazing. There is a small disturbed area adjacent to the west boundary of the site which appears to be the former sand pit noted in the geology maps.</p> <p>Please note that a small portion of the north west corner and portion of the east boundary were not visible in the aerial photograph.</p>

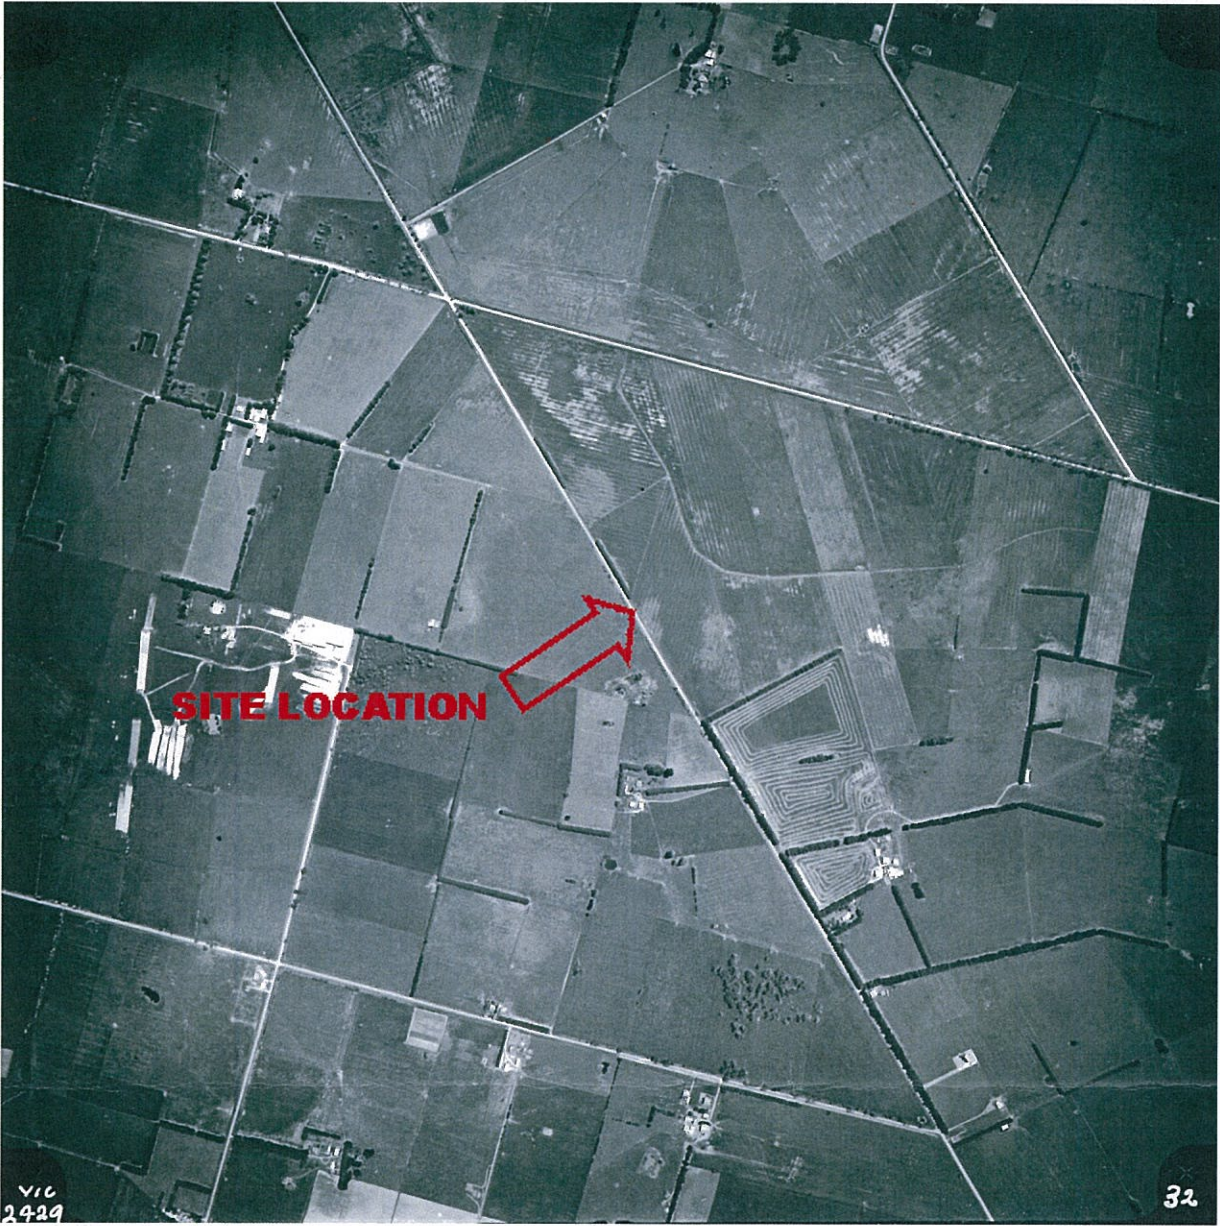
Year: 1970a

Year	Scale	Summary
1970	1:12,000	<p>The site appears to not have been significantly modified although the site may be used for cropping. It appears that one of the small dams north of the large buildings located in the south west portion has been filled. There appears to be a building towards the middle of the south boundary. There appears to be a small structure midway along the east boundary. A new building appears to have been constructed north of the buildings in the south west portion. There appears to be two very small areas of disturbance towards the centre of the site. There also appears to be disturbed soil where two fence lines intersect in the eastern portion of the site.</p> <p>The surrounding area appears to be used for grazing, however there appears to be extractive activities (quarrying, sand excavation) approximately 500 m west of the site. There appears to be a small dam constructed 200 m across Pound Road to the south.</p>

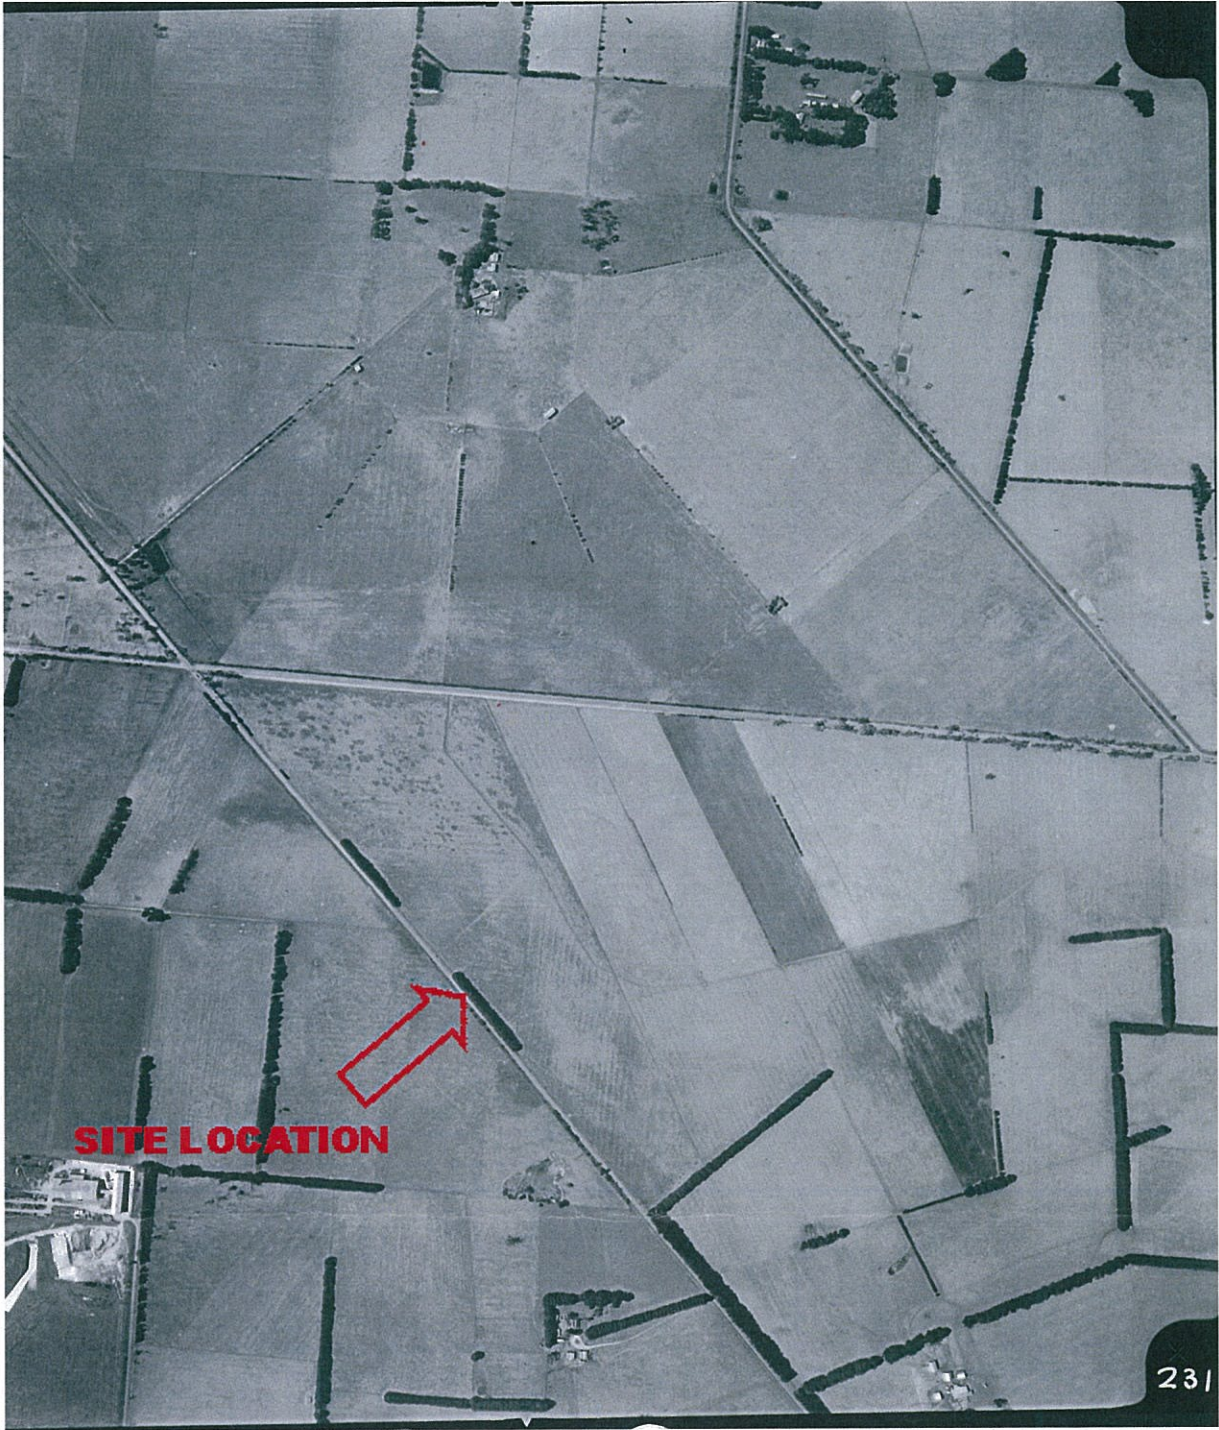
Year: 1978a

1978	1:10,000	<p>The site appears to not have been significantly modified. The building located towards the middle of the south boundary cannot be easily seen. There appears to be a small shed/building located close to the south east corner of the site. There appears to be a darker patch of paddock midway along the northern boundary within the site.</p> <p>There appears to be no significant change in the surrounding area.</p> <p>Please note that a small portion of the southern west corner of the site near the buildings was not visible in the aerial photograph.</p>
1987	1:10,000	<p>There appears to be two high voltage transmission lines running parallel to the south boundary of the site. There appears to be a new residence built approximately 100 m north west of the buildings in the south west portion. The dam near the west boundary appears to be dry, however, the water course and the dam north of the water course appear to be nearly full. There appears to be two disturbed areas in two of the northern paddocks. A residence has been constructed adjacent to the east boundary.</p>
