PSP 31.2 Toolern Part C - Paynes Road

Land Capability Assessment

VW07633.RPT.Final | Final

September 2014

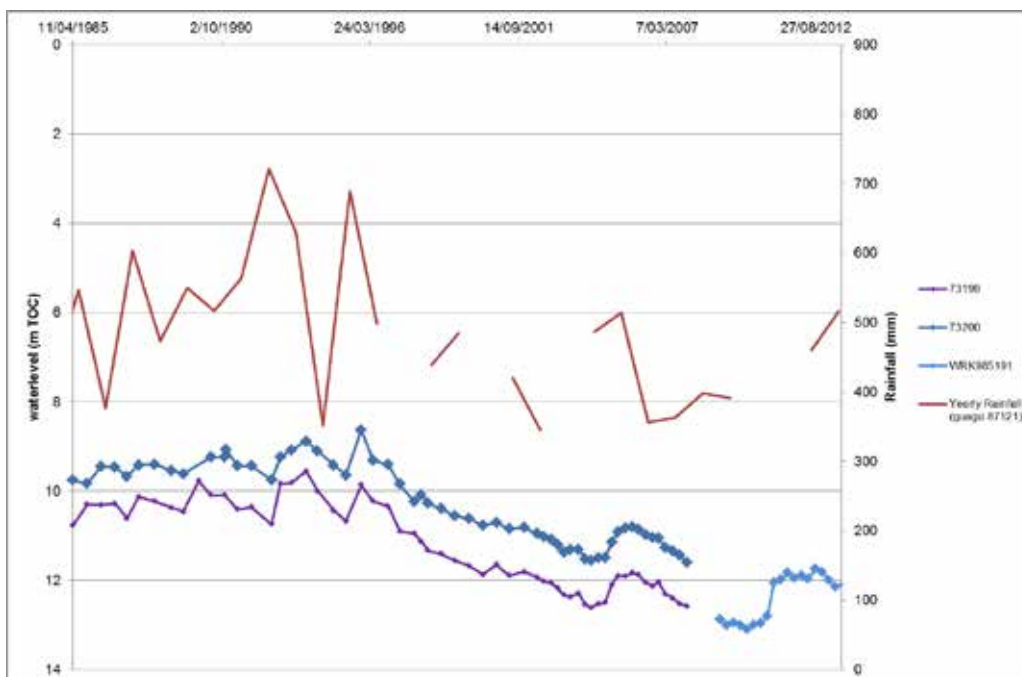
Figure 7.1 : Hydrographs for the site

The hydrographs above are for three monitoring bores (73199, 73200 and WRK985191) within a 5 km radius of the site. All three bores are located to the east of the site near the corner of the Western Freeway and Leakes Road.

Time series groundwater data indicates the water table follows medium term rainfall trends (5 to 10 years). Groundwater levels across the basalt aquifer will vary in the order of 1 to 2 metres (). In wet periods (mid 1990s) water tables were shallowest and during dry periods, particularly 2007 to 2009, water tables fell by approximately 1 m and have since risen in response to the recent wet period.

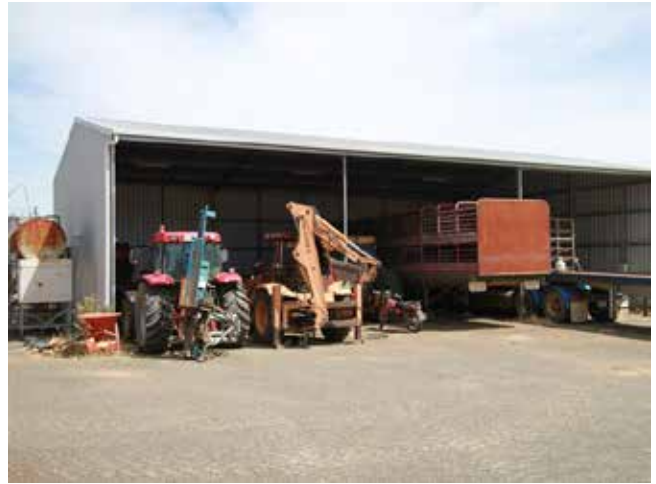
Plate 9.2 : Example of typical farm machinery shed

Storage shed construction can vary depending on their age and can be variously formed of timber, corrugated iron, asbestos cement sheeting, blocks/bricks and concrete. Some sheds may also incorporate concrete floor slabs while others do not.

Based on the above, the most likely sources of contamination include spillages of fuels as well as impacts on soils by metals resulting from general machinery/equipment storage and maintenance of farm vehicles. However, spillages of other agricultural chemicals may also impact upon soils. Given that such chemicals are typically stored in small volumes (less than 20L) impacts are therefore likely to be extremely localised in extent. Additional contaminants of concern can also include biological contaminants and nutrients associated with leakages from septic tank systems.

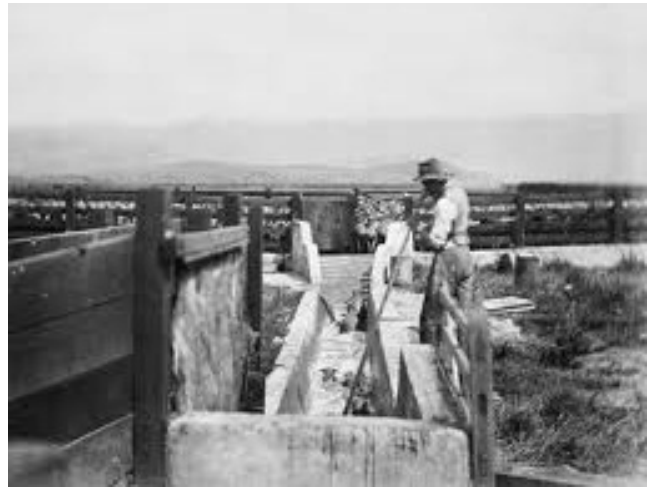
Plate 9.4 : Example of typical sheep dip

Contamination of soil and groundwater can result from the above activities as the liquid formulation either leaks from defects in the dipping infrastructure (be it a permanent sheep dip or mobile trough) or drains from sheep while they are retained in the holding enclosures after dipping is completed.

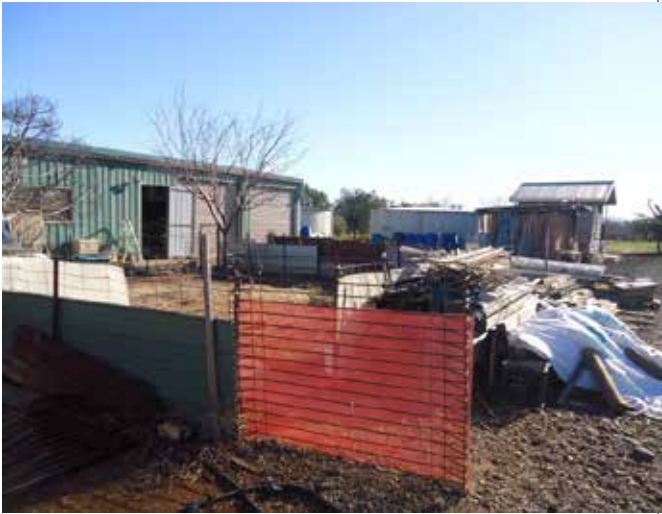
Stockyard with piles of materials, pens, sheds, water tanks

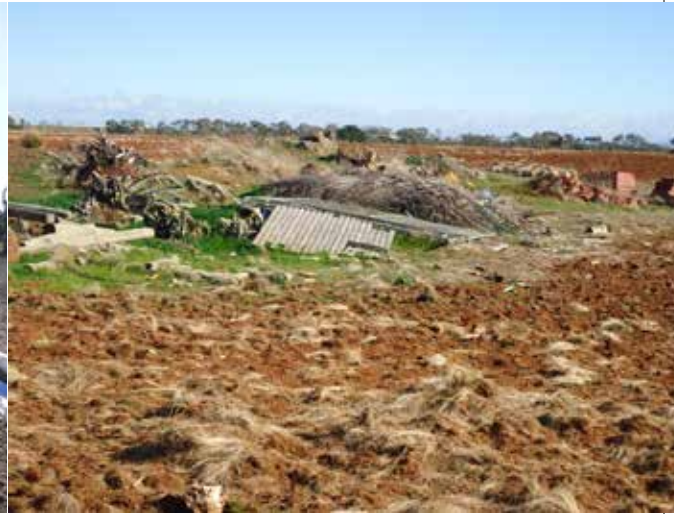
Example of stockpiled materials

- Classification and appropriate removal (if required) of various stockpiles and dumped materials observed at numerous sites across the study area. This includes subsequent validation following removal. It is noted that sampling of some stockpiles of soil observed may indicate that the material is suitable for re-use as part of future development and as such removal may not be required in all instances. *Timing: This task should be undertaken on a site-by-site basis during future site development*
