Bushfire-Prone Area Assessment Report

Brompton Lodge,

Cranbourne

Date of Inspection: 10th April, 2013

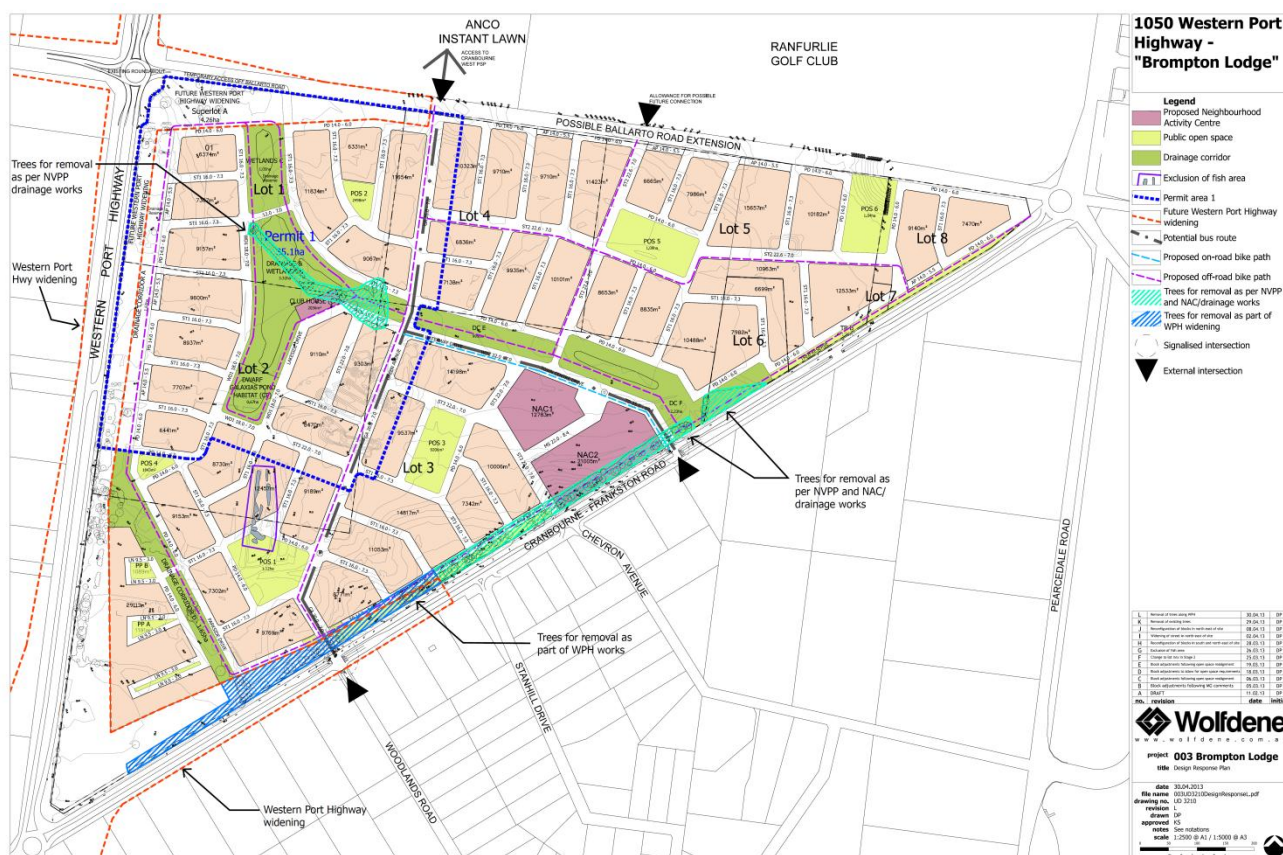
Figure 3. Design response plan.

The proposal involves the potential residential development of the site area (Figure 3). This development will include high density residential properties, as well as associated road infrastructure, and public open space. Patches of remnant vegetation on the property will be retained in reserves on the site.

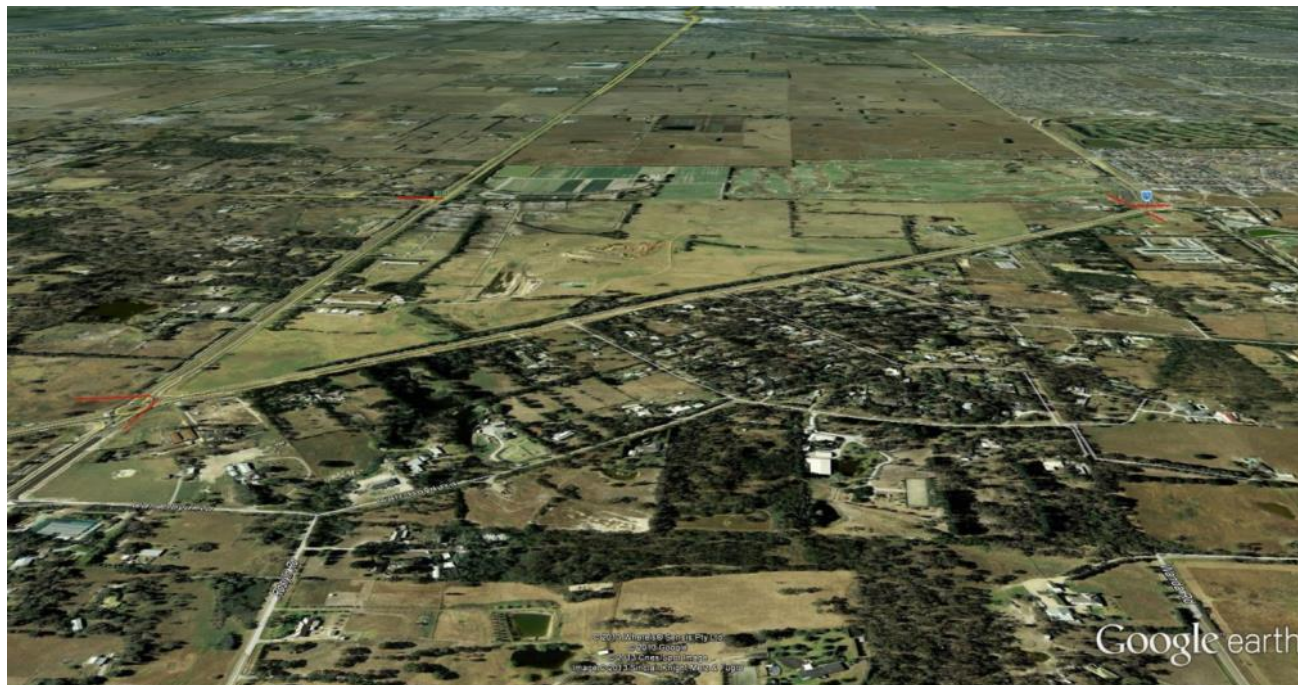
Figure 4. Topographical view of site

The area around the site is generally characterised by open pastureland and residential development on relatively low, flat terrain (Figure 4). Much of the vegetation in the region has been cleared; however, small patches of remnant vegetation remain in isolated spots around the region.

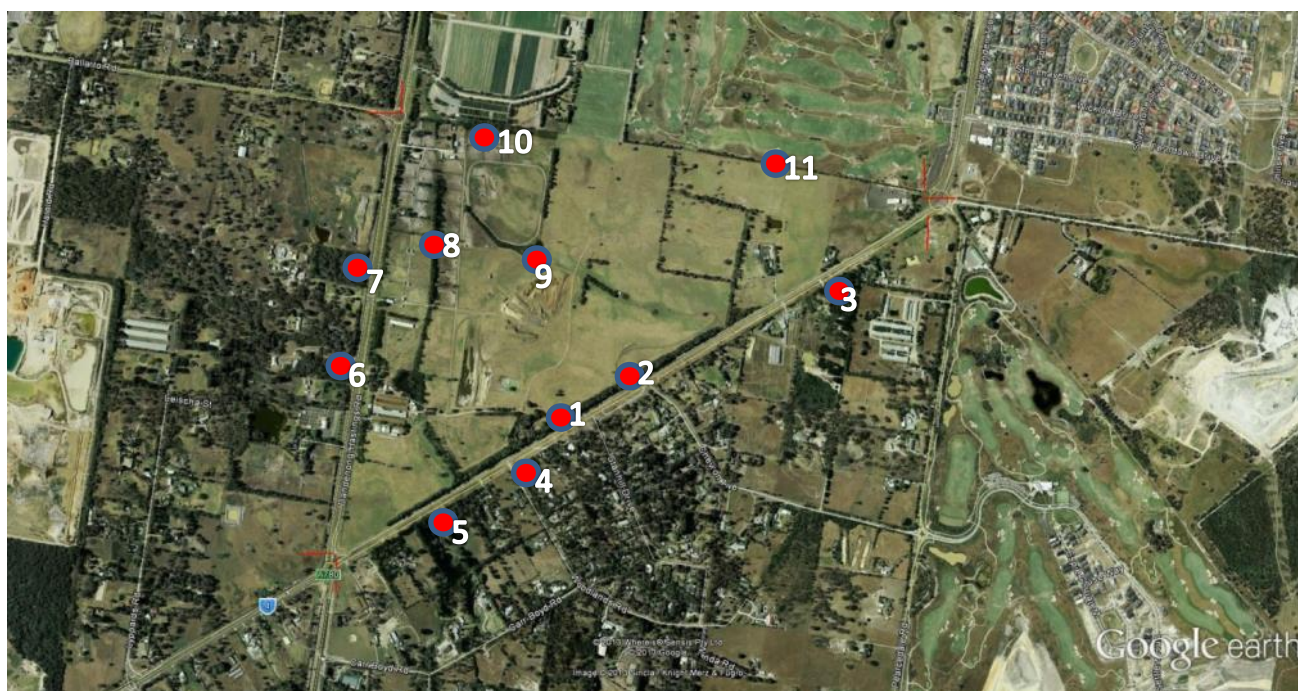
Figure 5. Sampling points

A site inspection was undertaken on 10th April 2013, using AS3959 (2009) assessment methodology to determine the potential bushfire risk for the proposed subdivision development. Areas on and surrounding the site were inspected to determine classifiable vegetation which may pose a significant bushfire risk to the future subdivision. Bushfire parameters were assessed at sampling points of classifiable vegetation (Figure 5). These include distance measurements from classifiable vegetation and slope under the vegetation. Using these inputs a corresponding Bushfire Attack Level (BAL) was determined to define setback distances from vegetation to the proposed development.

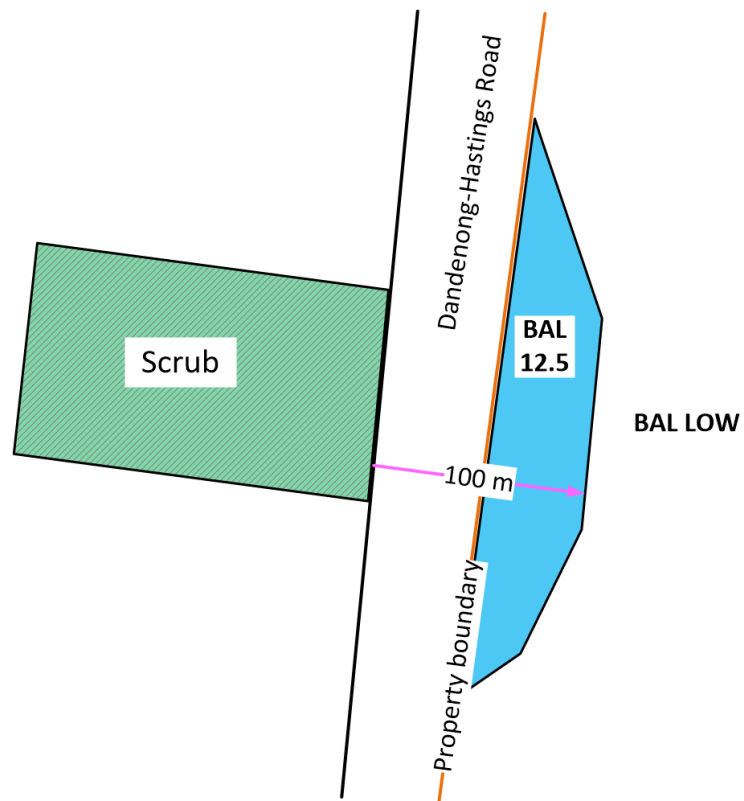
The BAL construction areas relating to vegetation patches in the area are also depicted in Figure 11 to provide further detail.

Figure 11. BAL 12.5 construction area in relation to the west of the site (sampling points 6 and 7).

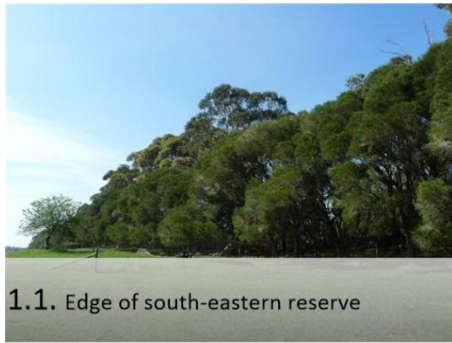
| Sampling Point | Aspect | Classification | Justification |
|---|---|---|---|
| 1 | South (on the property) | Forest | <ul style="list-style-type: none"> • Trees between 10-30 m in height • Canopy cover between 30 - 70% • Dominated by eucalypts |

1.1. Edge of south-eastern reserve

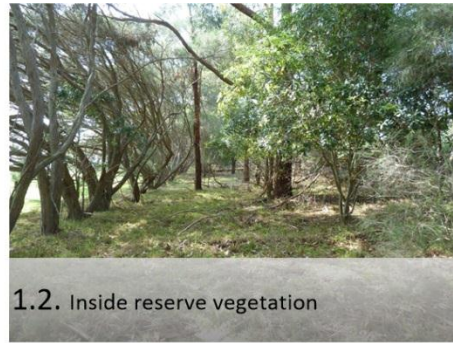
1.2. Inside reserve vegetation

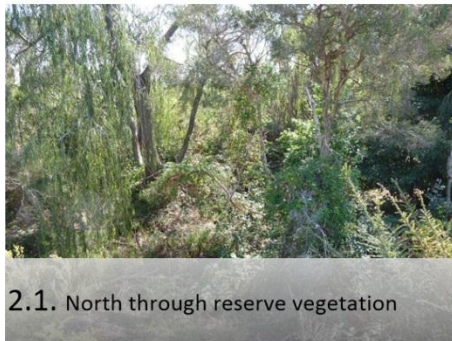
| Sampling Point | Aspect | Classification | Justification |
|---|---|---|---|
| 2 | South-east (on the property) | Forest | <ul style="list-style-type: none"> • Trees between 10-30 m in height • Canopy cover between 30 - 70% • Dominated by eucalypts |

2.1. North through reserve vegetation

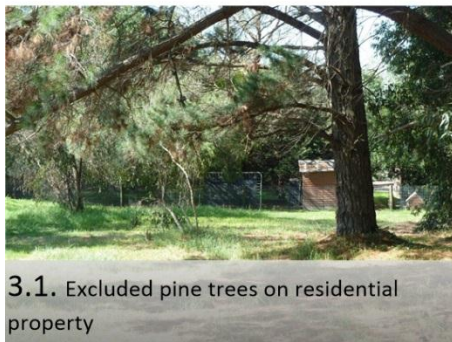
| Sampling Point | Aspect | Classification | Justification |
|---|---|---|---|
| 3 | South-east | Excluded | <ul style="list-style-type: none"> • Low threat vegetation a patch of pine trees with limited understorey between residential properties |

3.1. Excluded pine trees on residential property

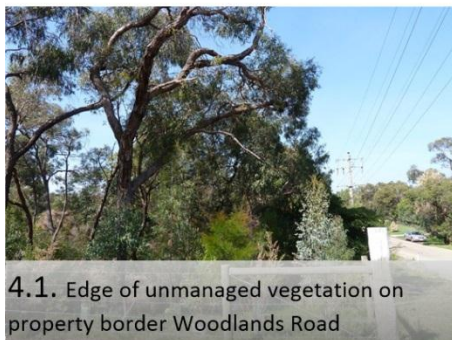
| Sampling Point | Aspect | Classification | Justification |
|---|---|---|---|
| 4 | South | Excluded | <ul style="list-style-type: none"> • Single area of vegetation less than 1 ha in area and not within 100m of other areas of vegetation being classified (note: vegetation at samples 1 & 2 will be removed). |

4.1. Edge of unmanaged vegetation on property border Woodlands Road

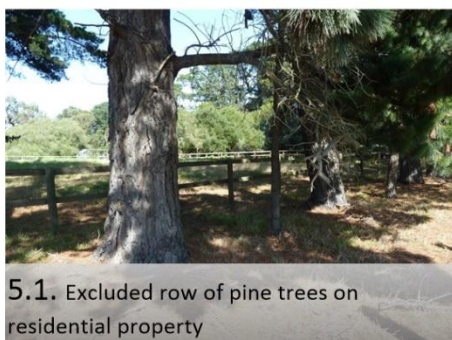
| Sampling Point | Aspect | Classification | Justification |
|---|---|---|---|
| 5 | South-west | Excluded | <ul style="list-style-type: none"> • Strip of vegetation less than 20 m in width and not within 20 m of other classified vegetation |

5.1. Excluded row of pine trees on residential property

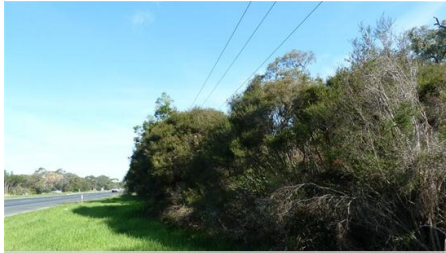
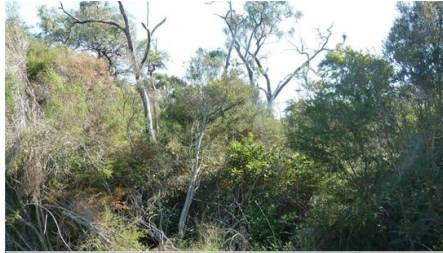
| Sampling Point | Aspect | Classification | Justification |
|---|---|---|---|
| 6 | West | Scrub | <ul style="list-style-type: none"> • Trees greater than 2 m in height • 10 – 30% foliage cover |

6.1. Edge of scrub vegetation off
Dandenong-Hastings Road

6.1. Inside scrub vegetation

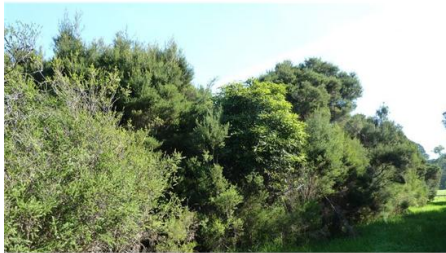
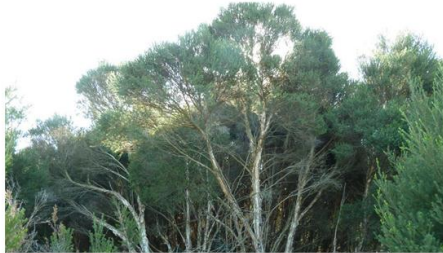
| Sampling Point | Aspect | Classification | Justification |
|---|---|---|---|
| 7 | West | Scrub | <ul style="list-style-type: none"> • Trees greater than 2 m in height • 10 – 30% foliage cover |

7.1. West along edge of scrub vegetation
off Dandenong-Hastings Road

7.2. Inside scrub vegetation

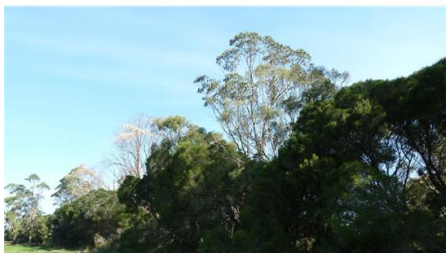
| Sampling Point | Aspect | Classification | Justification |
|---|---|---|---|
| 8 | West (on the property) | Excluded | <ul style="list-style-type: none"> • Strip of vegetation less than 20 m in width and not within 20 m of other classified vegetation |

8.1. South along narrow corridor of
excluded vegetation

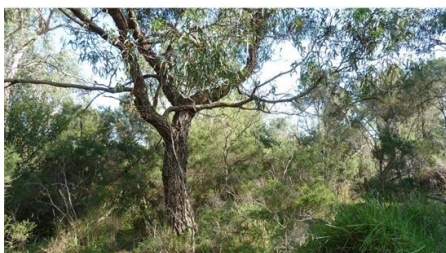
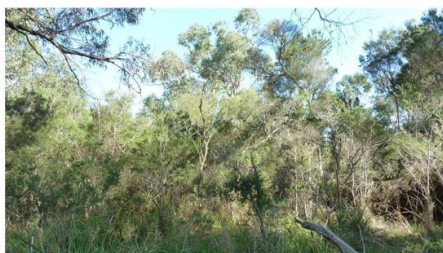
| Sampling Point | Aspect | Classification | Justification |
|---|---|---|---|
| 9 | (centre of the property) | Scrub | <ul style="list-style-type: none"> • Trees greater than 2 m in height • 10 – 30% foliage cover • Dominated by eucalypt trees |

9.1. Reserve scrub vegetation

9.1. Inside reserve scrub vegetation

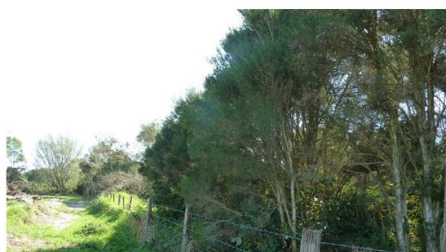
| Sampling Point | Aspect | Classification | Justification |
|---|---|---|---|
| 10 | North | Excluded | <ul style="list-style-type: none"> • Strip of vegetation less than 20 m in width and not within 20 m of other classified vegetation |

10.1. West along edge of excluded border
vegetation

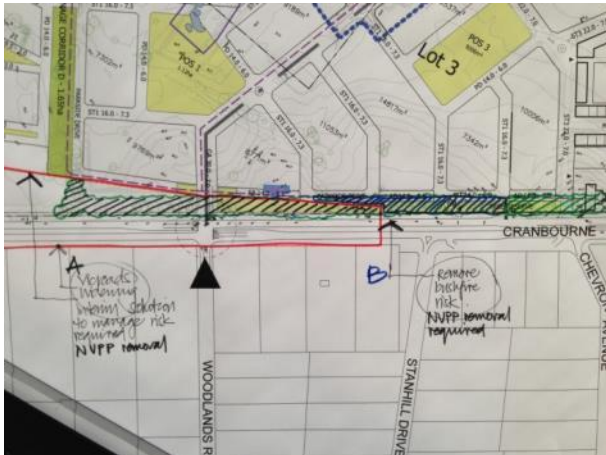
Vegetation modification along southern boundary of the site:

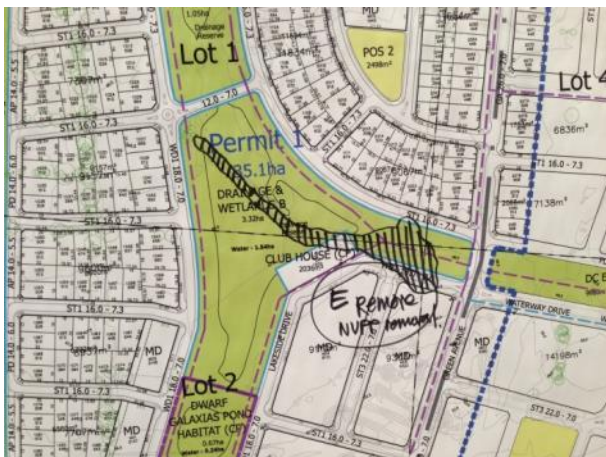
Vegetation modification on remnant vegetation on the site:
