**Shenstone Park PSP assessment**  
Hydrologic regime report

February 2018

**This document is the hydrologic regime report, which builds on the values report (documented in the companion report).**

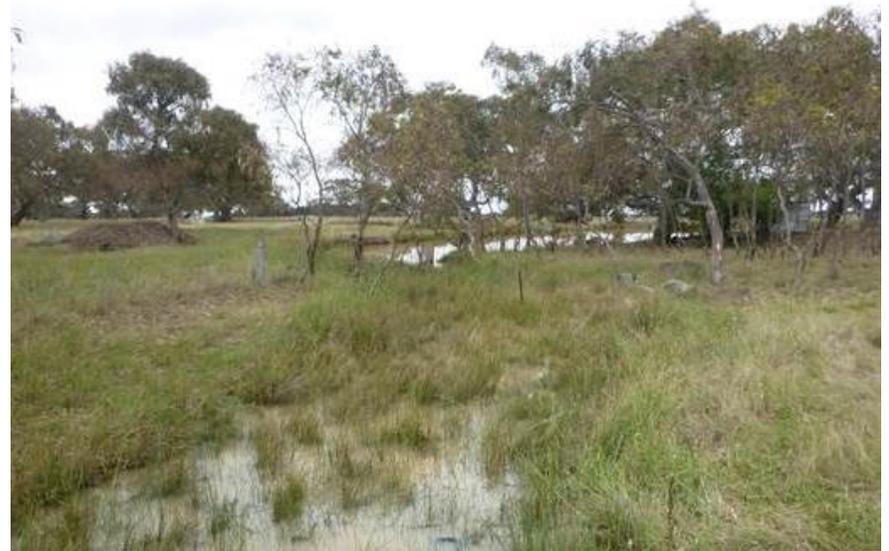
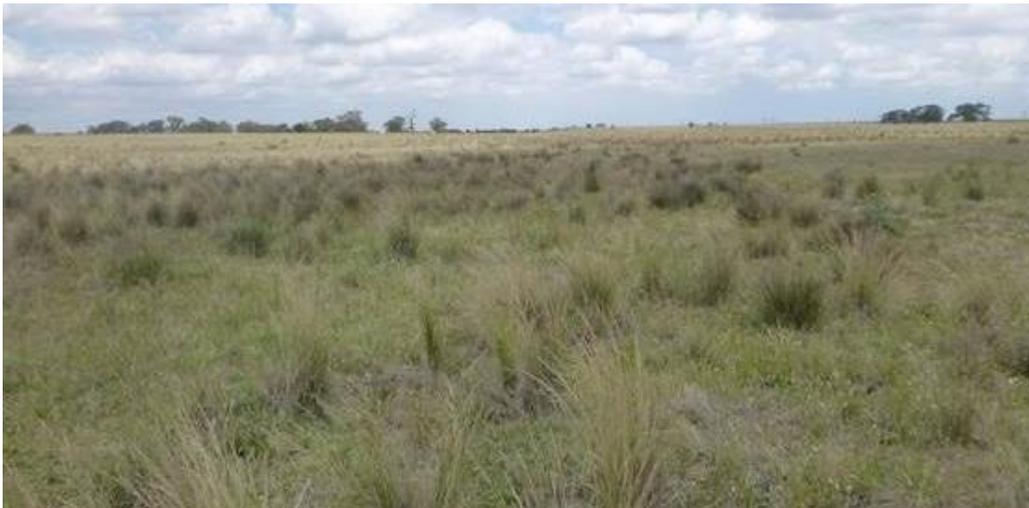
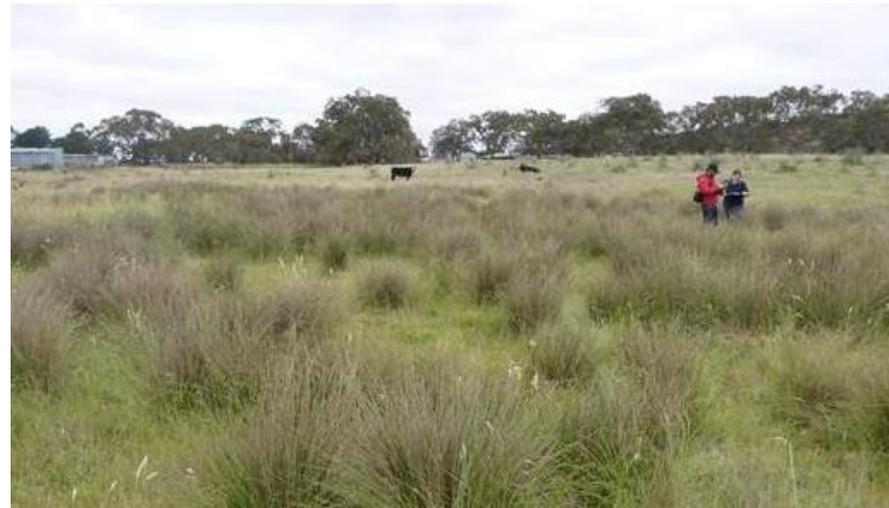
- Plains Grassy Woodland (top right image) and modified indigenous wetland vegetation (bottom right) communities along the lower section of the Merri Creek tributary (Reach 3)
- Creekline Tussock Grassland vegetation community along Curly Sedge Creek (bottom left image)

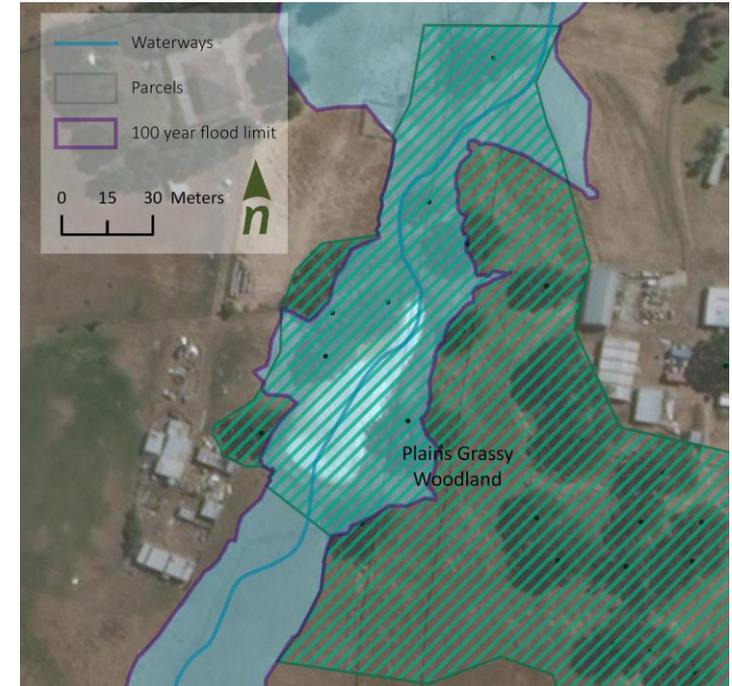
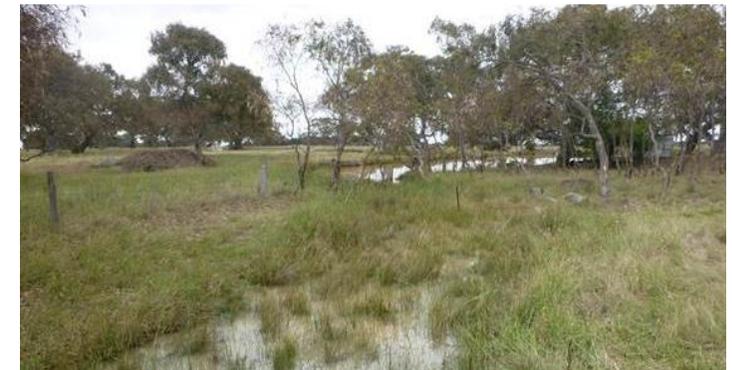
# Plains Grassy Woodlands – Merri Creek tributary

<b>Location and relationship to waterway</b>	Comprised primarily of large, old River Red Gums ( <i>Eucalyptus camaldulensis</i> ) surrounding the existing dam and extending away from the stream to the south-east. The majority of this community is outside the 100 year flood extent.
<b>Structure and cover</b>	Large, old (100+ years) River Red Gums over a low, often sparse, understorey of indigenous and introduced grasses.
<b>Area</b>	0.75 hectares within the 100 year flood extent. Connected to a larger 150 hectare area containing a mixture of remnant Plains Grassy Woodland and Plains Grassland patches and scattered, old trees.
<b>Key indigenous species and cover</b>	Throughout: <i>Eucalyptus camaldulensis</i> (10%) Within 100 year flood extent: <i>Rytidosperma duttonianum</i> (5-25%), <i>Juncus</i> sp. (5-25%), <i>Amphibromus nervosus</i> (1-5%), <i>Eleocharis acuta</i> (1-5%), <i>Poa labillardierei</i> (<1%) Outside 100 year flood extent: <i>Rytidosperma caespitosum</i> (5 – 25%), <i>Rytidosperma racemosum</i> var. <i>racemosum</i> (5 – 25%), <i>Austrostipa scabra</i> (1-5%), <i>Austrostipa bigeniculata</i> (1-5%), <i>Rytidosperma geniculatum</i> (1-5%), <i>Anthosachne scabra</i> (1-5%)

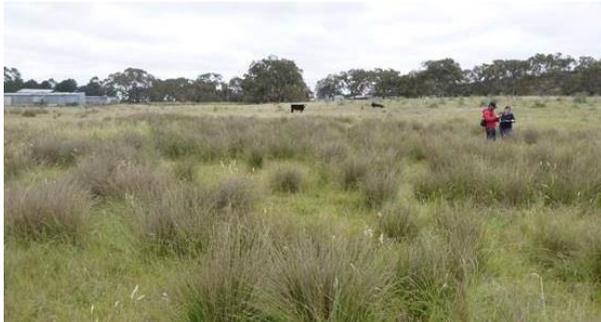
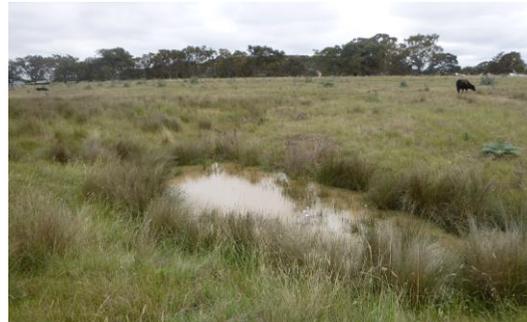
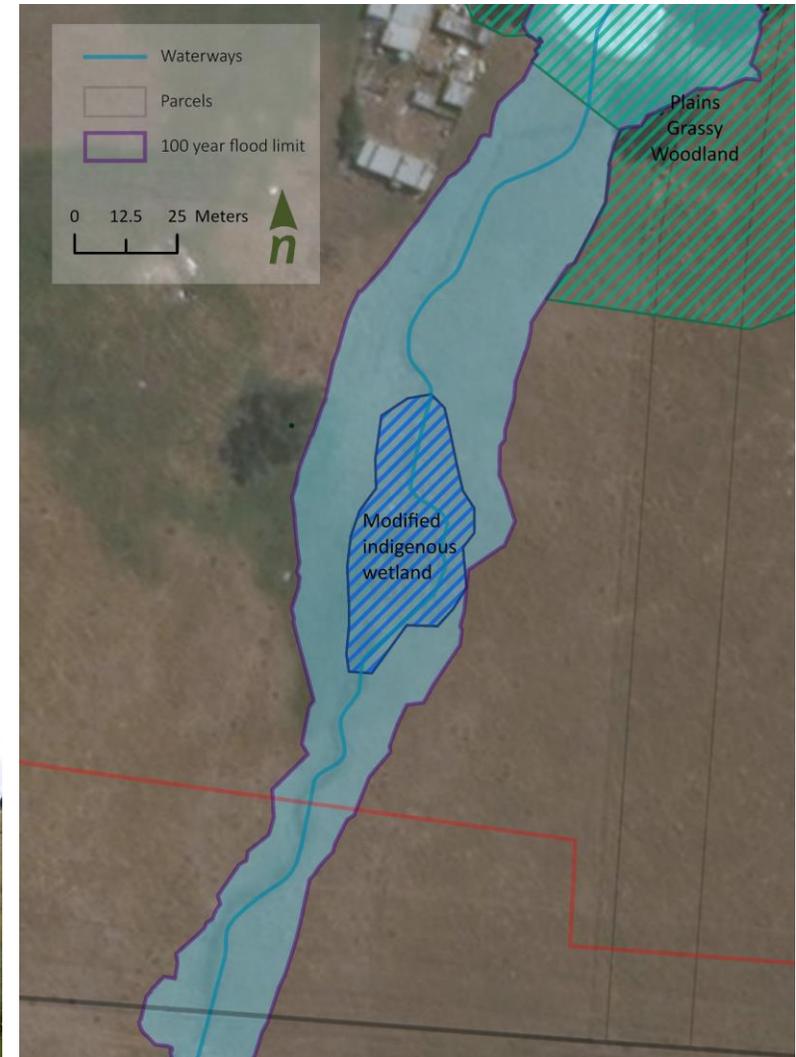
# Modified indigenous wetlands – Merri Creek tributary

<b>Location and relationship to waterway</b>	A small in-stream marsh and associated ponds formed upstream of an exposed rock outcrop which has caused localised ponding of flow.
<b>Structure and cover</b>	Dense sward of rushes (40%) above grassy understorey with occasional herbaceous species.
<b>Area</b>	0.14 hectares
<b>Key indigenous species and cover</b>	<i>Juncus flavidus</i> (25-50%), <i>Juncus filicaulis</i> (5-25%), <i>Rytidosperma duttonianum</i> (1-5%), <i>Amphibromus nervosus</i> (<1%), <i>Carex inversa</i> (<1%), <i>Eleocharis acuta</i> (<1%), <i>Poa labillardierei</i> (<1%)
<b>Habitat features</b>	Sitting water, dense rushes and tussocks, surface rocks (basalt)
<b>Landscape context</b>	Close proximity (<500 m) from the vegetated Merri Creek corridor
<b>Conservation significance</b>	Poor indigenous species diversity and the small extent means this community is of limited value for the conservation of biodiversity.

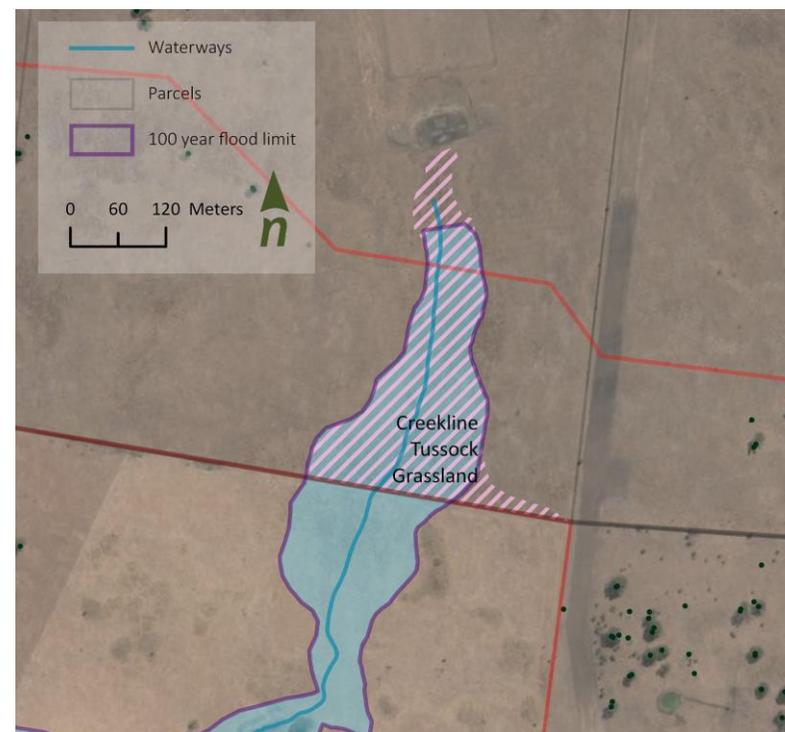
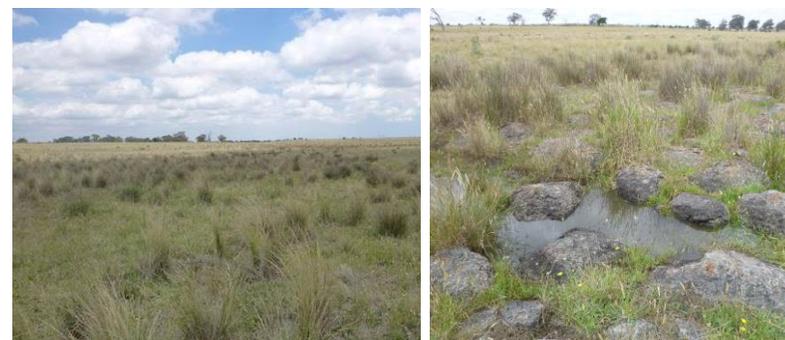
# Creekline Tussock Grassland – Curly Sedge Creek

<b>Location and relationship to waterway</b>	Situated within the head of Curly Sedge Creek, this community covers the majority of the open valley floor. The stream channel is poorly defined through this section and shallow flows will disperse across large areas of the tussock grassland during heavy rains.
<b>Structure and cover</b>	Moderate to dense grassland comprised of 0.5 – 1 m tall Common Tussock-grass ( <i>Poa labillarderei</i> ) over a primarily exotic understorey of grasses and occasional herbaceous species. In wetter areas immediately below the farm dam and near the precinct boundary, the cover of rushes and sedges has increased. The cover of Common Tussock-grass varies across the area, ranging from dense swards (>50% cover) to individual, scattered plants (<5% cover).
<b>Area</b>	5 hectares
<b>Key indigenous species and cover</b>	<i>Poa labillarderei</i> (5-50%), <i>Juncus flavidus</i> (5-25%), <i>Juncus filicaulis</i> (1-5%), <i>Juncus gregiflorus</i> (1-5%), <i>Carex tereticaulis</i> (<1%), <i>Calocephalus lacteus</i> (<1%), <i>Rytidosperma duttonianum</i> (<1%)
