**HYDROGEOLOGICAL, SALINITY, ACID SULPHATE SOIL AND
GEOTECHNICAL ASSESSMENT**

CRAIGIEBURN WEST PSP

Reference: 1801684

Client: Victorian Planning Authority (VPA)

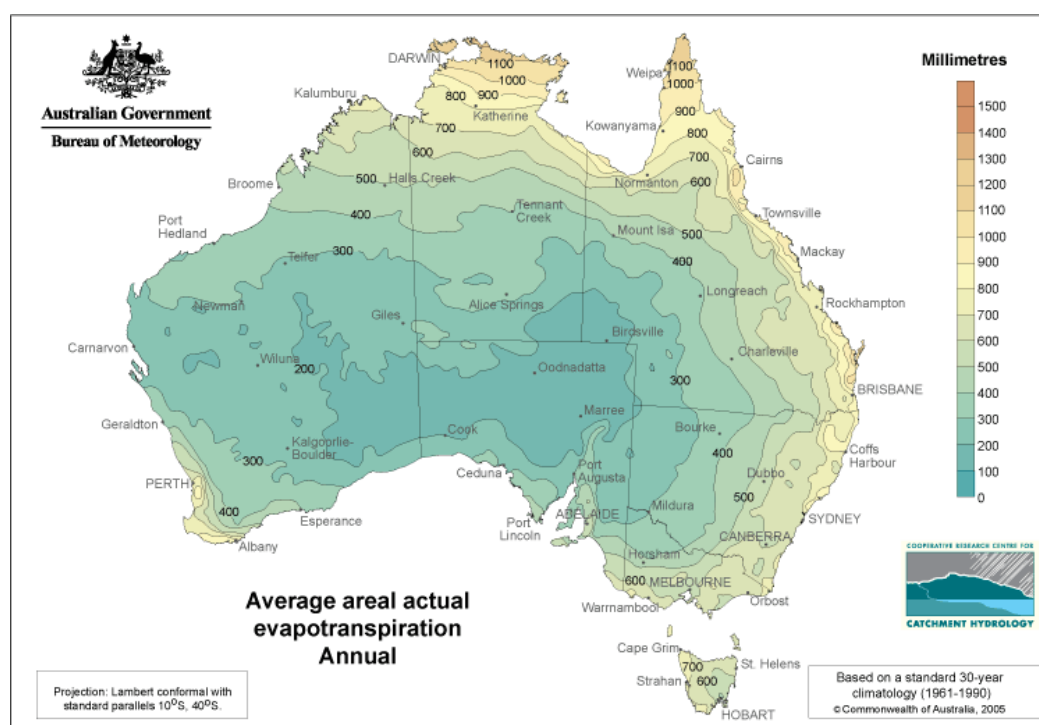
Figure 3-2: Average Annual Areal Actual Evapotranspiration data⁴

The PSP area is located in a region which has a mean actual evapotranspiration of between 500 and 600 mm/year (presented in Figure 3-2). The PSP area is expected to receive an average of between 0 and 100 mm/year of infiltrated precipitation.

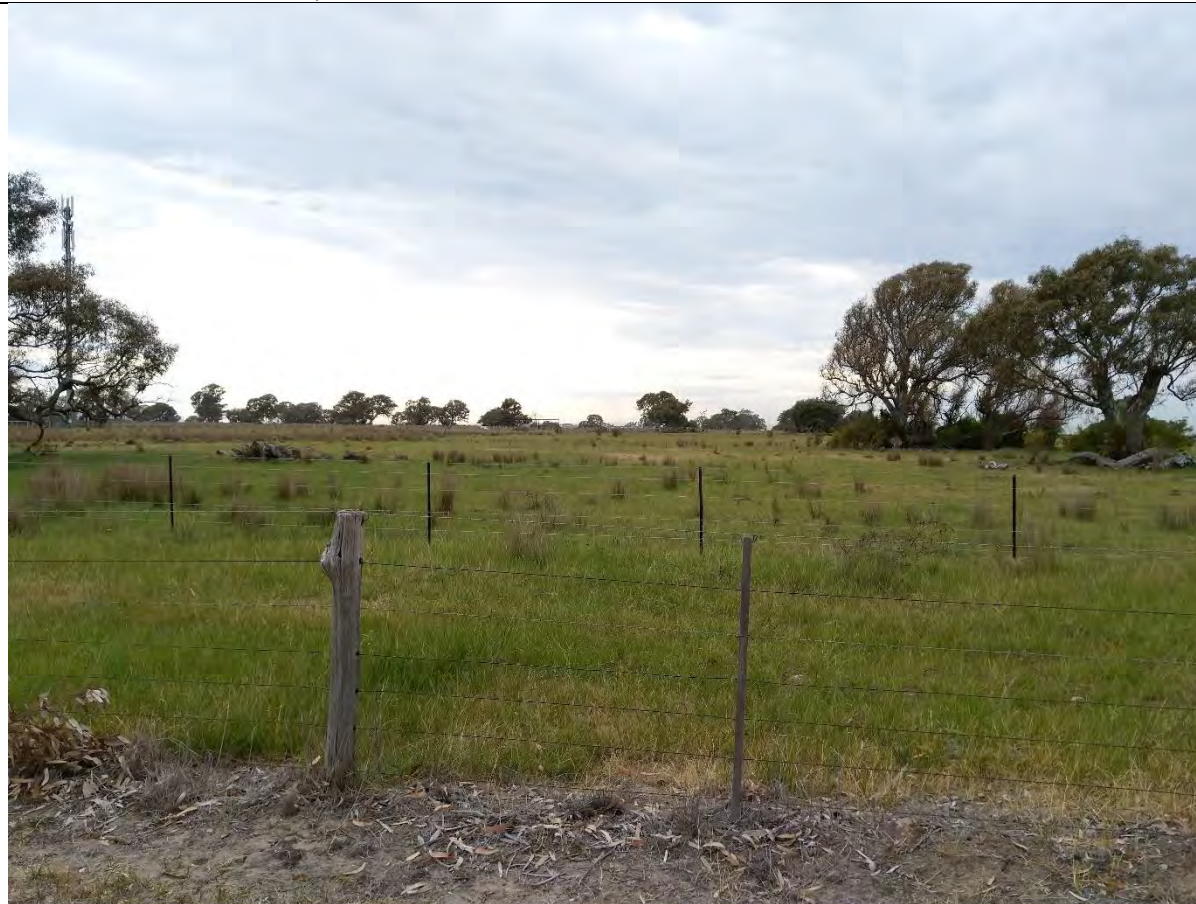
IMG 04. South west portion of 1760 Mickleham Road, greener vegetation and some reed grasses were observed

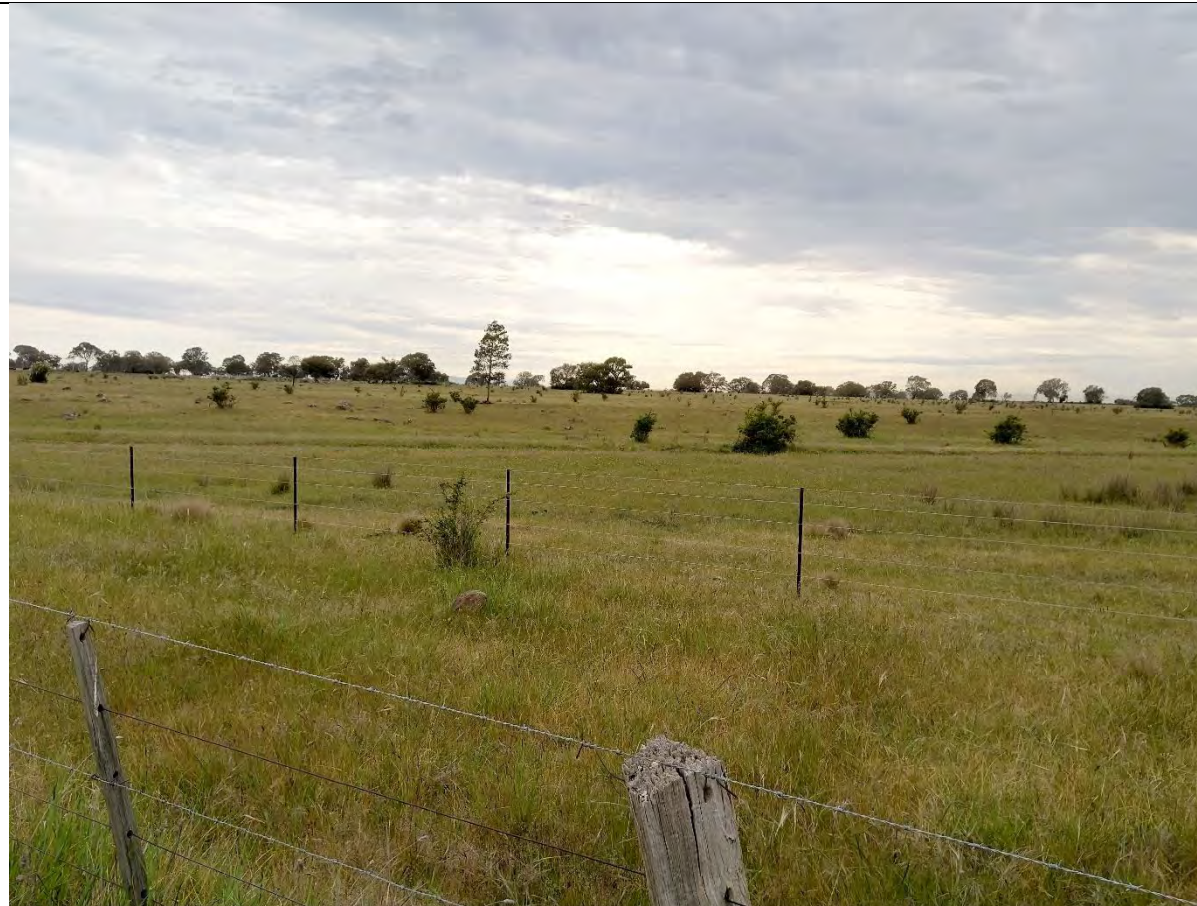
IMG 05. West portion, unnamed drainage channel was observed extending to the south east

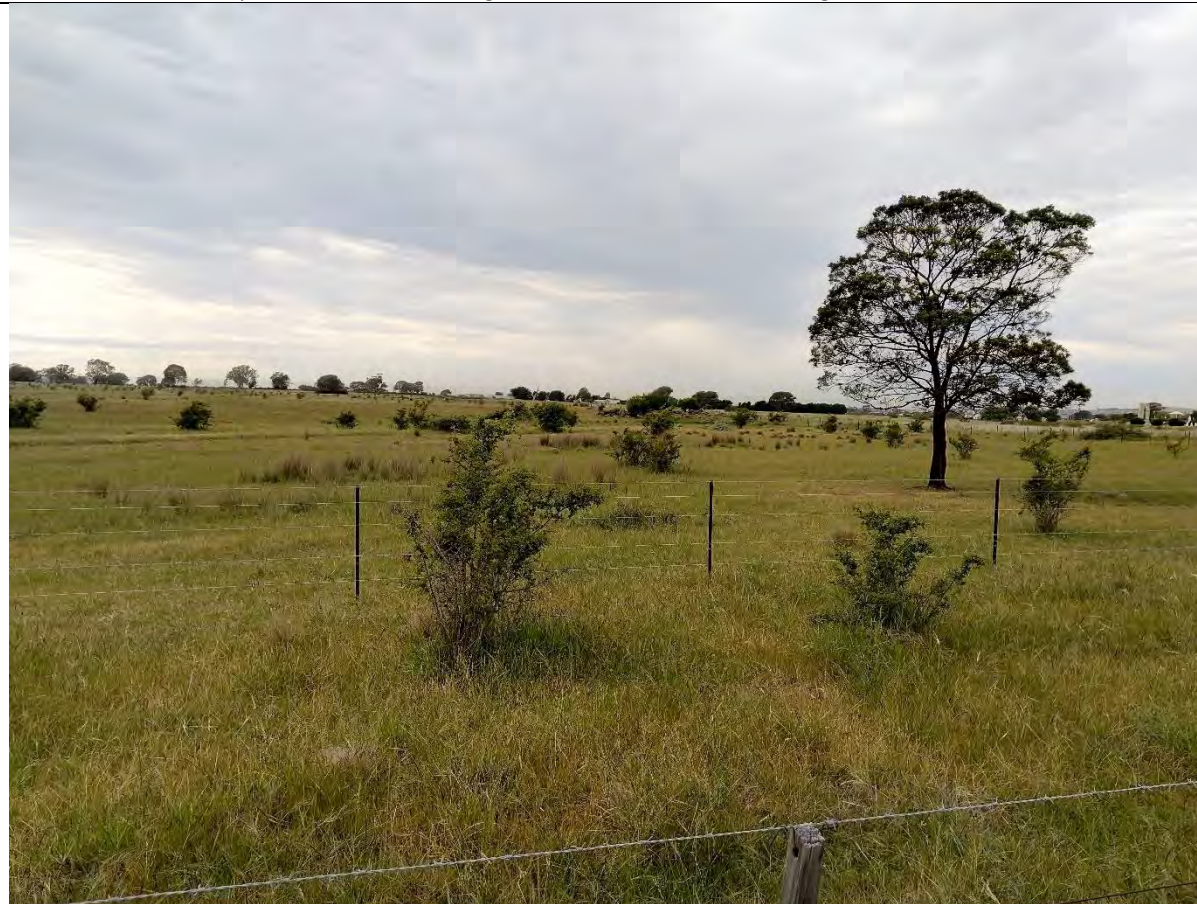
IMG 06. West portion, unnamed drainage channel was observed extending to the south east

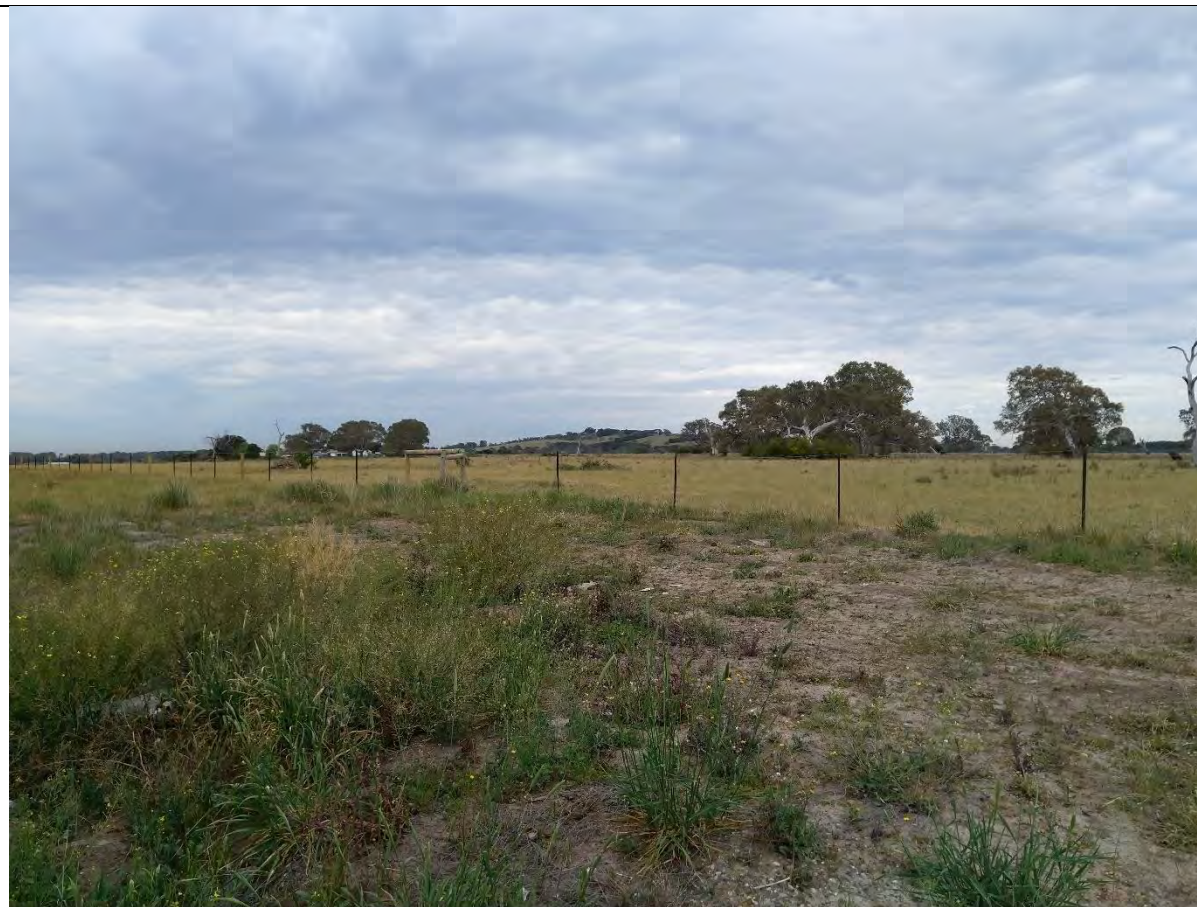
IMG 018. View west of the north portion from the east boundary, some areas of surficial fill were observed along the east boundary

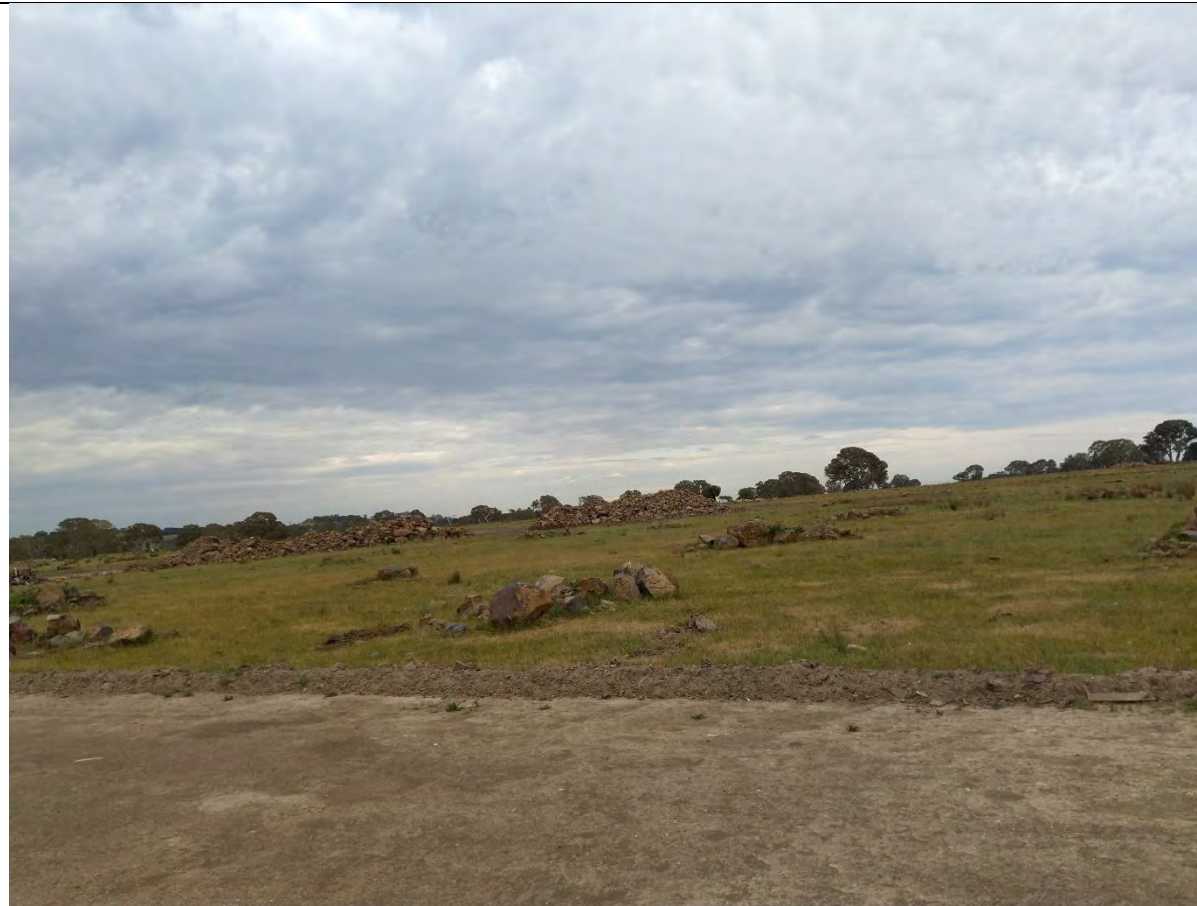
IMG 019. View west of the north portion from the east boundary, some areas of surficial clearing and shallow basalt floaters were observed

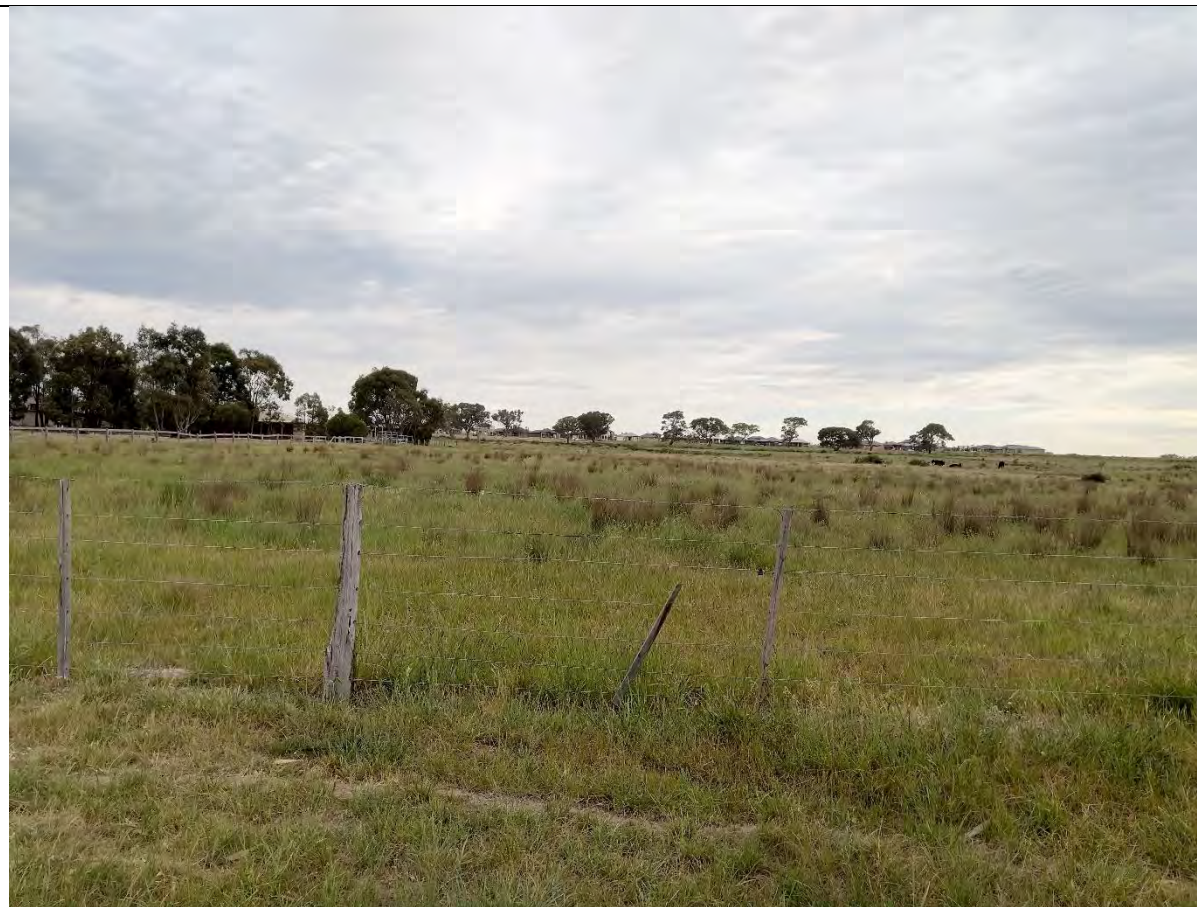
IMG 020. View to the north of Olivers Road in the north portion, reed gasses were observed indicating a drainage or potential shallow groundwater area

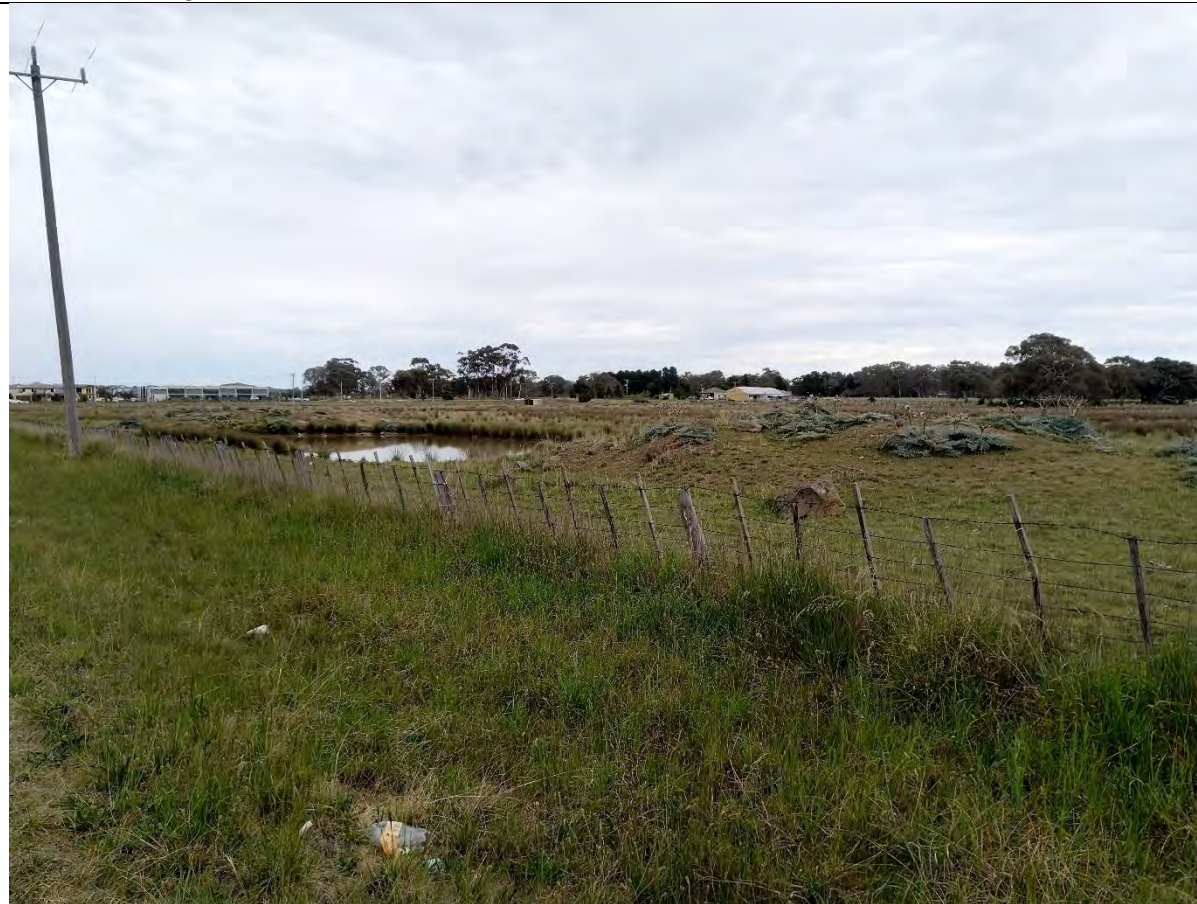
IMG 022. View to the west of Olivers Road a dam was located along the east boundary, large basalt floaters were observed in the embankments and reed grasses through the paddock further west

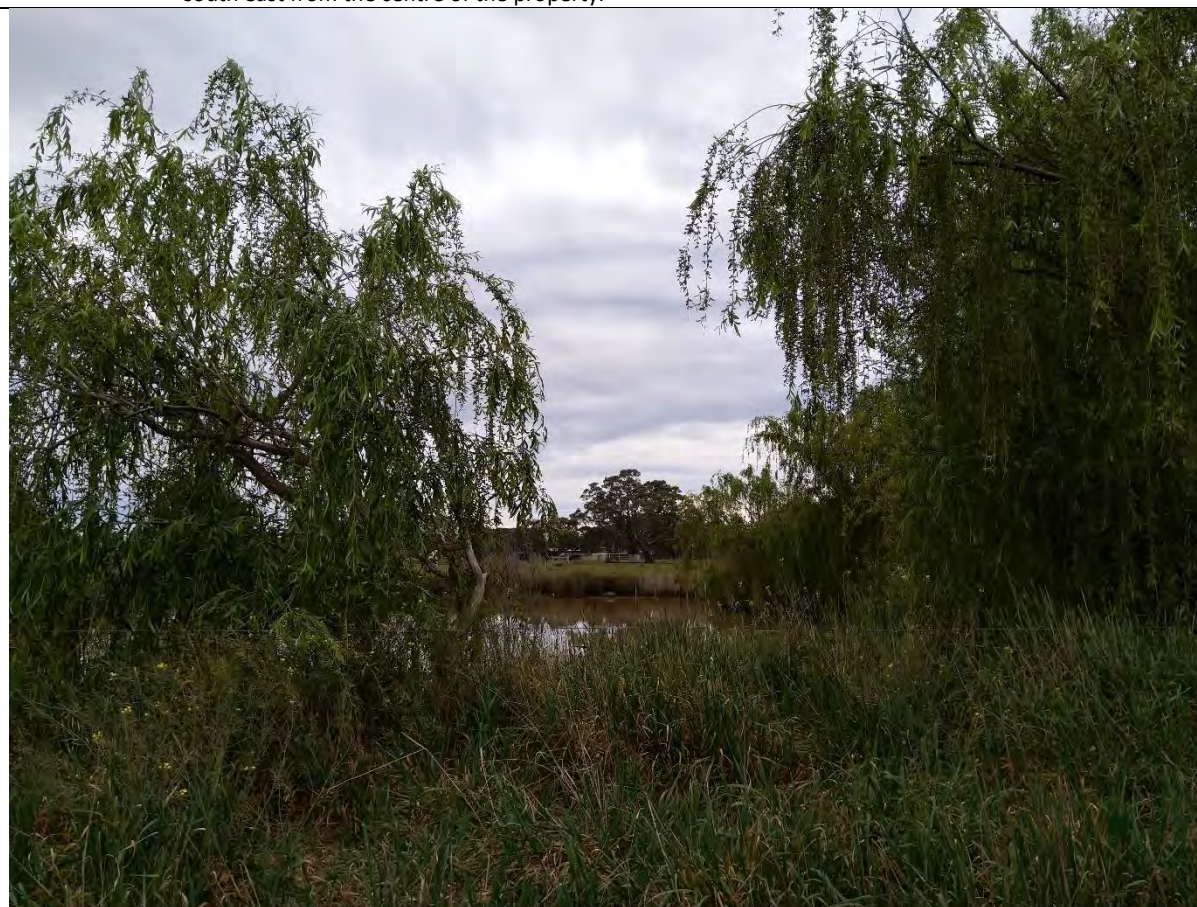
IMG 028. East portion of 1340 Mickleham Road, a large dam was observed. Drainage continued through a drainage reserve to the east through the neighbouring residential development

640 Craigieburn Road Mickleham	26	Topography grading to south east. Basalt boulders observed in excavation spoil/dam embankment, some reed grass vegetation observed throughout the paddock. Property use comprised agricultural (grazing).	IMG_023, IMG_040
665 Craigieburn Road Craigieburn	28	Topography grading to south east. Lager tree vegetation observed across the north portion of the property, some reed grass vegetation observed throughout the paddock. Site use comprised agricultural (grazing).	IMG_025
1480 Mickleham Road Craigieburn	27	Topography grading to south east. Lager tree vegetation observed across the east portion of the property, some reed grass vegetation observed throughout the paddock. Site use comprised agricultural (grazing).	-
1430 Mickleham Road Craigieburn	29	Topography grading to south east, a single dam with high embankment located along east boundary in line with a drainage alignment present through the residential development to the east. Some reed grasses and willow trees observed surrounding the dam area. Property use comprised agricultural (grazing).	IMG_028

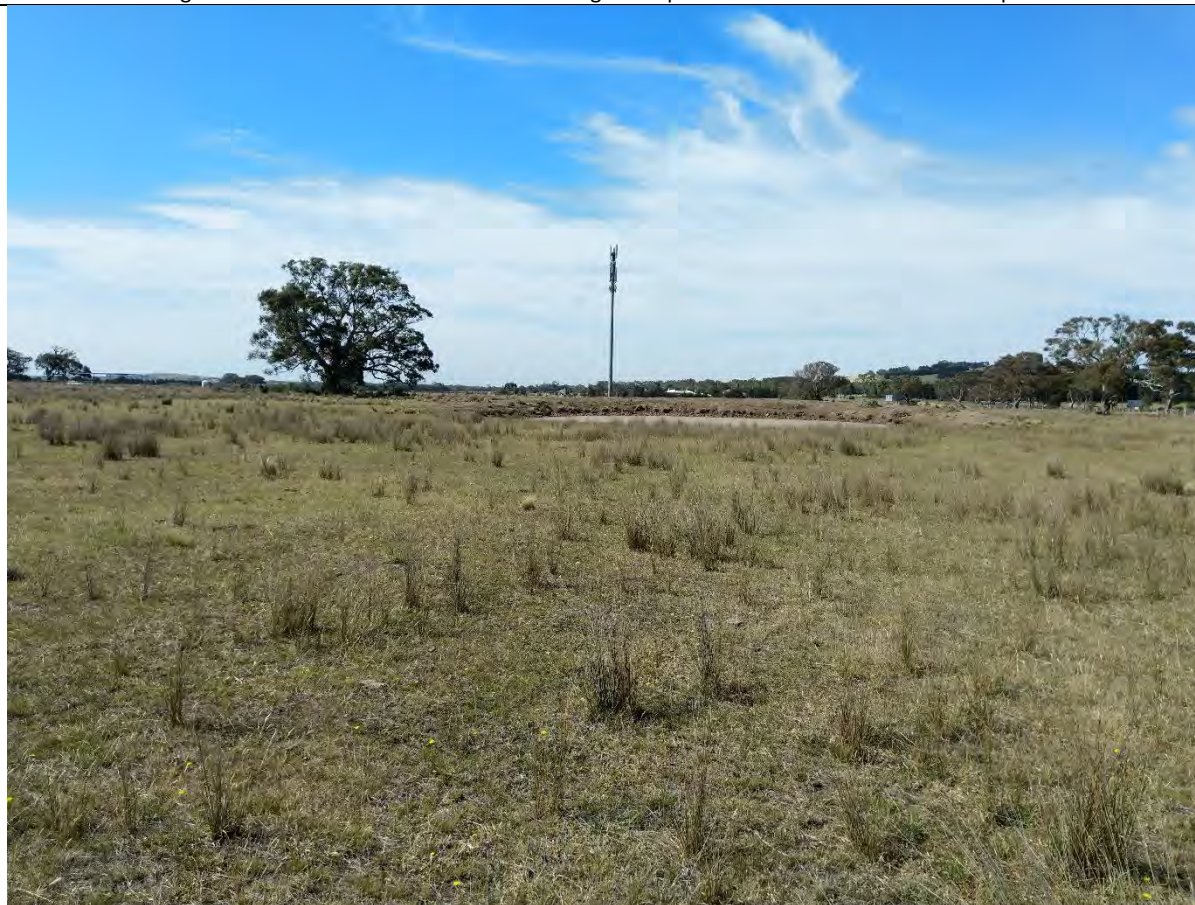
IMG 032. 1760 Mickleham Rd, Mickleham near BH03, the property as grassed. Onsite dams were observed to be cutdown and basalt floaters were observed with in the subsurface soils.

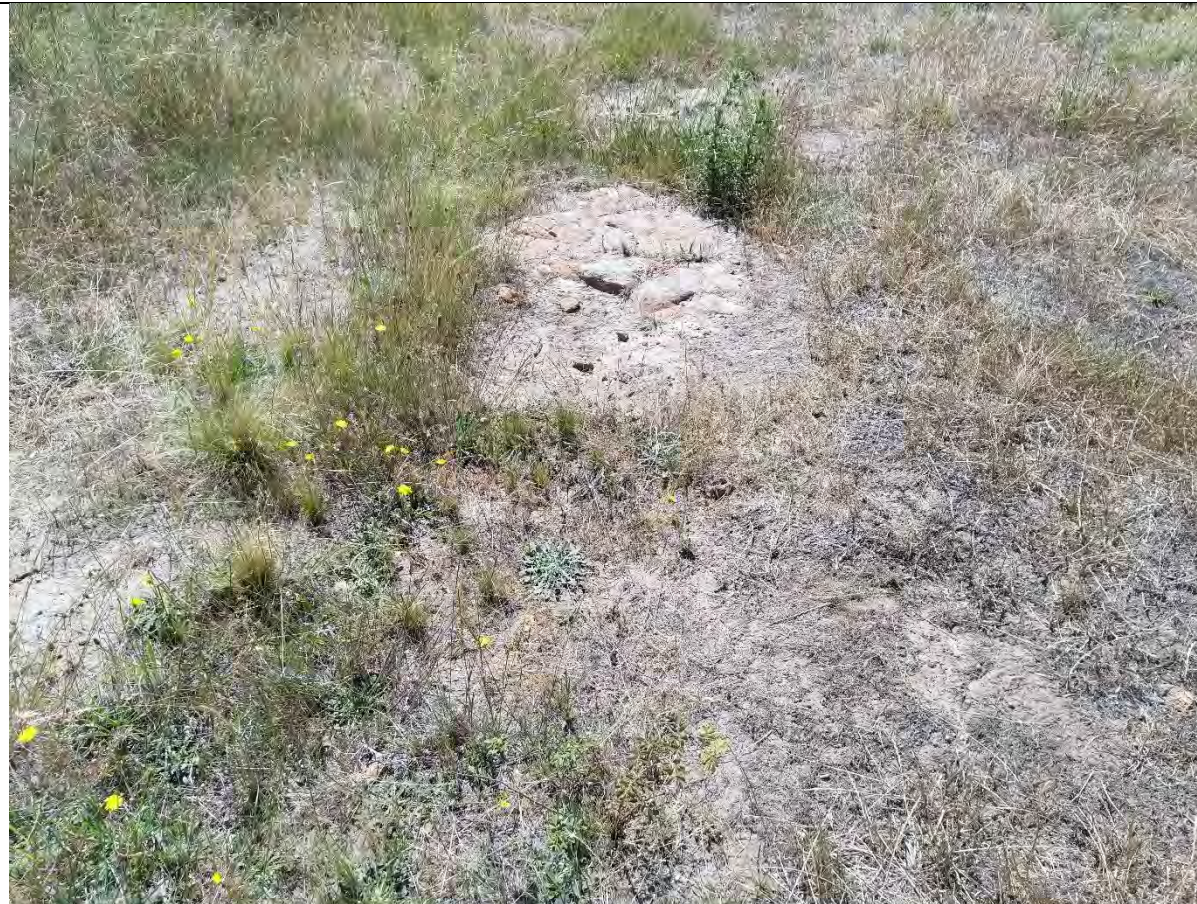
IMG 033. 1760 Mickleham Rd, Mickleham, basalt floaters were observed through surface soils across the site

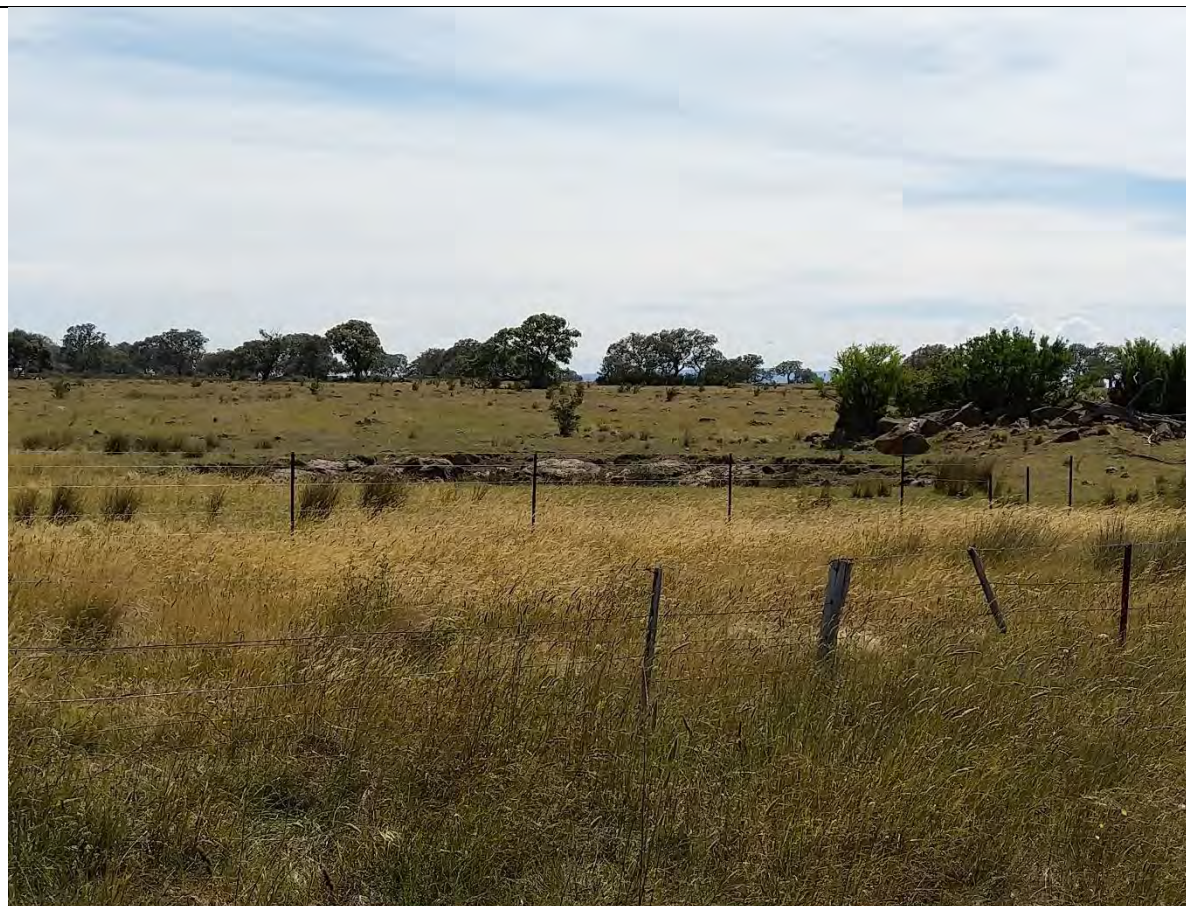
IMG 035. View north from the east portion of 1720 Mickleham Rd, Mickleham near BH07, the property as grassed sand located within a surface water drainage alignment sloping to the south east. Dam walls in the property to the north shows the shallow nature of the underlying basalt rock.

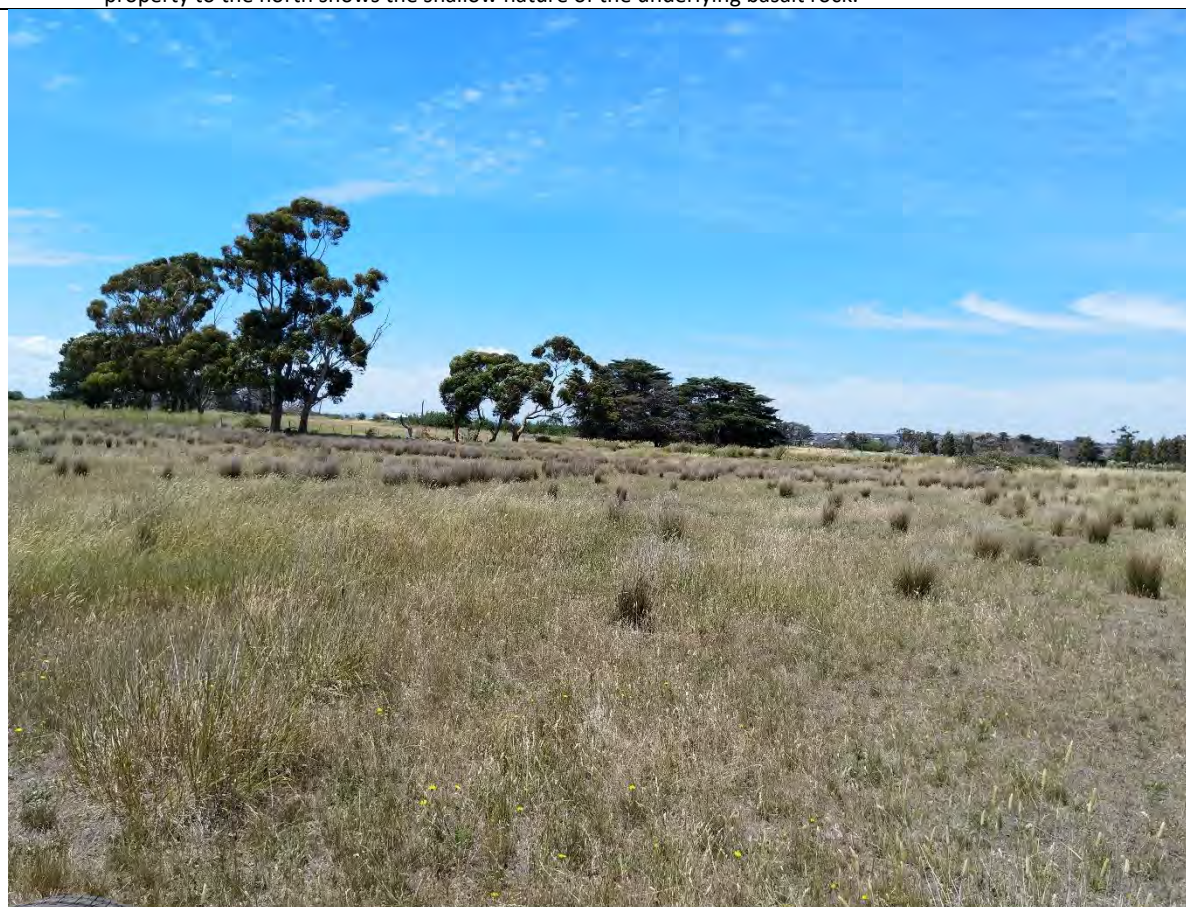
IMG 036. South east portion of 220 Olivers Rd, Mickleham, the property as grassed generally sloped to the south east with dams located along low points to intercept surface water runoff. An area of reed grass was observed through the surfaces water drainage alignment.

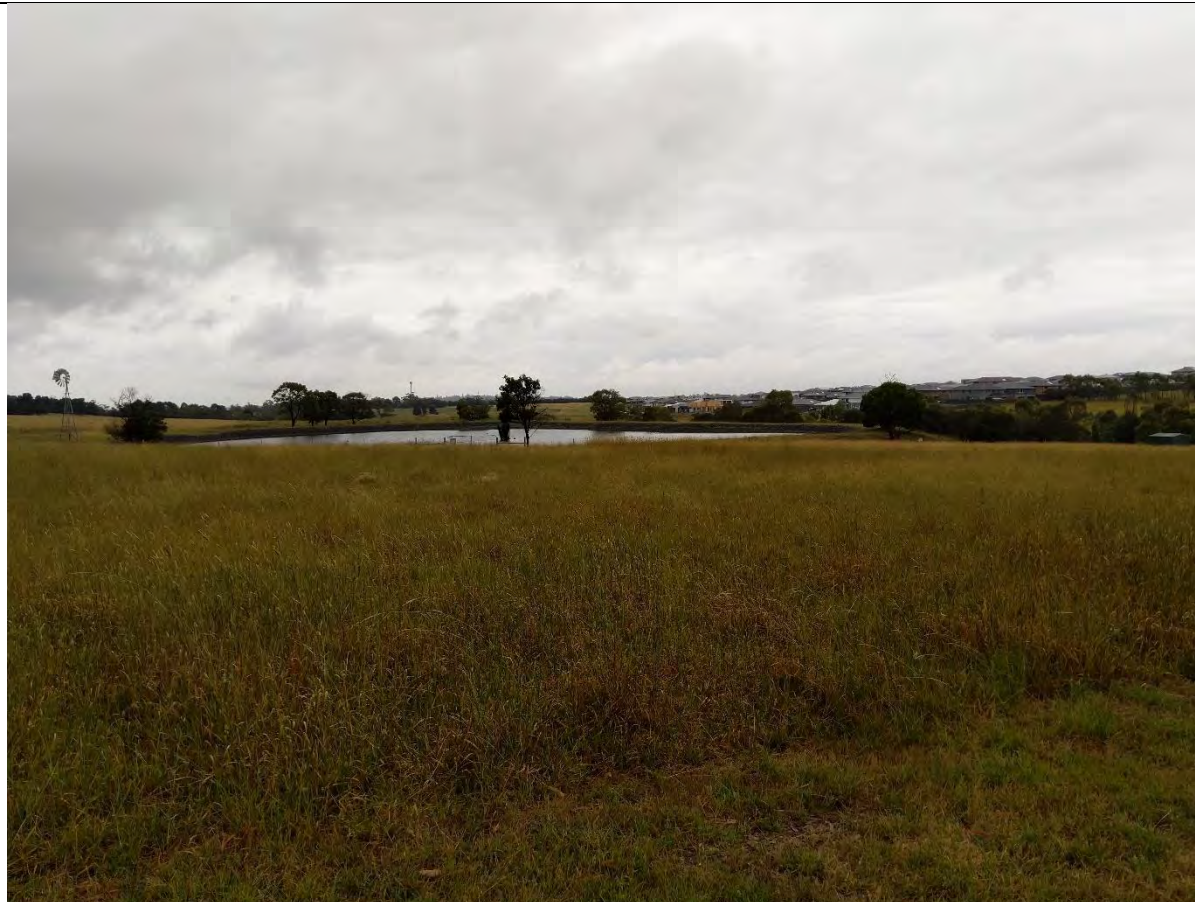
IMG 039. South portion of 20 Dunhelen Lane, Yuroke, the property contained a series of ponds as part of the waste water management system of the property before discharging into Yurok Creek.

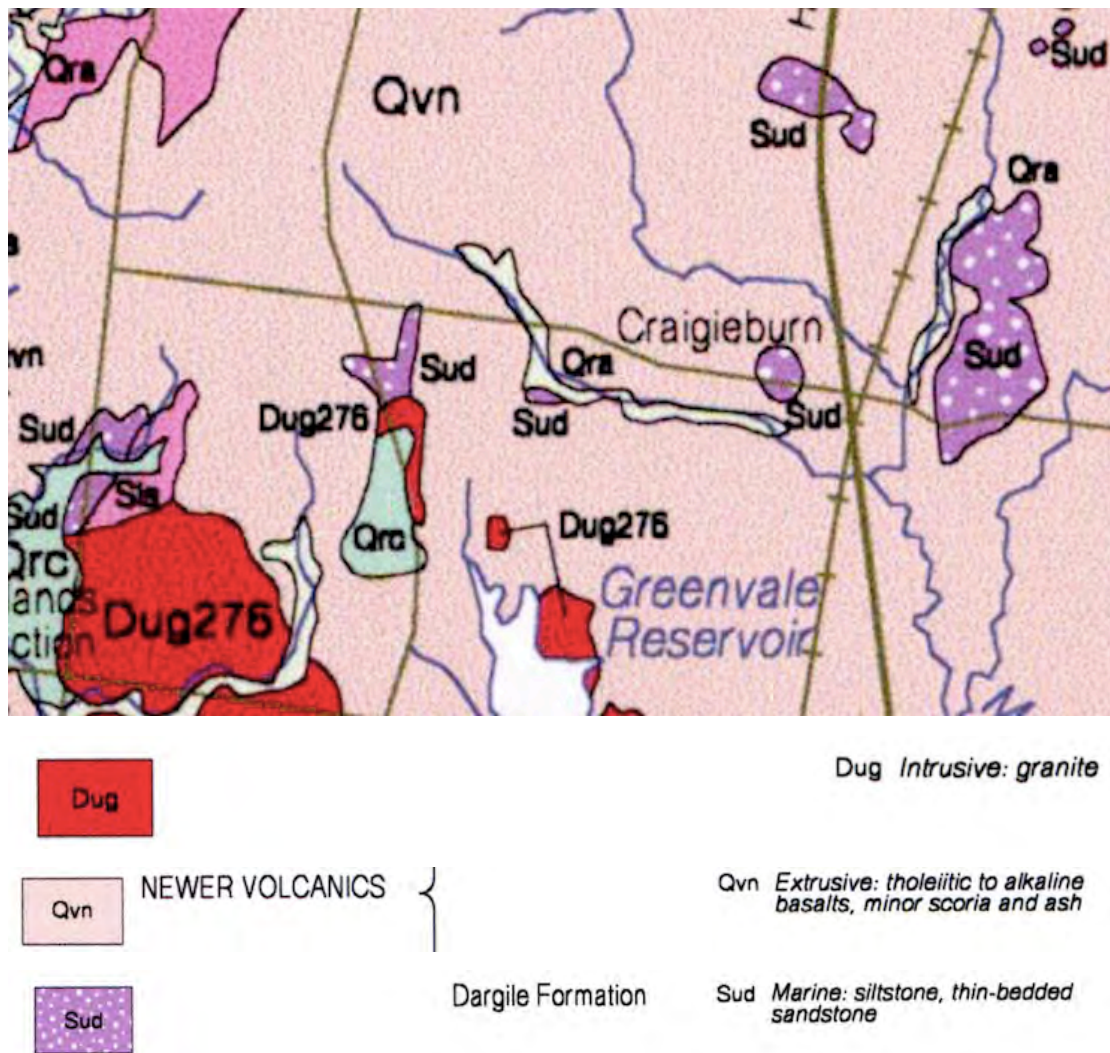
Figure 1 Surface Geology Underlying and Surrounding Investigation Area
(Geoscience Australia 1:250000 Melbourne Map Sheet)

1. Quaternary aged Newer Volcanics (Qvn)
2. Silurian aged Siltstones (Sud)
3. Devonian aged Granite (Dug)

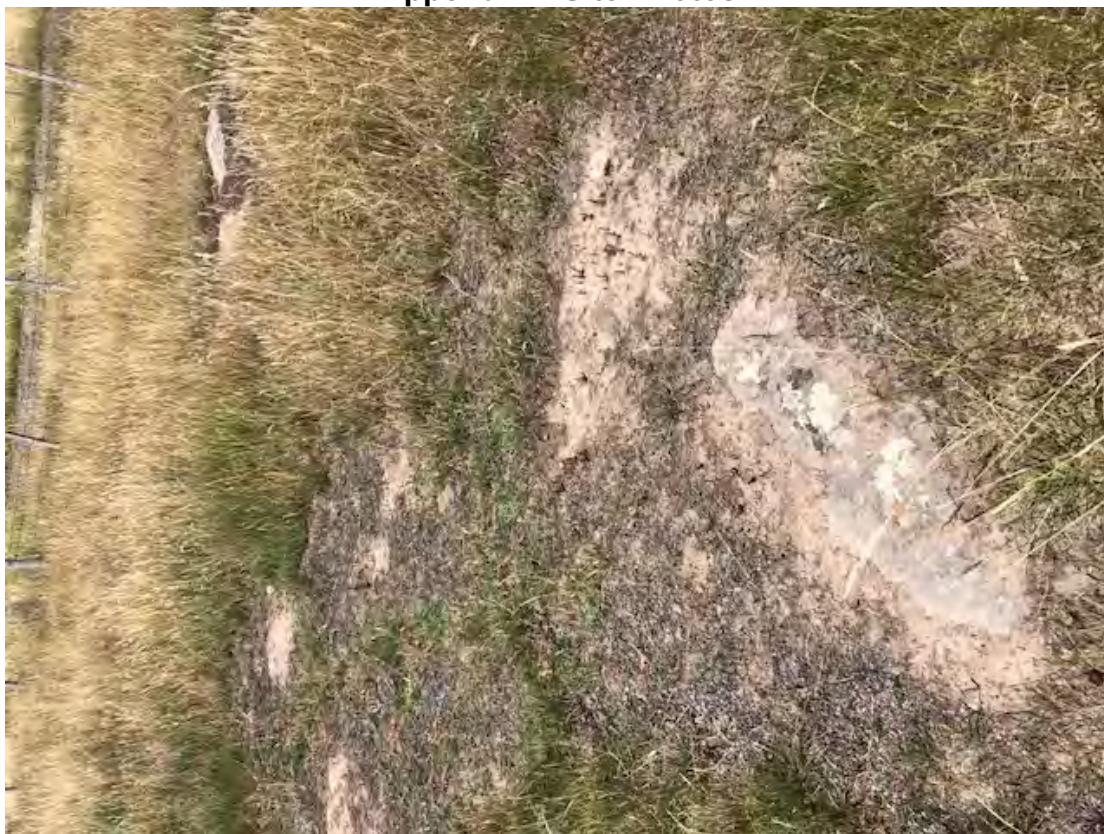
Plate 1 (above) Basalt rock outcroppings

- Shallow hard rock deposits were encountered over significant areas of the precinct. This will impact excavation activities including excavation of service trenches, road cutting, pile inserts and foundation construction.

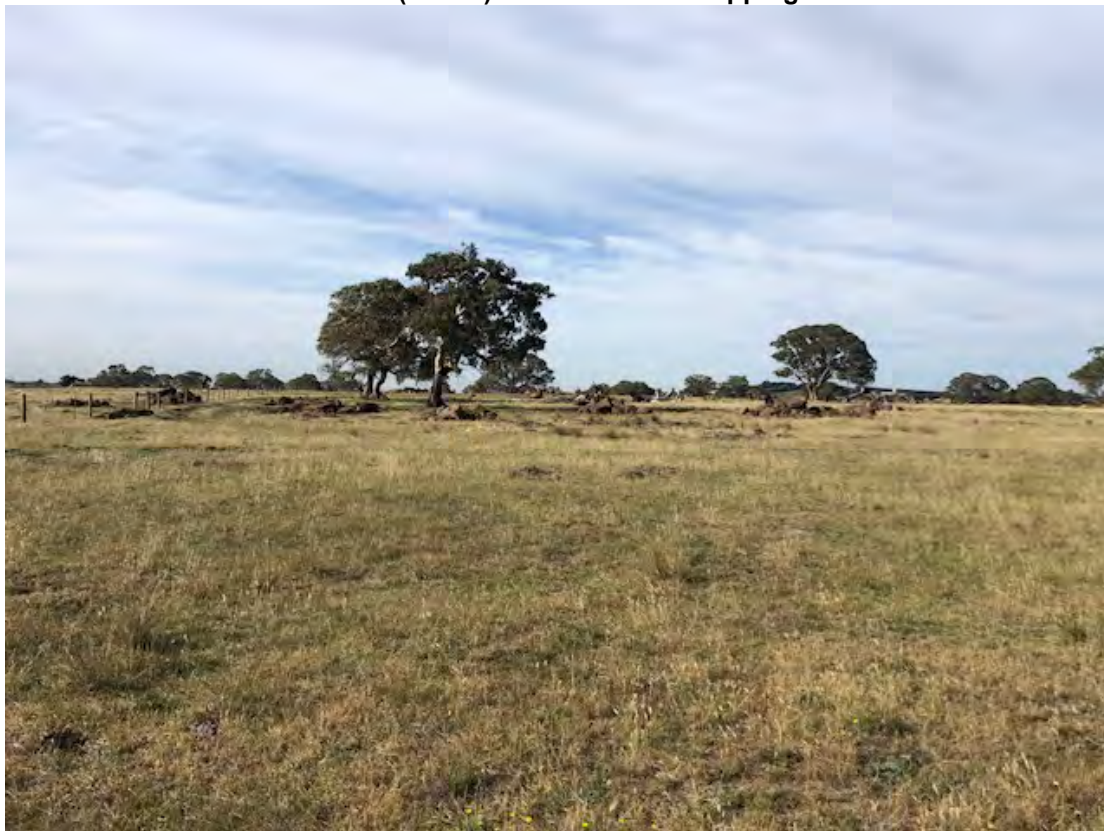
Plate 2 (below) Look south east over northern areas showing stony rises.

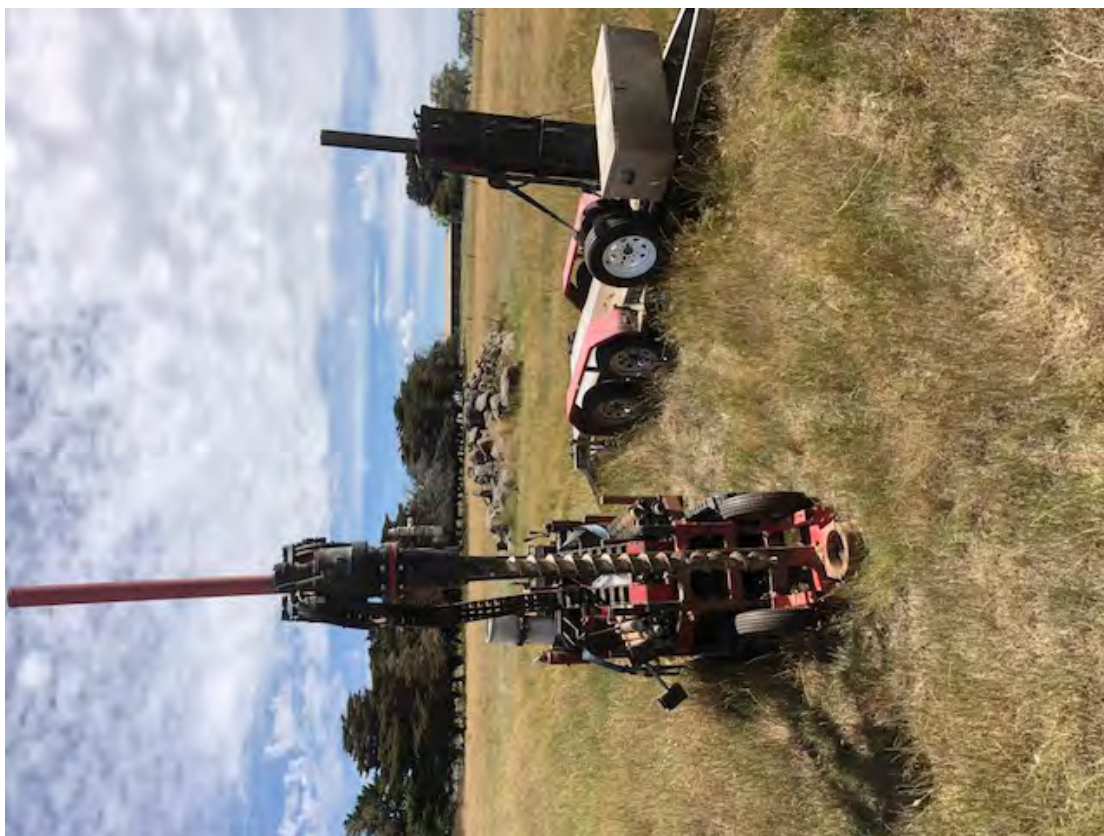
Plate 3 (above) Drilling BH05

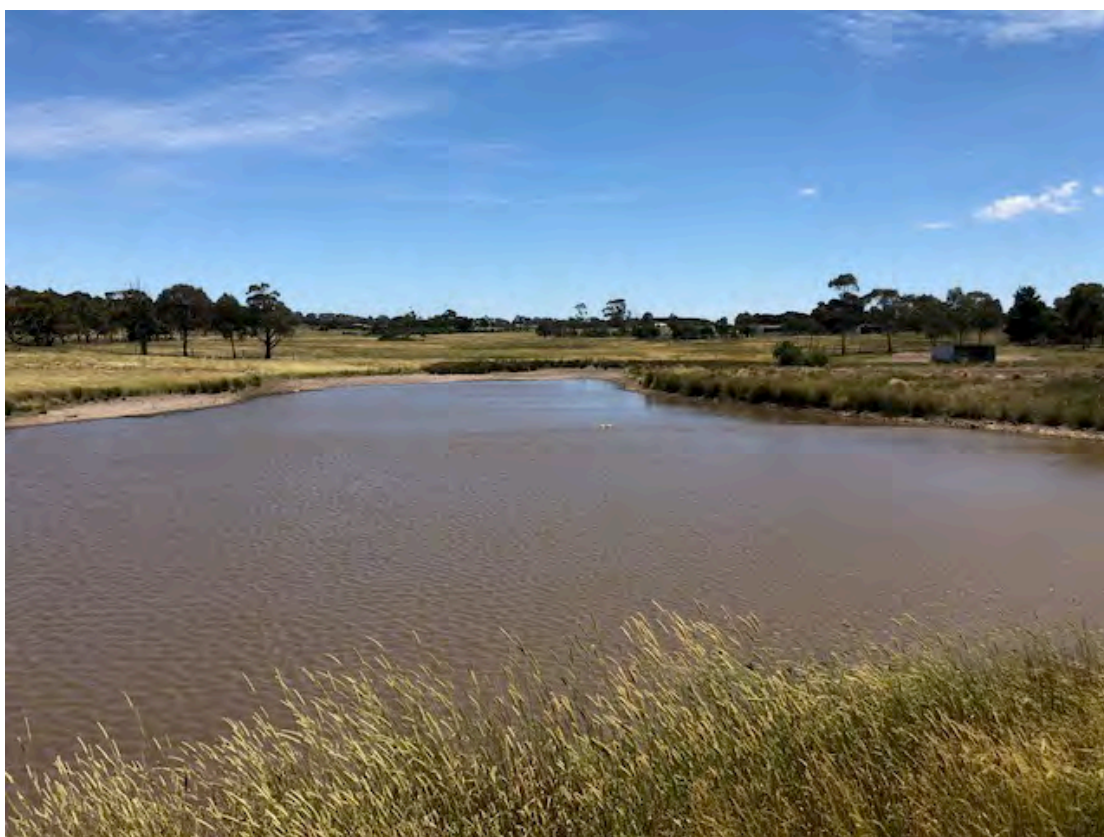
Plate 4 (above) Example of large farm dam within precinct.

- Numerous farm dams. Groundwater not encountered – perched water tables over endemic clays (where present) likely throughout wetter months, drainage required where foundations/utilities/roading are founded in this zone. Existing dams MUST not be used as subdivisional development areas without further site specific intensive geotechnical assessment and are better suited as incorporation in WSUD or as landscape amenities.
