Craigieburn West Precinct Structure Plan Preliminary Land Contamination Assessment

Craigieburn West, Victoria

Prepared for:
Victorian Planning Authority
Level 25, 35 Collins Street
Melbourne, Victoria, 3000

21 December 2018

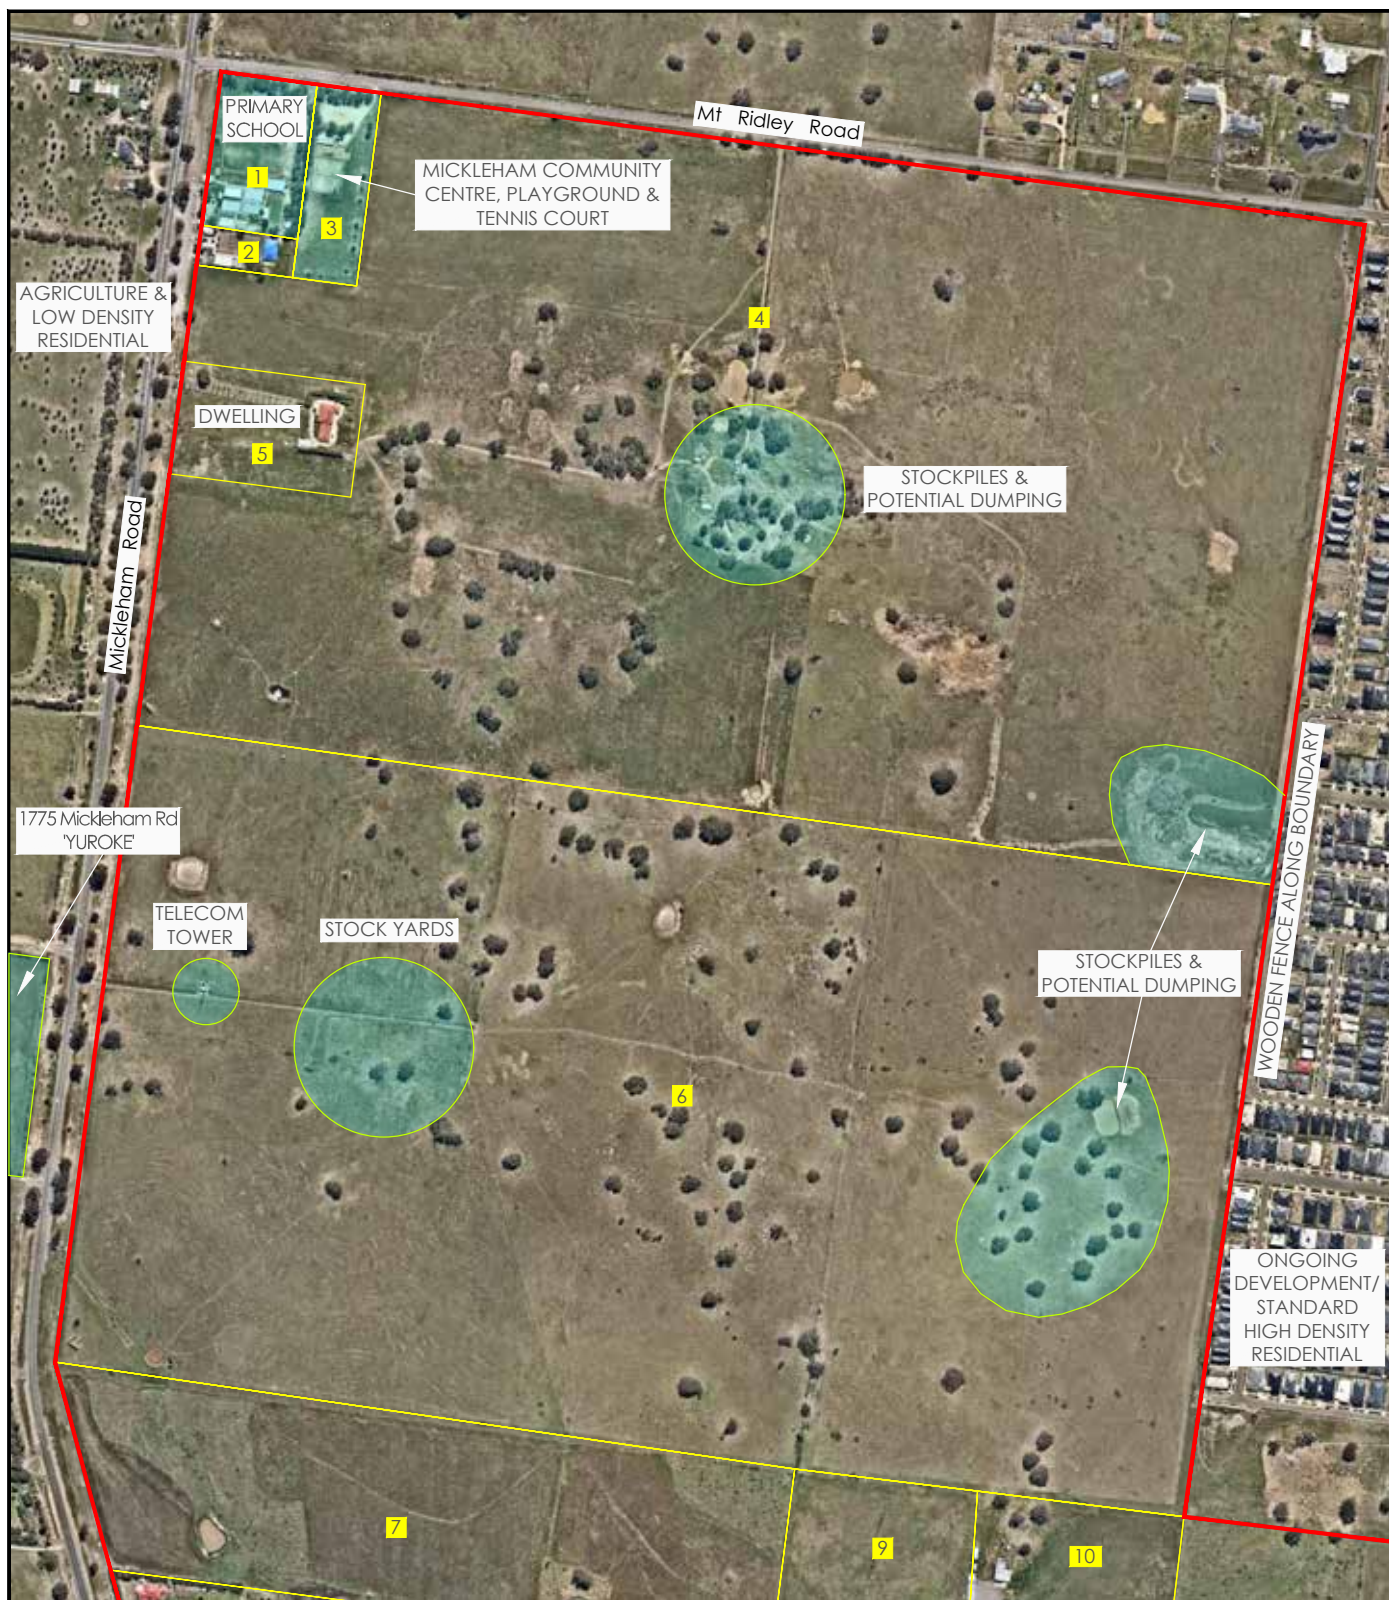
On 30 October 2018, Landserv completed a site inspection of the Study Area involving walking and driving around the study area to identify potential AECs and provide a grounding for other components of the Preliminary Assessment. A summary of the site inspection is provided in **Table 2.3** and displayed in **Figures 3 to 6**, with photographs taken during the site inspection provided in **Appendix E**.
