Kinley Development

Geotechnical Framework

Hume Lilydale Pty Ltd & LBJ Corporation Pty Ltd

April 2020

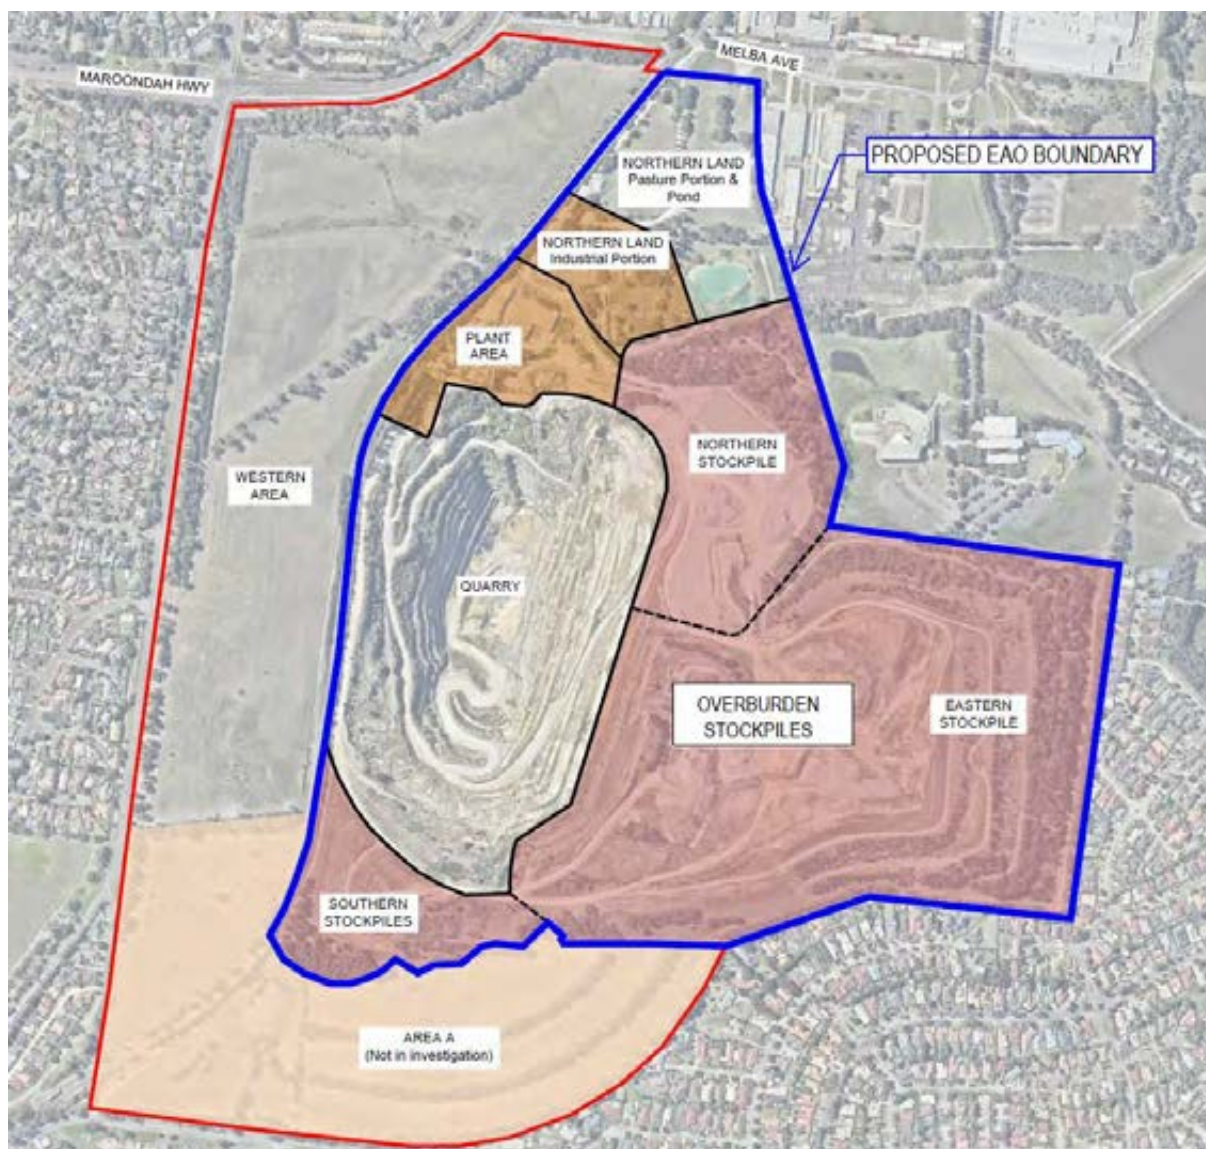
Figure 3.1 Extract of T+T drawing 1000511-F3 showing extent of proposed area of Environmental Audit Overlay.
