**RE: Craigieburn West Precinct Structure Plan (PSP)**  
**Submissions made on behalf of [REDACTED] Whites Lane, Yuroke (Mickleham)**  
**PSP property ID 16**

**Aitken Creek Waterway Values Assessment**

# Waterway Corridors

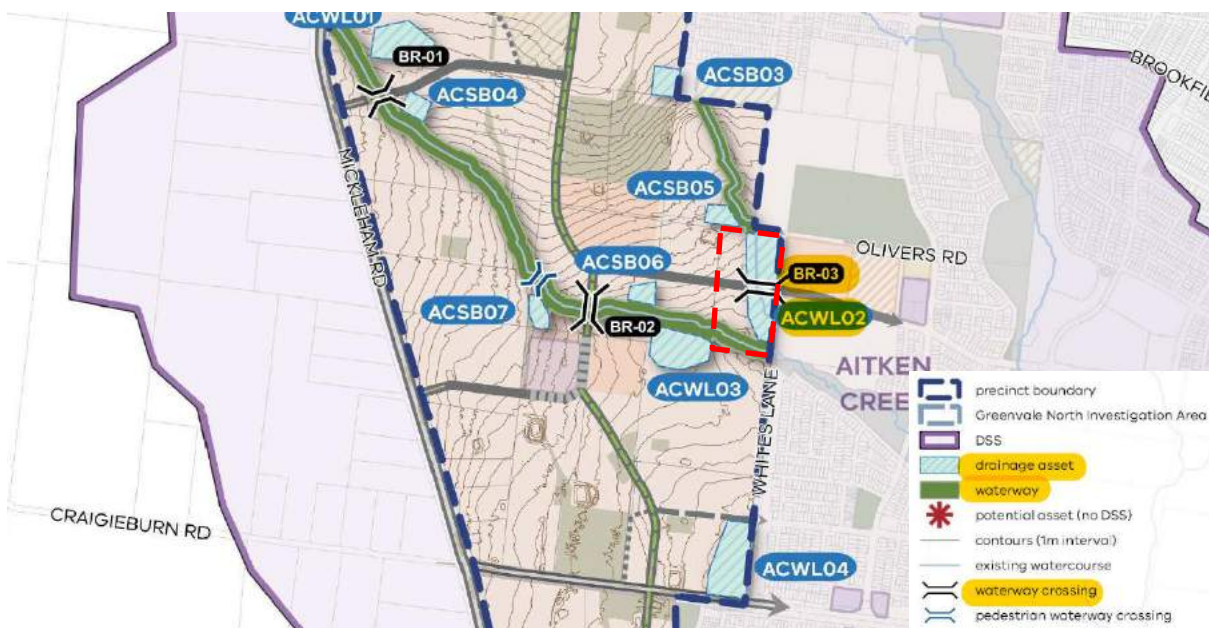
Figure 3 Extract of Integrated Water Management Plan - draft CW PSP, pg. 21 – subject site dashed red

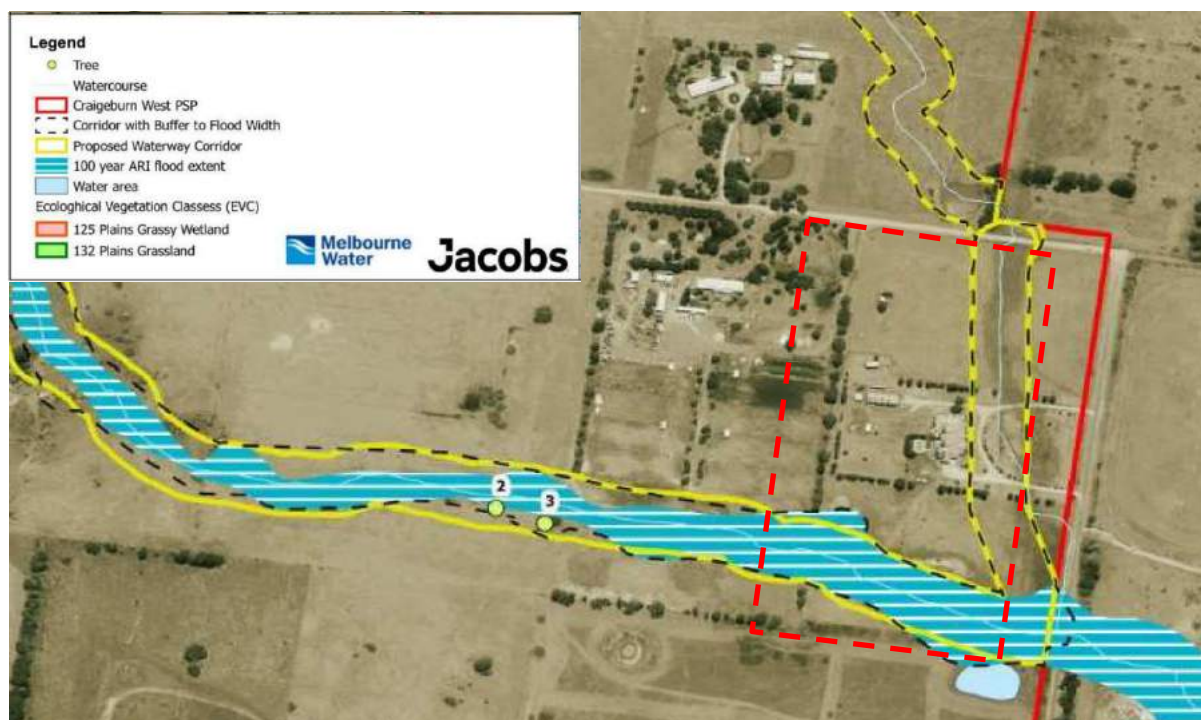
Figure 4 Proposed waterway corridor - Aitken Creek Waterway Values Assessment, December 2020 – subject site dashed red

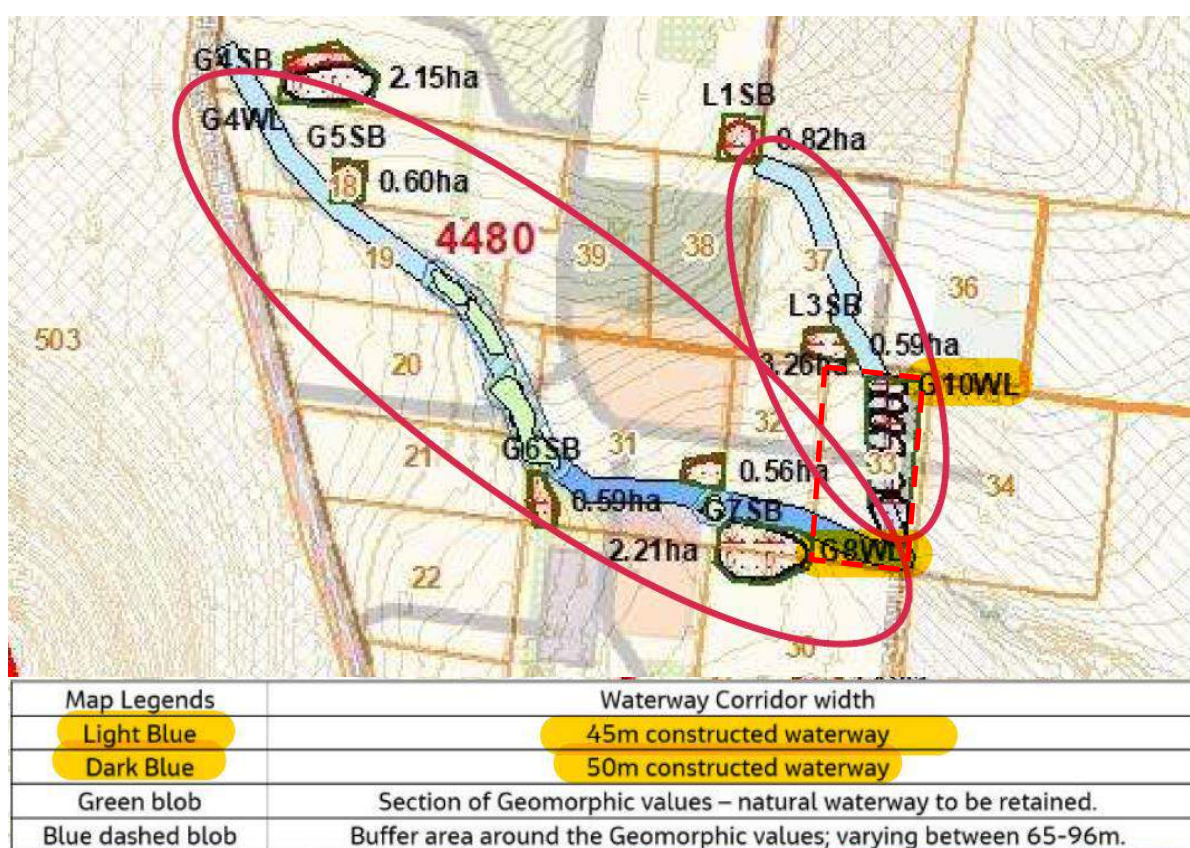
Figure 5 Proposed buffer widths and locations - Aitken Creek Waterway Values Assessment, December 2020 – subject site dashed red

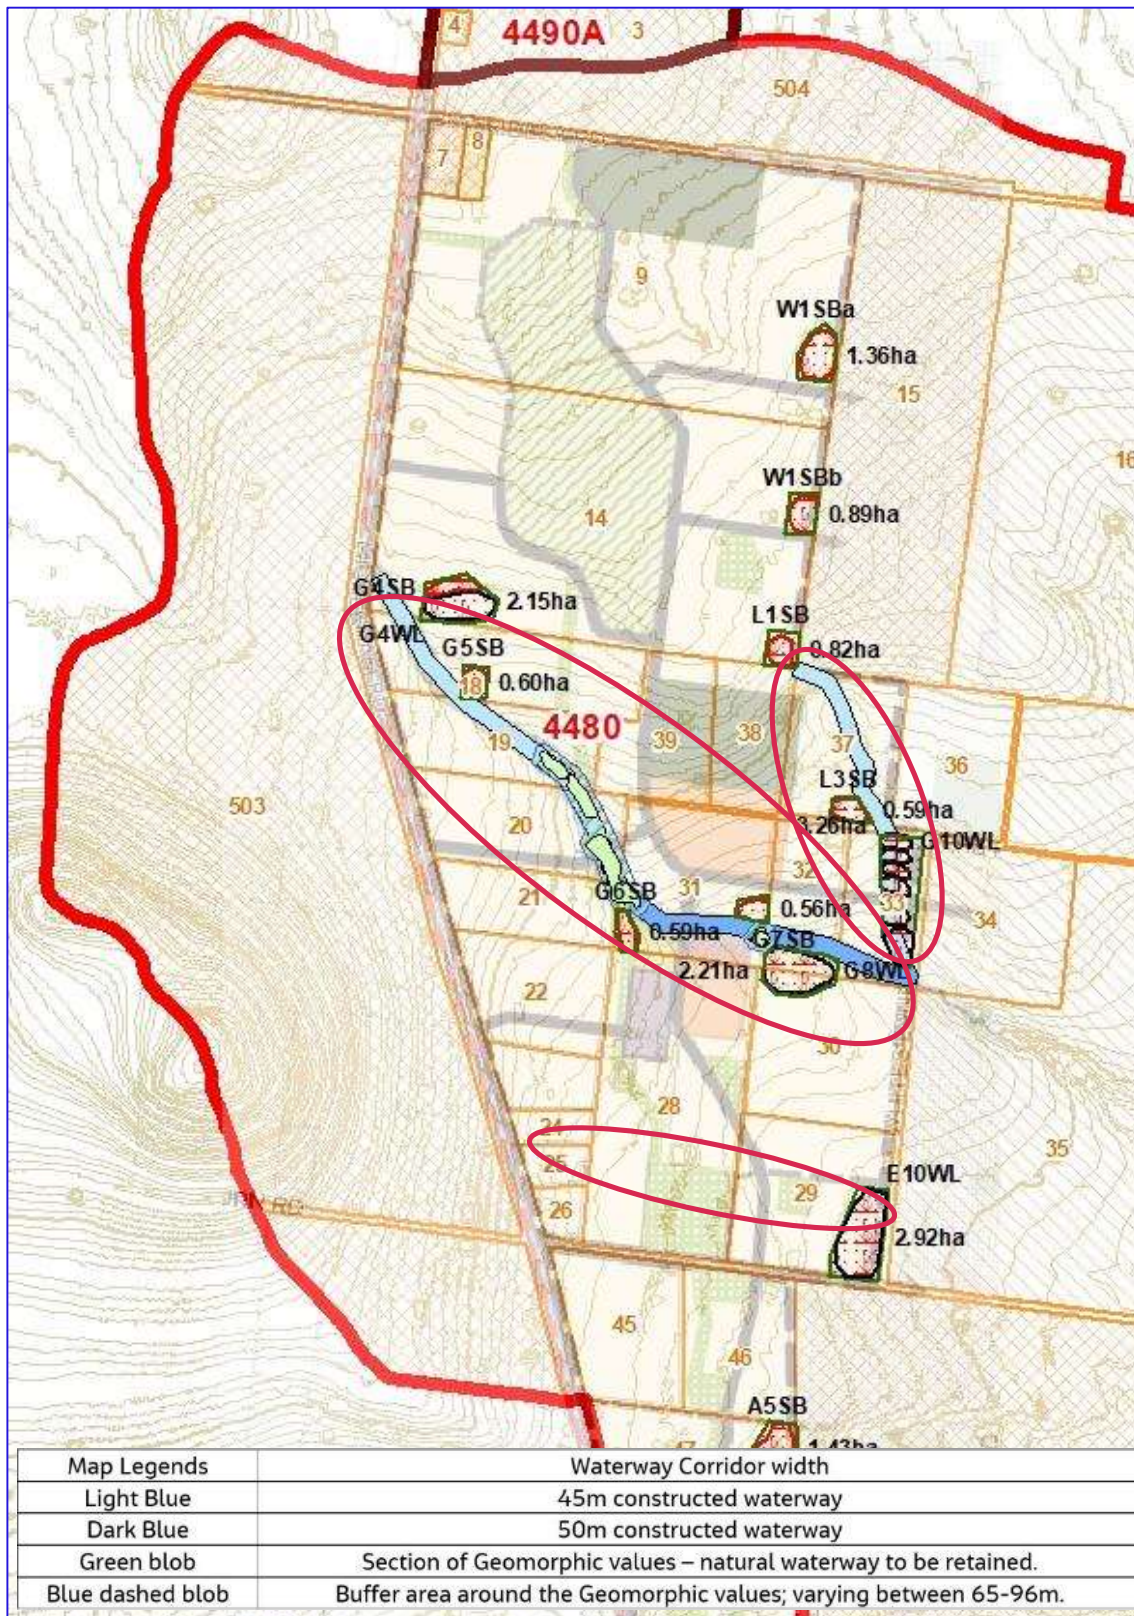
Figure 1-4. Proposed buffer widths and asset locations. Aitken Creek main channel and tributaries as they pass through the PSP circled in red (our emphasis). Asset reference codes link to Table 1 1. Map courtesy of Melbourne Water.

As part of the DSS revision process, waterway corridor widths and drainage asset locations have been proposed for the DSS by Melbourne Water (Figure 1-4 and Table 1-1).

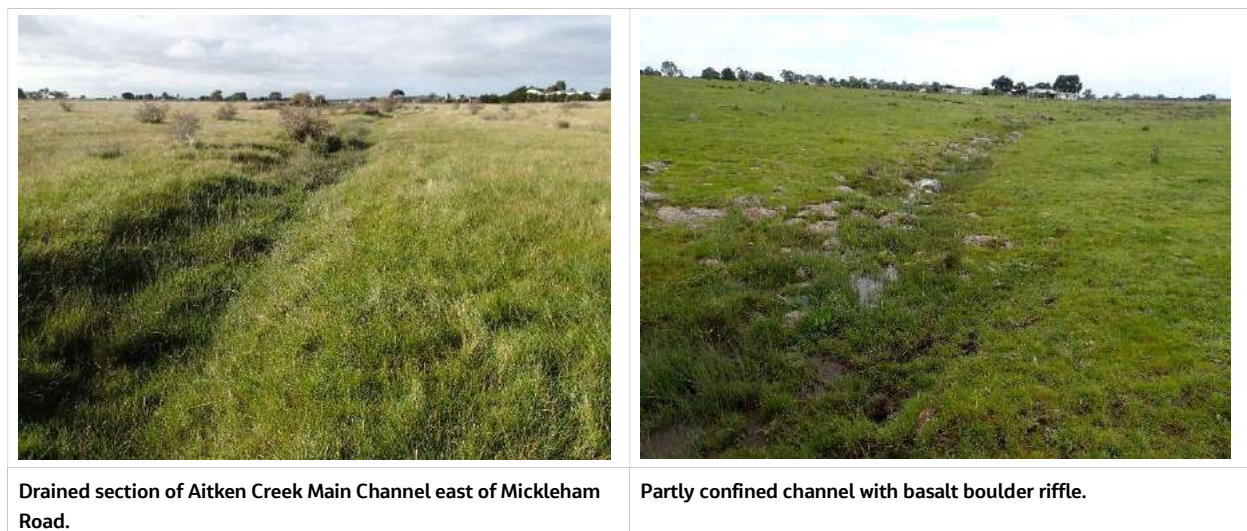
Figure 3-1. Selected photographs of 'Valley Fill Intact' Stream Form along Aitken Creek – main channel.

The main channel of Aitken Creek was assessed as having a 'Valley Fill Intact' stream form with insignificant values and geomorphic features in poor condition. Whilst we have assessed the stream form as 'Valley Fill Intact', the form and condition of the creek has been significantly altered as a result of agricultural development. The valley in sections has been drained (Figure 3-1). There has also been extensive alteration of topography through the removal and relocation of basalt boulders and the excavation of farm dams/water storages. Basalt boulder riffles are present in some sections (Figure 3-1).

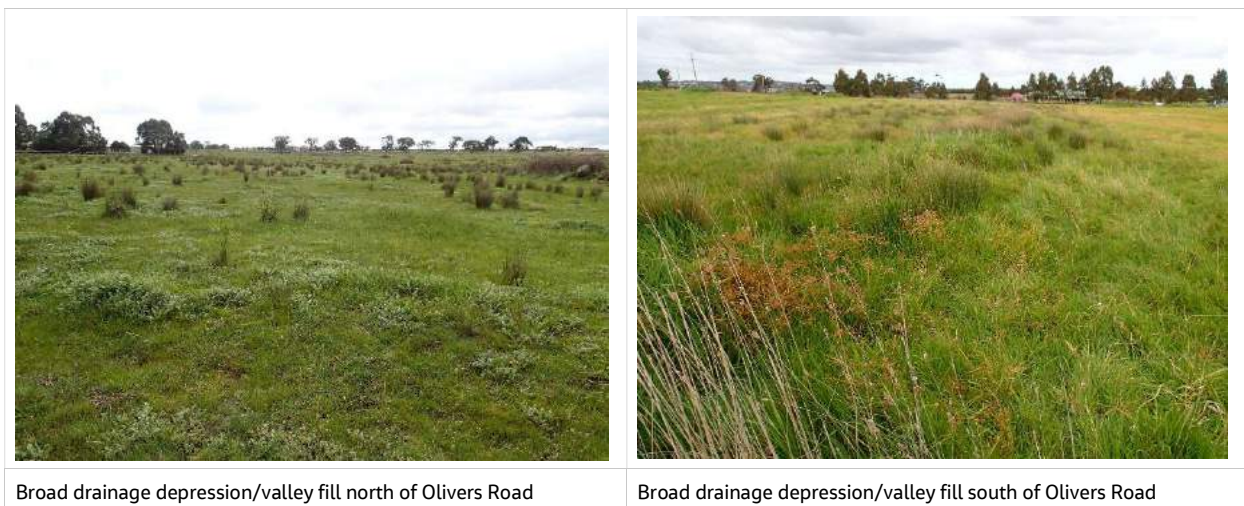
Figure 3-2. Selected photographs of 'Valley Fill Intact' Stream Form along Aitken Creek – north east tributary (left) and north east extension (right).

Inspection of this reach was from the roadside due to access restrictions (Figure 3-2). This reach is likely to have been extensively modified through agricultural development. It was assessed as having a 'Valley Fill Intact' stream form with insignificant values and geomorphic features in poor condition, however these reaches do still provide an important function as a headwater stream. These areas would experience seasonal inundation and play an important role in regulating the flow of water, sediment and nutrients in the catchment.

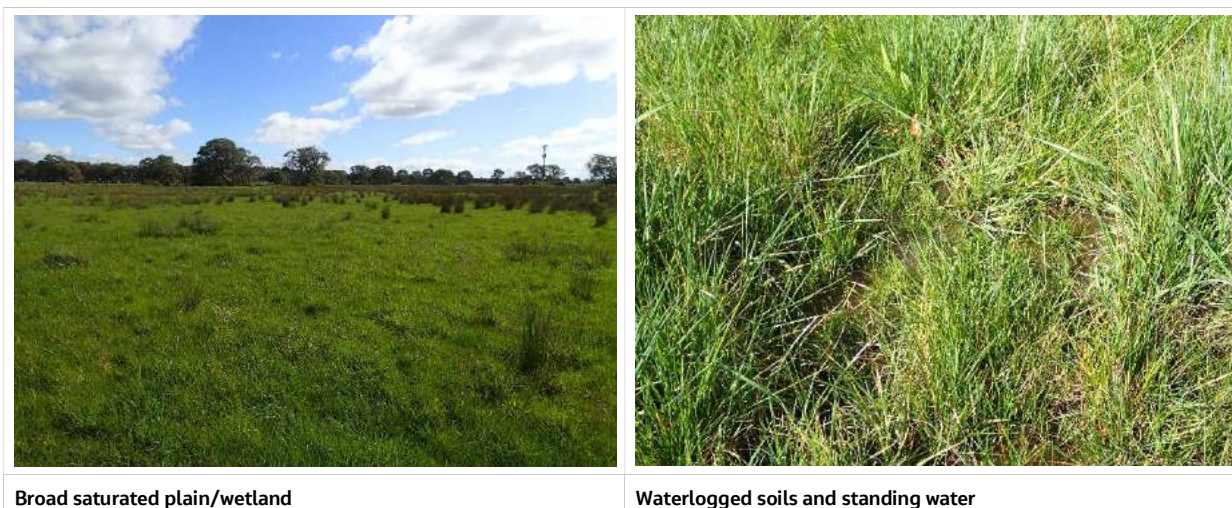
Figure 3-3. Selected photographs of 'Valley Fill Intact' Stream Form along Aitken Creek – south east tributary.

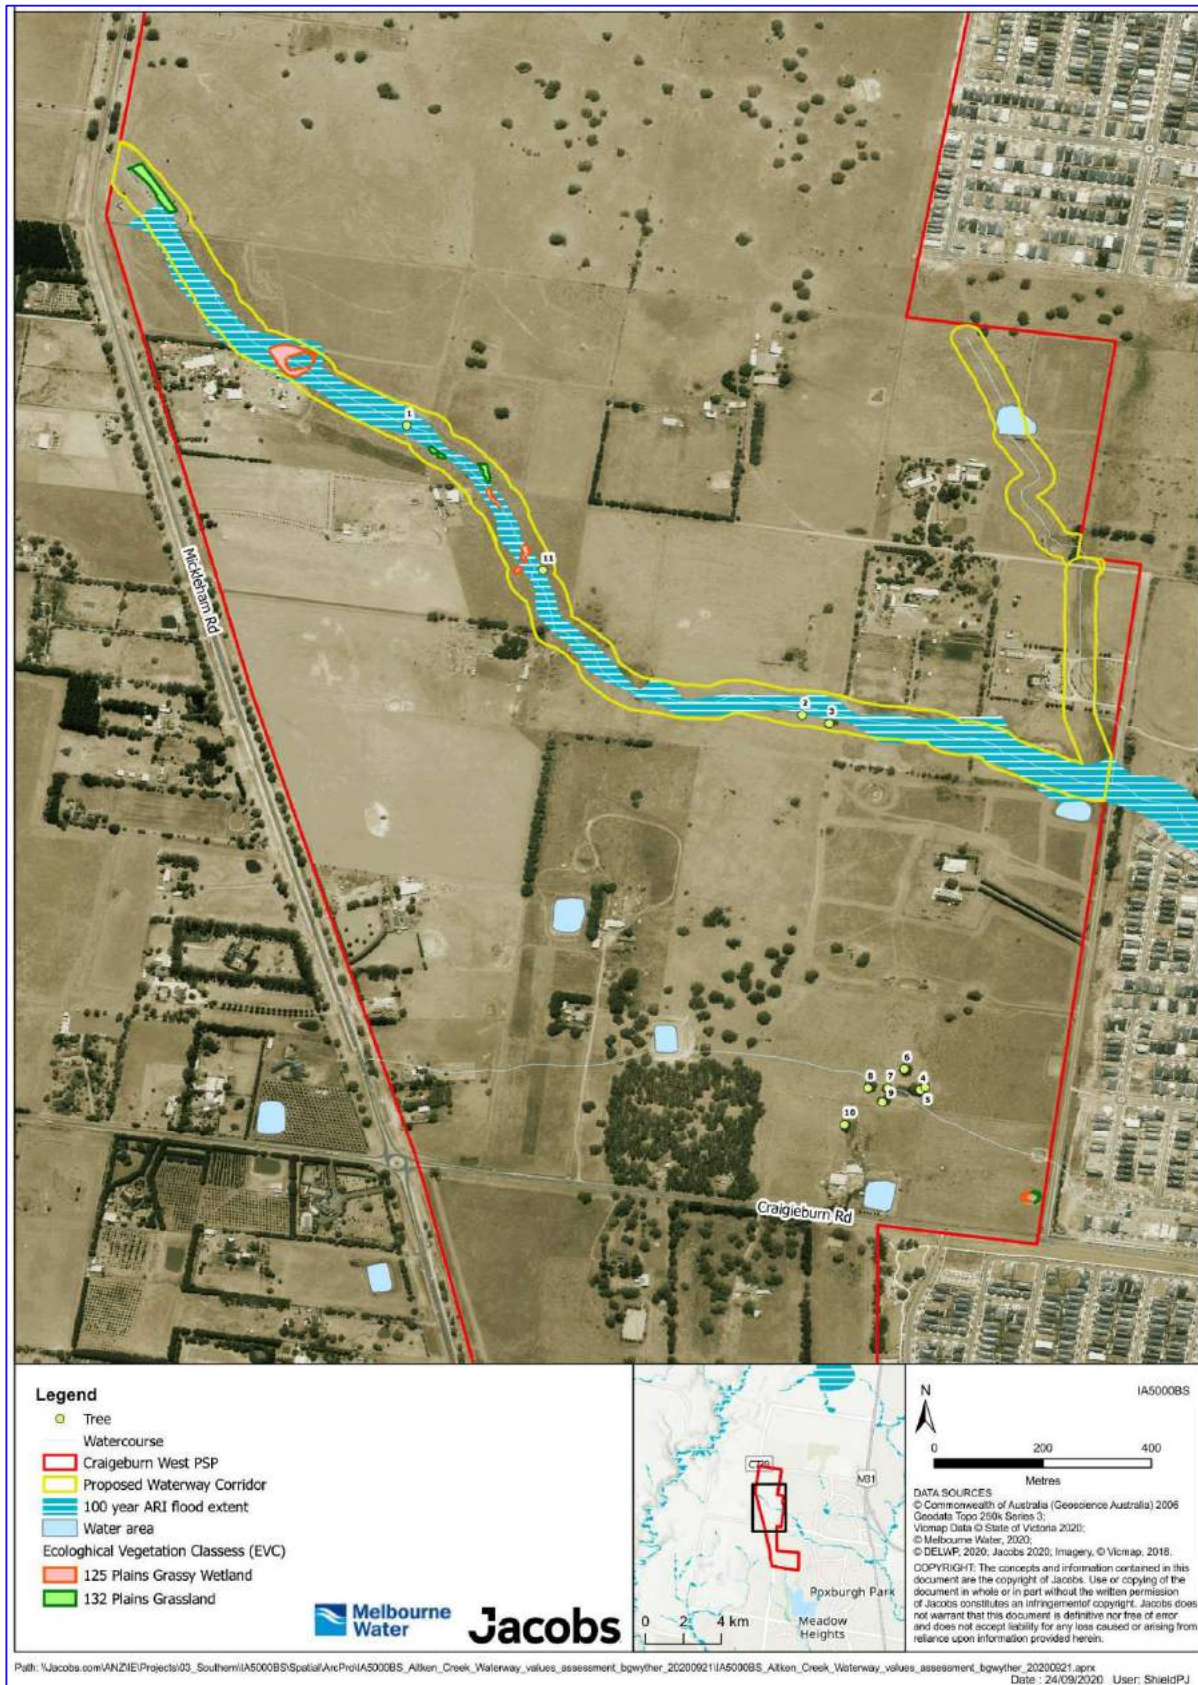
Figure 3-4. Location of ecological values mapped within Aitken Creek Main Channel.

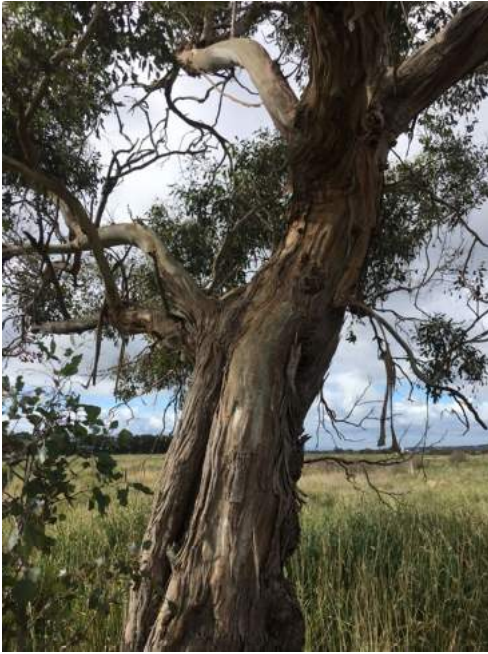
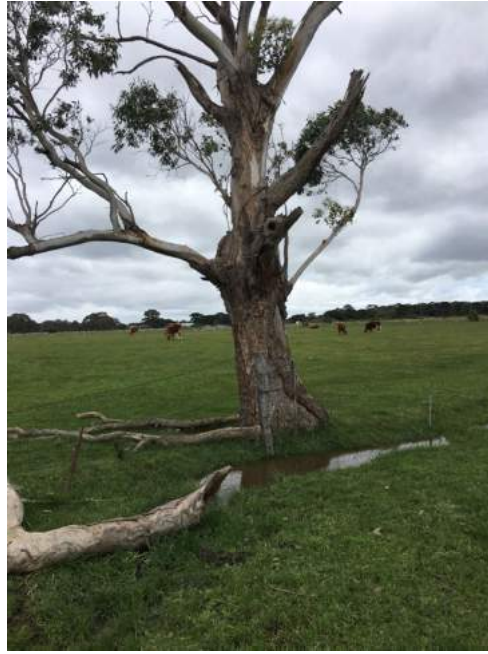
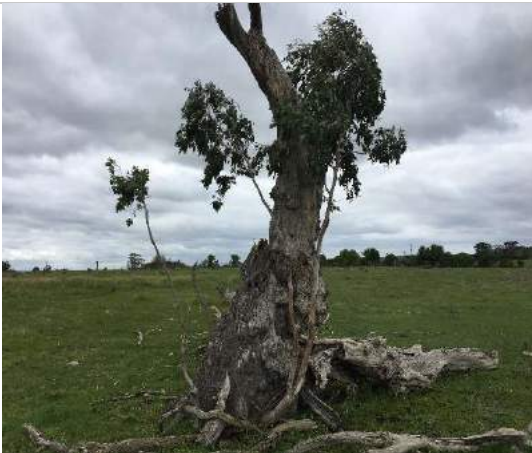
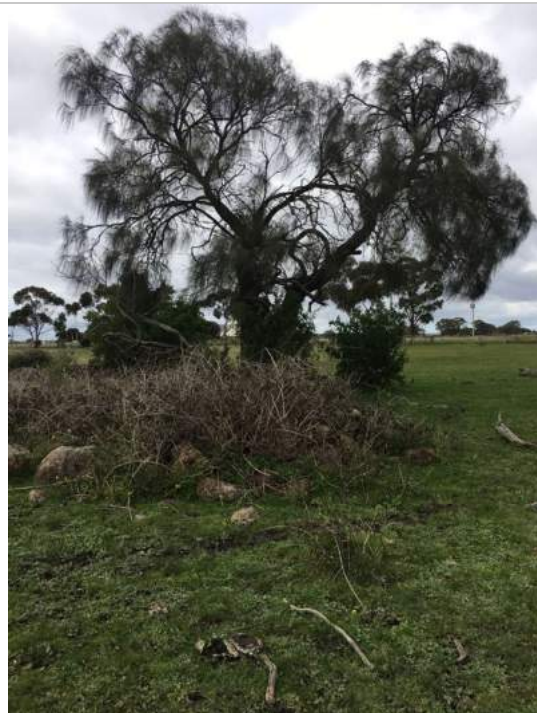
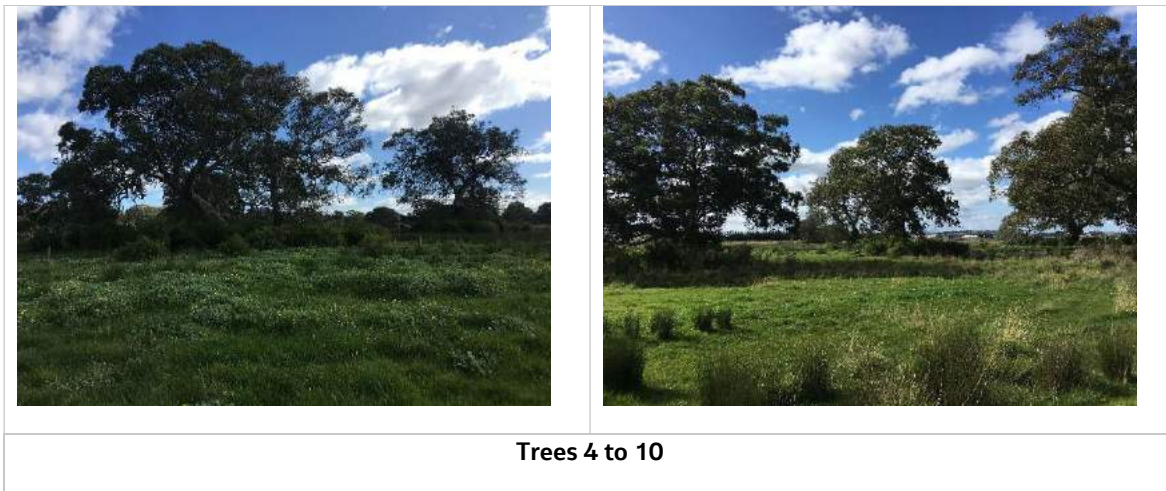
Figure 3-5. Mature trees along Aitken Creek. Photos taken during fieldwork in August 2020. Identification numbers refer to Table 3-2 .

Number	Species	Diameter at breast height (cm)	Size	Hollow Bearing	Canopy Health	Comment
1	<i>Eucalyptus ovata</i> var. <i>ovata</i>	74	Small	No	30-70%	
2	<i>Eucalyptus ovata</i> var. <i>ovata</i>	75	Small	No	30-70%	DBH estimated
3	<i>Allocasuarina verticillata</i>	50	Small		>70%	DBH estimated. Species may not technically comprise a scattered tree in this part of landscape.
4	<i>Eucalyptus camaldulensis</i>	185	Large	Yes	>70%	
5	<i>Eucalyptus camaldulensis</i>	84	Large		>70%	
6	<i>Eucalyptus camaldulensis</i>	168	Large	Yes	>70%	
7	<i>Eucalyptus camaldulensis</i>	92	Large	Yes	>70%	
8	<i>Eucalyptus camaldulensis</i>	130	Large	Yes	>70%	DBH estimated
9	<i>Eucalyptus camaldulensis</i>	140	Large	Yes	>70%	DBH estimated
10	<i>Eucalyptus camaldulensis</i>	110	Large		>70%	DBH estimated
11	<i>Eucalyptus ovata</i> var. <i>ovata</i>	83	Large		<30%

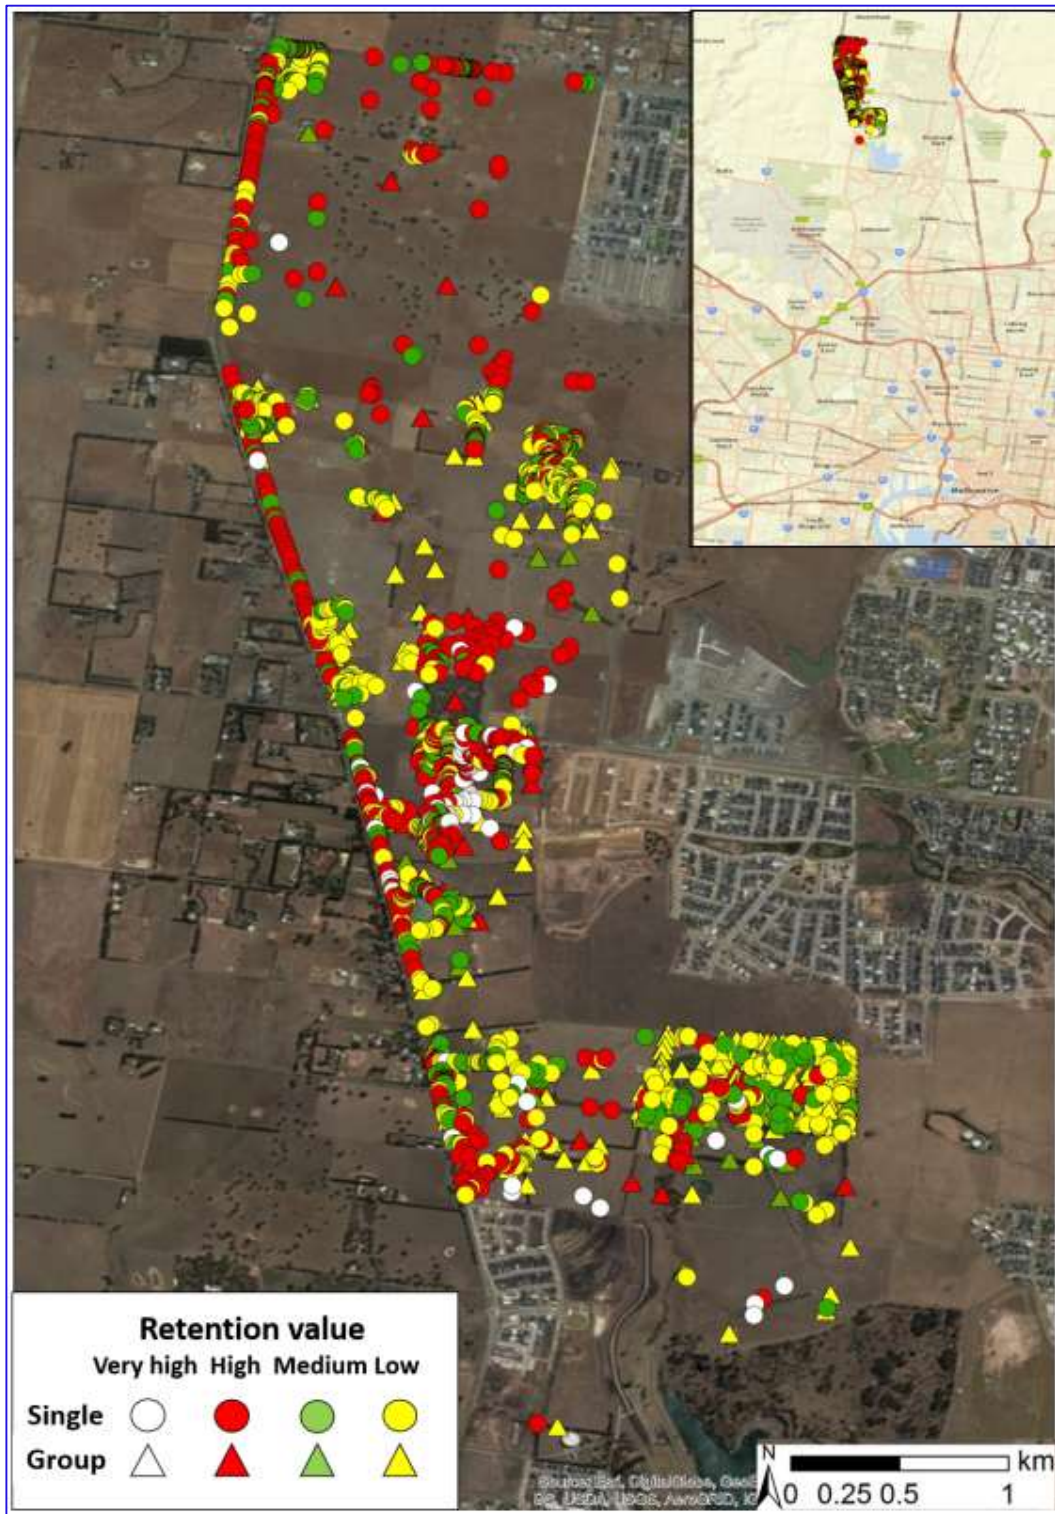
Figure 3-7. Retention value of mature trees in the DSS (Tretec, 2018).

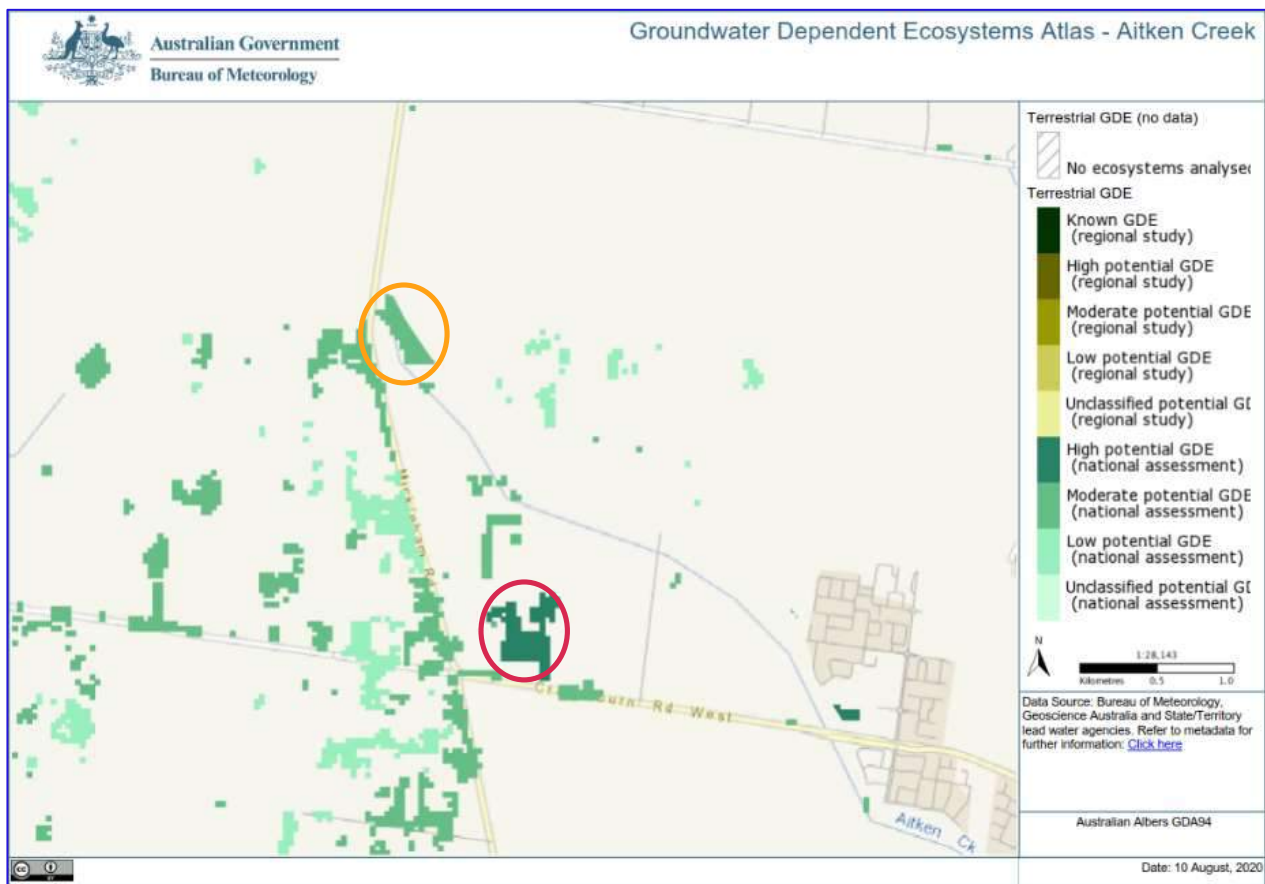
Figure 3-9. Modelled groundwater dependent terrestrial ecosystems. The stand of River Red Gums is circled in red, vegetation at the north west end of Aitken Creek is circled in orange.

Aitken Creek is mapped as having a high potential to be an aquatic groundwater dependent ecosystem (GDE) as part of a national assessment of GDE potential (Australian Bureau of Meteorology, n.d.). In addition, the Stand of River Red Gums is mapped as having a high potential to be a terrestrial GDE (circled in red in Figure 3-9) and vegetation at the north west end of Aitken Creek is mapped as having a moderate potential to be a GDE (circled in orange). There are other scattered patches mapped as potential terrestrial GDEs (Australian Bureau of Meteorology, n.d.).

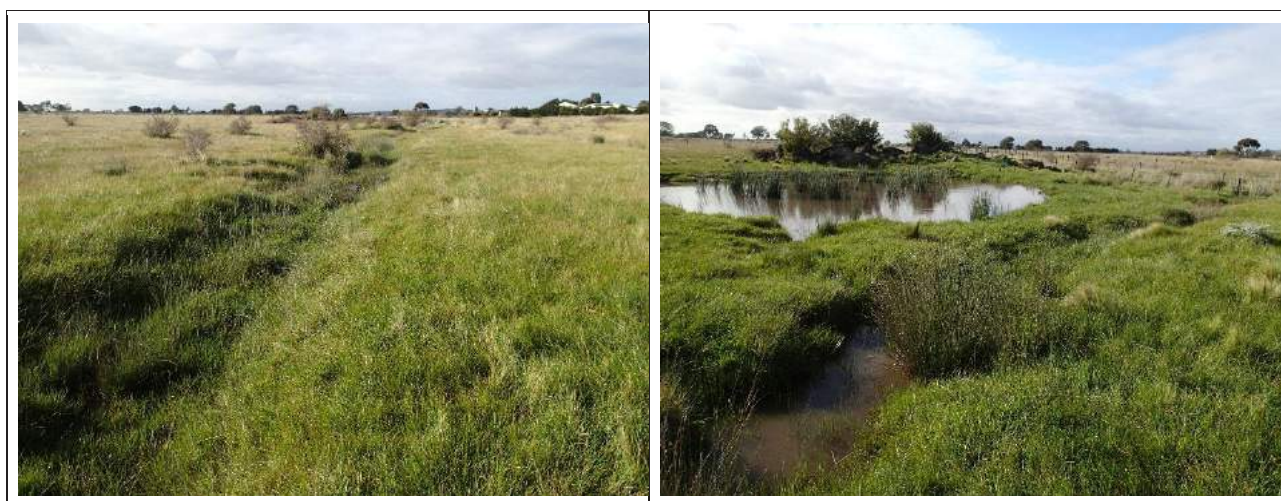
Figure 1 Scheme Property 14 – Drained creek (left) and farm dam (right).

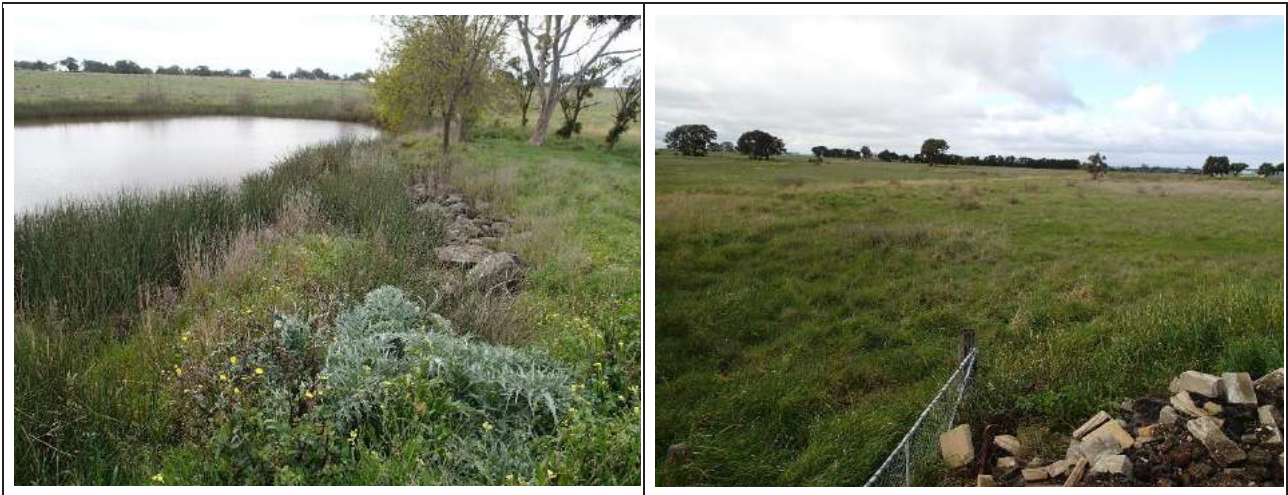
Figure 2 Scheme Property 19 – Farm dam (left) and downstream creek/drainage depression traversing valley fill (right).

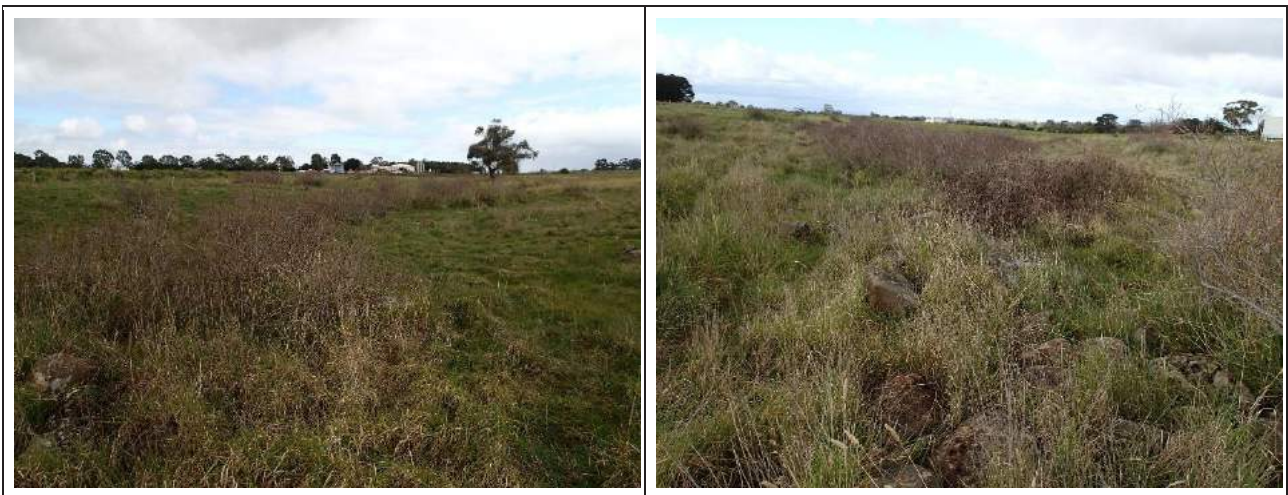
Figure 3 Scheme Property 20 – Partly confined channel with exposed basalt boulders.

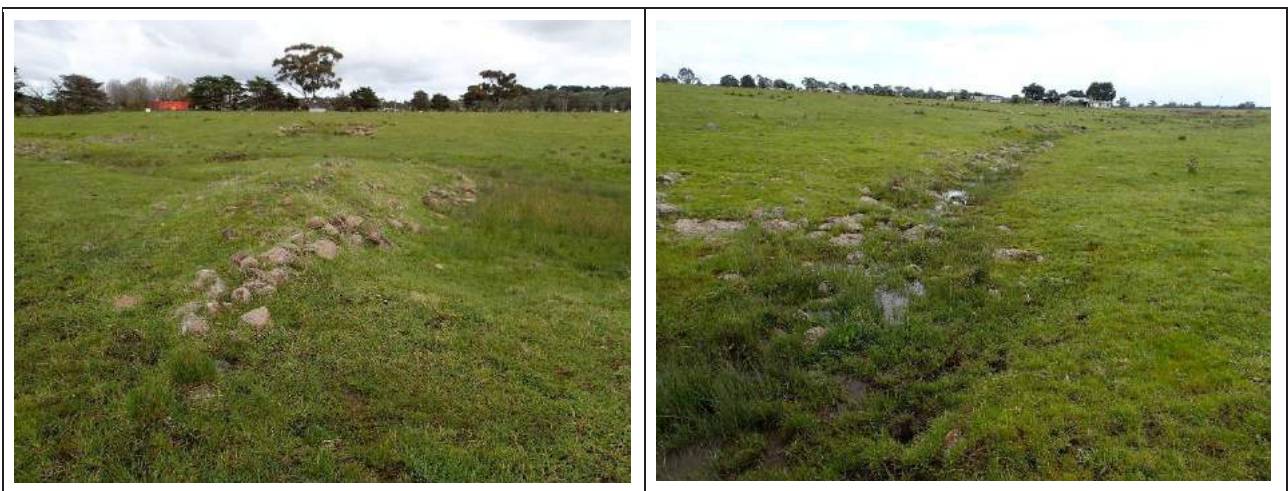
Figure 4 Scheme Property 21 – Raised boulder surfaces along waterway corridor and remnants of quarry (left) and basalt boulder/riffle (right).

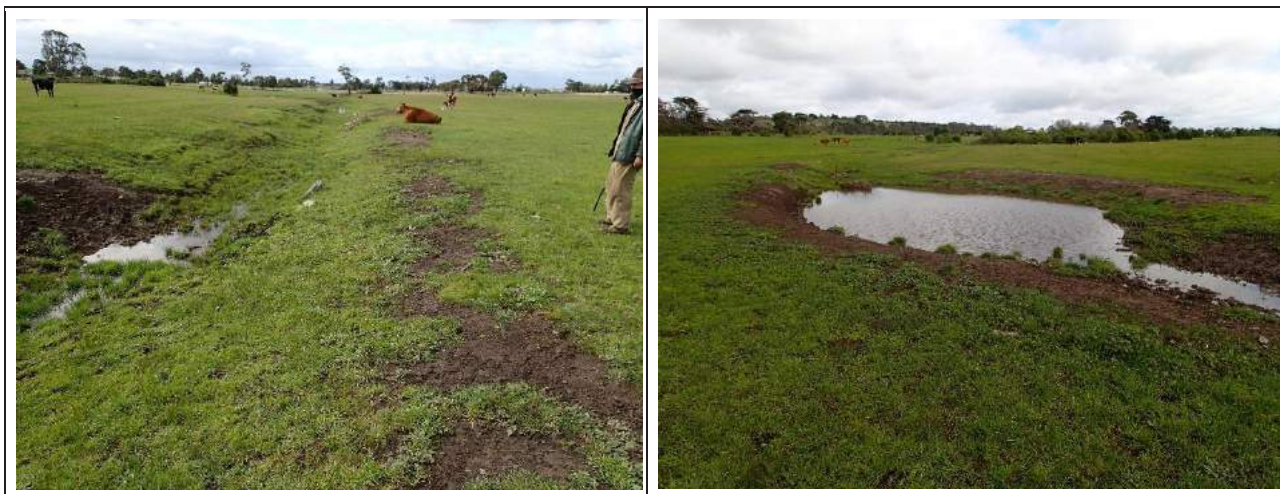
Figure 5 Scheme Property 31 – Drained creek (left) and onstream watering point for cattle (right).

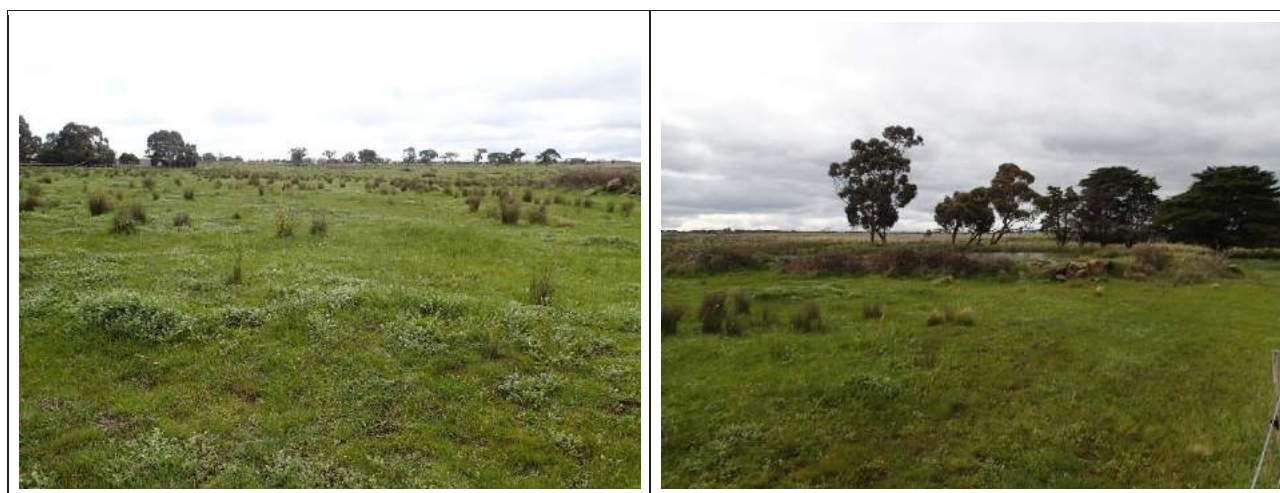
Figure 1 Scheme Property 37 – Broad drainage depression/valley fill (left) and farm dam (right).

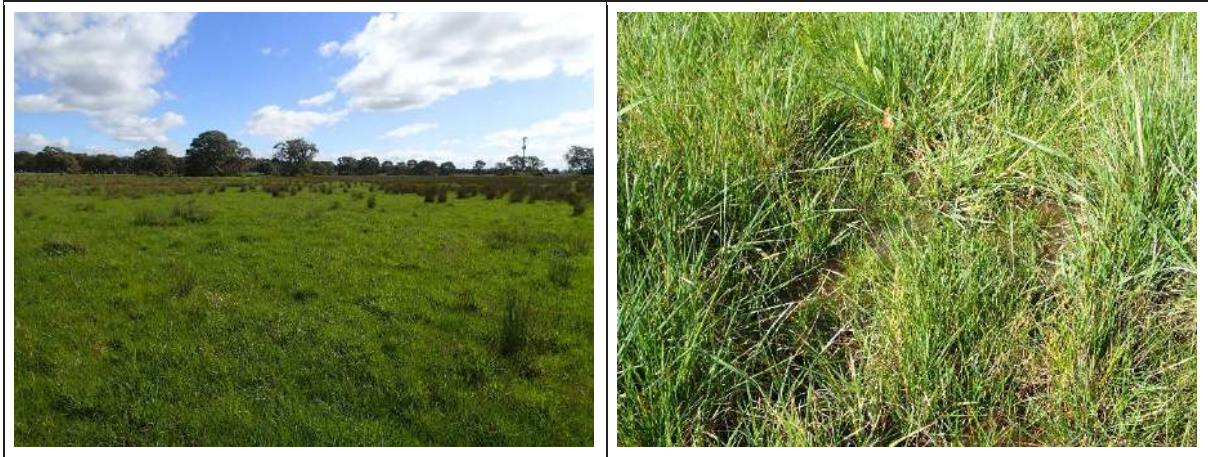
Figure 1 Scheme Property 29 – Broad saturated plain/wetland.

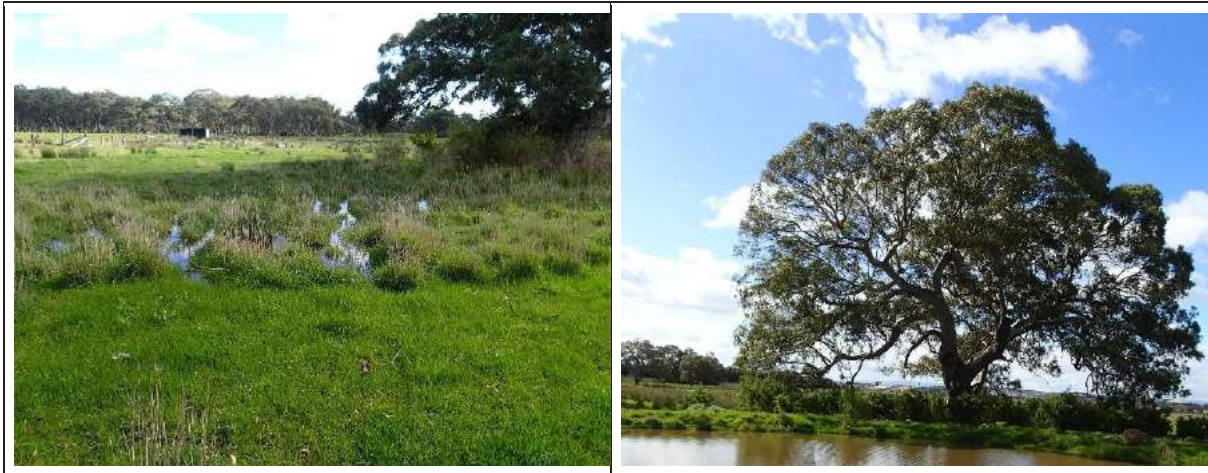
Figure 2 Scheme Property 29 – Saturated fields (left) and large tree adjacent to farm dam (right).

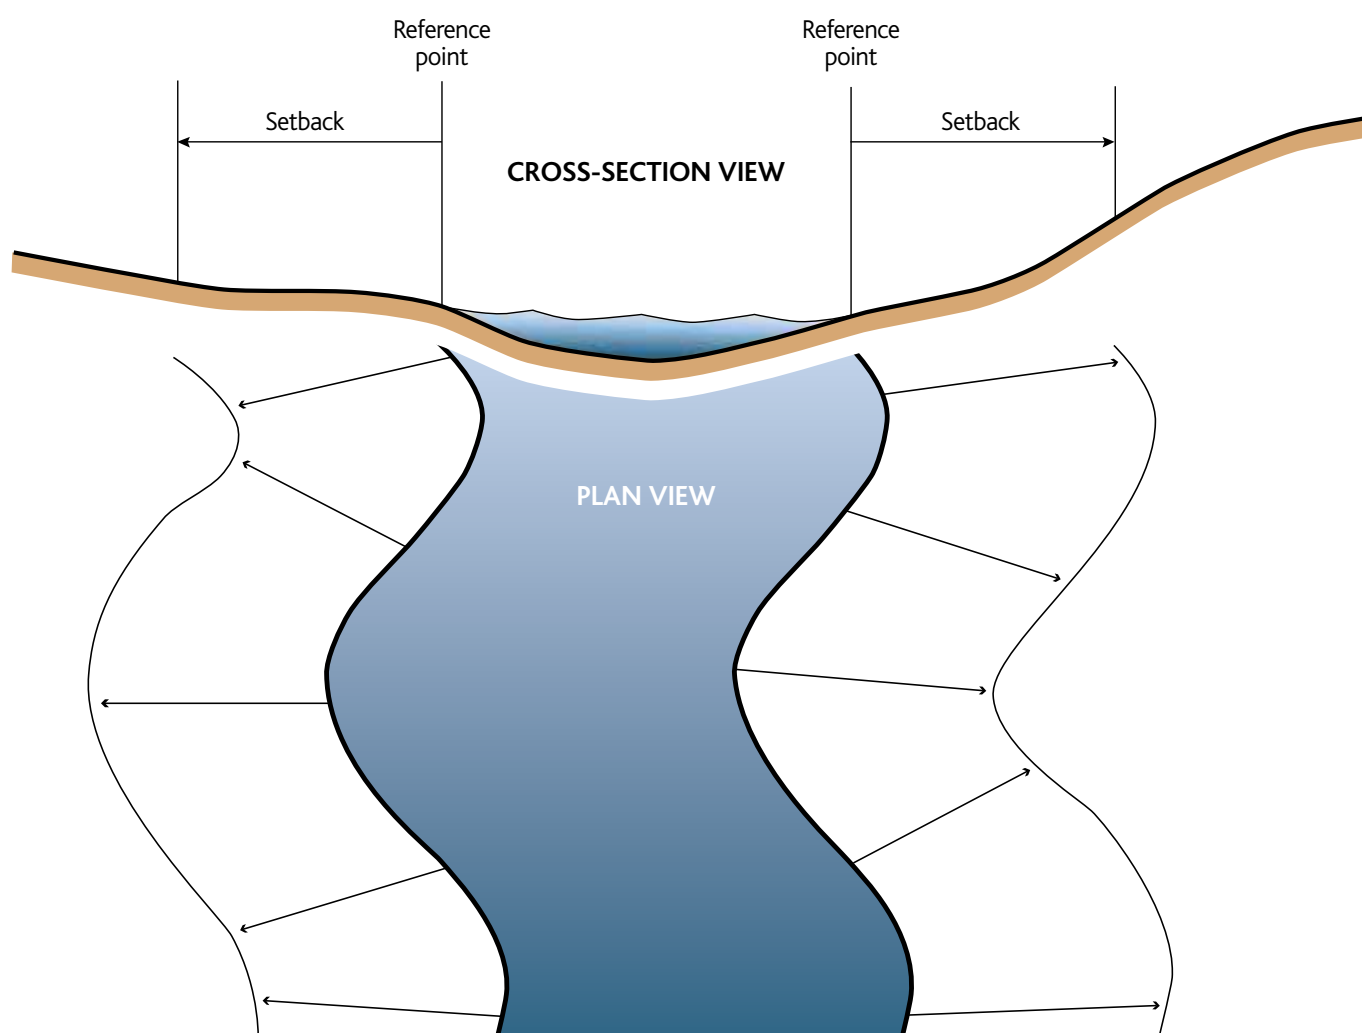
Figure 1. Schematic illustration of setback from waterway

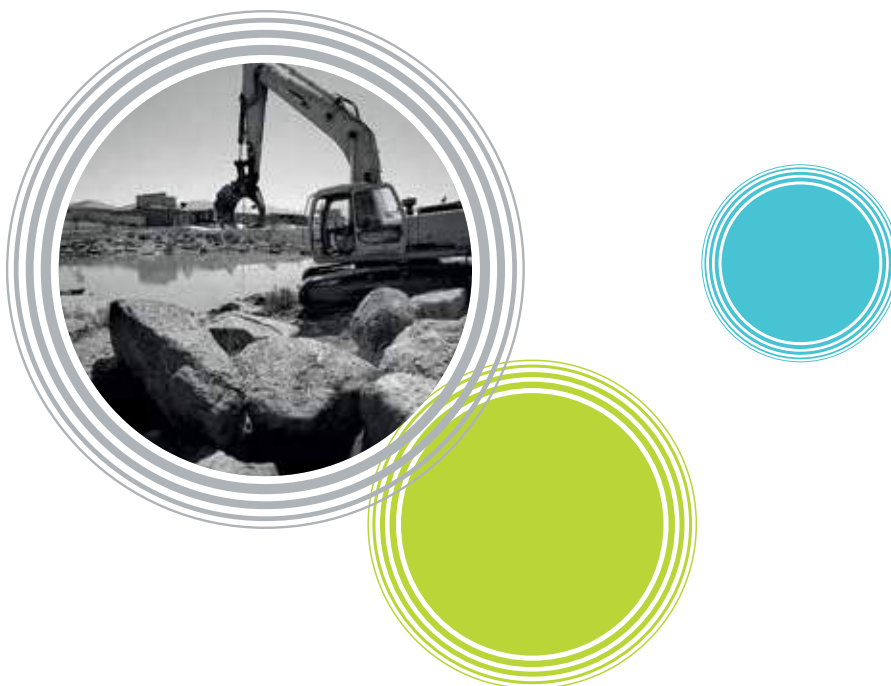
a third order stream. Streams of lower order joining a higher order stream do not change the order of the higher stream, so if a first order stream joins a second order stream, it remains a second order stream. The Strahler stream order concept is illustrated schematically in Figure 2.
