**RE: Craigieburn West Precinct Structure Plan (PSP)**  
**Submissions made on behalf of [REDACTED] Whites Lane, Yuroke (Mickleham)**  
**PSP property ID 16**

**Aitken Creek Waterway Values Assessment**

# Waterway Corridors

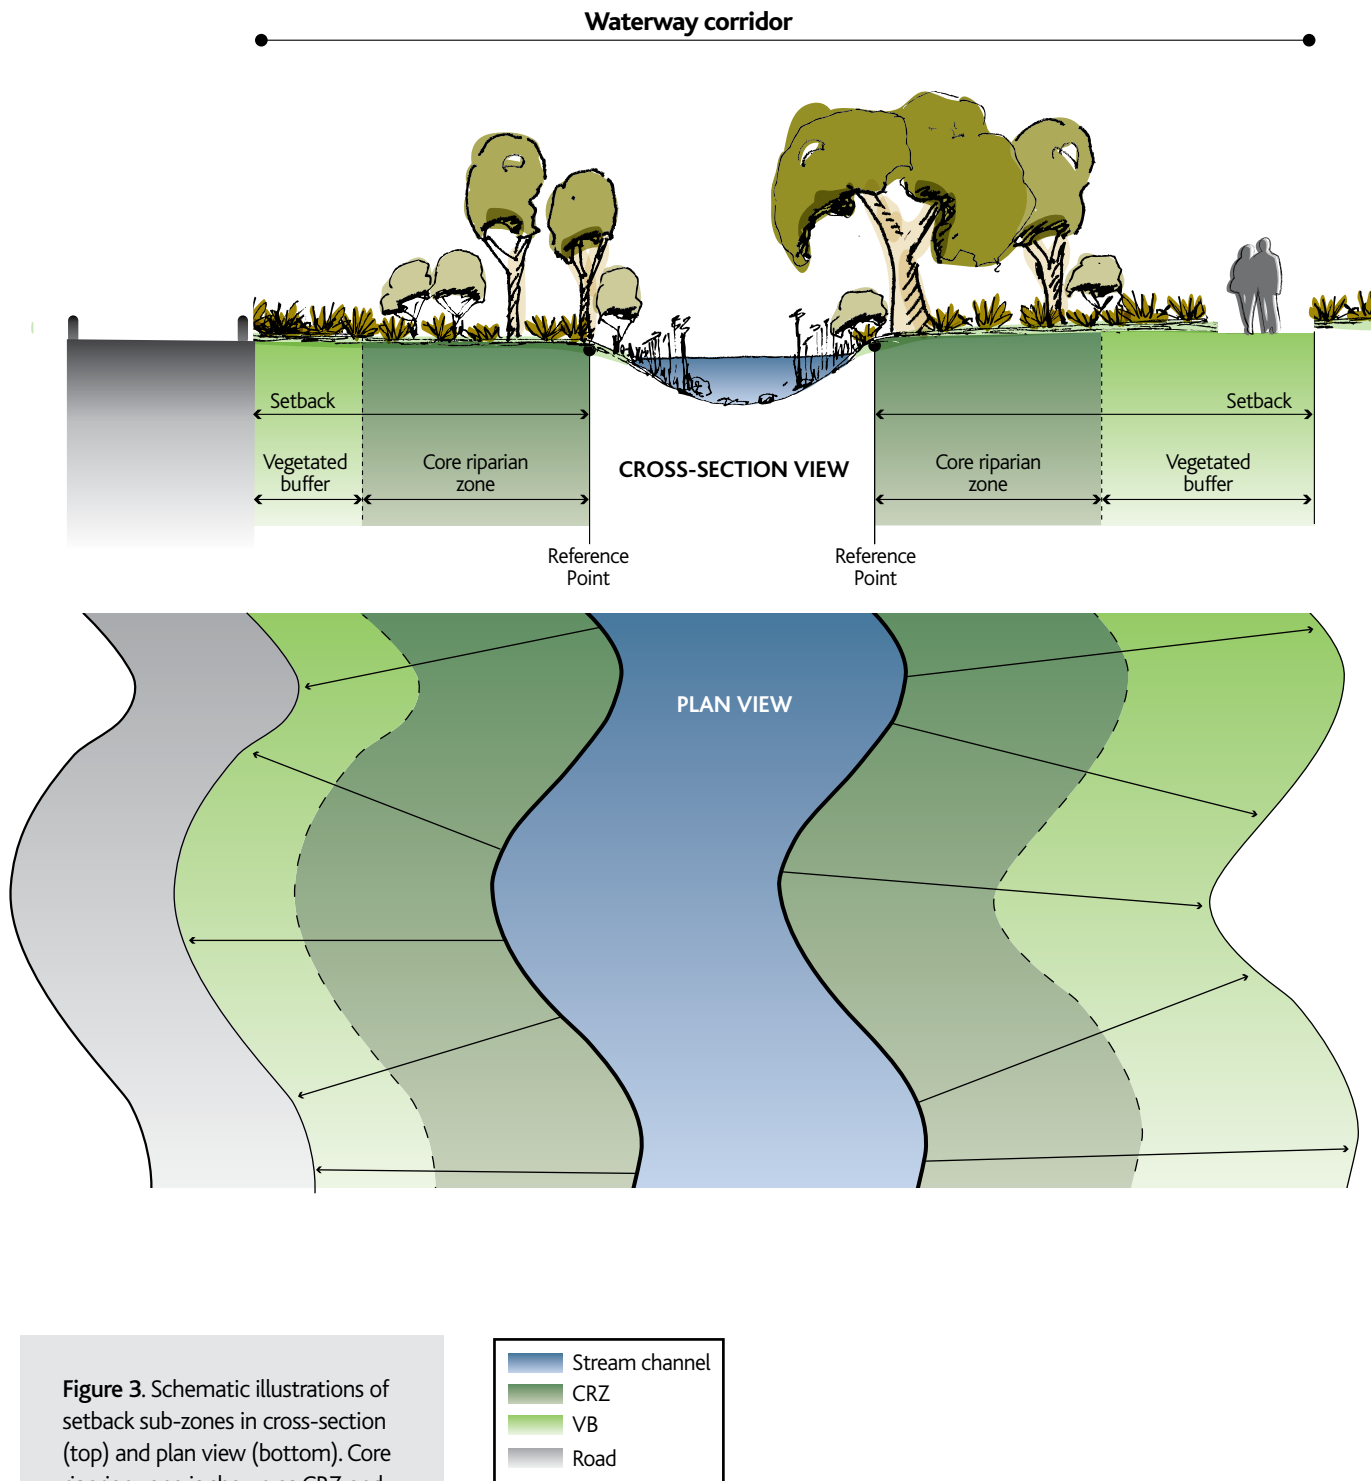
**Figure 3.** Schematic illustrations of setback sub-zones in cross-section (top) and plan view (bottom). Core riparian zone is shown as CRZ and vegetated buffer as VB.

The core riparian zone is fully vegetated with native vegetation selected in accordance with the vegetation component of the Healthy Waterways Visions<sup>6</sup>. Depending on various factors such as geographic location, stream form and current condition, the required vegetation type may vary from

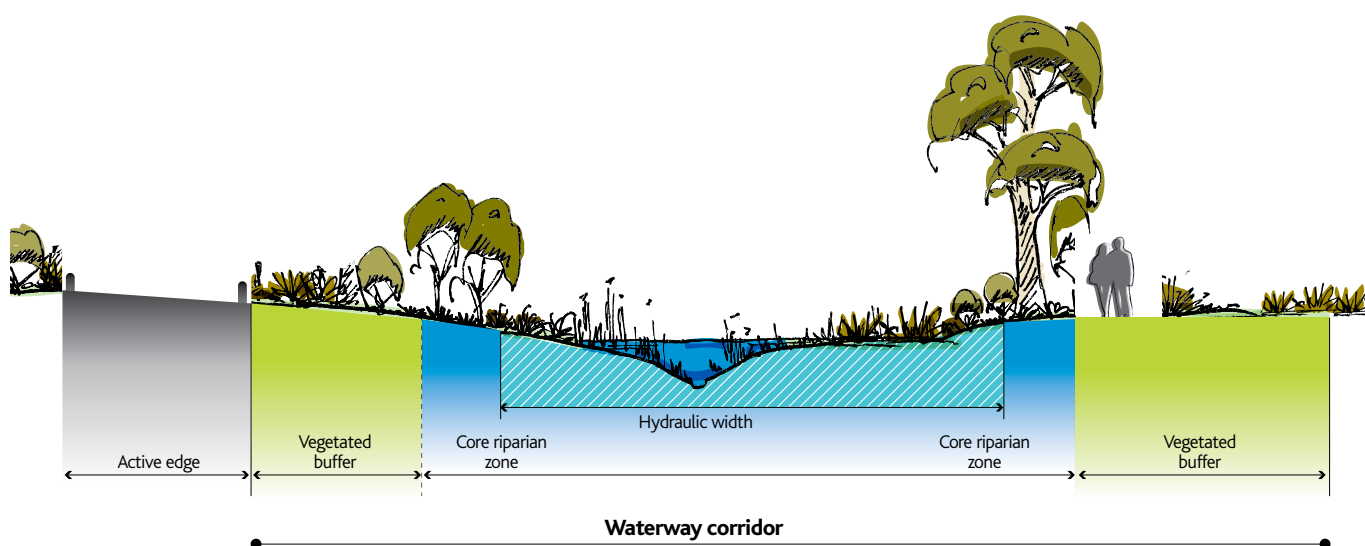
Figure 4. Example of setback sub-zones for constructed waterways
