Land Capability Assessment

Document no: IS311600-GN-RPT-0001-Wallan PSP
Revision no: 1

Wallan South and Wallan East Precinct Structure Plans
20 June 2022

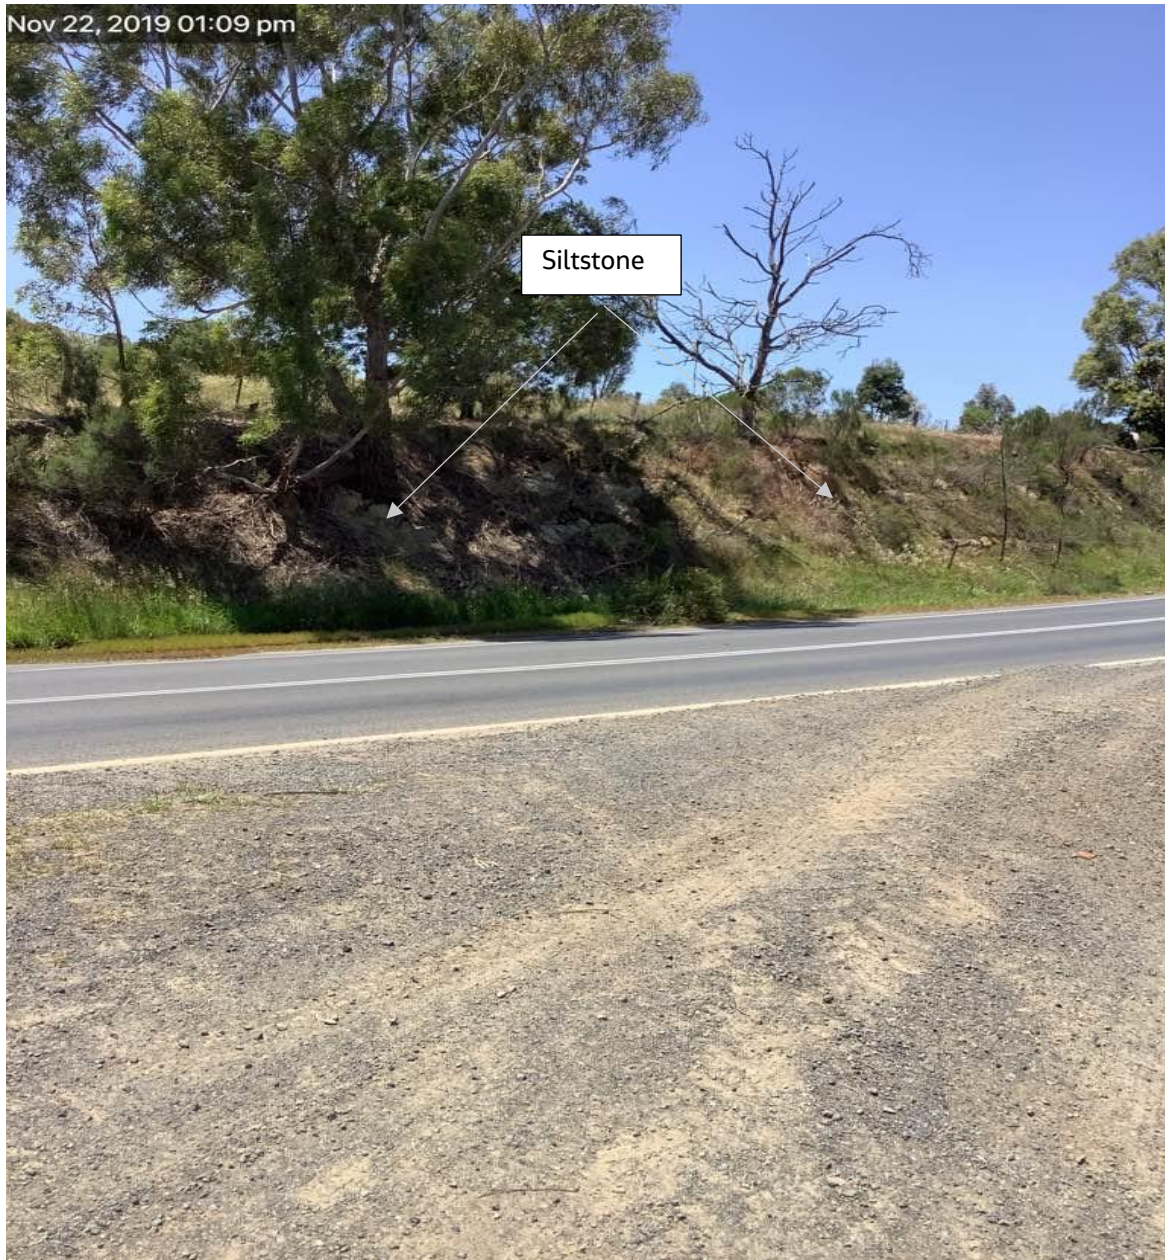
Figure 5-2. Siltstone and residual soil along the Darraweit road

The site inspection confirmed the above in part, with rock outcropping (siltstone) observed across the study area as well as alluvial deposits along creek. These are illustrated in the images Figure 5-2 and Figure 5-3.

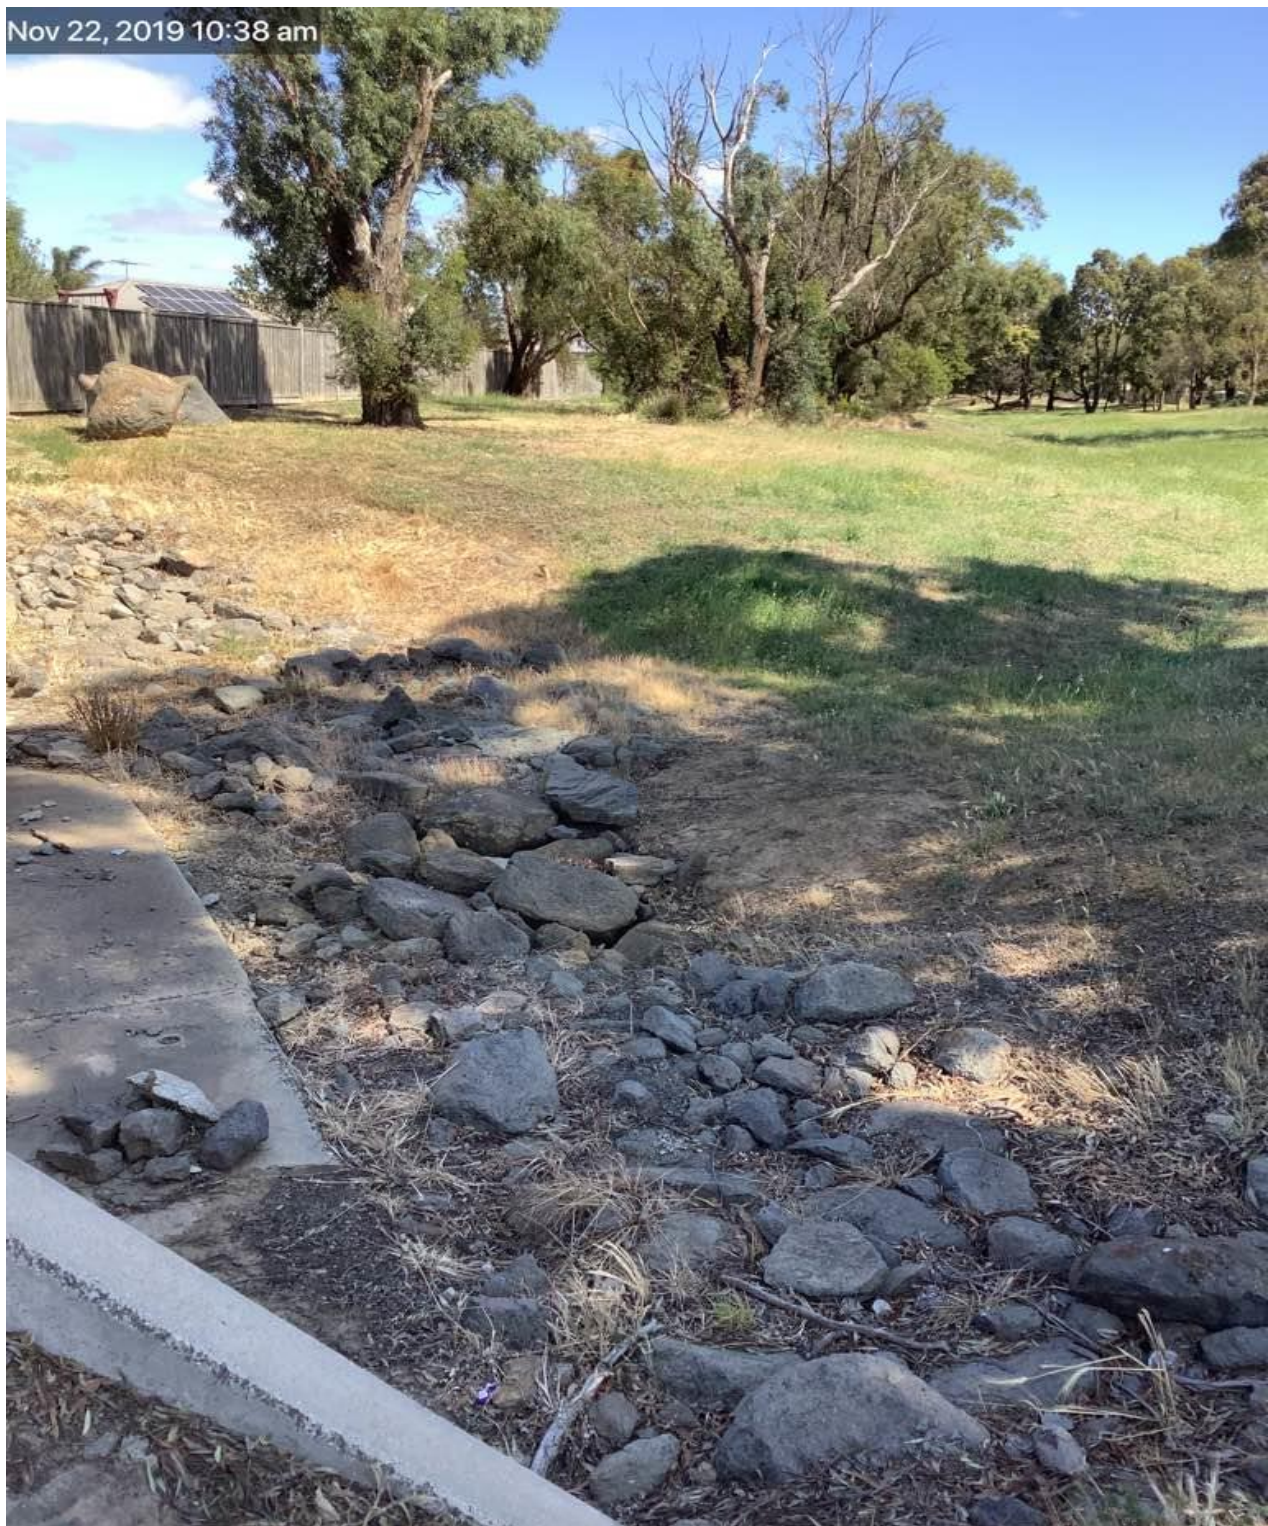
Figure 5-3. Alluvium deposit and basalt outcrops along the drainage channel in Wallan South

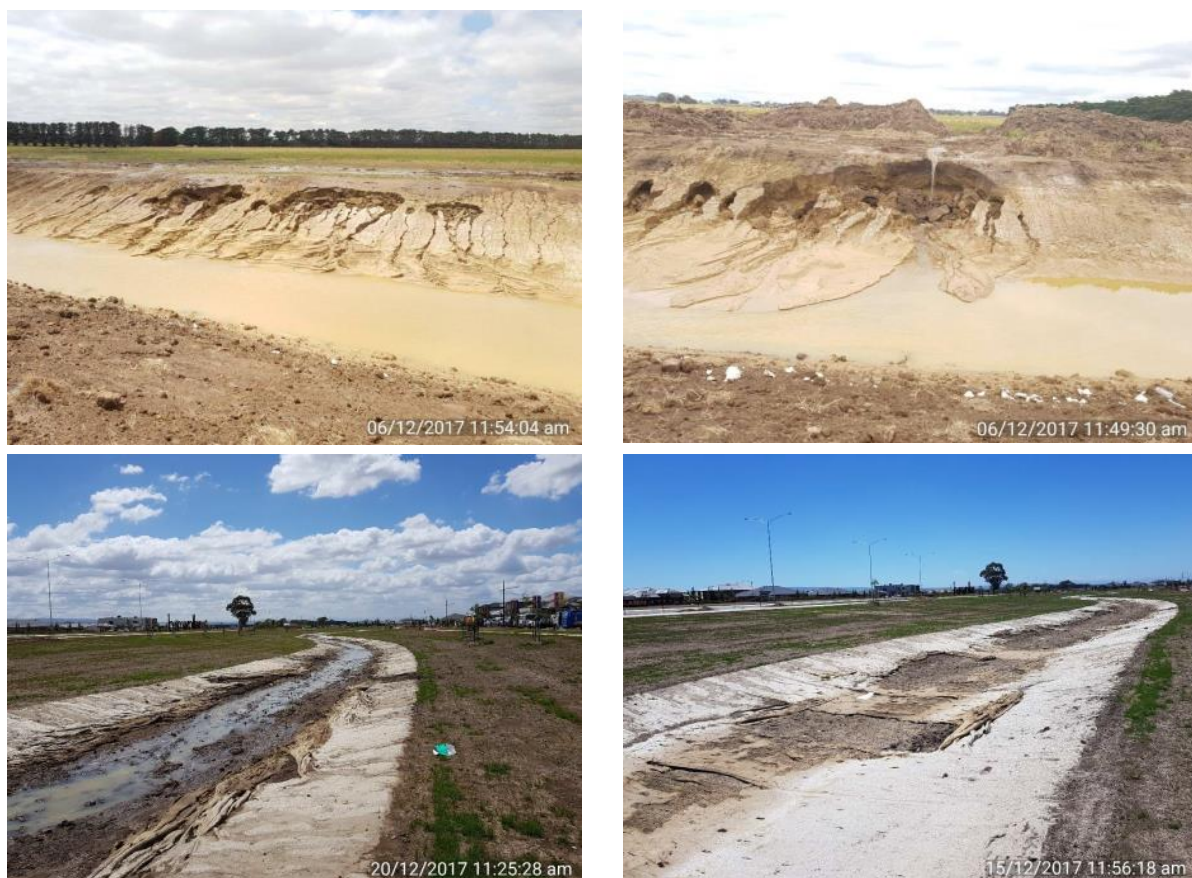
Figure 5-7. Selected photographs of erosion and damage to drains at Merrifield following rainfall events (Brizga & Seymour 2018).

Figure 2-7 shows some selected photographs of erosion and damage to drains in the Merrifield development area following rainfall events, which is located approximately 20 km south of Wallan. These are shown here as examples of poor sodic soil management. Construction and drainage works have been undertaken without an adequate appreciation of the erodibility of the underlying sodic soils. The occurrence of this erosion and concerns expressed by Melbourne Water have led to further investigations into the stability of soils in this area and how they should be treated (Van de Graaf 2018). It has also prompted reconsideration of what scale of construction and waterway engineering works is necessary to mitigate erosion risks and what is considered an acceptable standard for the waterway design, given the erosion risks (Brizga & Seymour 2018, Jacobs 2019a).

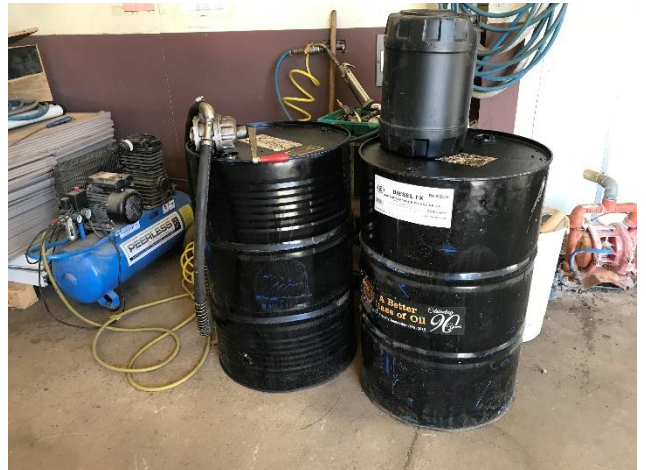
Picture 7-4. Storage of oils and lubricants (Lots 2-4)

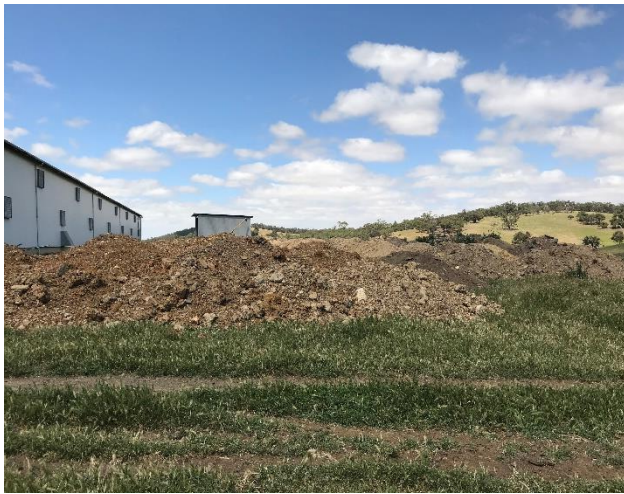
Picture 7-7. Soil stockpiles (Lots 2-4)

The former battery egg farm at Lots 2 – 4 (Wallan South PSP) are currently used for dwelling, storage of plant and equipment, and sheep grazing. Stockpiling of soils was also noted at the former egg farm and in some cases building rubble was also identified.

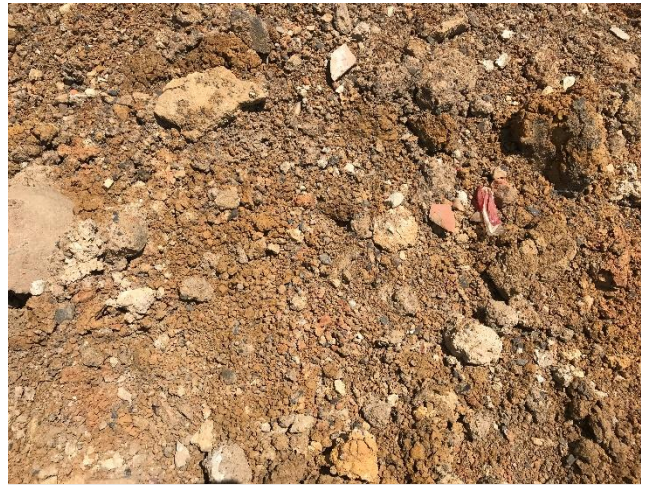
Picture 7-8. Building rubble observed within soil stockpiles (Lots 2-4)

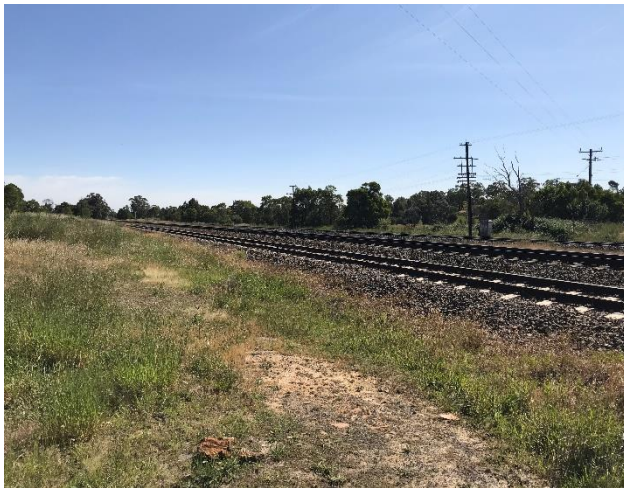
Picture 7-9. Rail siding, looking south-west (Lots 36-42)

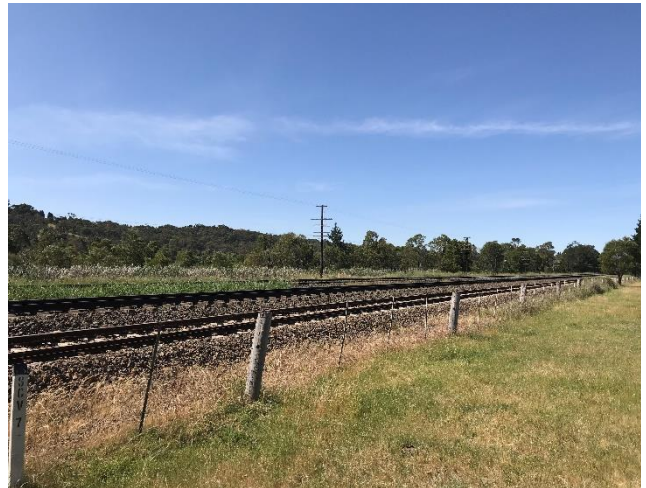
Picture 7-10. Rail siding, looking north-west (Lots 36-42)
