Report

Casey Fields South and Devon Meadows PSP Land Capability Assessment

Client Reference No. A0580 and A2200
Prepared for: Victorian Planning Authority
10 February 2023

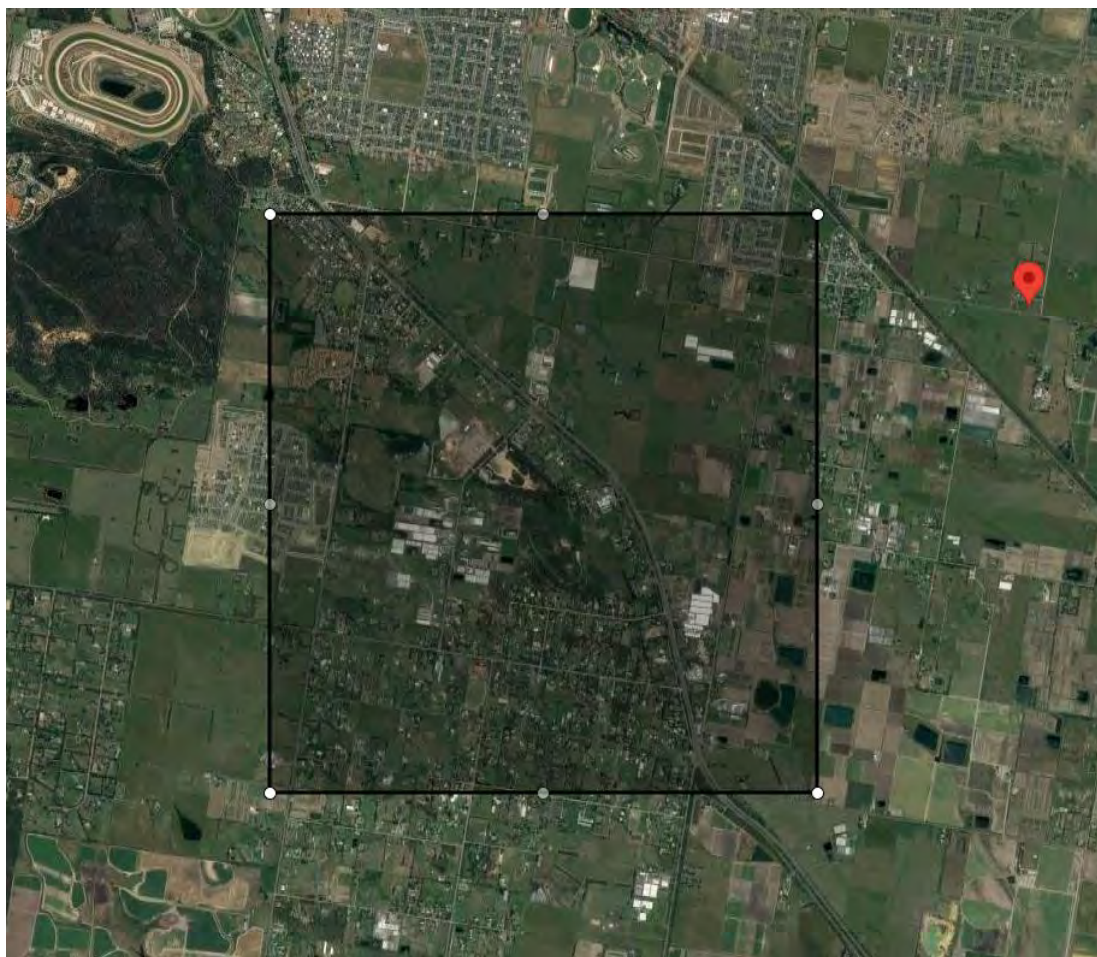
A search of the National Pollutant Inventory (NPI) database (www.npi.gov.au) for the Casey Fields South and Devon Meadows PSP area showed there were no industrial premises that trigger the thresholds to report their annual emissions to NPI (Figure 5-9). The closest facility that reports its emissions to NPI is the Clyde Feedmill (red pin on Figure 5-9) which is located approximately 1.5km east of Clyde-Five Ways Road.

Figure 5-9 NPI database search for the Casey Fields South and Devon Meadows PSP area (black shaded area)

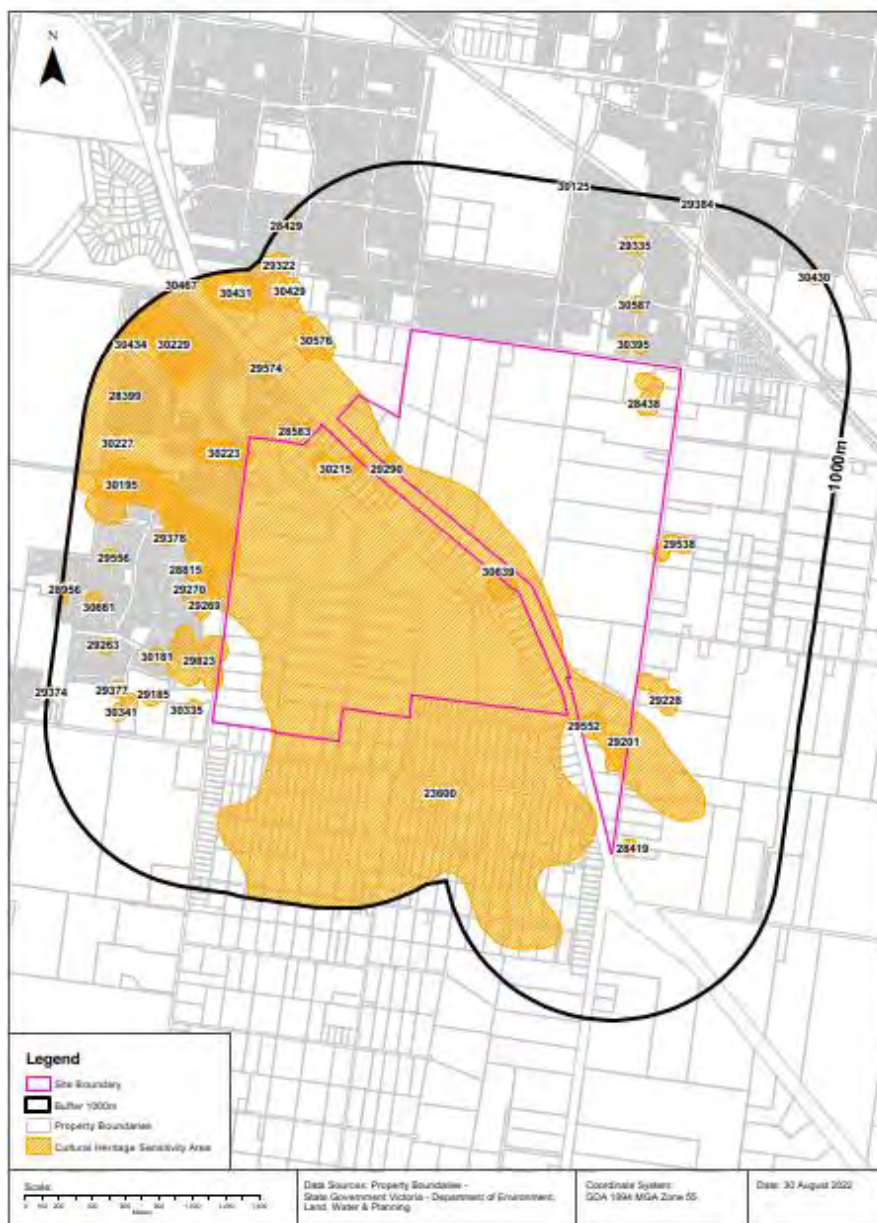
Figure 6-1: Areas of cultural heritage sensitivity in and surrounding the PSP area.

Lotsearch reported 45 sites of Cultural Heritage Sensitivity as specified in Division 3 of Part 2 in the Victorian Aboriginal Heritage Regulations 2018, within the dataset buffer. Site 23600 overlays most of the Devon Meadows PSP and overlays with land dune deposits (Qd1). Six other sites are with the PSP, and the others sit outside the PSP but within the 1,000m buffer of the dataset. These sites are 28438, 29201, 29552, 29290, 30215 and 30639. All sites identified by Lotsearch are shown in Figure 6-1 below.

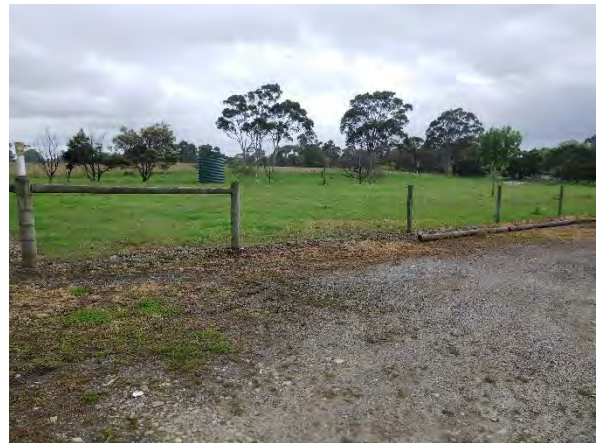
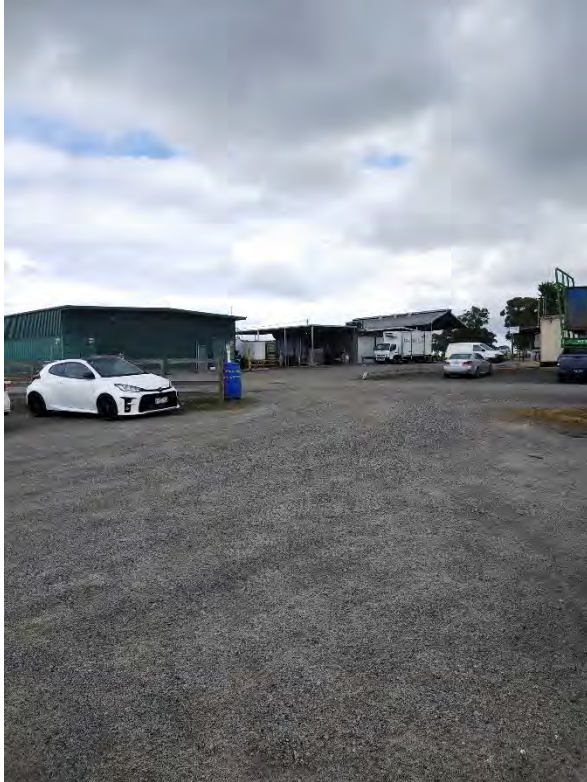
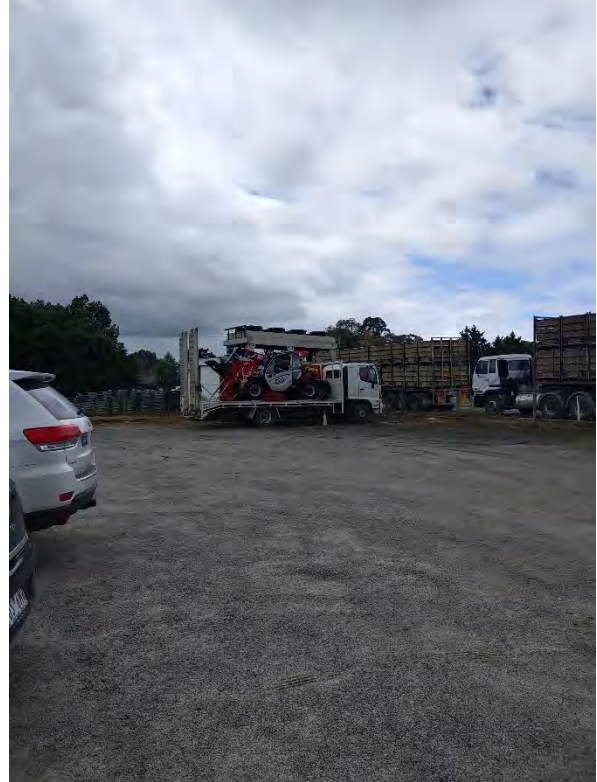
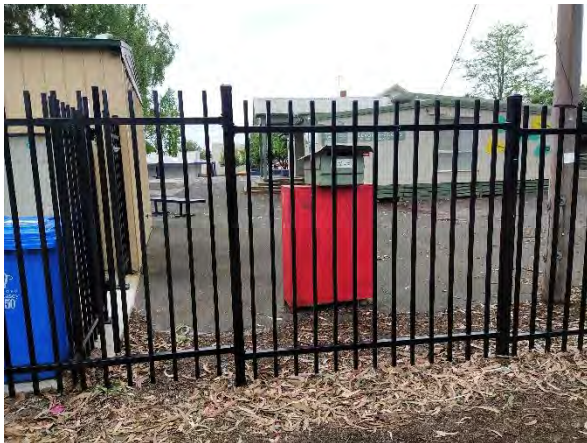
Figure 72: Limnos Poultry, 109-111 Craig Road, Cranbourne South

-	Limnos Poultry 109-111 Craig Road, Devon Meadows	Poultry farm	Sheds, wooden pellets, machinery, and trucks onsite. Minor surface waste observed. Potential impacts to groundwater from nutrients, pathogens and use of alum and other chemicals due to site use.	Yes	Medium	Proceed to Preliminary Risk Screening Assessment

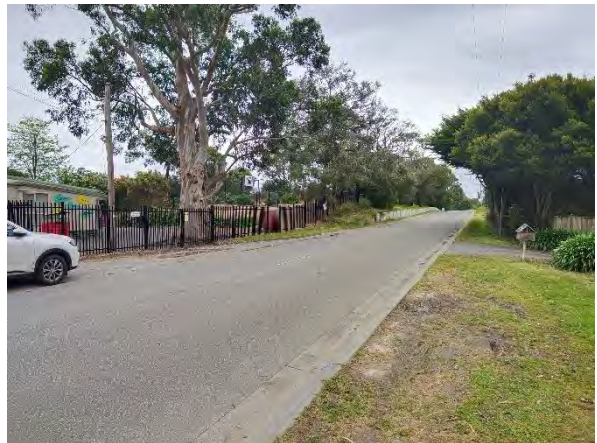
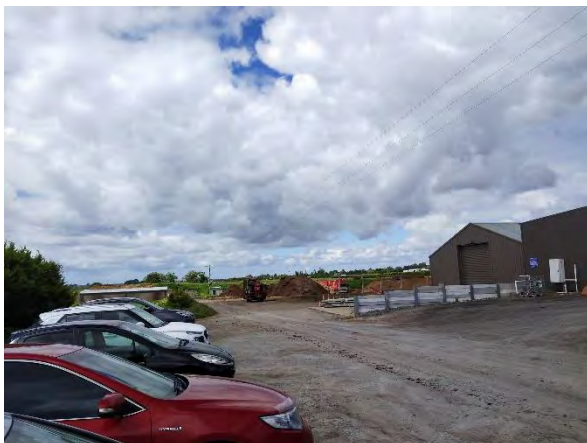
Figure 75: 50 Worthing Road, Clyde

-	50 Worthing Road, Devon Meadows	Primary School	Portables, basketball court and schoolyard. Current EPA works approval for sewage treatment.	Yes	High	PRSA or audit option applies Proceed to Environmental Audit if a new land use is proposed
101	7-11 Petrol station 2025 South Gippsland Highway, Clyde (Corner Clyde-Five Ways Road and South Gippsland Highway)	Petrol station	Service station. The shelter façade appeared rotten. No signs of contamination were observed.	Yes	High	PRSA or audit option applies Proceed to Environmental Audit if a new land use is proposed

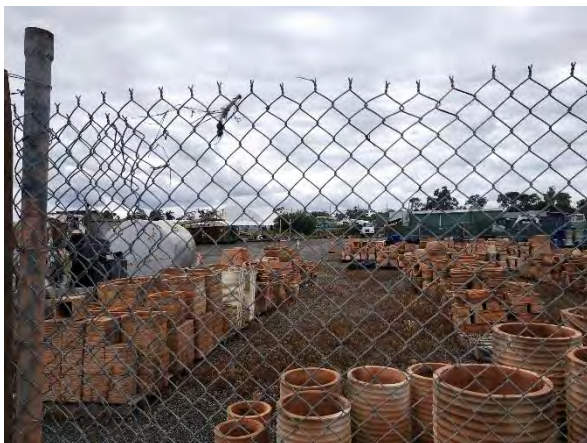
Figure 119: Golden Nursery, 1945 South Gippsland Highway, Clyde

ID	Property name / Address	Current Site Use / Activity*	Description / Findings	Site Inspections	Potential for Contamination	Where a sensitive land use is proposed, the Recommended Further Action is:
93	Golden nursery 1945 South Gippsland Highway, Clyde	Plant nursery	Greenhouses and sheds. Gravel stockpiles, a freight container, and surface waste (metal, terracotta pots) onsite.	Yes	Medium	Proceed to Preliminary Risk Screening Assessment
92	Clear view commercial glass 1925 South Gippsland Highway, Clyde	Glass manufacturer	Glass merchant. Shed with surrounding yard. Difficult to see much from the road. The site generally looked neat in appearance.	Yes	High	Proceed to a PSRA or Environmental Audit
