Preliminary Site Investigation – Phase I Environmental
Site Assessment

Grangefields (Melton East) PSP

Prepared for 3L Alliance
19 November 2019

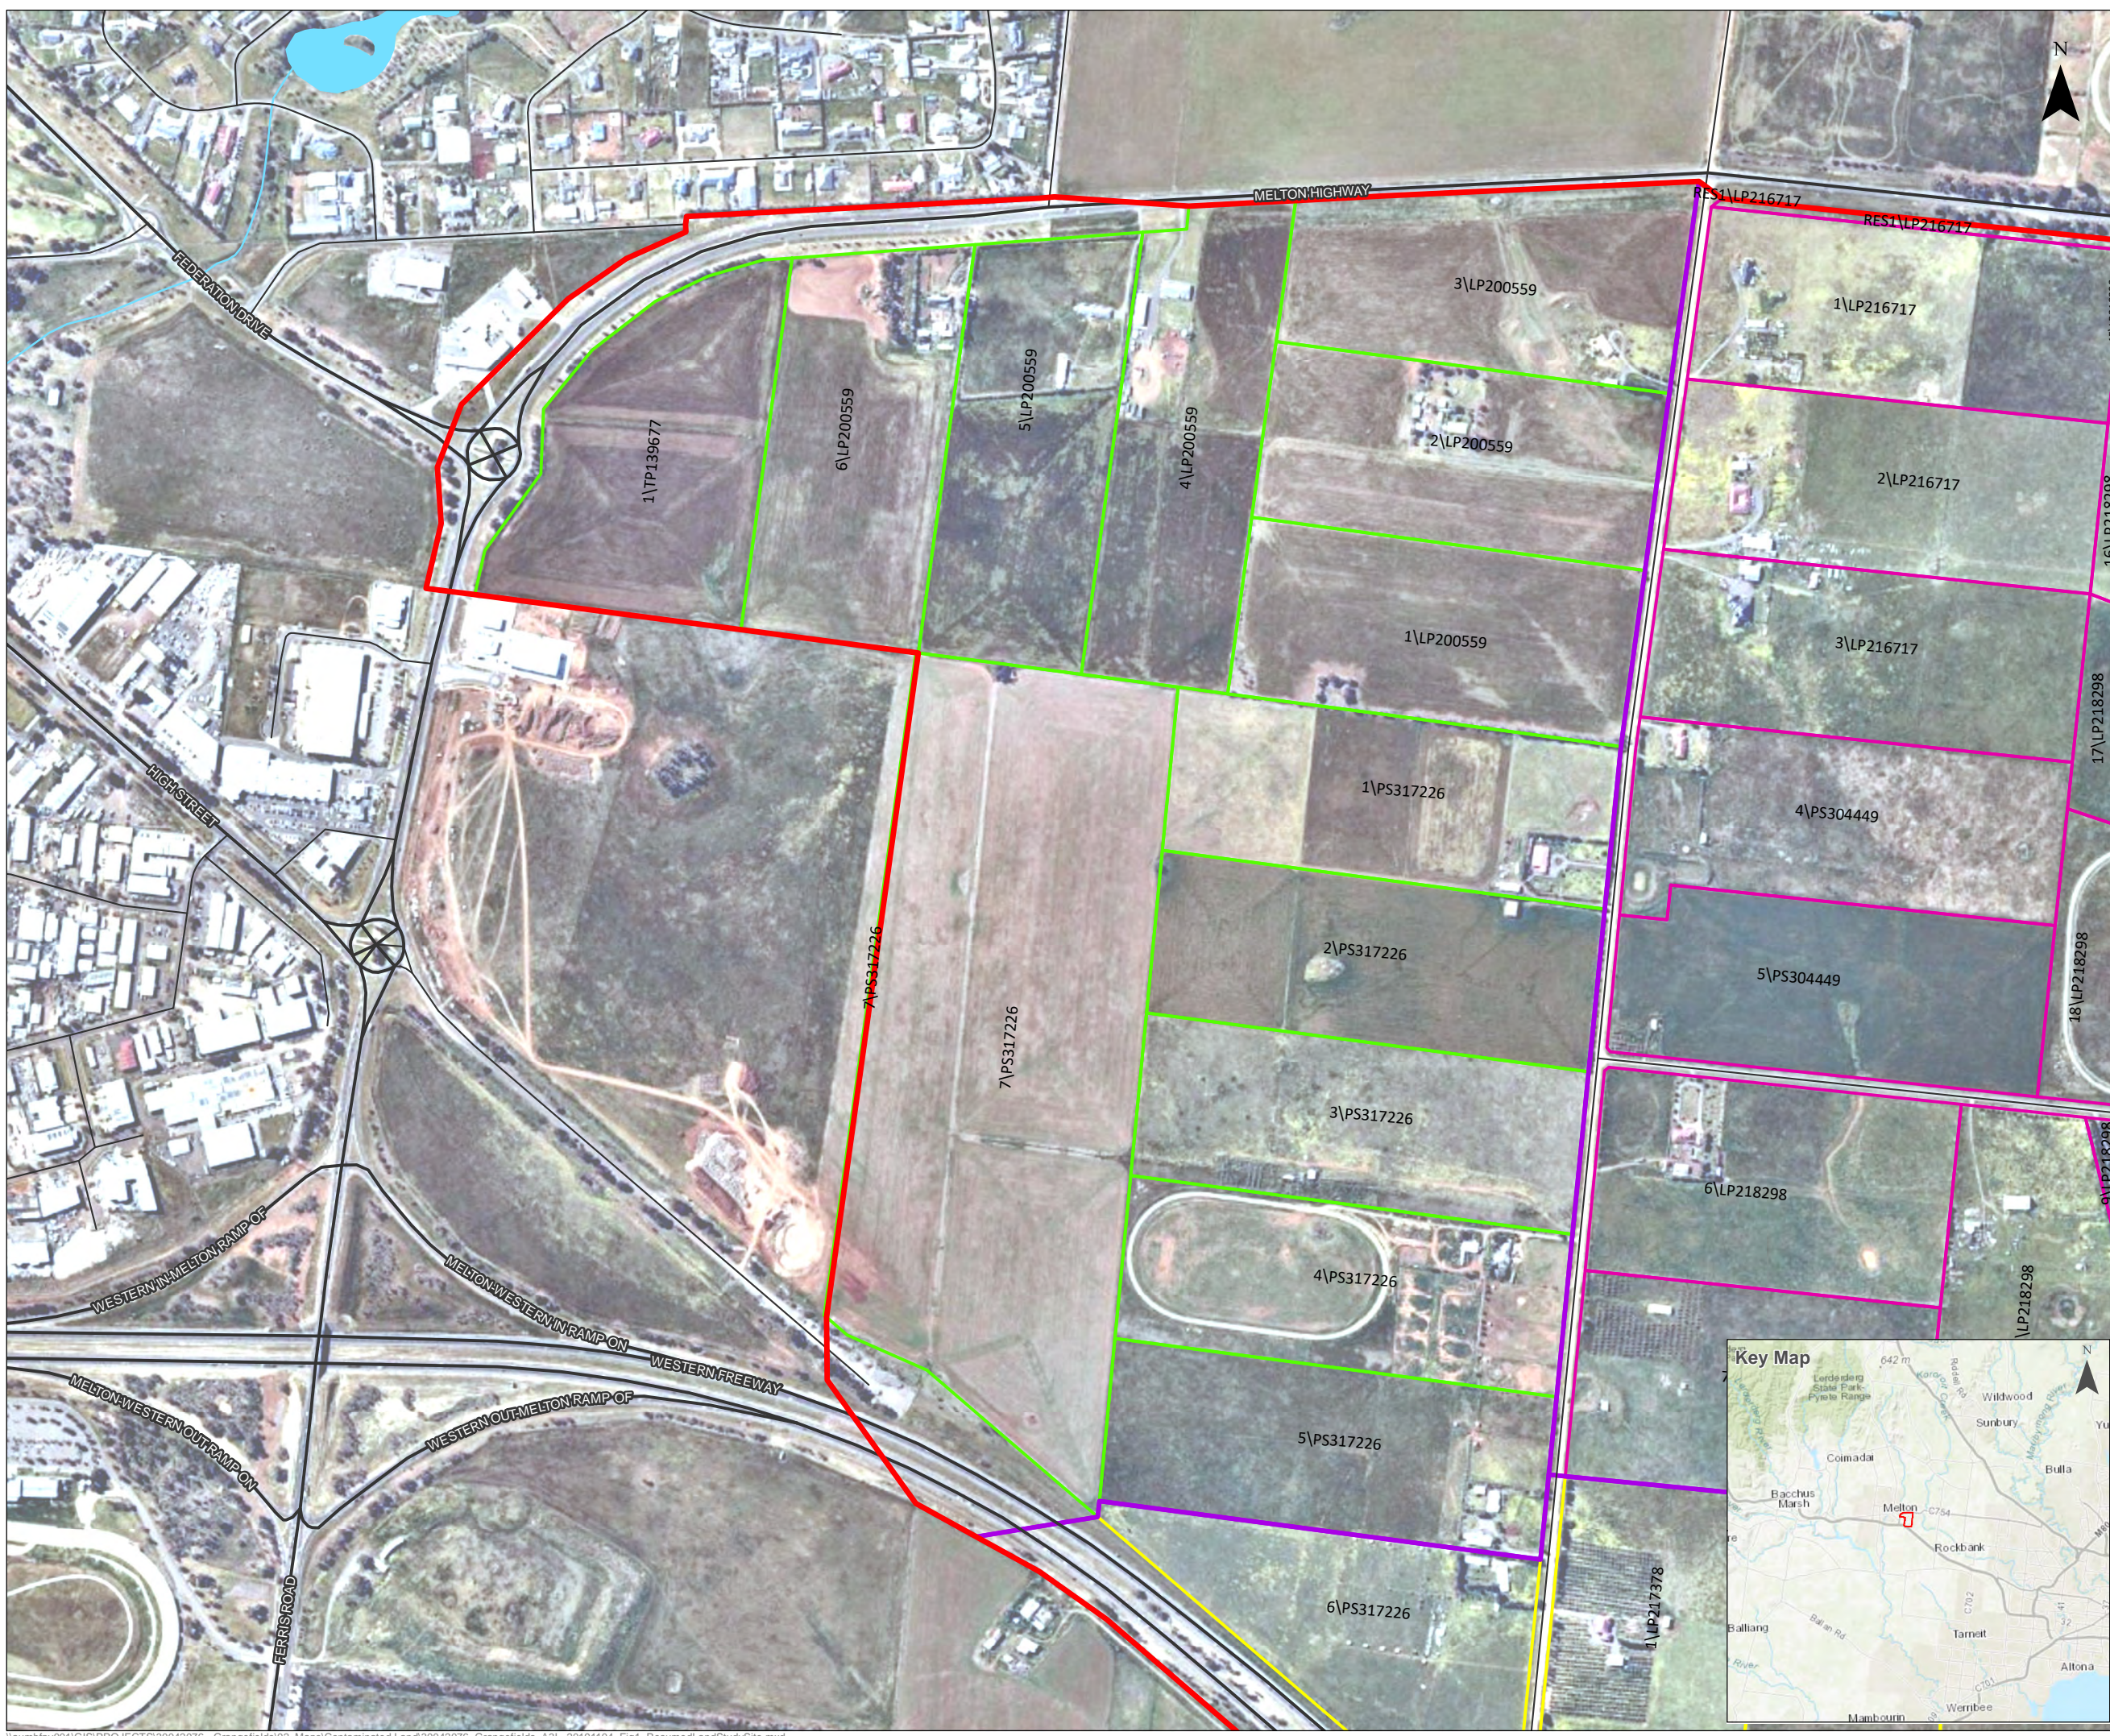
Due to considerable size, the desktop site history investigation has been broken up into five Precinct Parts (PP) –PP1 to PP5; as shown in **Appendix A**, Figure 1.

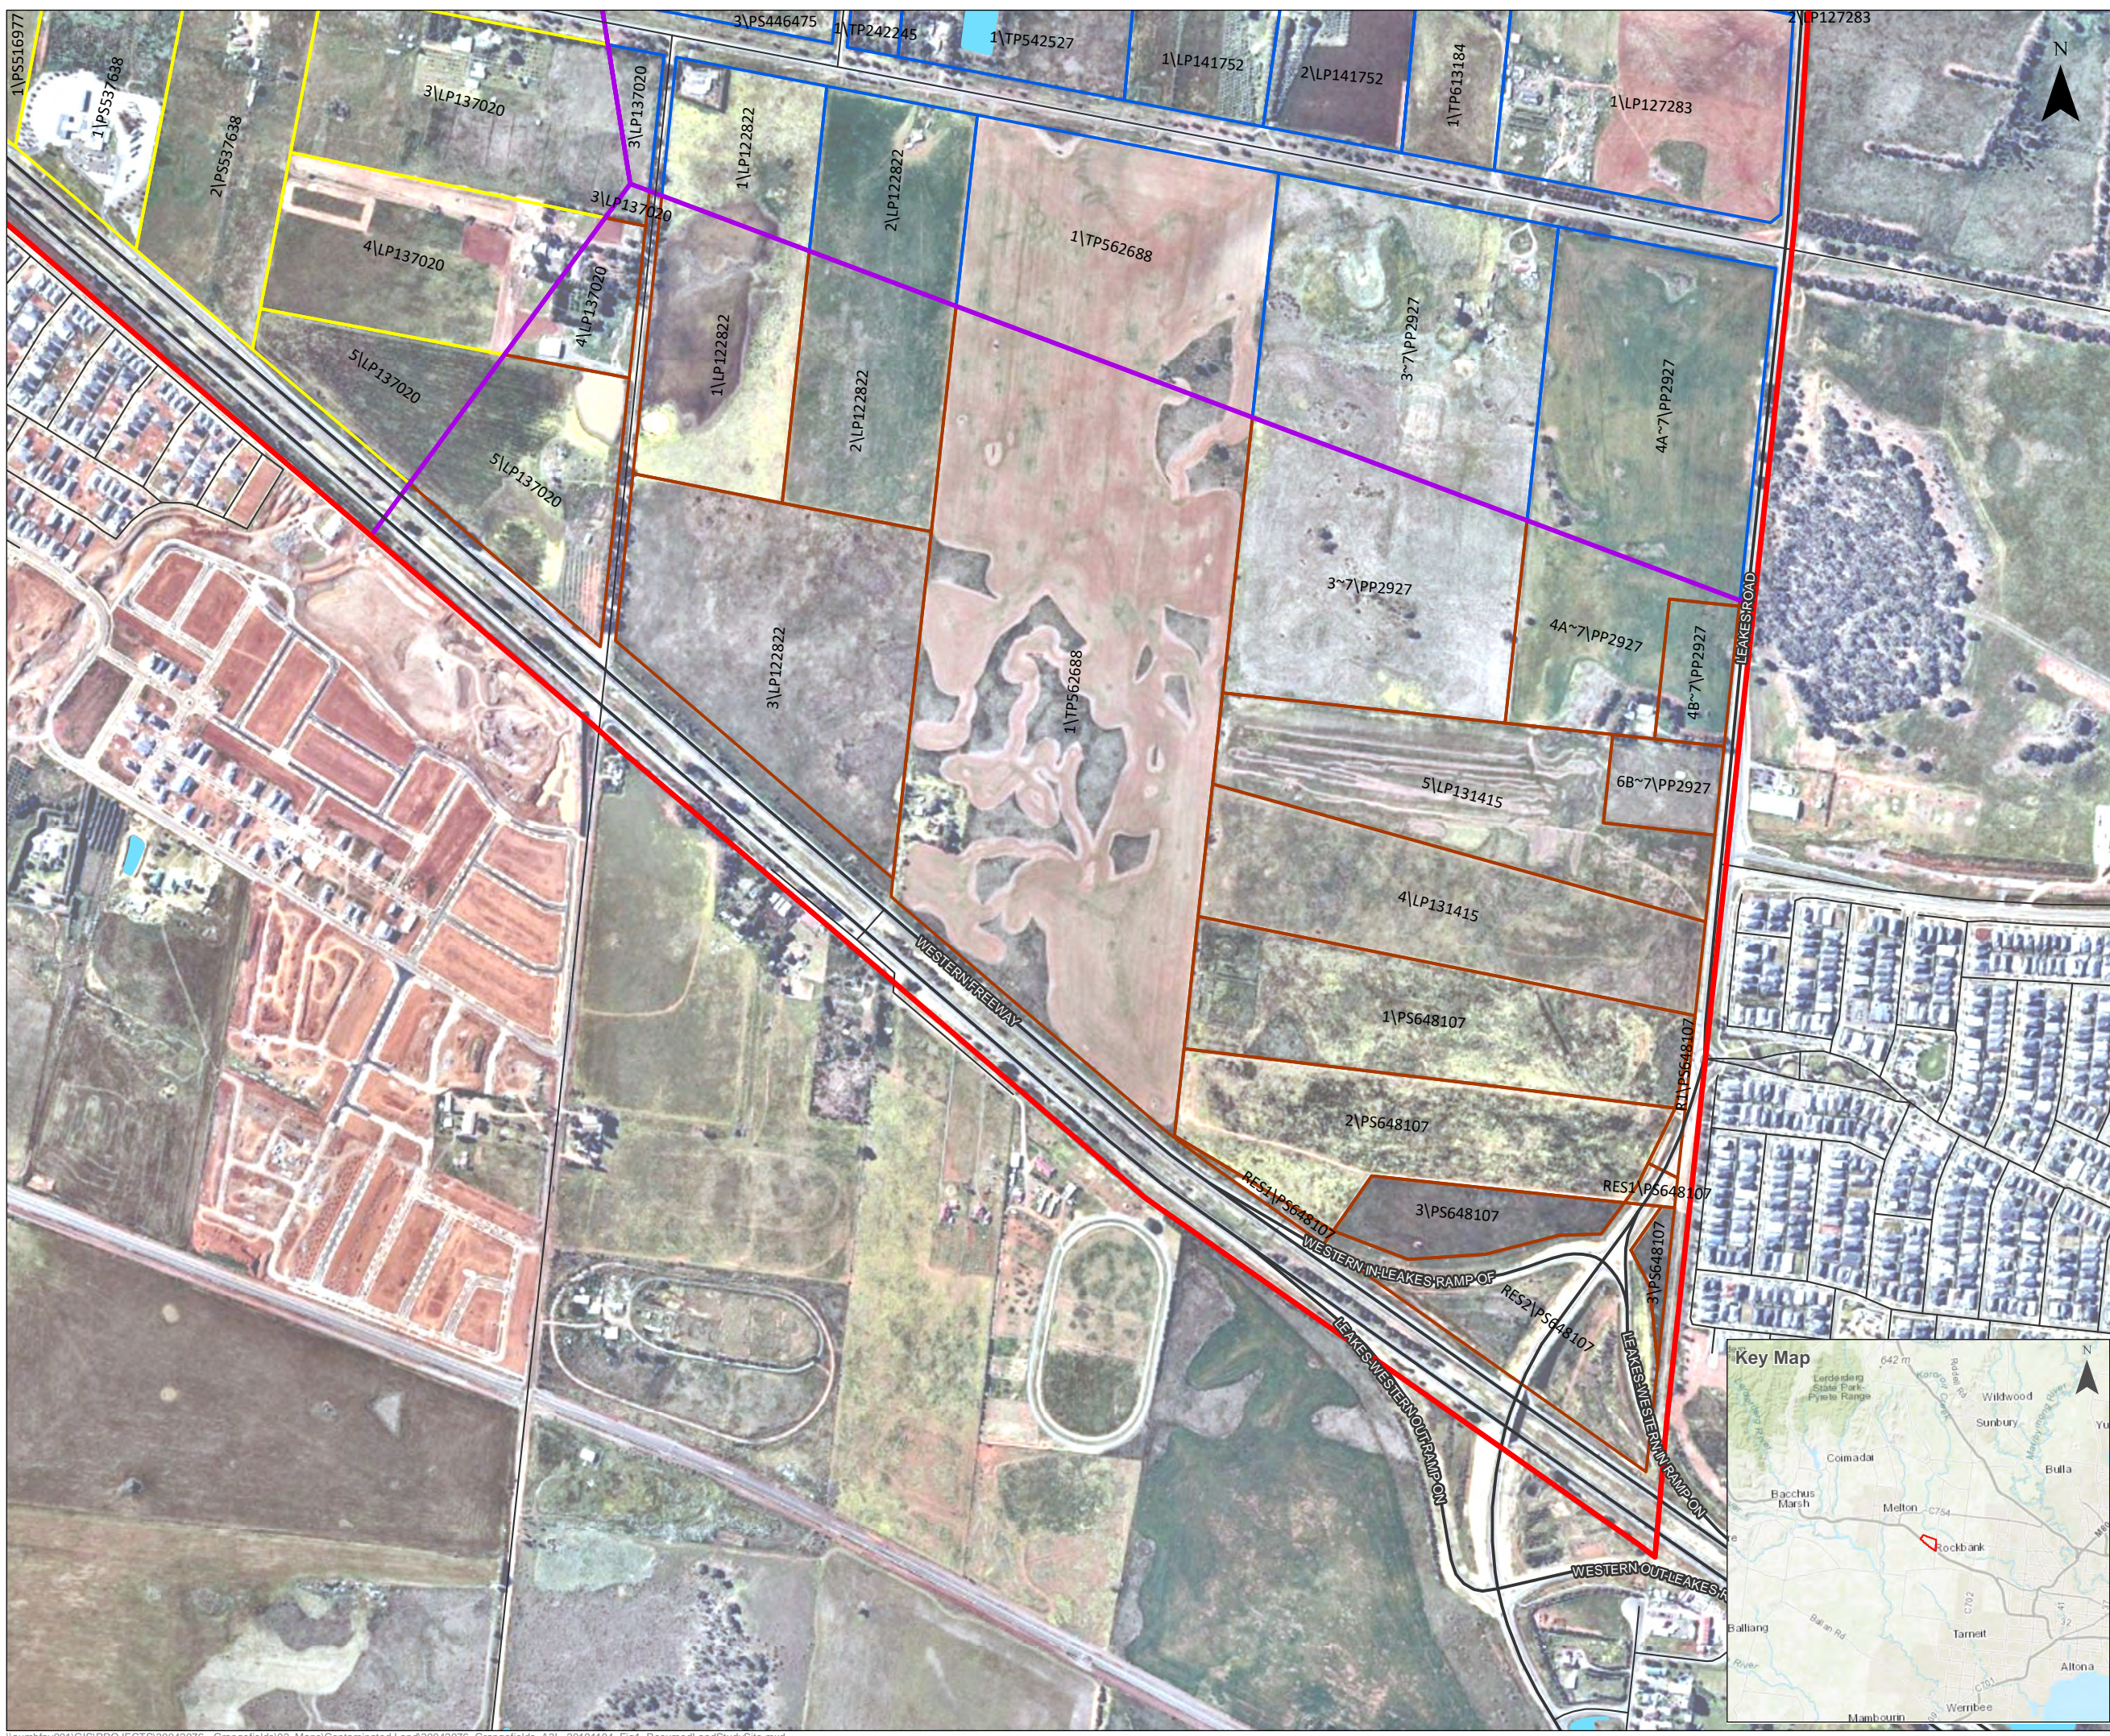
PROJECT: Grangefields
PROJECT NO: 30042076
FIGURE NO: 2
FIGURE TITLE: Level Of Assessment DSE(2005)
CREATED BY: JR14941
DATE: 19/11/2019
VERSION: DRAFT 1
PAGE SIZE: A3

The remainder of the precinct has been indicated to be a low potential for significant contamination, triggering assessment level C requiring "General duty under Section 12(2)(b) and Section 60(1)(a)(iii) of the Planning and Environment Act 1987". It should be noted however that this assessment was a high level review and there is potential for contamination to be present in areas where potential was not identified.
