Land Capability Assessment

Document no: IS419400-0000-NP-RPT-0001
Revision no: 3

Melton East Precinct Structure Plan Area
7 July 2023

Project name: Melton East Precinct Structure Plan Area

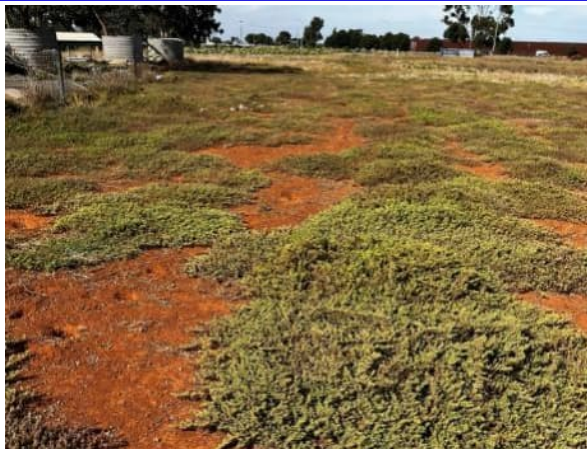
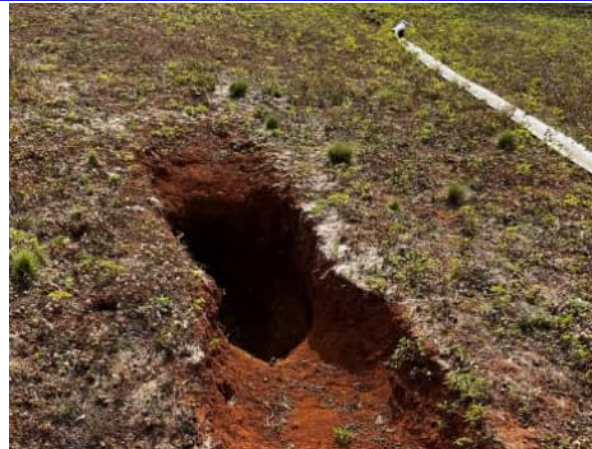
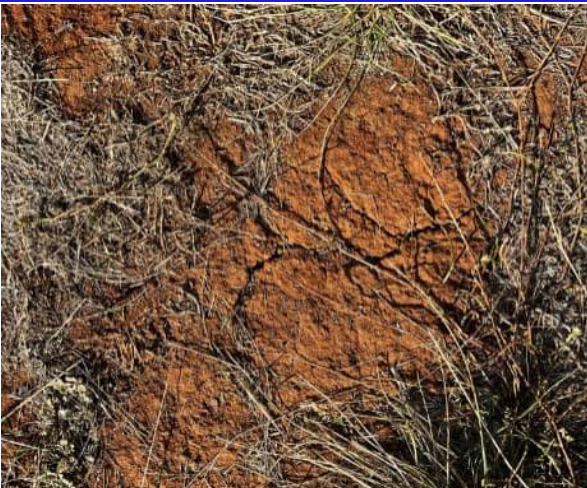
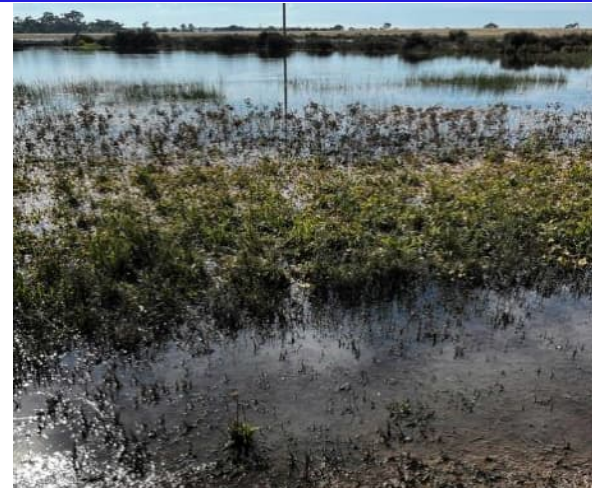
Picture 5-1. Site Inspection – Selective Photographs

A selection of photographs that illustrate common observations relating to land use and surface conditions across the Melton East PSP area. Top Left: Example of hard setting surfaces that form at surface. Top Right: Erosion of soils that has been caused by flow release from pipe. Bottom Left: Cracking of soil surface. Bottom Right: Swamp at 66 Paynes Road.

Picture 5-1 shows selective photos taken of surface conditions whilst completing site inspections in the area. This would appear to be generally consistent with the descriptions of soil characteristics and soil deterioration hazards provided by Jeffrey (1981). No significant areas of erosion were noted during the field inspection. Localised erosion of the subsurface was evident at points where flows have exited from pipes. High water tables and waterlogging was evident at the location of a swamp.

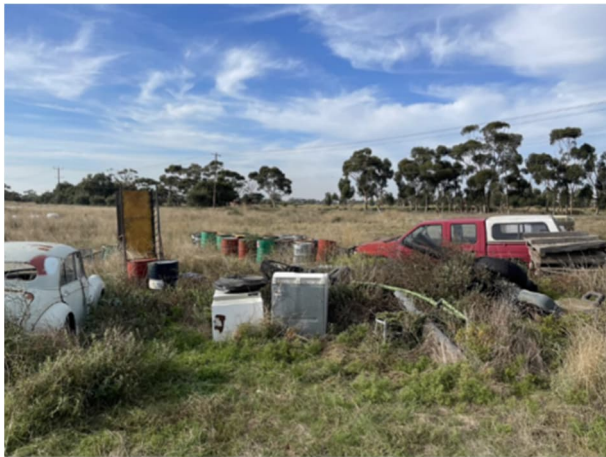
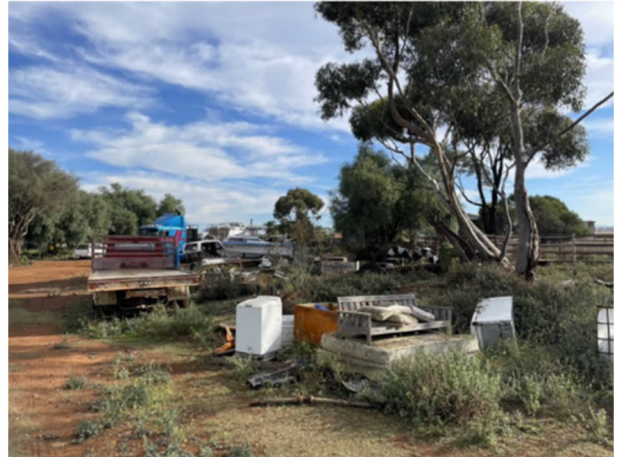
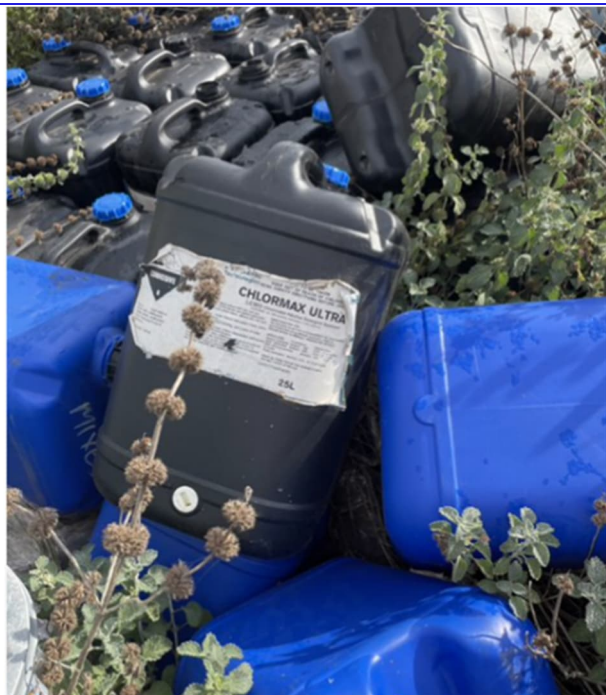
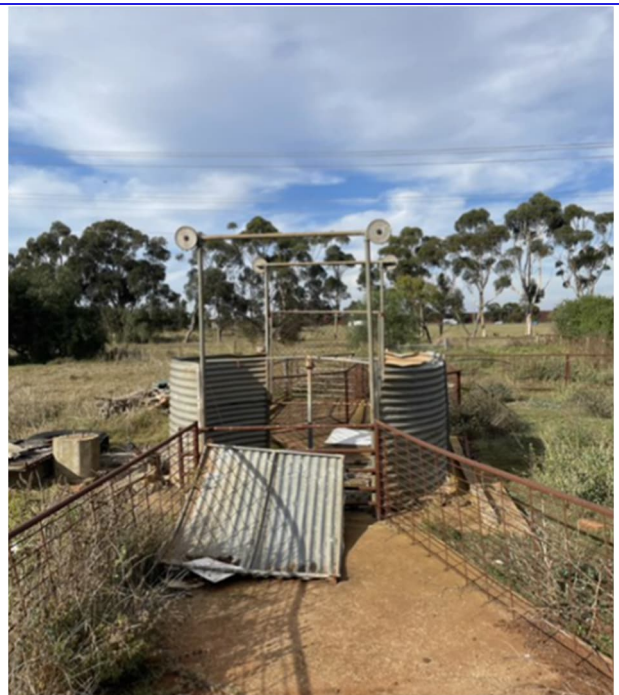
Picture 7-1. Site Inspection – Selective Photographs

A selection of photographs that illustrate common observations relating to land use across the Melton East PSP area. Top left: Example of general surface waste. Top Right: Example of general surface waste. Bottom Right: Drums of empty Chrlormax Ultra (cleaning product) Bottom Left: Sheep spray infrastructure
