VICTORIAN PLANNING AUTHORITY

MAY 2023

SODIC/DISPERSIVE SOILS PEER REVIEW AND ASSESSMENT

MERRIMU PRECINCT

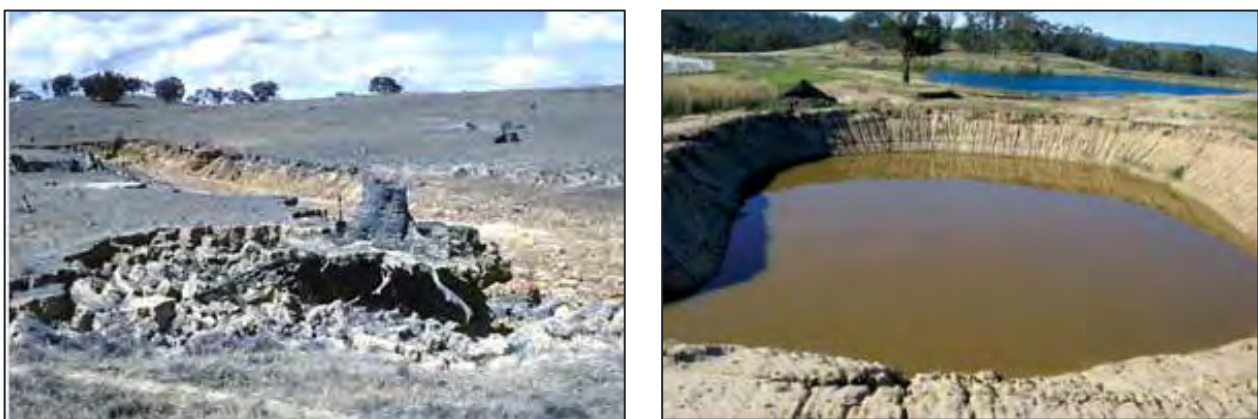
The reason these soils are highly susceptible to erosion is that when a sodic soil encounters non-saline water or rainwater, water molecules are drawn in-between the clay platelets resulting in swelling of the clay and, often, the detachment of clay platelets into the water making the water cloudy in a process called dispersion. Dispersed clay particles are readily suspended in the water and can be transported in the water. Dispersion can lead to the development of tunnel, gully and surface erosion.

Figure 4.1 Tunnel erosion of dispersive clay subsoil, <https://vro.agriculture.vic.gov.au> (accessed 2022) (Left), and construction of dam in dispersive soils leading to rill erosion, <https://nre.tas.gov.au> (accessed 2022) (Right)

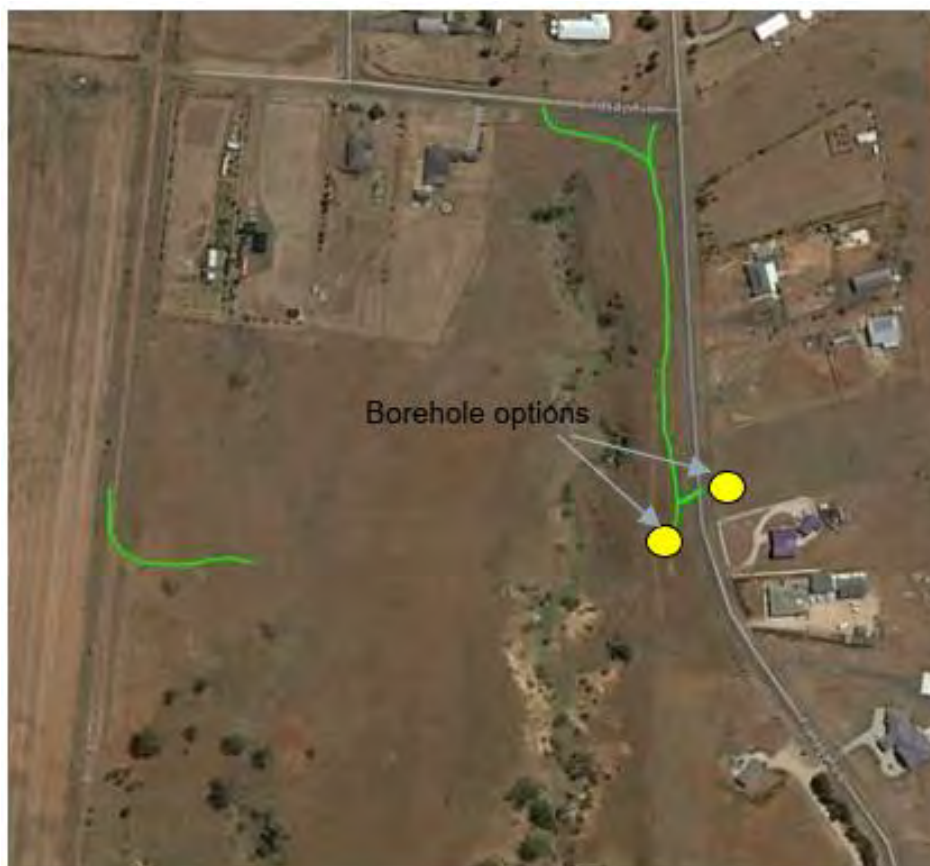
The first location identified with possible tunnel erosion was a deep gully on the “North site” (located just south of the intersection between Lindsay Avenue and Flanagans Drive). The gully was described as comprising Stony Rises basalt at the surface, basalt in the upper profile, and possibly Werribee Formation at depth. At the base of the gully some erosion and slope instability were observed. Coffey (2020b) outlined two possible locations where deep boreholes could be drilled with the intention of establishing the thickness of the basalt overlying the Werribee Formation.

Figure 5.2 North site with the two borehole locations

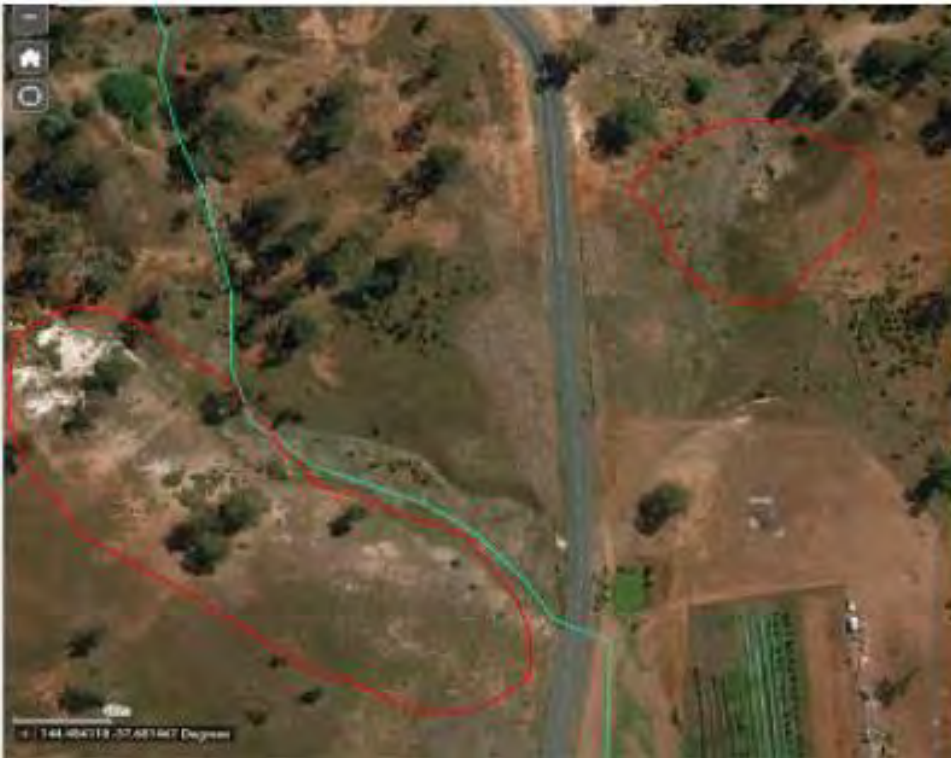
The second location named the “South site” (located along the southern boundary of the Merrimu Precinct) was described as having Werribee Formation in the lower slopes with Newer Volcanics in the upper slopes. Erosion was observed to comprised mostly channel and sheet erosion of varying size and area.

Figure 5.3 South site

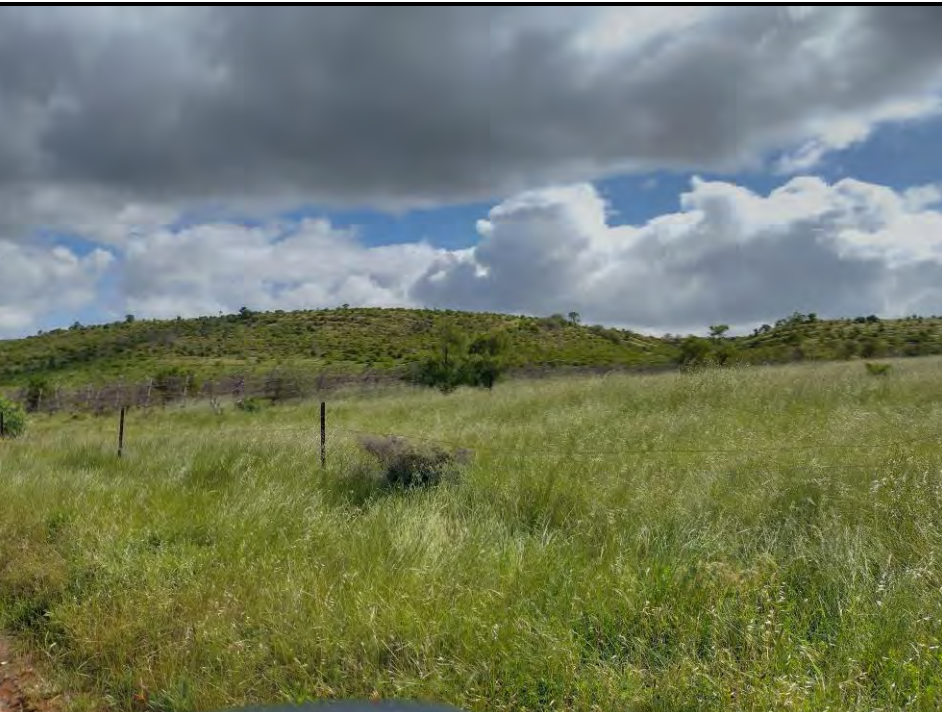
2	15 November 2022	
Description Looking east from Lerderberg Park Road to escarpment in distance. Evidence of major erosion control plantings on escarpment, terracing.

- Thin topsoil with unconsolidated gravel and rock across much of the Precinct,
- Agricultural land and winery in the southwestern and eastern portions of the Precinct. Terracing on slopes was observed (Photo 2),
- Several residential properties were observed along Possumtail Run, with many seemingly not permanently occupied.
- Residential properties were also observed along Flanagans Drive.

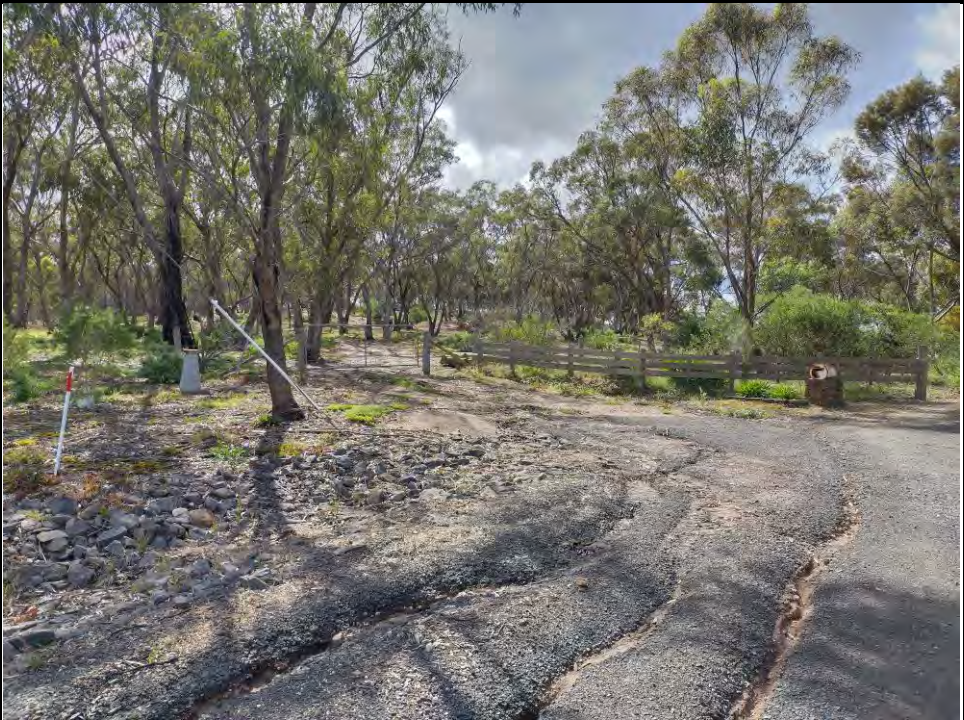
Photo No. 3	Date 15 November 2022

Description Photo taken on Wells Road, showing erodible road treatment and gully erosion in underlying sediments.

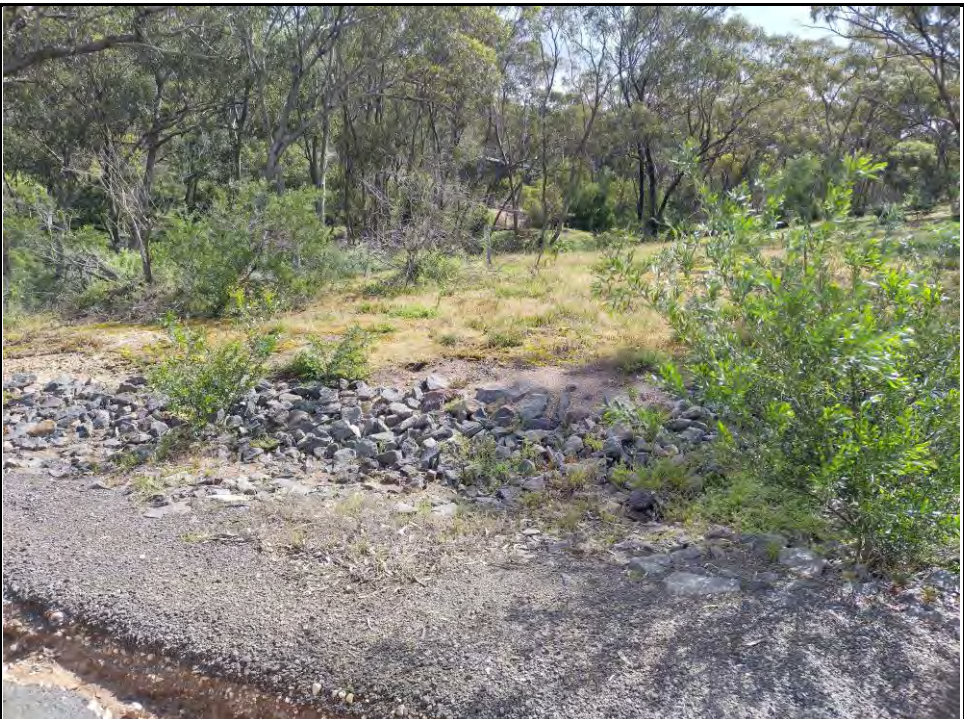
Photo No. 4	Date 15 November 2022

Description Photo taken on Wells Road, showing erodible road treatment and gully erosion in underlying sediments. Rudimentary engineering controls show some success in stabilizing sediments.

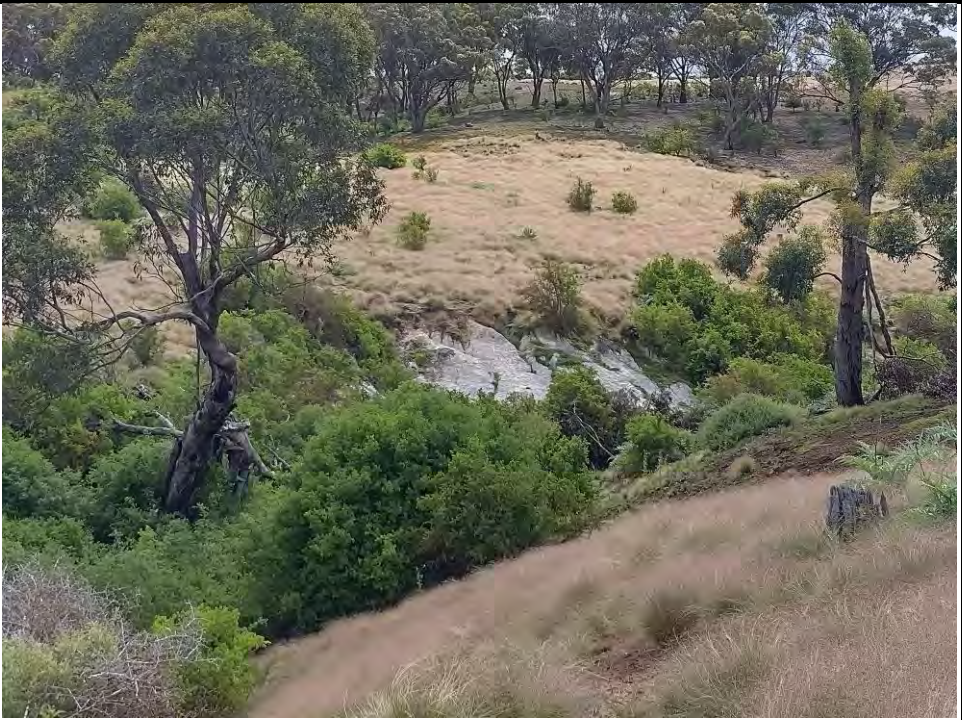
5	15 November 2022	
Description Looking east from the east end of Oconnel Road. Exposed sediments show erosion where vegetation is absent. Further up and down gradient, gully appears stabilized with vegetation (trees, grass, scrub). This area not fenced, stock not excluded, no riparian management visible.

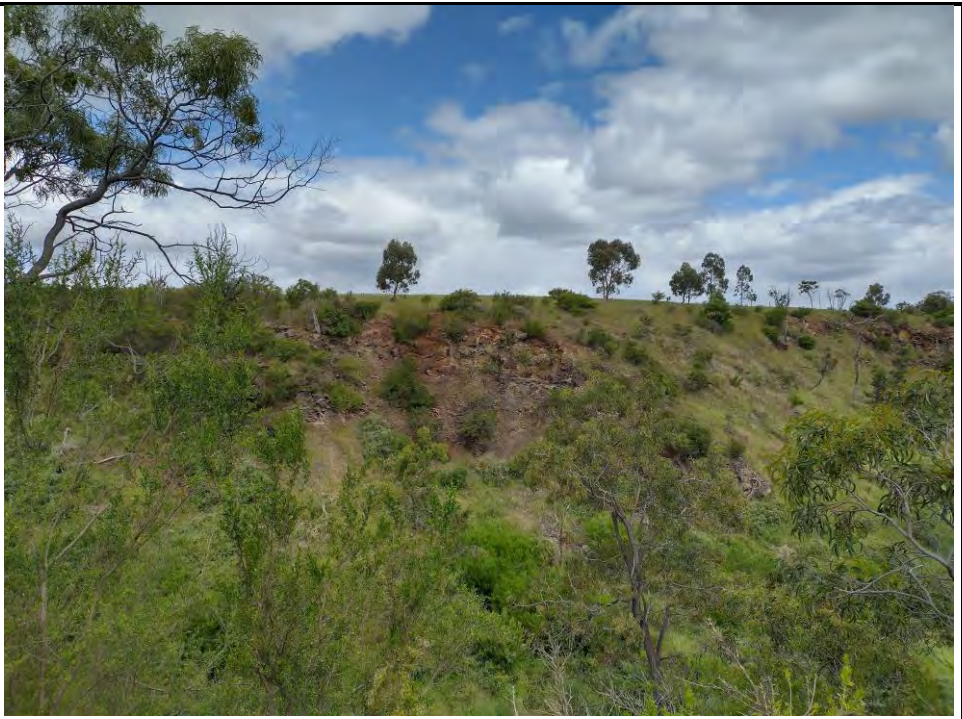
6	15 November 2022	
Description View of gully from driveway east of Possumtail Run. Upper unit interpreted to be Newer Volcanics, lower unit (not exposed) is inferred to be Werribee formation.

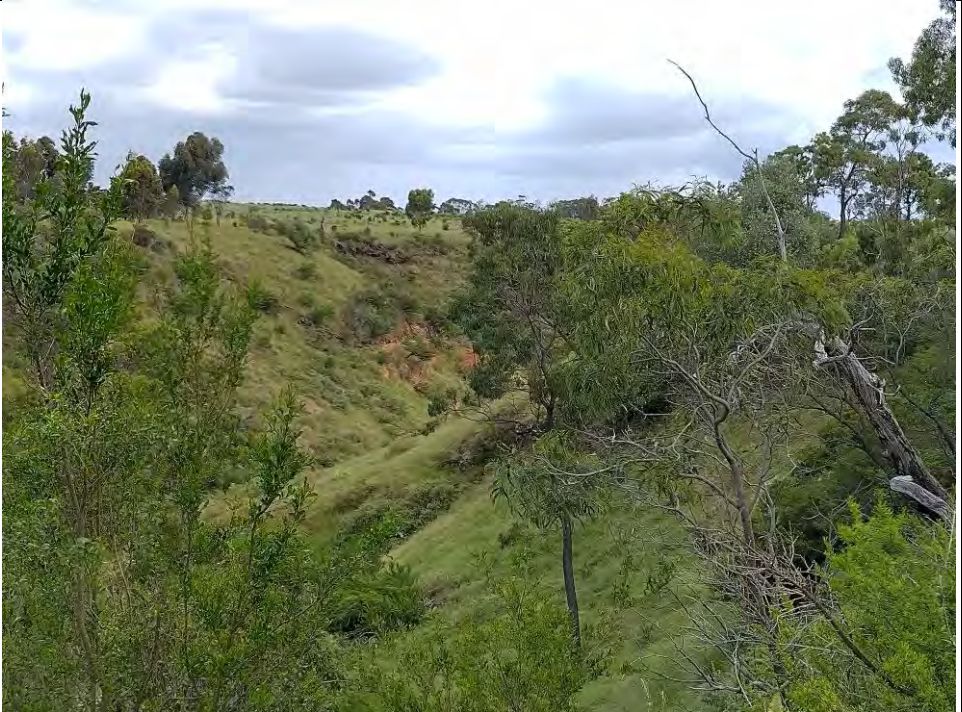
7	15 November 2022	
Description View of same gully from driveway east of Possumtail Run. Upper unit interpreted to be Newer Volcanics, lower unit (exposed) is inferred to be Werribee formation. Highly dispersive zone appears to be close to base of Newer Volcanics, given base of gully is well vegetated.

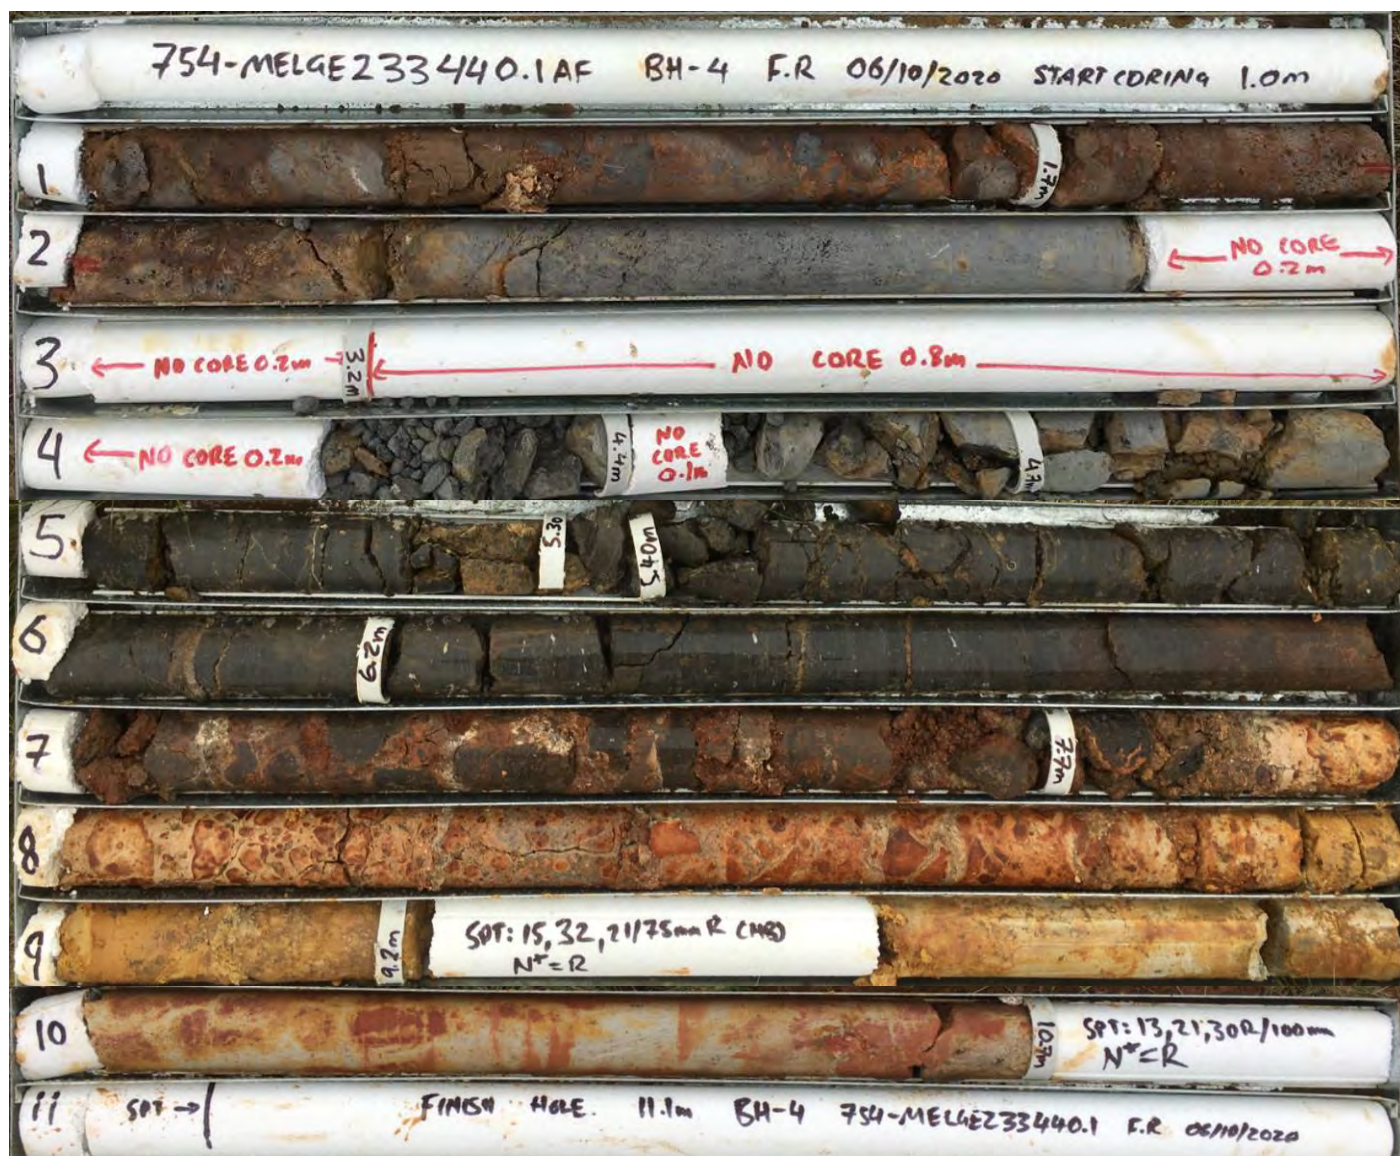
Photograph 10: Erosion feature in gully

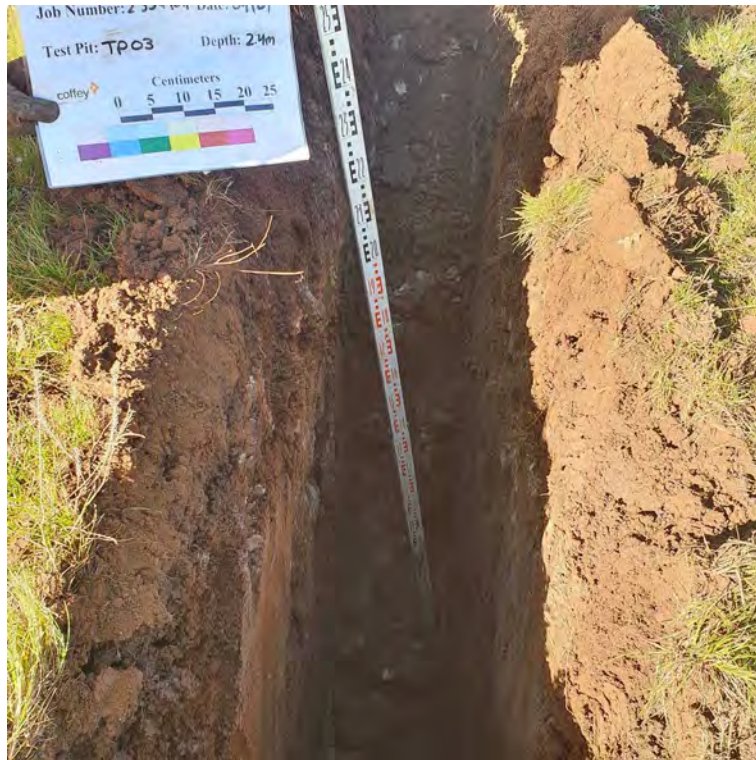
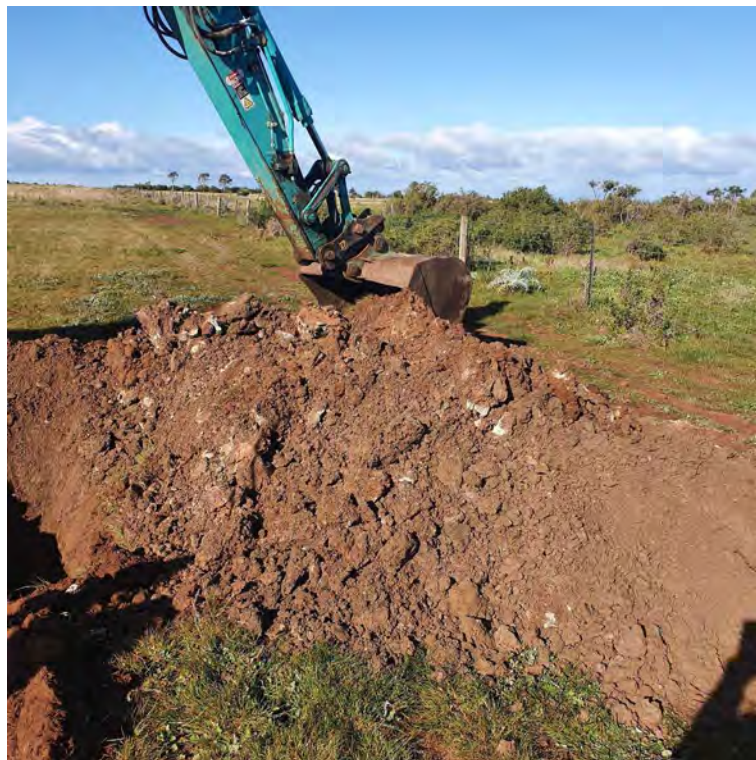
CH	CLAY: high plasticity, dark brown, with fine to coarse graiend sand, trace rootlets, trace calcareous pockets.	M	Fb	100	2	TOPSOIL
									VSt - H		200	4	RESIDUAL SOIL - NEWER VOLCANICS	
		2	Not Encountered	B		1.0			becoming brown-orange, mottled grey			300		6
		3												
						1.5								
						2.5			Test pit TP103 terminated at 2.4 m Target depth					
						3.5

Test pit

Excavated spoils

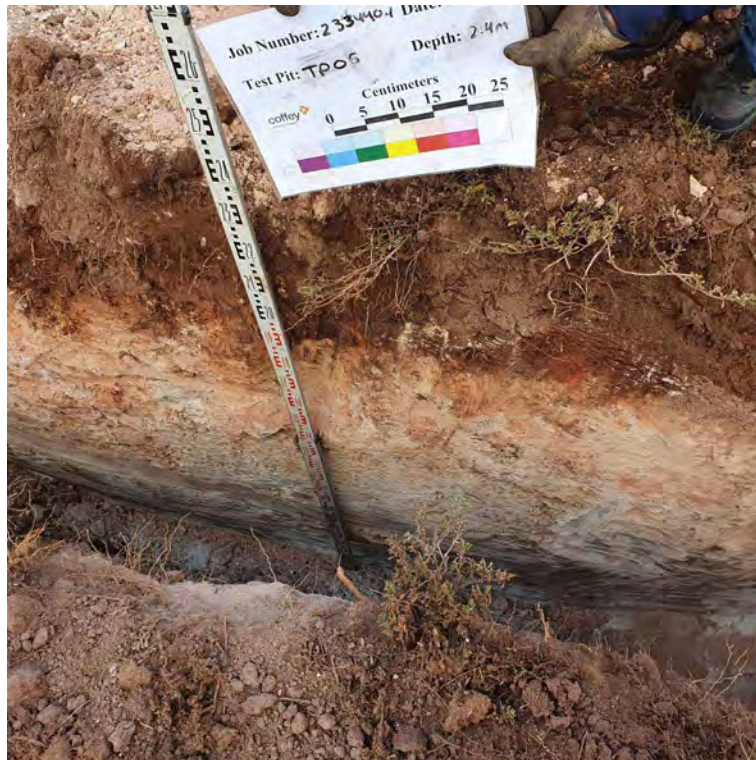
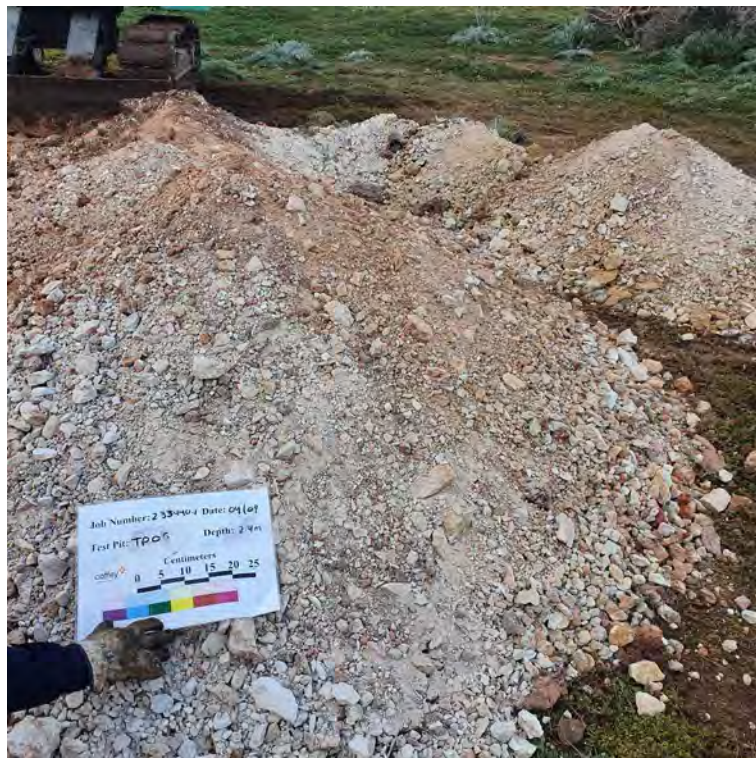
excavation information					material substance									
method	support	penetration	water	samples & field tests	RL (m)	depth (m)	graphic log	soil group symbol	material description	moisture condition	consistency / relative density	hand penetrometer (kPa)	DCP (blows/100 mm)	structure and additional observations
N		1						CH	CLAY: high plasticity, brown-red, trace rootlets.	M	Fb			TOPSOIL
		2						CH	Sandy CLAY: high plasticity, orange, mottled pale grey, fine to coarse grained sand.	D	VSt - H			RESIDUAL SOIL - NEWER VOLCANICS
		3				0.5								calcareous
						1.0		SC	SAND: fine to coarse grained, pale brown and orange brown, mottled pale grey.		VD			R
						1.5								
						2.0								
						2.5			Refusal on weathered rock Test pit TP105 terminated at 2.5 m Refusal					
						3.0								
						3.5

Test pit

Excavated spoil (calcareous soil)

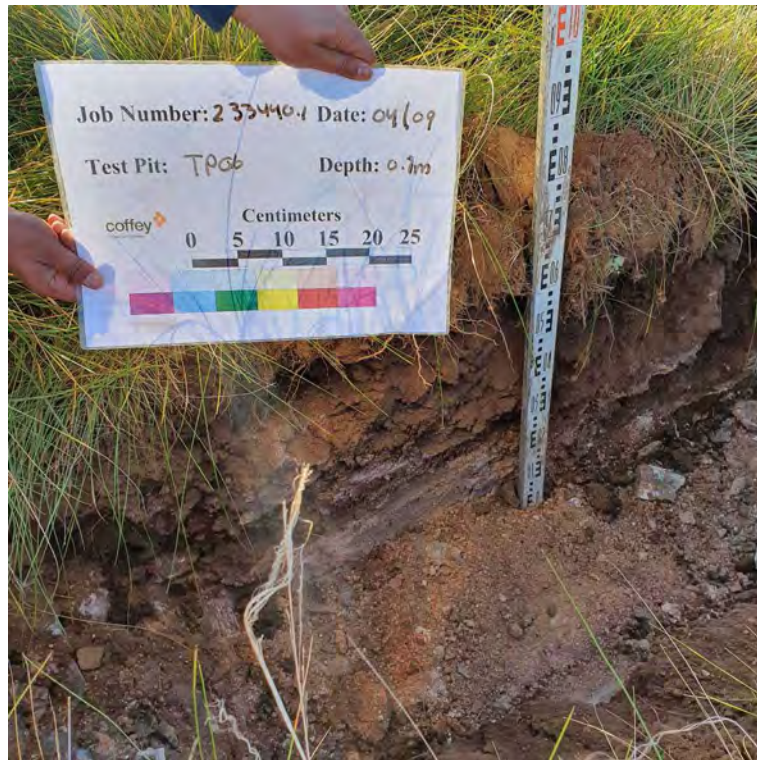
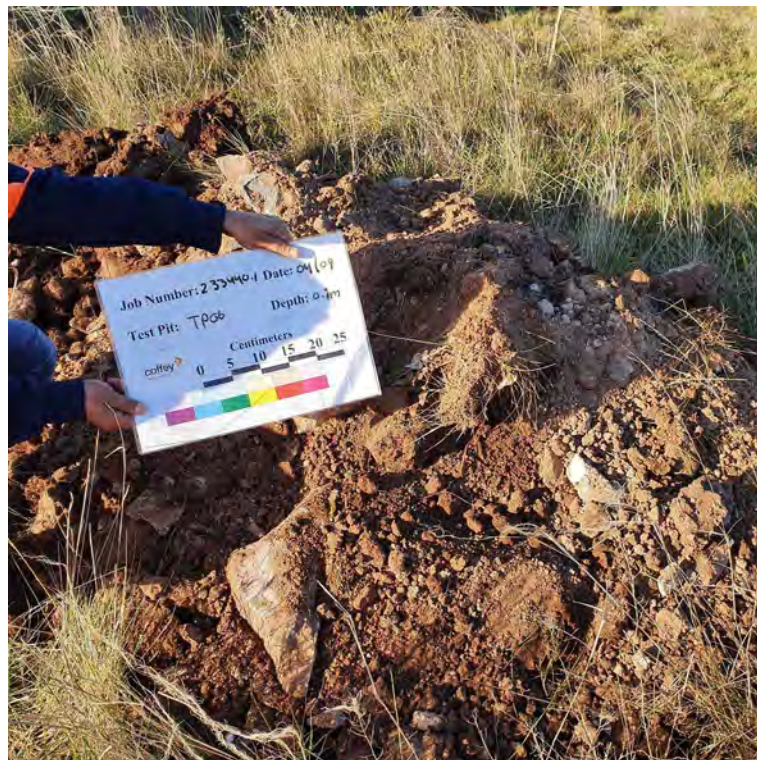
ML CH	TOPSOIL: Clayey SILT: low liquid limit, brown with sand, trace rootlets. CLAY: high plasticity, dark brown,, with fine to coarse grained gravel, trace boulders. becoming pale brown	M	Fb H	100 200 300 400	2 4 6 8 10	TOPSOIL boulder found between 0.0m-0.7m RESIDUAL SOIL - NEWER VOLCANICS R
						1.0			Refusal on weathered rock / boulders Test pit TP106 terminated at 0.8 m Refusal					
						1.5								
						2.0								
						2.5								
						3.0								
						3.5

Test pit

Excavated spoil

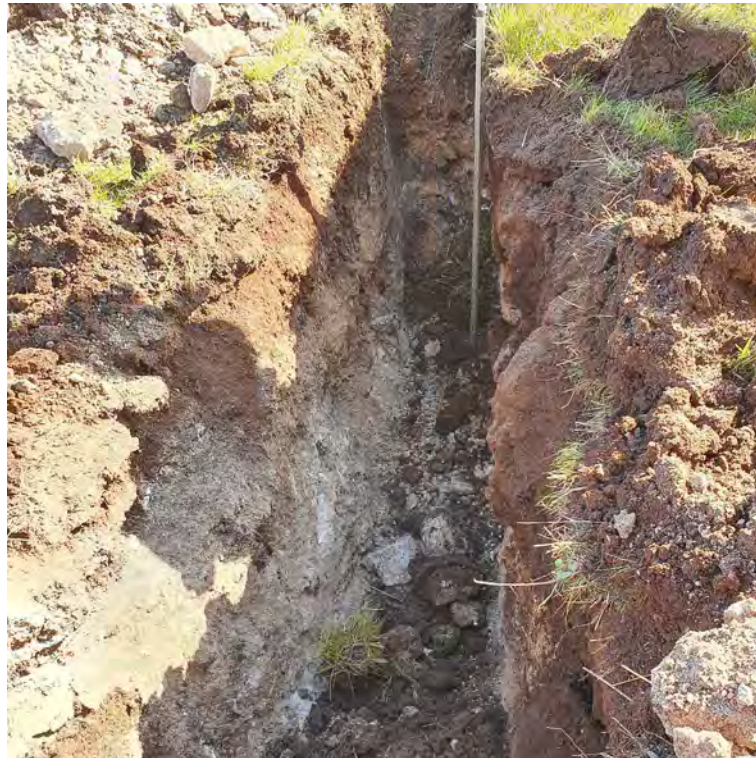
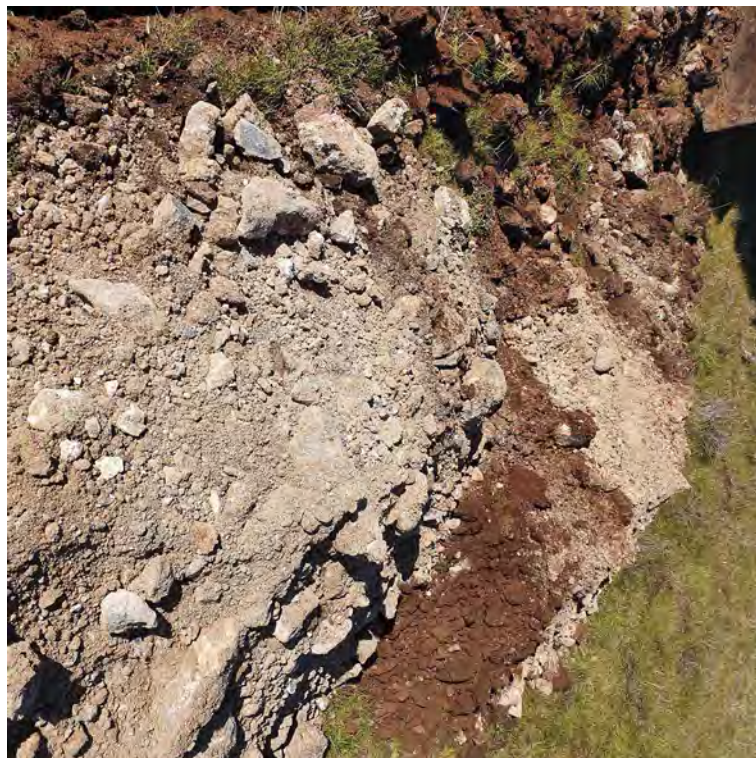
excavation information						material substance								
method	support	penetration	water	samples & field tests	RL (m)	depth (m)	graphic log	soil group symbol	material description	moisture condition	consistency / relative density	hand penetrometer (kPa)	DCP (blows/ 100 mm)	structure and additional observations
↑ N ↓ E	1 2 3		Not Encountered	D		0.5		ML	TOPSOIL: Clayey SILT: low liquid limit, brown with sand, trace rootlets. CLAY: high plasticity, dark brown, mottled dark grey, trace rootlets. becoming pale brown-pale grey, mottled cream, with fine to coarse grained sand and fine to medium grained gravel	M	Fb			TOPSOIL
						1.0	CH	RESIDUAL SOIL - NEWER VOLCANICS						
						1.5		Refusal on weathered rock / boulder Test pit TP107 terminated at 1.4 m Refusal						
						2.0								
						2.5								
						3.0								
						3.5

Test pit

Excavated spoil

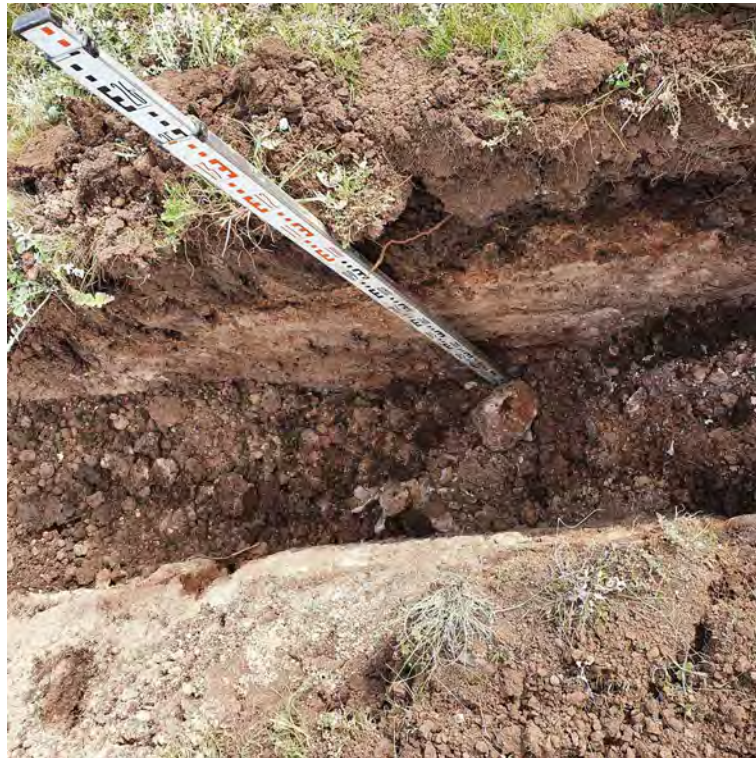
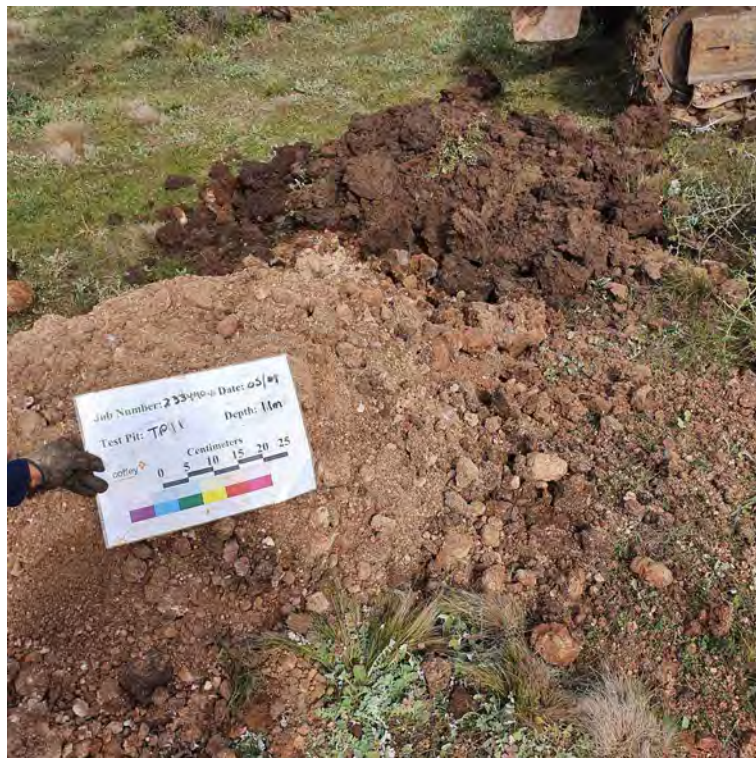
CH	CLAY: high plasticity, dark grey-dark brown, trace fine grained sand, trace rootlets.	D	VSt - H	100 200 300 400	2 4 6 8 10	TOPSOIL
						0.5	CH	CLAY: high plasticity, pale brown-orange, mottled grey-red, with fine to coarse grained sand, trace fine to coarse grained gravel and boulder.	D				R calcareous	
						1.0								
						1.5			Refusal on weathered rock Test pit TP111 terminated at 1.1 m Refusal					
						2.0								
						2.5								
						3.0								
						3.5

Test pit

Excavated spoil

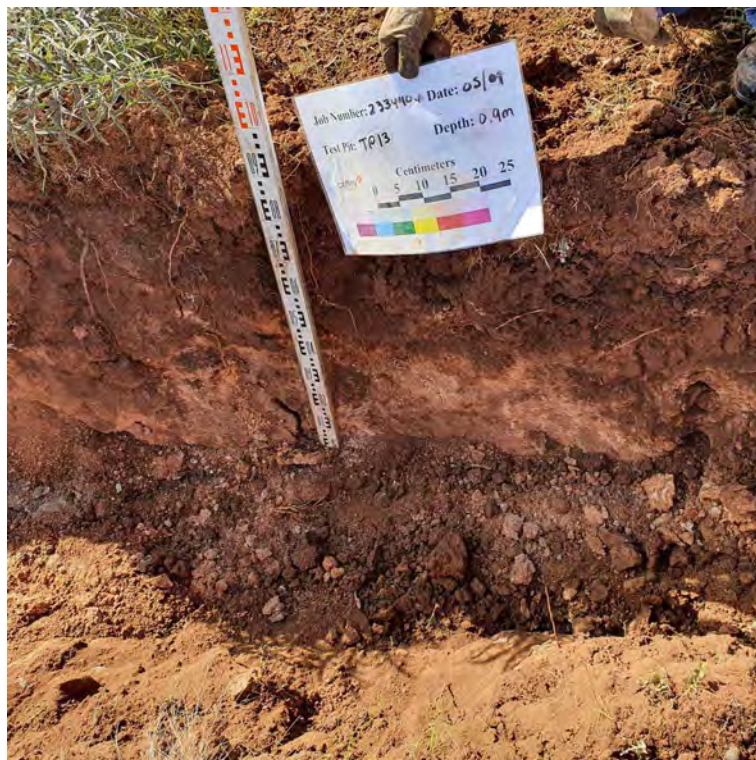
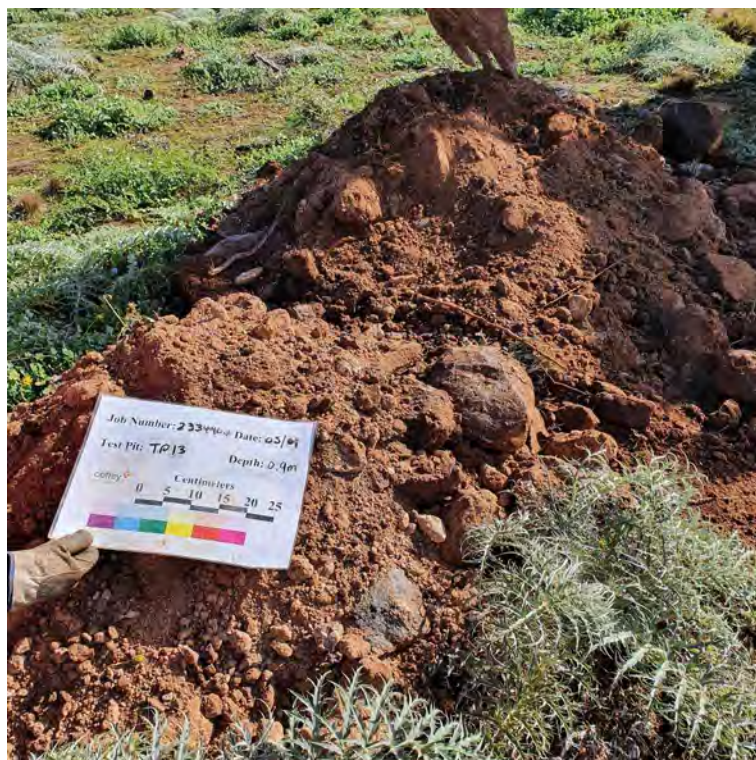
CH	CLAY: high plasticity, brown, trace fine grained sand, trace rootlets.	D	VSt - H	100 200 300 400	2 4 6 8 10	TOPSOIL
		CH						CLAY: high plasticity, yellow brown, mottled grey, with fine to coarse grained gravel, trace fine to coarse grained sand, calcareous mottling.						RESIDUAL SOIL - NEWER VOLCANICS
												1.0		Refusal on weathered rock Test pit TP113 terminated at 0.9 m Refusal
						1.5								
						2.0								
						2.5								
						3.0								
						3.5

Test pit

Excavated spoil

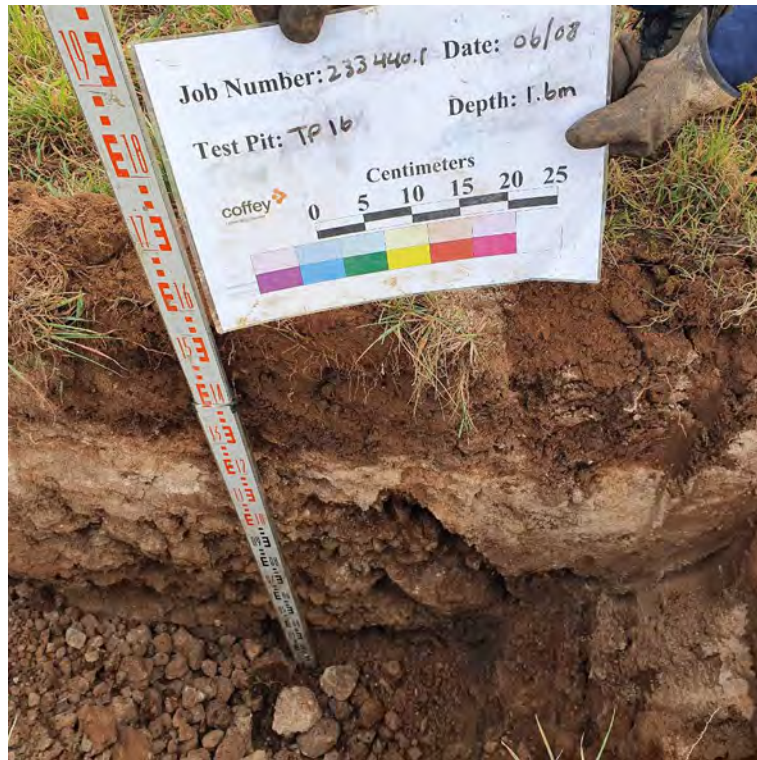
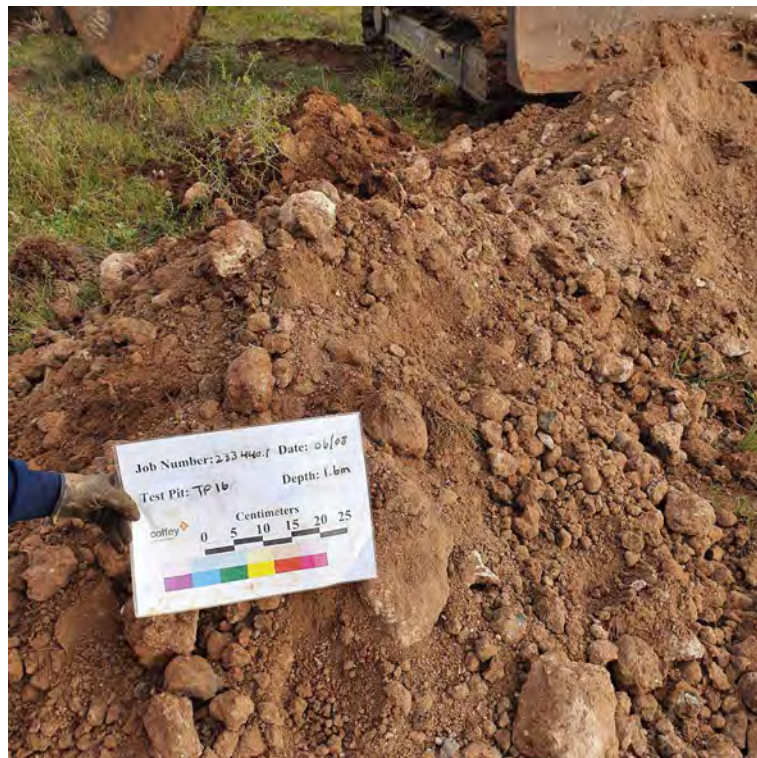
excavation information					material substance									
method	support	penetration	water	samples & field tests	RL (m)	depth (m)	graphic log	soil group symbol	material description	moisture condition	consistency / relative density	hand penetrometer (kPa)	DCP (blows/100 mm)	structure and additional observations
N		1						CH	CLAY: high plasticity, dark brown, with fine to coarse grained gravel, trace rootlets.	M	Fb			TOPSOIL
		2									H			RESIDUAL SOIL - NEWER VOLCANICS
		3				0.5		GC	CLAYEY GRAVEL: fine to coarse grained, pale brown, pale grey, mottled dark grey, calcareous.	D	VD			R
						1.0			with boulders					encountered big boulders, grey-dark grey mottled white
						1.5								
						2.0			Refusal on weathered rock Test pit TP116 terminated at 1.8 m Refusal					
						2.5								
						3.0								
						3.5

Excavated spoil

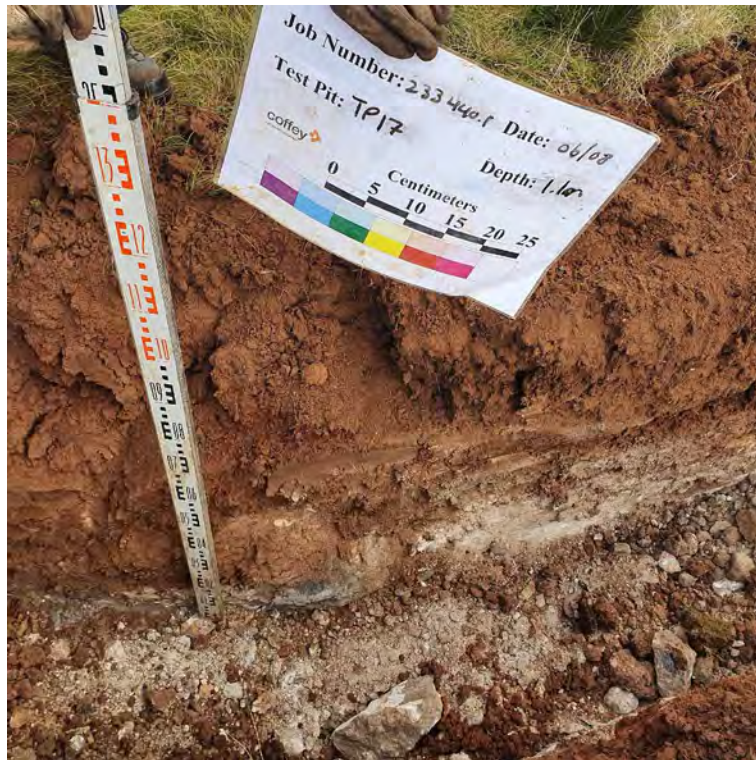
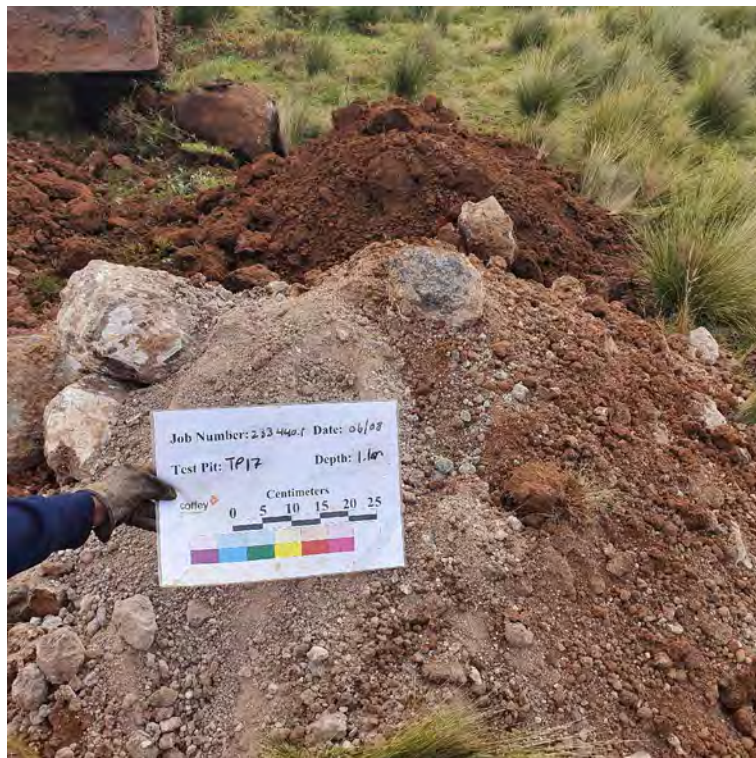
1.5									
						2.0			Refusal on weathered rock Test pit TP117 terminated at 1.1 m Refusal					
						2.5								
						3.0								
						3.5

Test pit

Excavated spoil

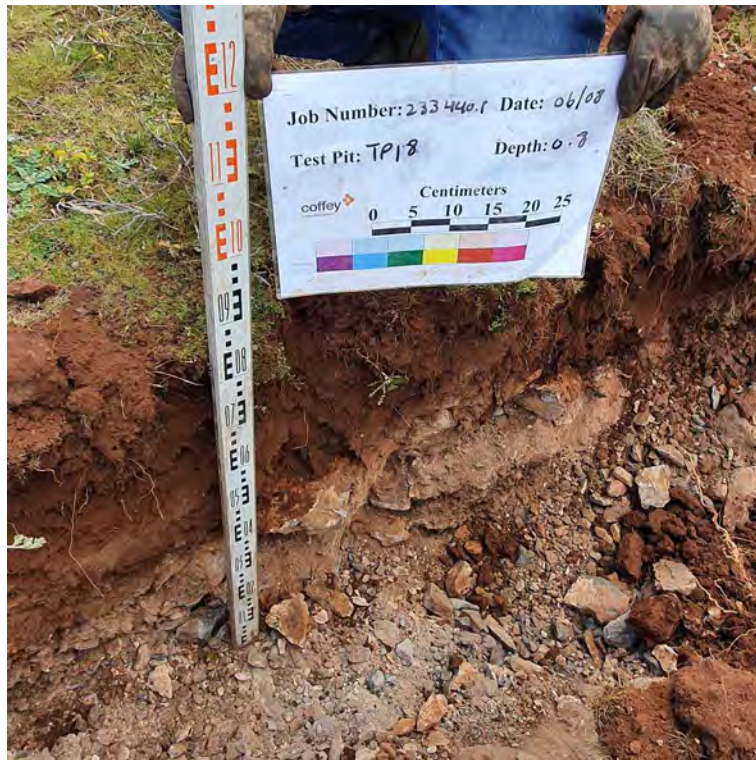
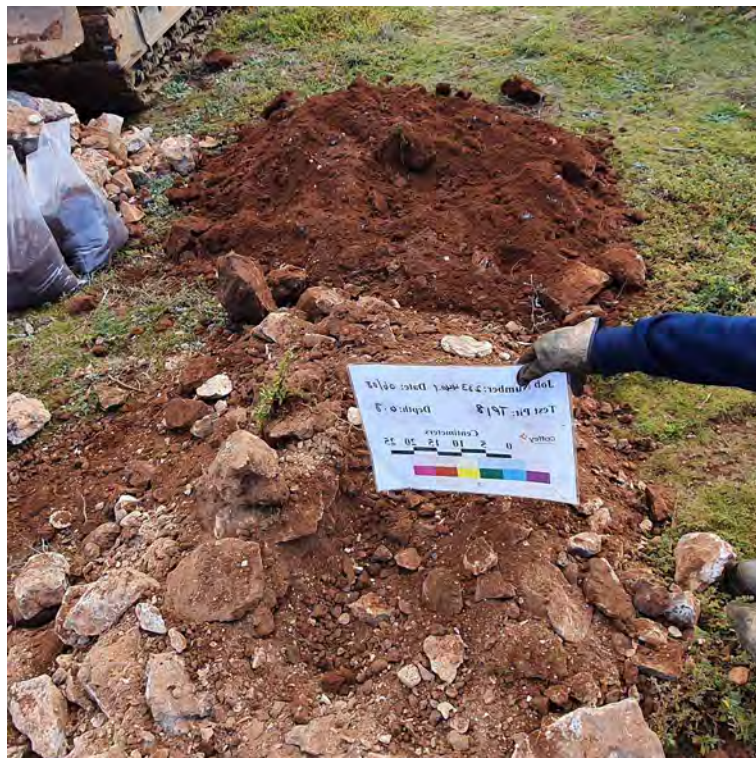
excavation information					material substance									
method	support	penetration	water	samples & field tests	RL (m)	depth (m)	graphic log	soil group symbol	material description	moisture condition	consistency / relative density	hand penetrometer (kPa)	DCP (blows/100 mm)	structure and additional observations
N		1		B				CH	CLAY: high plasticity, dark brown-red brown, trace rootlets.	M	H			TOPSOIL
		2				0.5			CLAYEY GRAVEL: fine to coarse grained, grey, mottled white, high plasticity clay, calcareous.	D	VD			RESIDUAL SOIL - NEWER VOLCANICS
		3				1.0			Refusal on weathered rock Test pit TP118 terminated at 0.8 m Refusal					EXTREMELY WEATHERED BASALT R
						1.5								
						2.0								
						2.5								
						3.0								
						3.5

Test pit

Excavated spoil

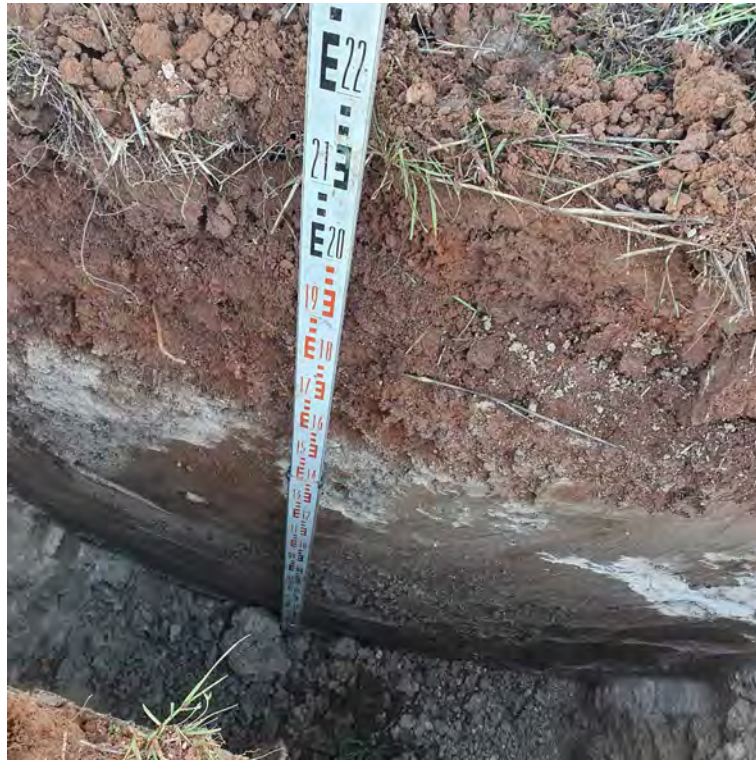
RESIDUAL SOIL - NEWER VOLCANICS		
		H												
		2				1.0			becoming pale grey-yellow brown, mottled orange					
		3		D		1.5								
						2.0								
						2.5			Test pit TP120 terminated at 2.1 m Target depth					
						3.0								
						3.5

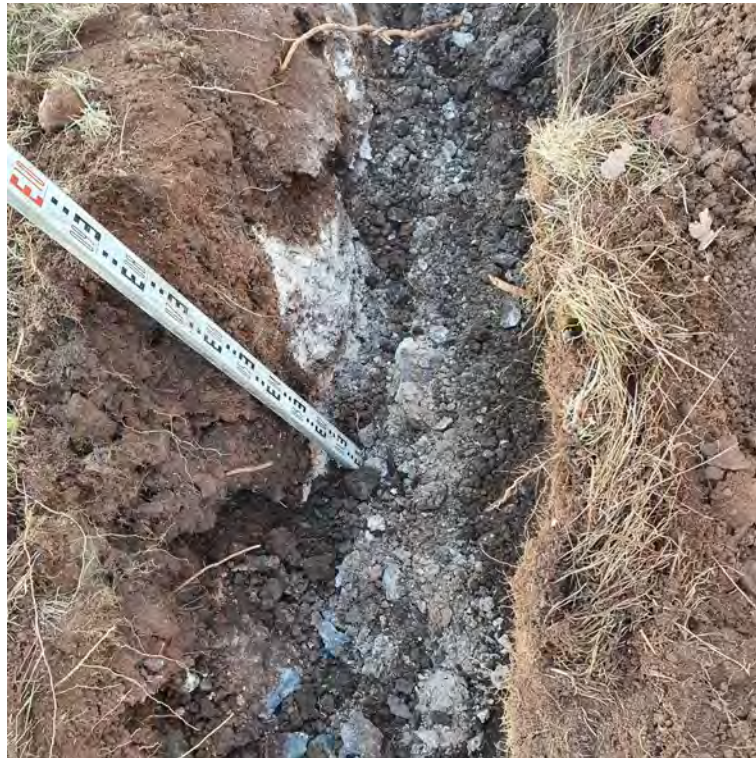
excavation information					material substance									
method	support	penetration	water	samples & field tests	RL (m)	depth (m)	graphic log	soil group symbol	material description	moisture condition	consistency / relative density	hand penetrometer (kPa)	DCP (blows/100 mm)	structure and additional observations
N		1				0.5		CH	CLAY: high plasticity, dark brown, trace rootlets.	M	Fb			TOPSOIL
		2							encountered big boulders, pale grey-white	D	H			RESIDUAL SOIL - NEWER VOLCANICS
		3				1.0			Refusal on weathered rock Test pit TP121 terminated at 0.8 m Refusal					R
						1.5								
						2.0								
						2.5								
						3.0								
						3.5

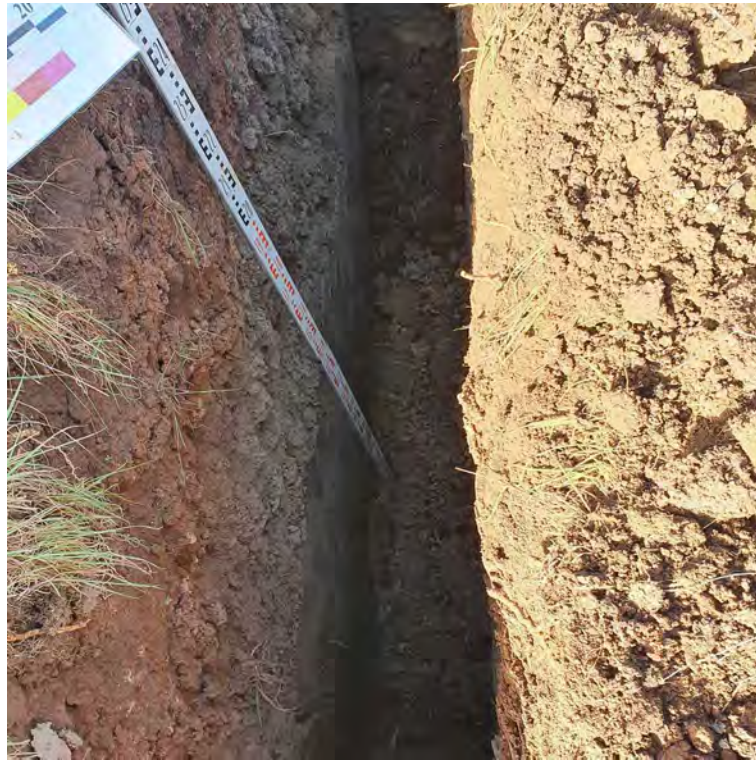
excavation information					material substance									
method	support	penetration	water	samples & field tests	RL (m)	depth (m)	graphic log	soil group symbol	material description	moisture condition	consistency / relative density	hand penetrometer (kPa)	DCP (blows / 100 mm)	structure and additional observations
N		1						CH	CLAY: high plasticity, dark brown-red brown, trace rootlets.	M	F - St			TOPSOIL
		2				0.5			becoming brown-red brown		H			RESIDUAL SOIL - NEWER VOLCANICS
		3				1.0		CH	CLAY: high plasticity, grey, mottled orange.					
				B		1.5								
						2.0								
						2.5								
						3.0			Refusal on weathered rock Test pit TP125 terminated at 2.6 m Refusal					
						3.5
