Desktop Land Capability Assessment

## Shepparton South East Precinct Structure Plan

Reference No. 30042612

Prepared for Greater Shepparton City Council

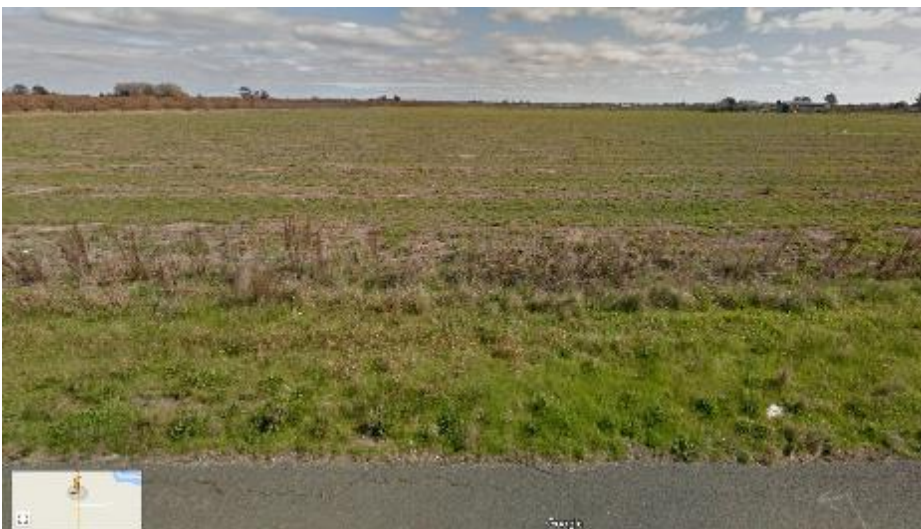
Figure 5-3: Typical topography for the site, looking west from Doyles Road

Figure 5-3 shows the typical topography of the farmland west of Doyles Road.
