#### **Parcel 4 – 220 Wangoom Road, Warrnambool**

Strata Geoscience and Environmental Pty Ltd was commissioned to perform a limited scope desktop geotechnical investigation to help inform the Precinct Development Plan (PCP) for an area broadly bounded by Wangoom Road, Dales Road, Aberline Road and the properties at 53 and 75 Rodgers Road. The majority of the precinct is included in the Farming Zone, aside from a small portion included in the Public Use Zone 1, associated with water storage basins. A Bushfire Management Overlay affects an area central to the site, associated with Tozer Reserve.

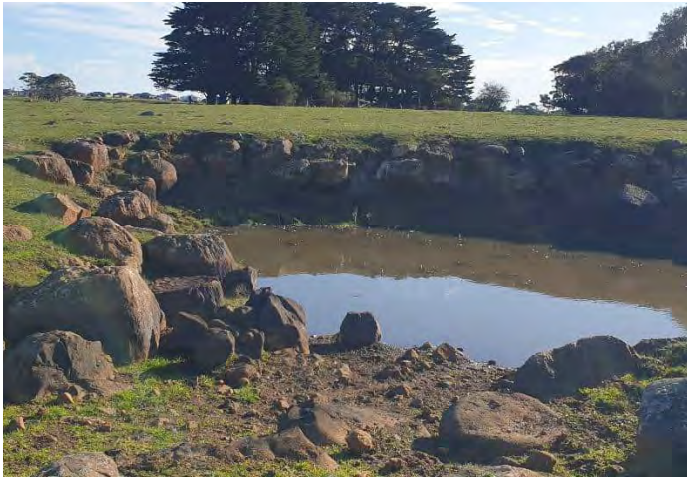
Photograph 6: View of the dam near the eastern boundary of site. The dam is cut into the side of a slope and its walls are primarily basaltic.

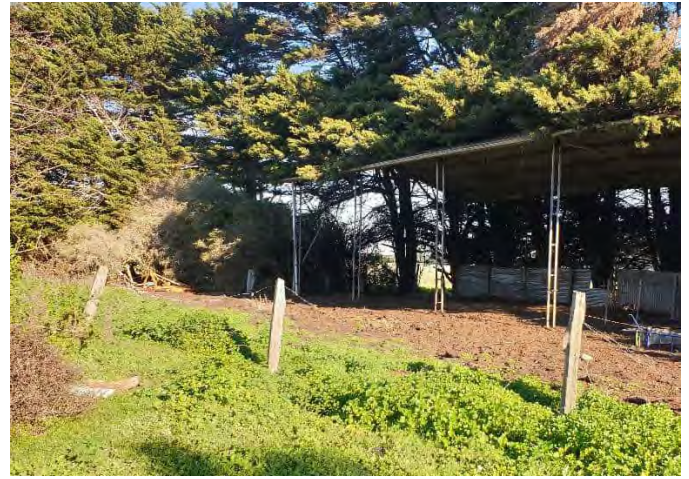
Photograph 7: View of the hay shed in the centre/northern portion of site. Some discarded metals/farming equipment can be seen in the left of image.

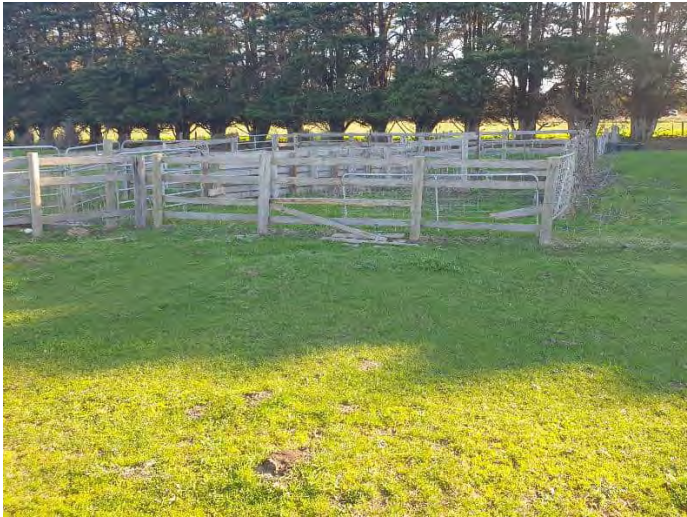
Photograph 8: View of the stockyards near the north western border of site.

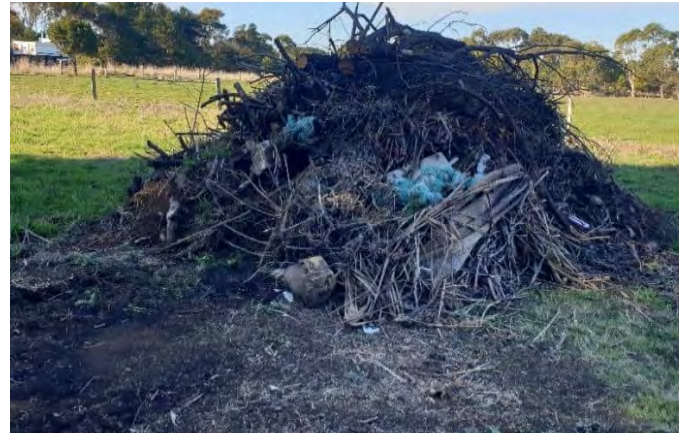
Photograph 9: View of the burn off pile in the north western border of site. The pile comprises mostly organics (wood cuttings, dry reeds), but also contains hard wastes (twine, metals, potential asbestos containing materials)

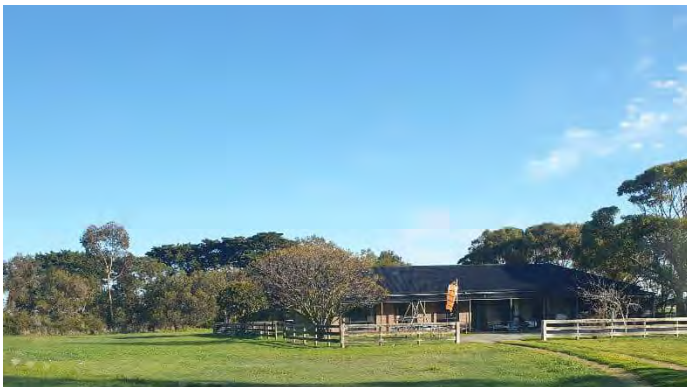
Photograph 10: View of the residence onsite. The site is mostly flat and borders with trees along boundaries.

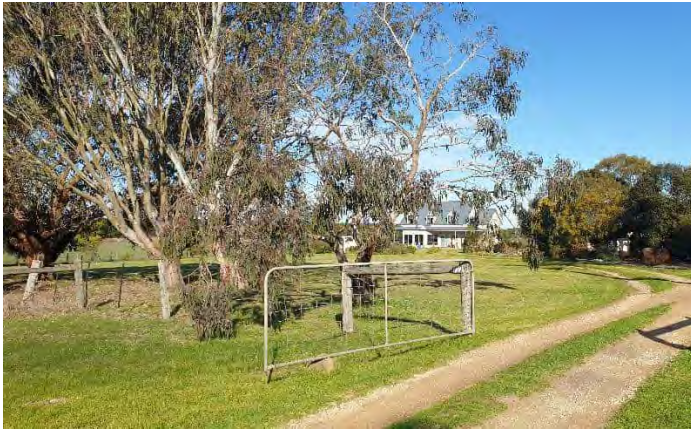
Photograph 12: View of the front of the site. The site is mostly flat with maintained grass and trees along the frontage.

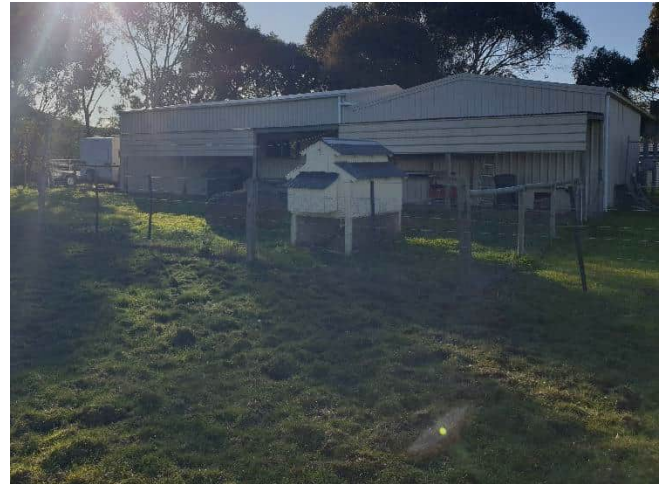
Photograph 13: View of the southwestern portion of site. A large shed and chicken coup are visible. Some drainage pipes can be seen that lead to an above ground water tank to the right of image.

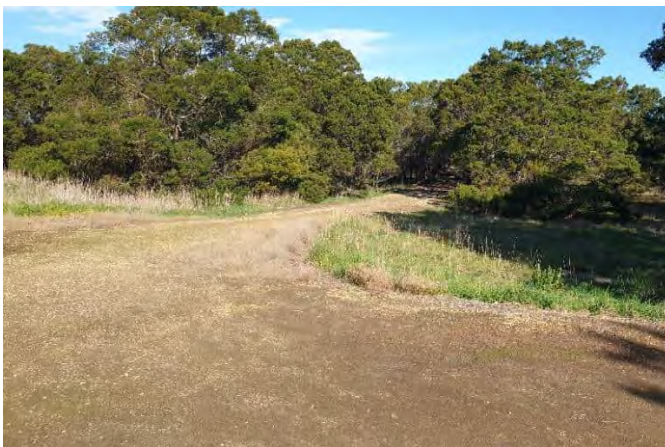
Photograph 14: View of Francis Tozer Reserve. The site contains mostly undisturbed native vegetation with a hardstand track through the site.

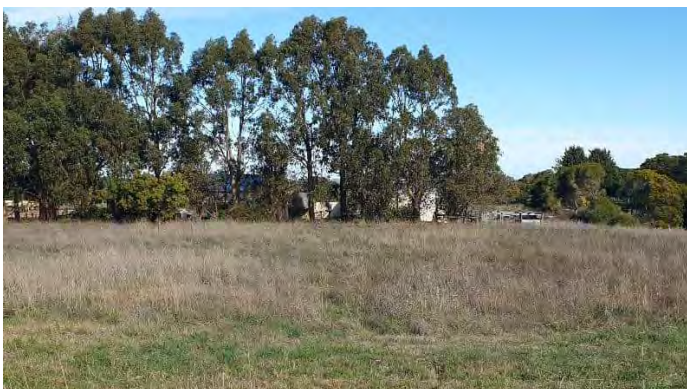
Photograph 15: View facing south of the front of site. A stockyard can be seen in the right of image, and the site office/sheds for the earthworks onsite can be seen behind the tree line.

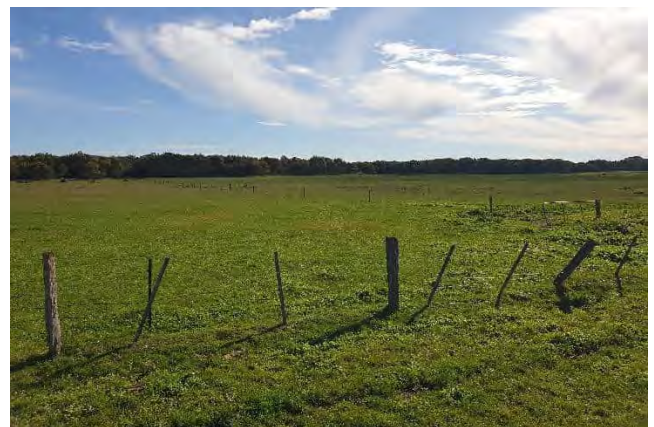
Photograph 16: View facing west of the centre portion of site. The site is mostly flat, sloping down towards the south.

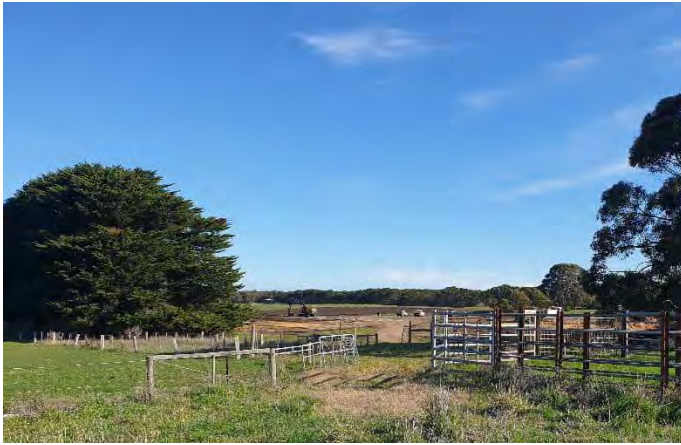
Photograph 17: View of the earthworks in the northern portion of site.

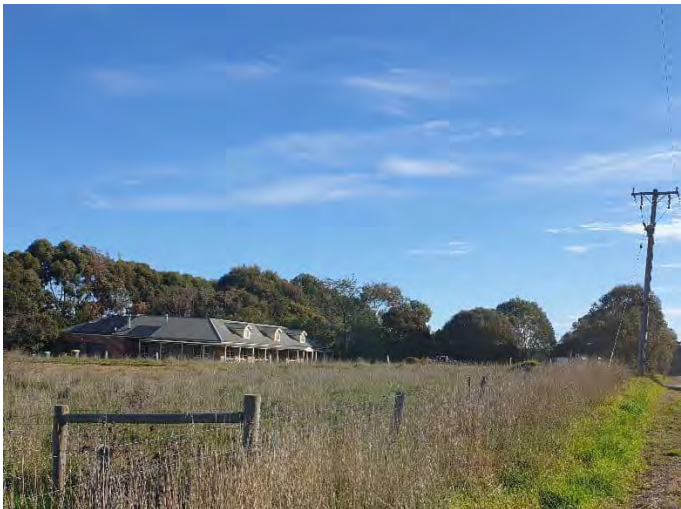
Photograph 18: View of the residence onsite

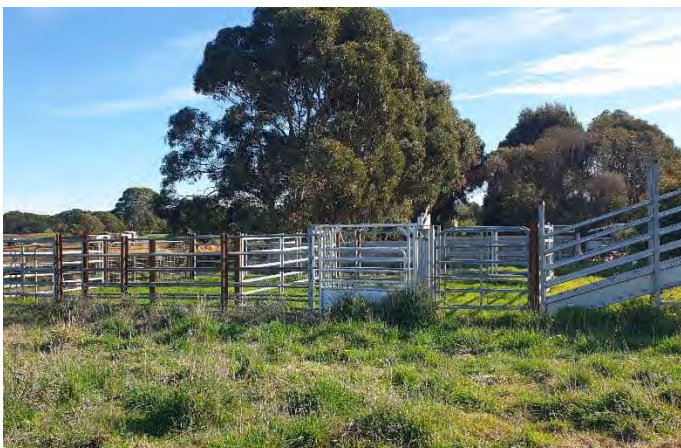
Photograph 19: View of the stockyards onsite

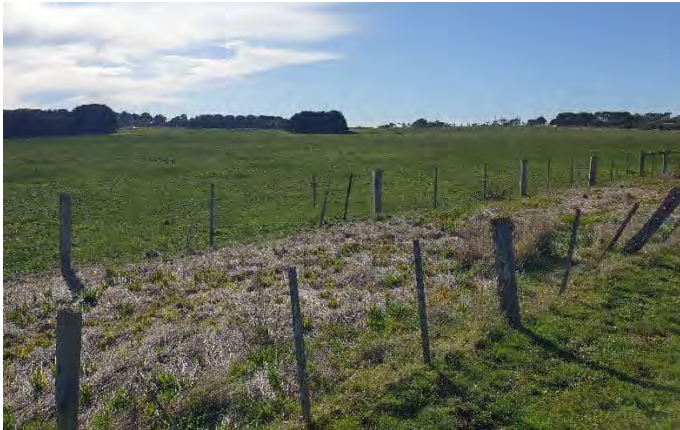
Photograph 20: View facing north from the southern boundary of site. The site is grassed and mostly flat, sloping up towards Wangoom Road to the north.

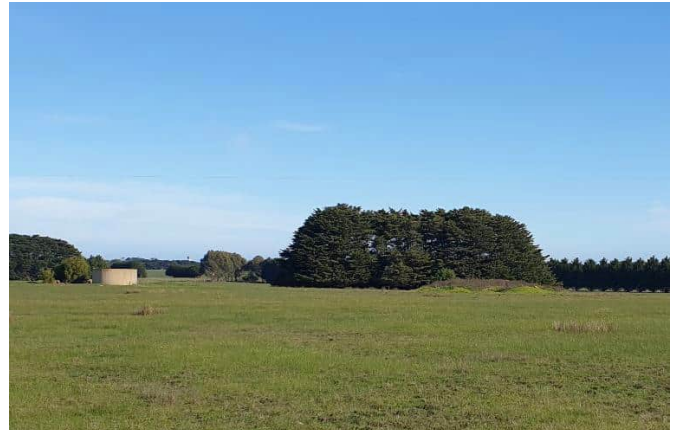
Photograph 21: View of the concrete above ground tank and soil stockpile in the northern portion of site. The stockpile has a different colour/type of grass growing on it.

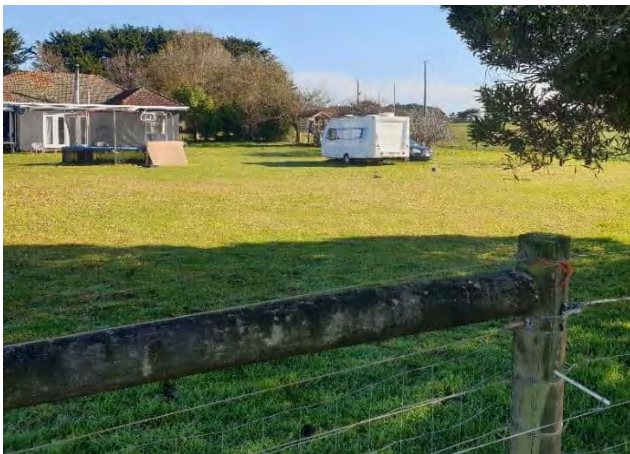
Photograph 22: View of the northern portion of site. The site is grassed and mostly flat, with a residence visible in the left of image.

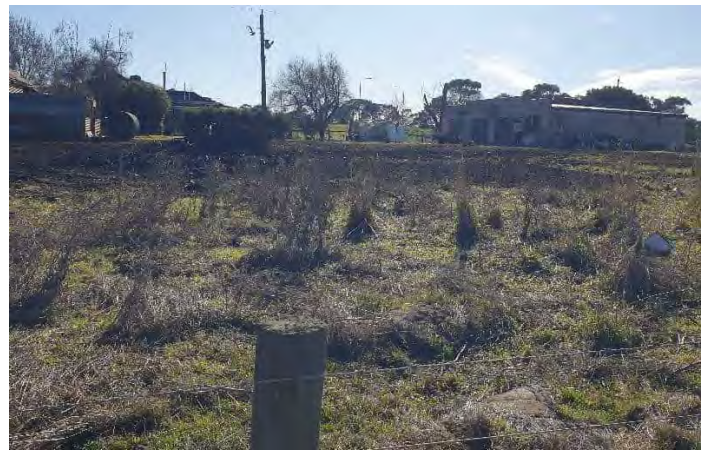
Photograph 23: View of the southern portion of site. The grass is in worse condition, a burn off pile is visible and two sheds can be seen on the right and left of image.

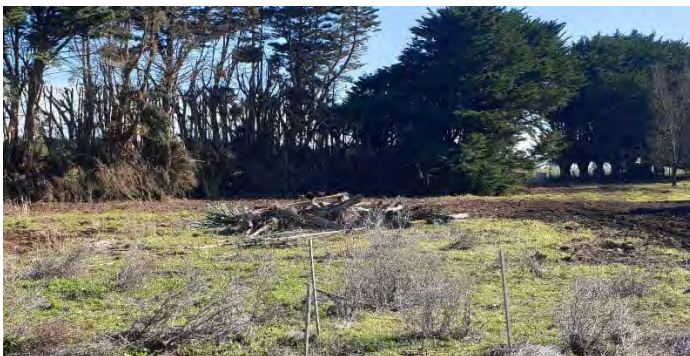
Photograph 24: View of a second burn off pile in the southern portion of site. The pile appeared to mainly contain wood products (tree cuttings and wooden beams)

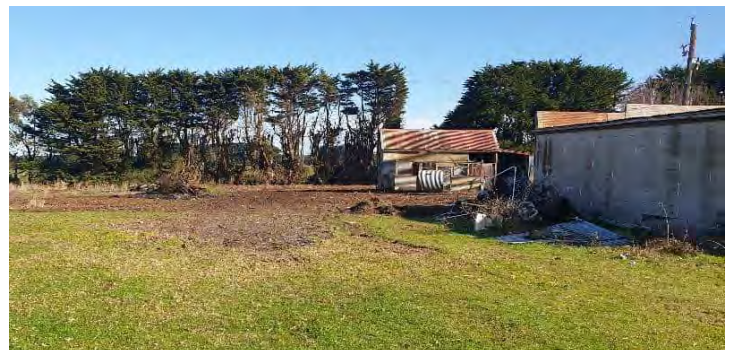
Photograph 25: View facing west from the southeastern portion of site. Hard waste can be seen stockpiled against the side of the shed. One of the burn off piles can be seen in the left of shot consisting of mostly organic material on top of ash visibly mixed with fill inclusions.

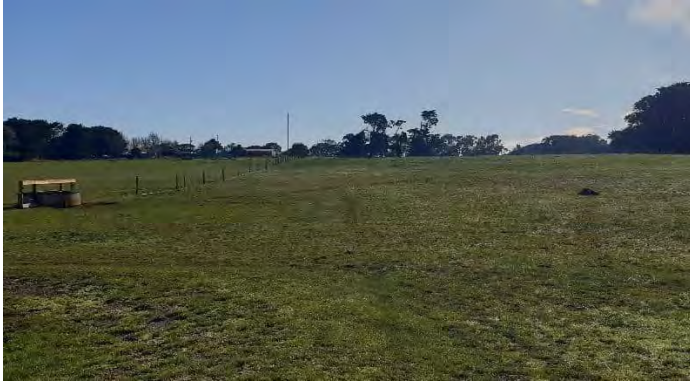
Photograph 26: View facing north from the centre of site. The site is mostly grassed and slopes up towards the north.

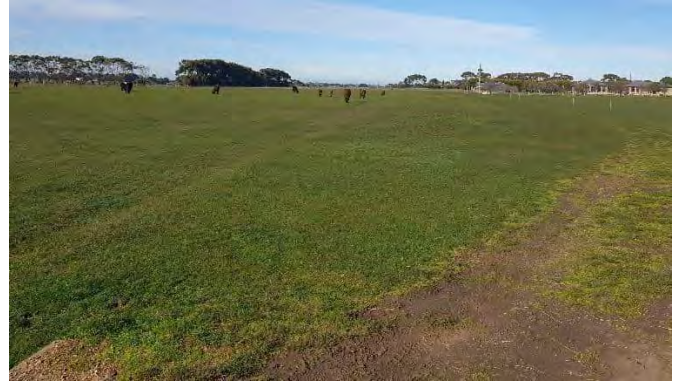
Photograph 27: View facing south from the centre of site. The site is flat in the southern portion and a residence is visible in the background right side of image.

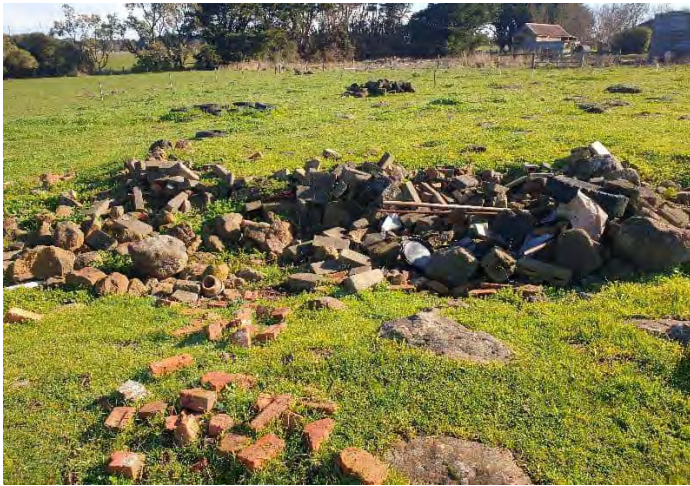
Photograph 28: View of the depression/small dam that has been filled with hard waste (bricks, bluestone, metals, plastic and tiles). In the background two addition piles of tyres and bluestone can be seen.

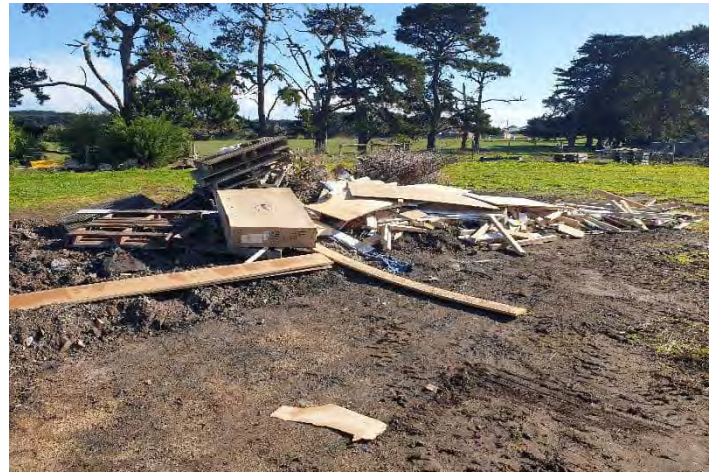
Photograph 29: View of the burn off area in the eastern portion of site. The burn off pile consists mostly of wood products (lumber, pallets, tree offcuts), mixed with domestic waste (plastics, clothes, cardboard).

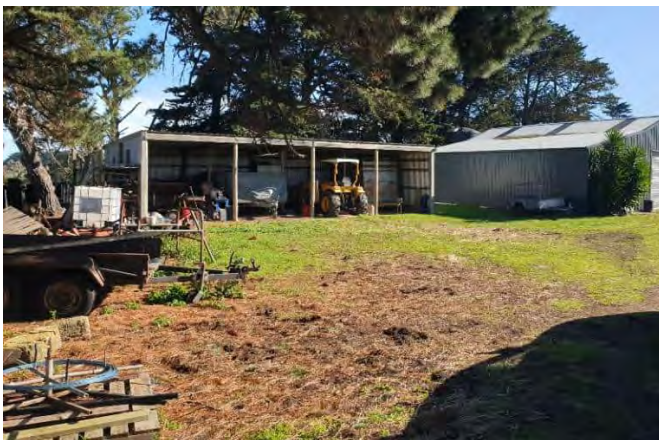
Photograph 30: View of the shed area in the eastern portion of site. The sheds contained farm equipment, trailers and tractors generally in good condition, old oil cans, jerry cans and an IBC were visible as well as mixed wood products (2x4s, PVC pipes, pallets).

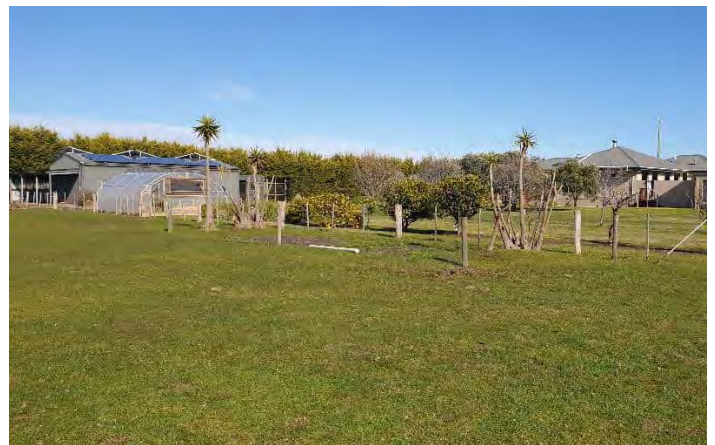
Photograph 31: View of the residence in the southwestern portion of site. The area contained a residence, shed and greenhouse.

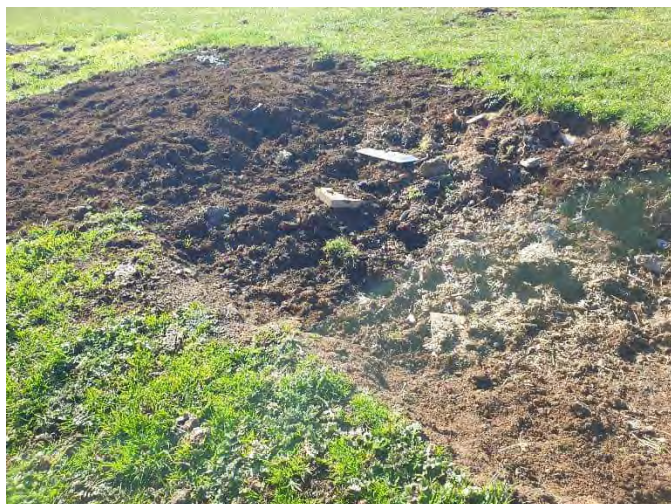
Photograph 32: View of a small scraped area containing topsoils mixed with fill inclusions (rubbish, wood, crushed rock, tile) in the southwestern portion of site.

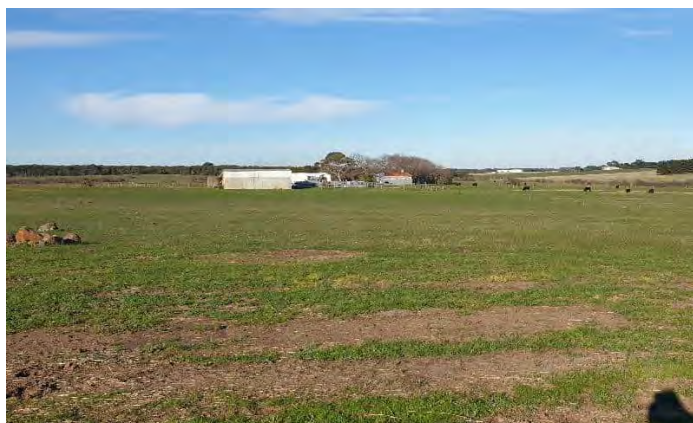
Photograph 33: View facing east of the centre portion of site. The site sloped down slightly towards the south. A residence and large shed are visible.

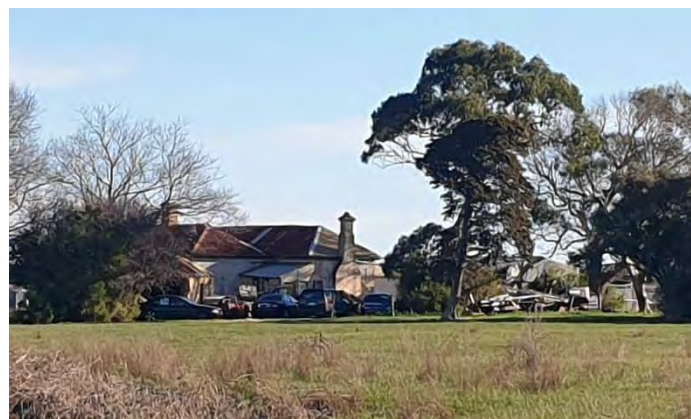
Photograph 34: View facing west of the residences. A stockpile of hard waste, and multiple cars both running and rusted shells are visible.

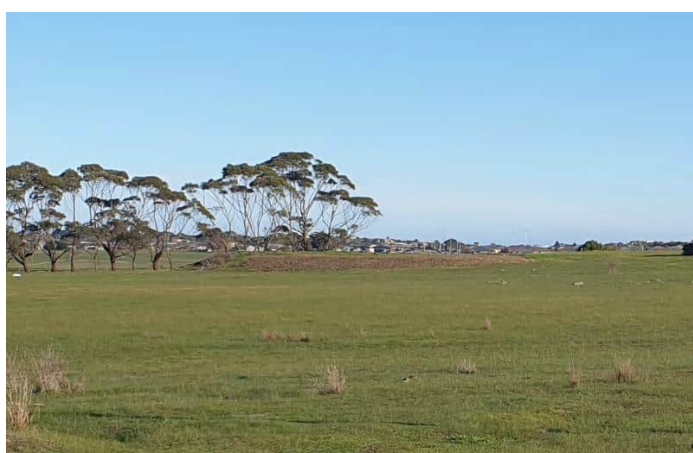
Photograph 35: View facing south of the built up platform in the northern portion of site. The built up area appears to be soils mixed with fill inclusions.

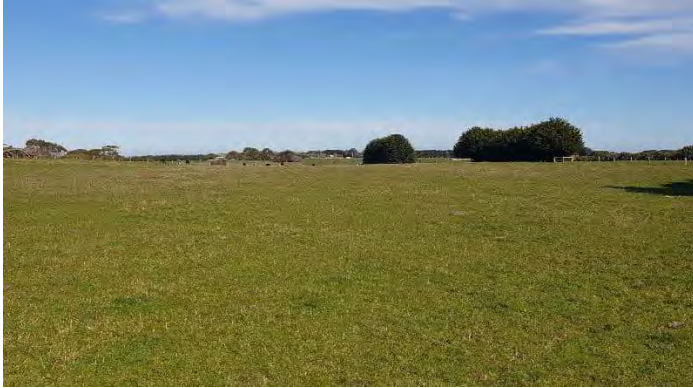
Photograph 36: View facing south from the northern boundary. Site slopes up towards the east.

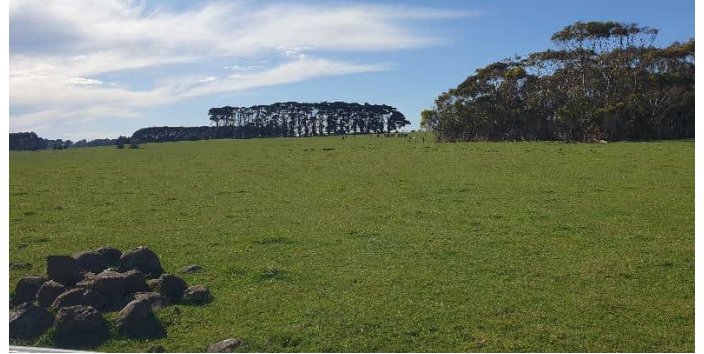
Photograph 37: View facing north from the southern boundary of site. The site slopes up towards the north and a grove of trees in the right of image provides a wind break to the paddocks.

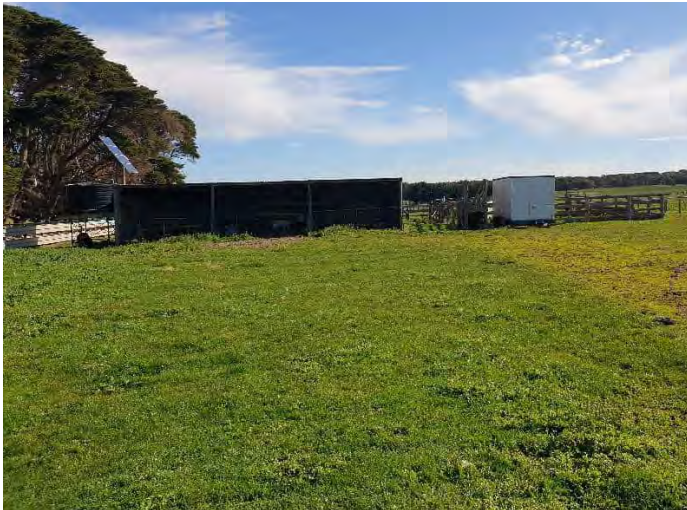
Photograph 38: View of the shed and stockyard in the centre of site. The shed contained old farm equipment and hard wastes (metals, plastics, wood).

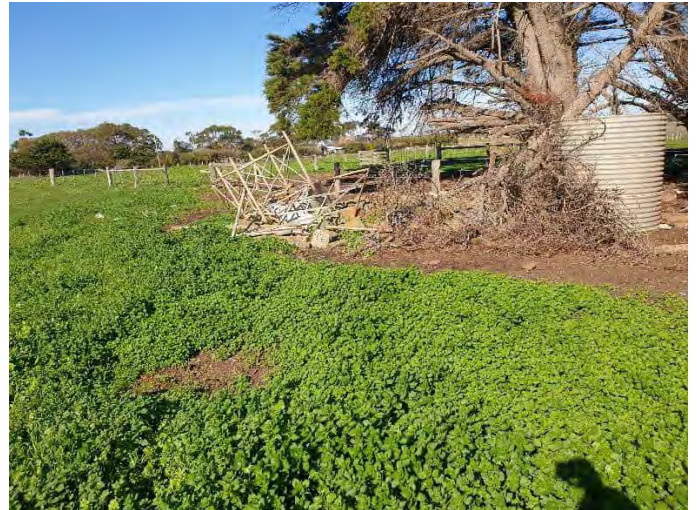
Photograph 39: View of stockpiled hard wastes adjacent to the shed onsite. Hard waste comprised of metals, large basalt cobbles, wood cuttings and processed wood

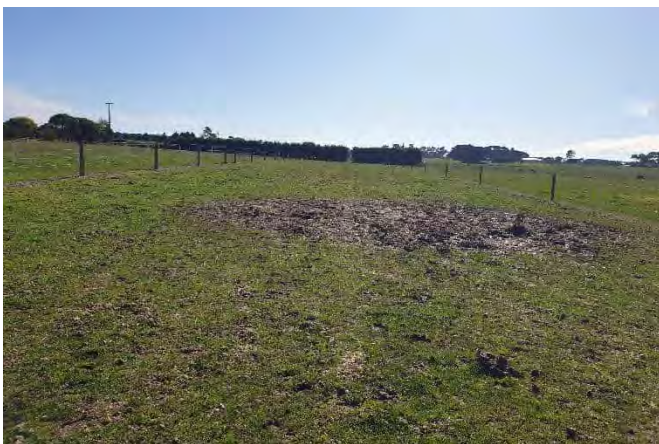
Photograph 40: View facing north from the centre of site. The site is grassed and mostly flat, used for horse paddocks.

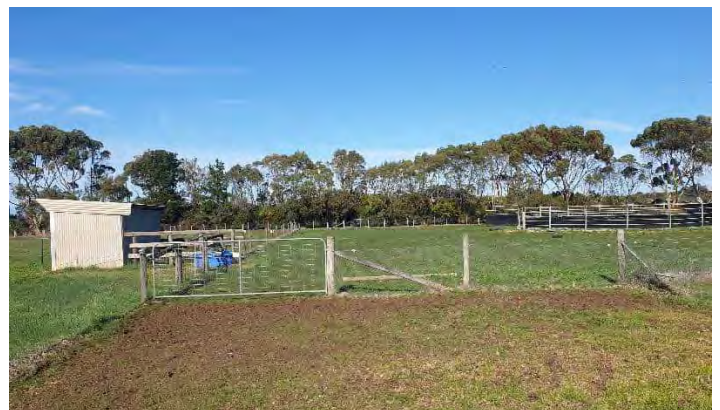
Photograph 41: View facing south of the southern portion of site. A horse rink can be seen to the right and a small horse shelter to the left.

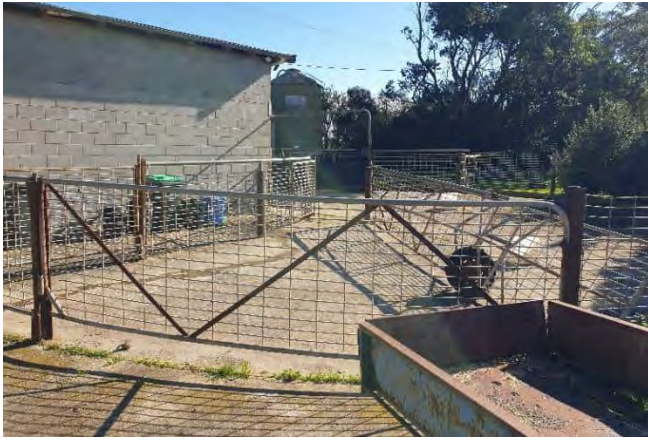
Photograph 42: View of the stockyard and dairy? In the southwestern portion of site. A grain? Silo can be seen behind the stockyard.

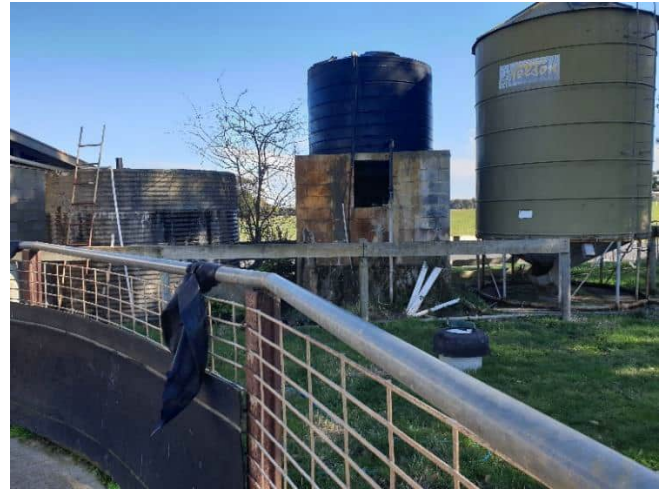
Photograph 43: View of two above ground tanks and a silo adjacent to the stockyards.

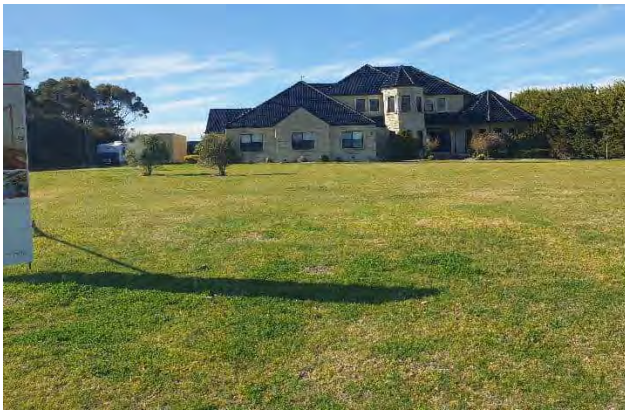
Photograph 44: View facing east from the western boundary of site. The site is primarily occupied by a residence.

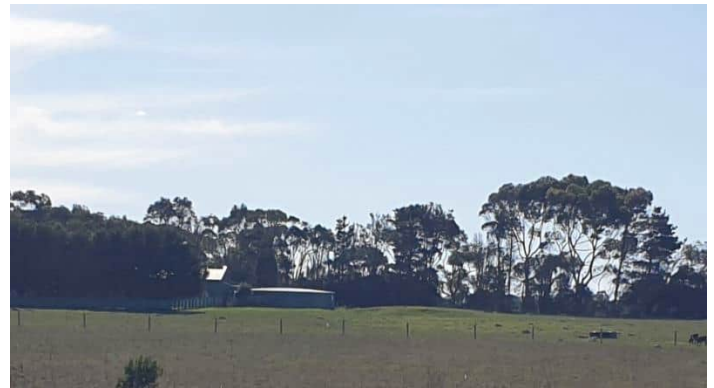
Photograph 45: View facing north of the eastern portion of site. A large rainwater tank and built up fill area can be seen.

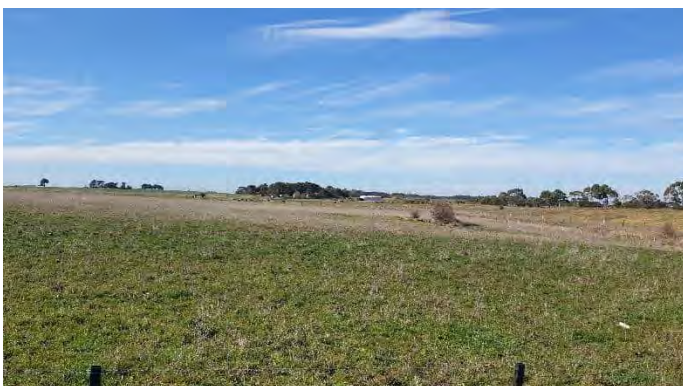
Photograph 46: View facing east from the western boundary of site. The site is mostly grassed and used for grazing. The ground slopes down towards the creek bisecting site.

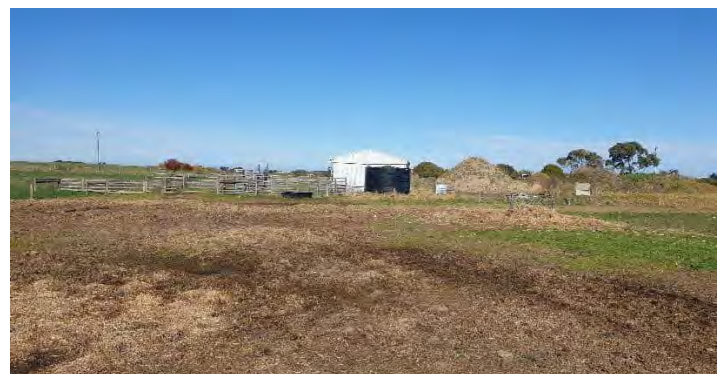
Photograph 47: View facing south from the western boundary of site. A shed, stockyards and several stockpiles are visible. Hard waste including pallets, processed wood, crushed rock, plastics and an IBC were visible around the shed.

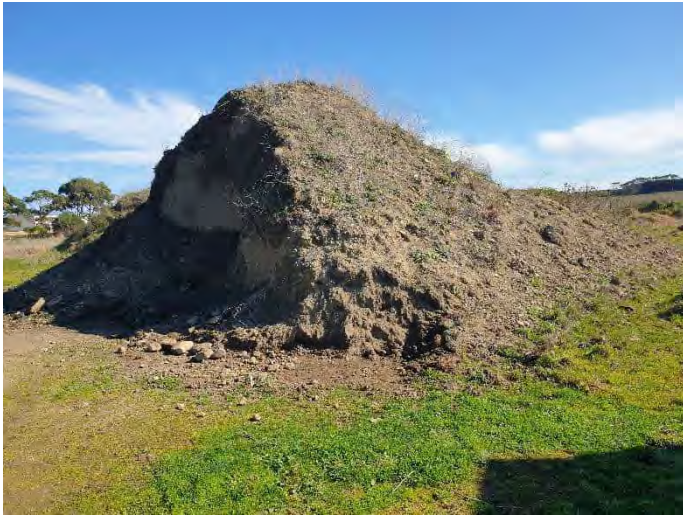
Photograph 48: View of one of the stockpiles around the shed. Soils consisted of a clayey silt with fill inclusions of crushed brick, concrete and rock. Several stockpiles onsite had a similar composition.

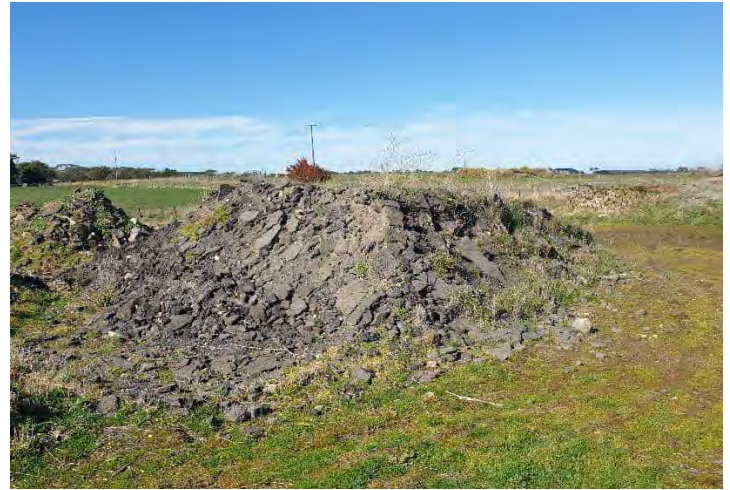
Photograph 49: View of a stockpile around the shed. Soils consisted of a clayey silt with large amounts of crushed asphalt. In the right of image some rusted farm equipment can be seen buried within a stockpile.

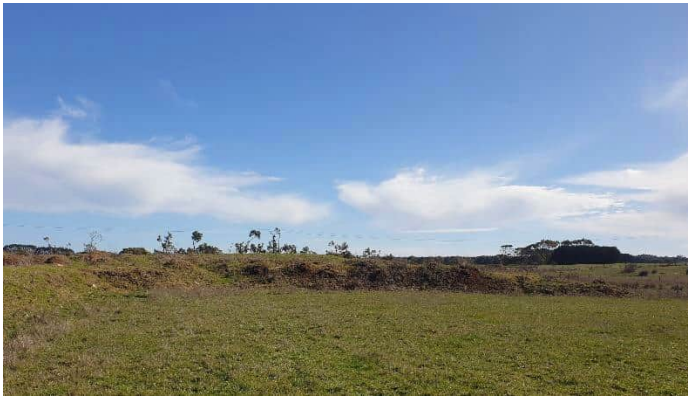
Photograph 50: View facing west of the large area of filling in the south western portion of site. The fill has a varied depth and profile multiple meters deep.

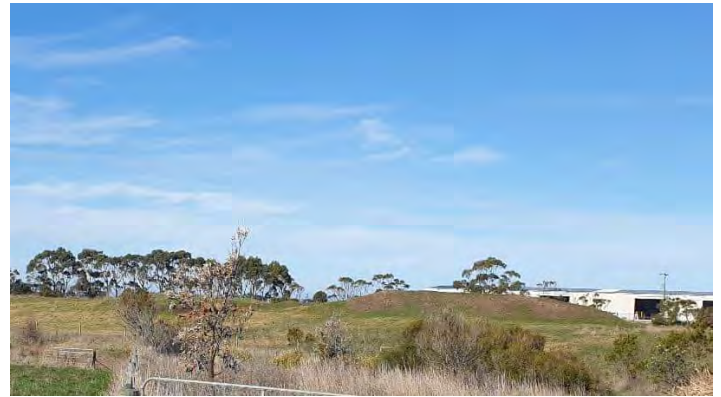
Photograph 51: View facing south towards the large area of filling. The filling covers most of the southwestern portion of site.

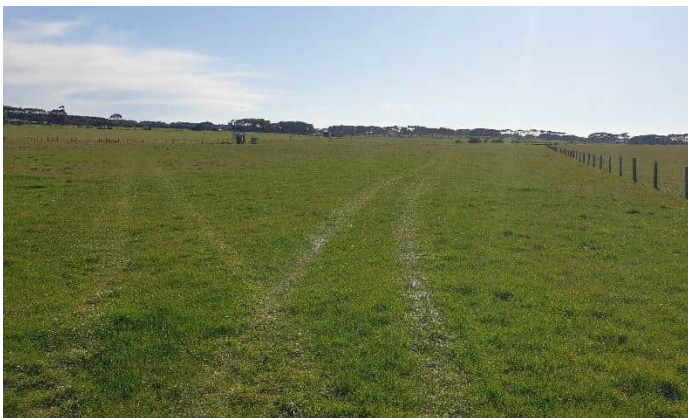
Photograph 52: View facing north from the southern boundary of site. The site is mostly flat, grassed and used for grazing.

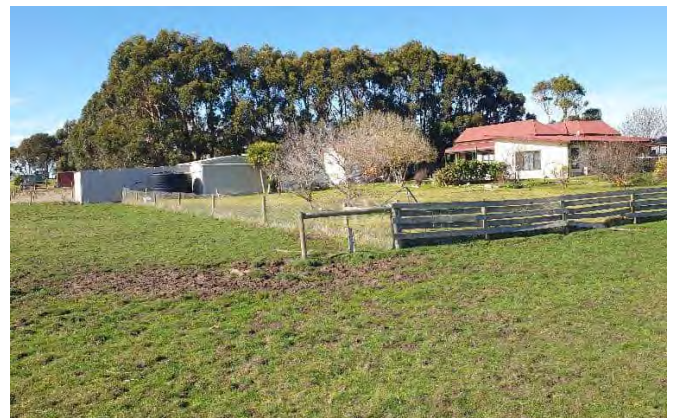
Photograph 53: View of the residence in the southeastern portion of site. The residence consists of a single story dwelling, with a garage, sheds and rainwater tanks visible.

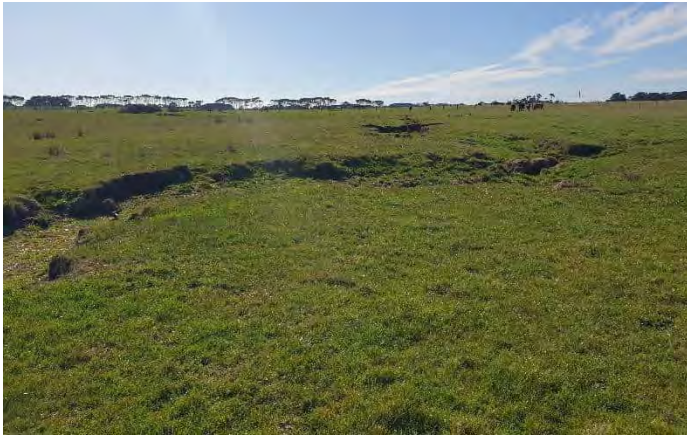
Photograph 54: View facing north of the creek onsite.

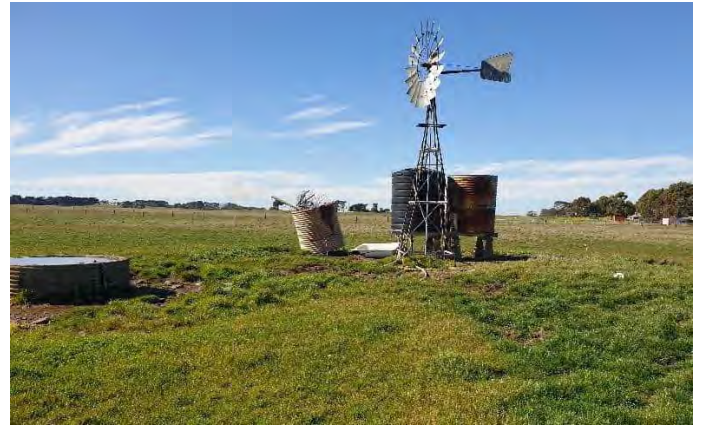
Photograph 55: View of the windmill and tanks in the western portion of site. An old tank, bathtub and water trough visible.

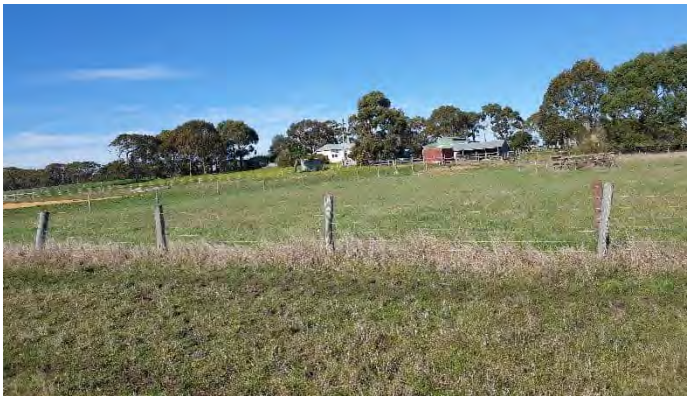
Photograph 56: View facing southeast from the northern boundary of site. The residence and sheds are visible, and an above ground tank

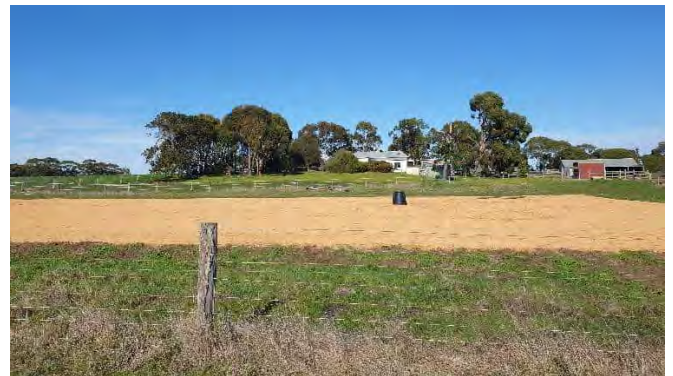
Photograph 57: View facing south from the northeastern boundary of site. The northeastern portion of site has been converted for horse/dressage, and a change in grass may indicate filling onsite.

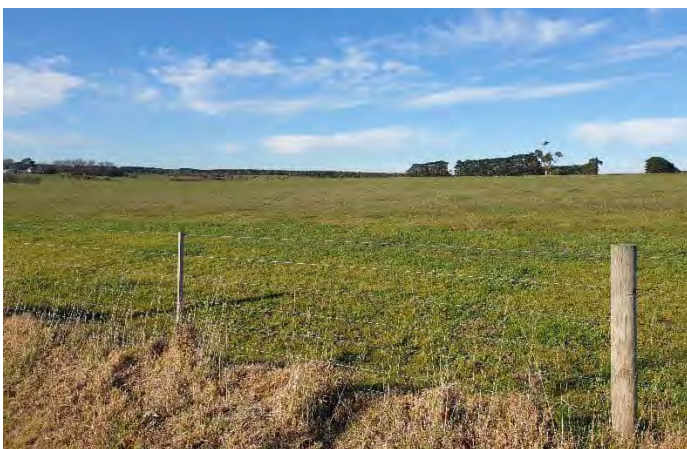
Photograph 58: View facing east from the western boundary. The site is grassed and slopes down to the north.

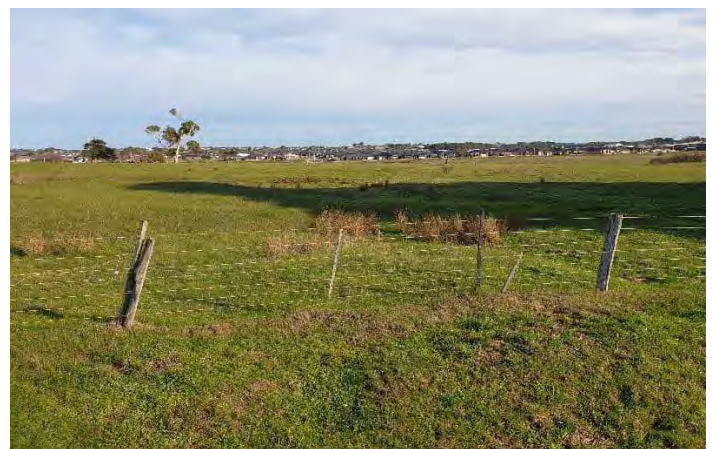
Photograph 59: View facing west from the eastern boundary. No structures or notable features were visible onsite

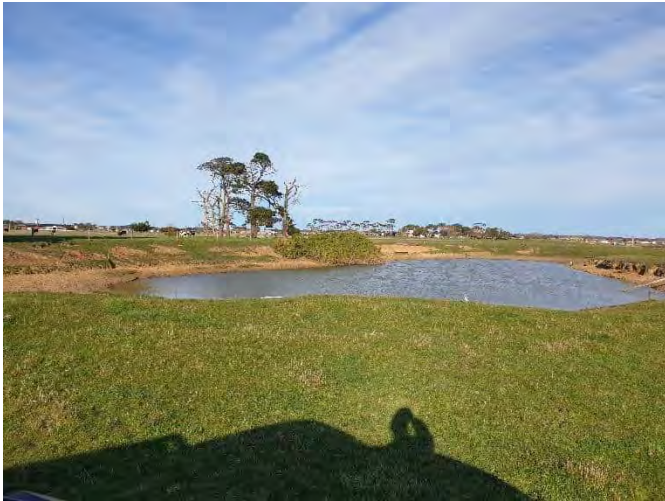
Photograph 60: View facing west from the eastern portion of site. The dam takes up a majority of the area and appears to be used by cattle for water.

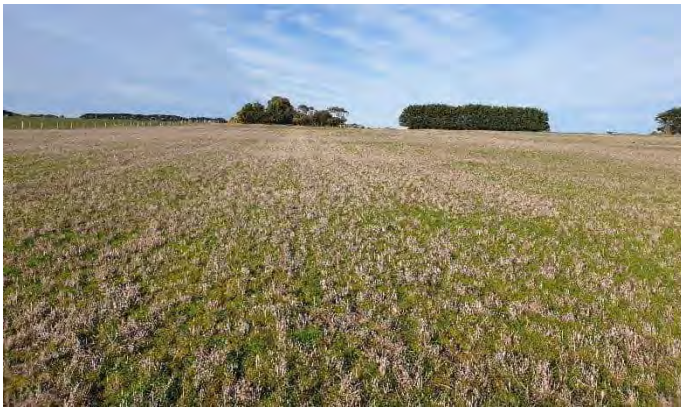
Photograph 61: View facing south from the northern portion of site. The site is mostly grazing and sloped up to the north.

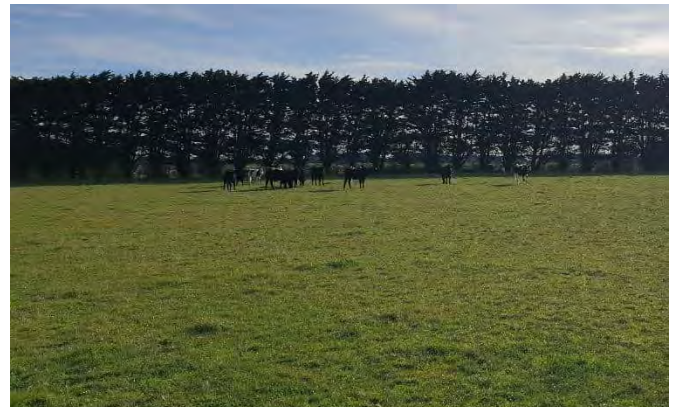
Photograph 62: View facing north from the southern portion of site. The southern portion of site is mostly flat.

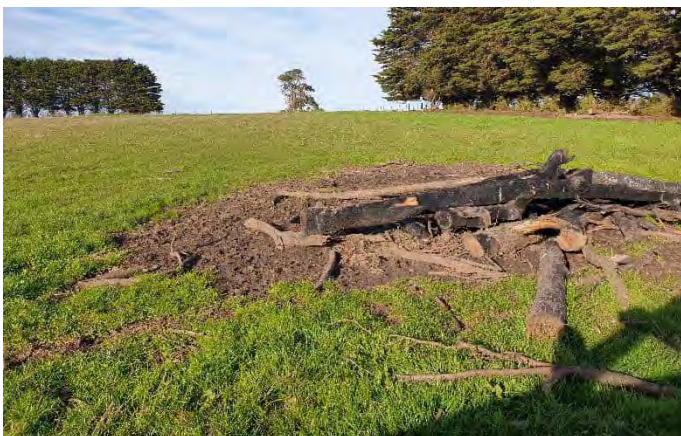
Photograph 63: View of a burn off pile in the northwestern portion of site. The pile consisted of wood cuttings with no other visible inclusions

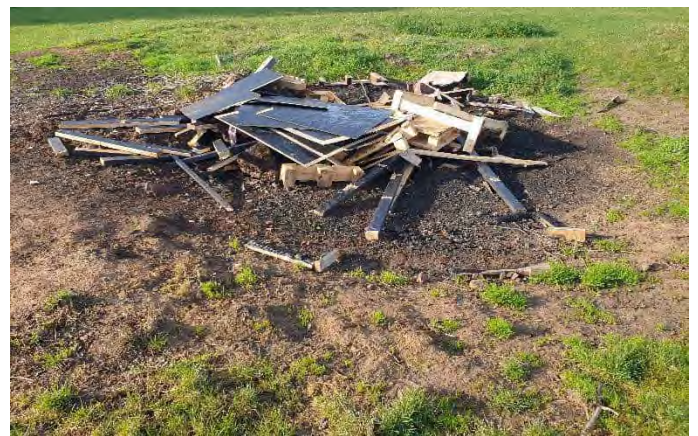
Photograph 64: View of a burn off pile in the southern portion of site. The pile consisted of processed woods including pallets with inclusions of bricks, metals and plastics visible

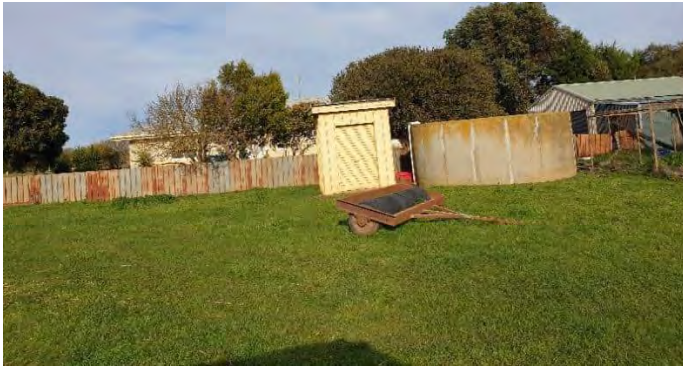
Photograph 65: View facing south of the homestead/works area. A residence, sheds, concrete water tank and animal enclosure are visible.

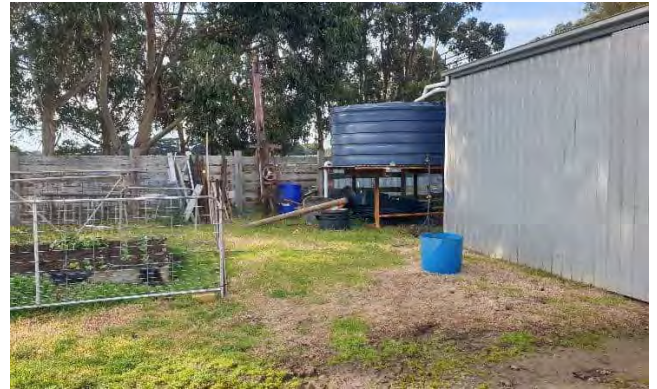
Photograph 66: View of the eastern portion of site, a shed and rainwater tank are visible and a stockyard is visible behind the shed.

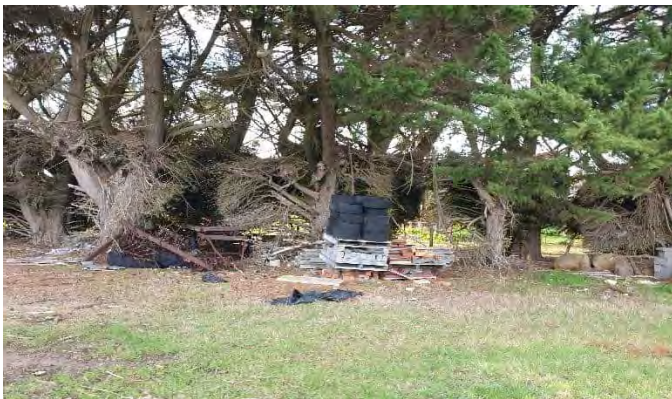
Photograph 67: View of the hard waste stored along the tree line in the south eastern portion of site. Old farm equipment, tyres, bricks, metals, plastics and building materials are visible.

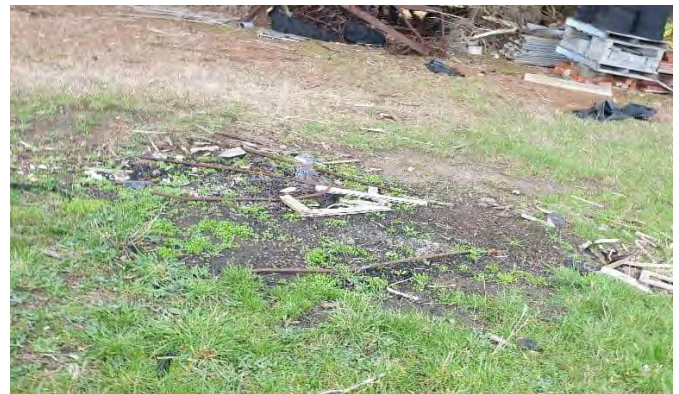
Photograph 68: View of a potential burn off area in the southeastern portion of site. Inclusions of metals, pallet wood, and rubbish are visible.

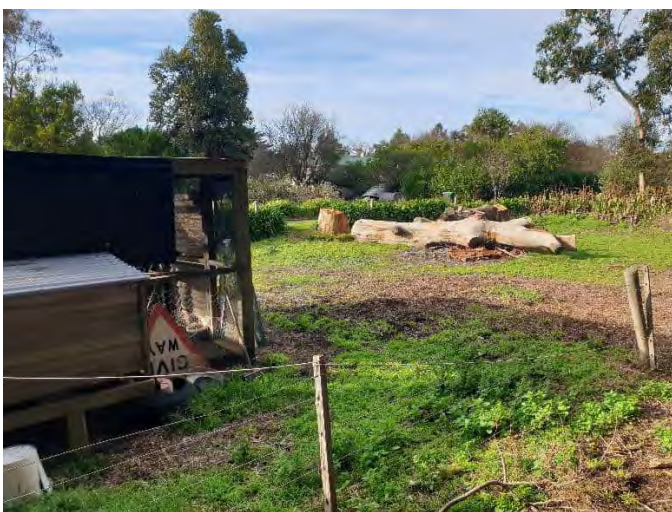
Photograph 69: View facing southeast from the southwestern boundary of site. A chicken coup and pile of wood cuttings are visible in the foreground, with a residence and multiple old tanks visible in the background

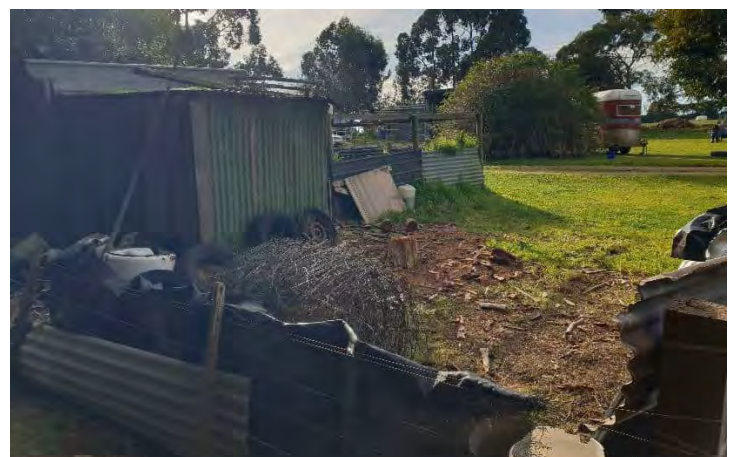
Photograph 70: View facing northeast from the south western boundary. Some sheds and vehicles are visible in the background. Stored wastes including tyres, wire mesh, wood chips/dust and old and plastic bucket and paint containers are visible.

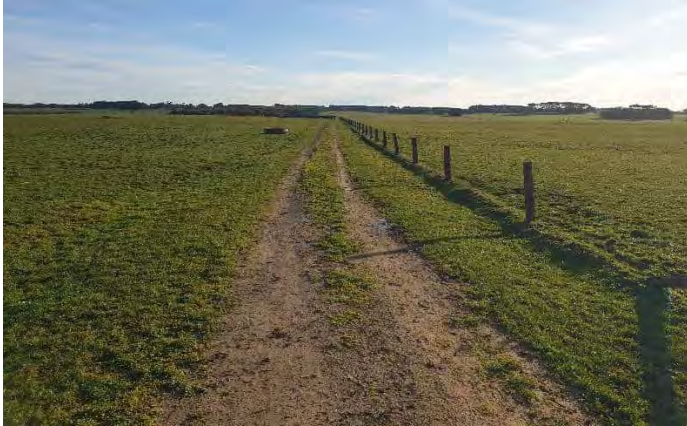
Photograph 71: View facing north from the southern boundary of site. The site is grassed and mostly flat, a water trough and large shed are visible in the background of image.

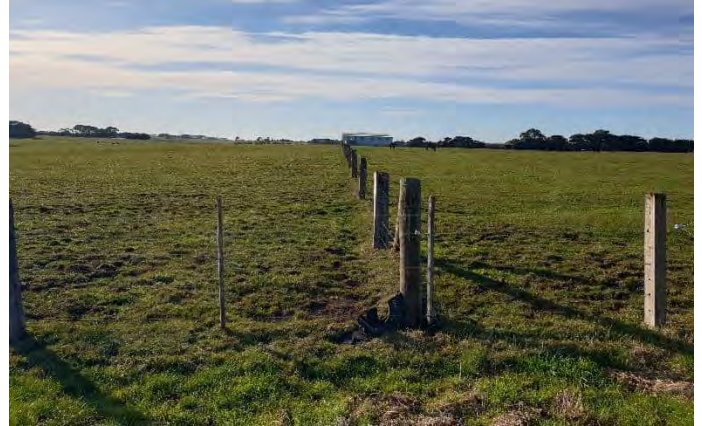
Photograph 72: View facing east from the western boundary of site. The large shed is visible and the site begins to slope down to the north.

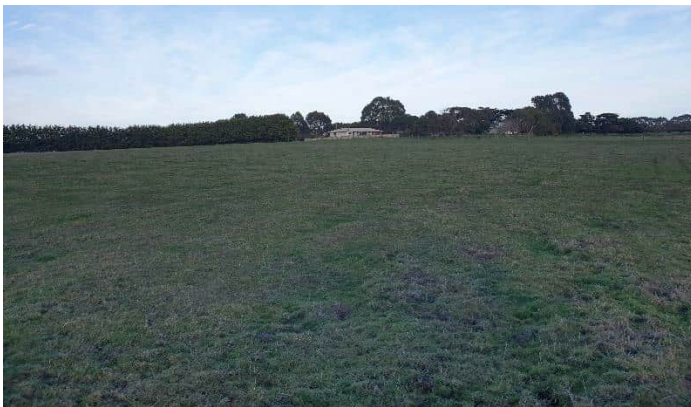
Photograph 73: View facing west from the eastern boundary of site. The site is mostly flat, sloping slightly down in the northern portion of site. A residence is visible in the background of image.
