#### **Parcel 4 – 220 Wangoom Road, Warrnambool**

Strata Geoscience and Environmental Pty Ltd was commissioned to perform a limited scope desktop geotechnical investigation to help inform the Precinct Development Plan (PCP) for an area broadly bounded by Wangoom Road, Dales Road, Aberline Road and the properties at 53 and 75 Rodgers Road. The majority of the precinct is included in the Farming Zone, aside from a small portion included in the Public Use Zone 1, associated with water storage basins. A Bushfire Management Overlay affects an area central to the site, associated with Tozer Reserve.

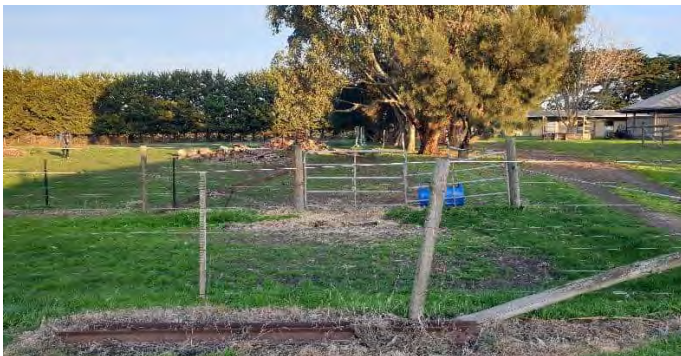
Photograph 75: View facing west from the north portion of site. Two stockpiles of wood cuttings are visible, and a gazebo and horse sheds are visible in the right of image.

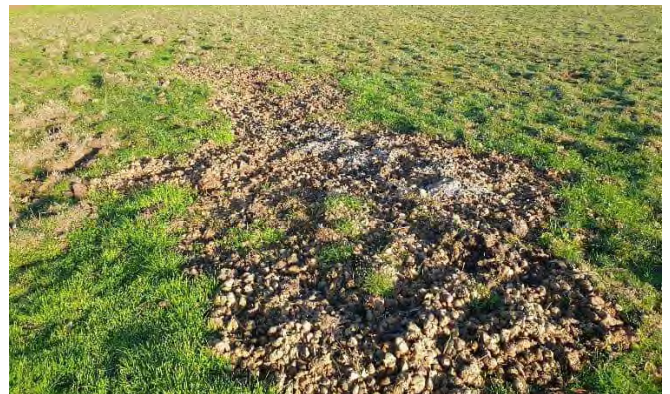
Photograph 76: View of a small area of charcoal/ash and manure.

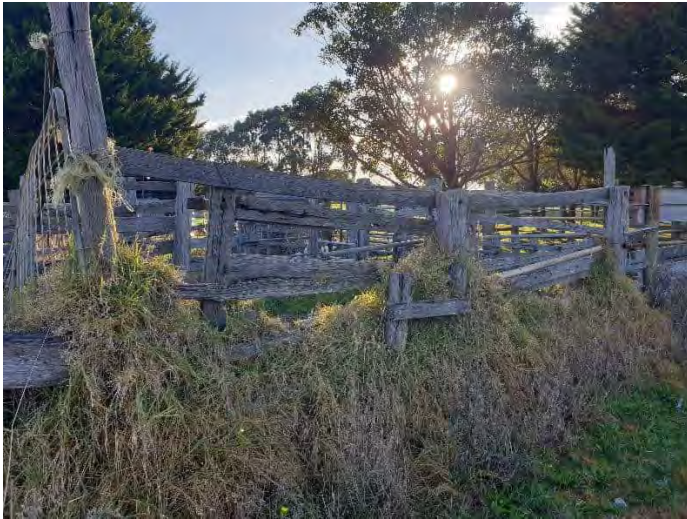
Photograph 77: View of the stockyards in the south western corner of site.

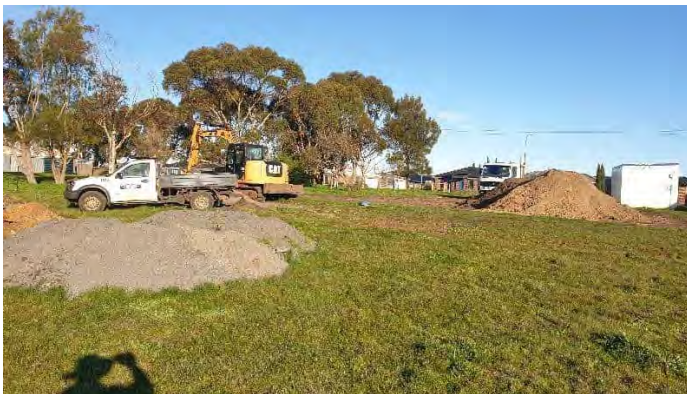
Photograph 78: View facing southeast from the north western portion of site. The western portion of site is used as a depot for a civil contractor, stockpiles of topsoil and crushed rock are visible.

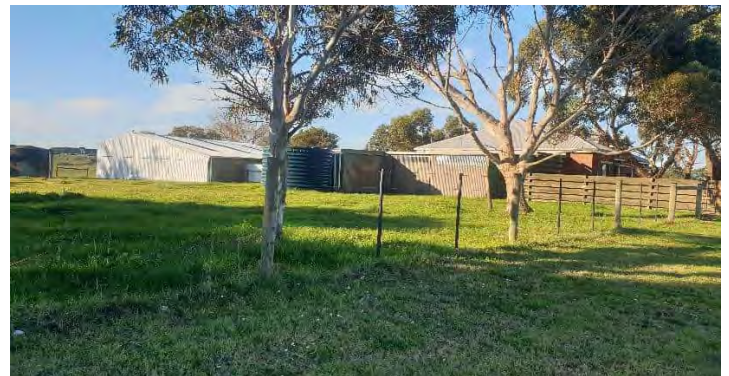
Photograph 79: View facing northeast from the southern boundary of site. The eastern portion of site was occupied by a residence, shed and two above ground tanks.

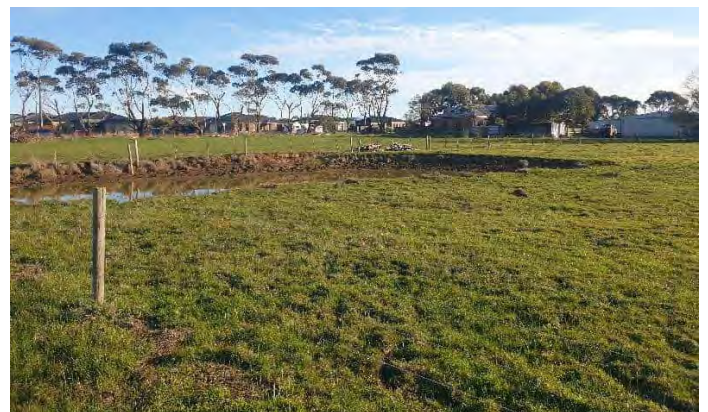
Photograph 81: View facing south east from the northern portion of site. A dam and two stockpiles of wood are visible.

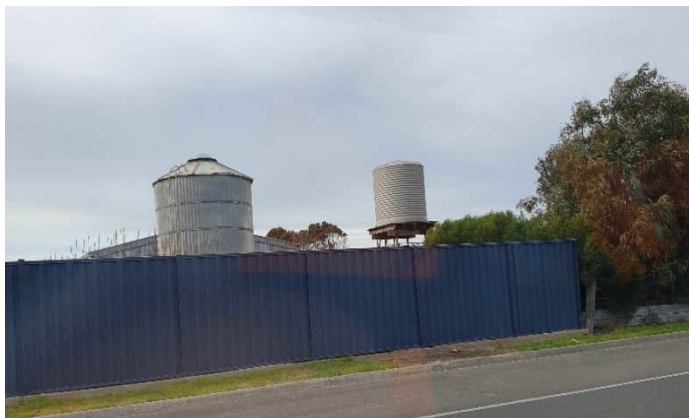
Photograph 82: View facing east of the site. The top of a large shed and above ground tank and silo are visible.

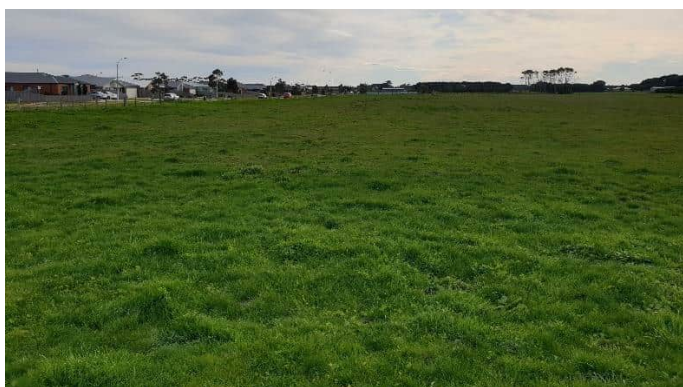
Photograph 83: View facing north from the southern boundary of site. The site is predominantly grassed and flat.

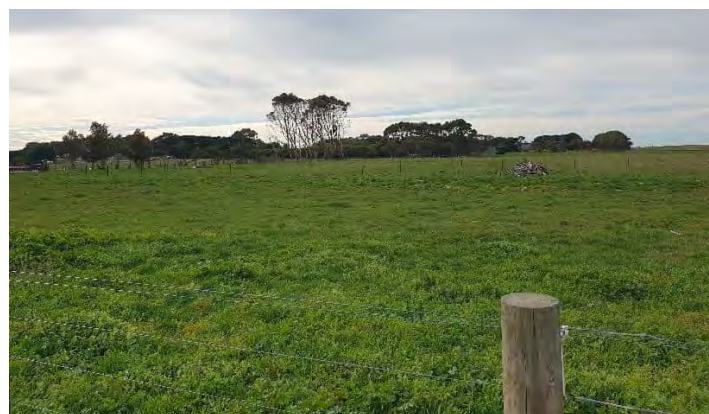
Photograph 84: View facing east from the western boundary of site. A stockpile of wood cuttings is visible.

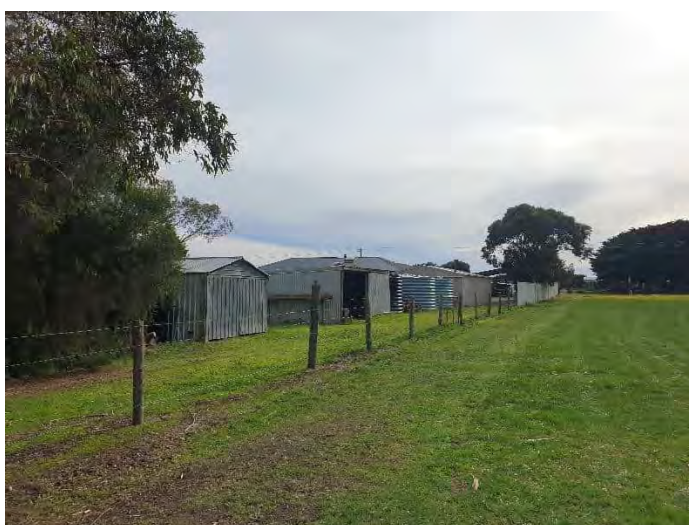
Photograph 85: View facing southwest from the eastern boundary of site. Multiple sheds and rainwater tanks are visible, the top of the residence is visible in the background of image.

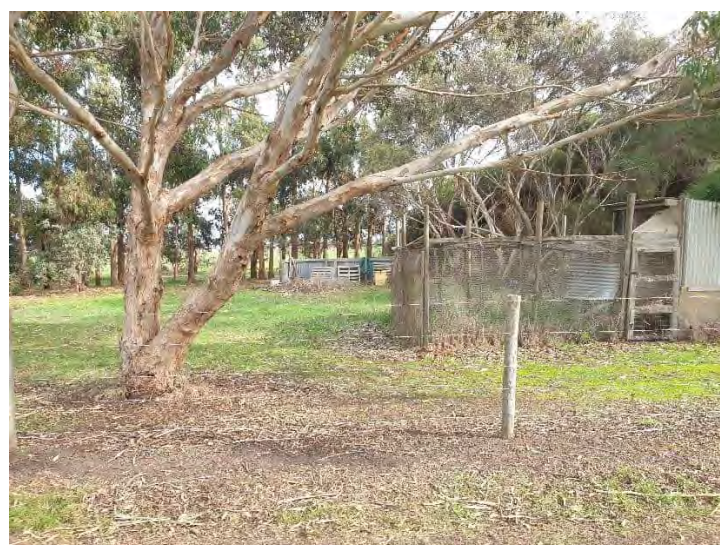
Photograph 86: View facing west from the eastern portion of site. An old chicken coup is visible

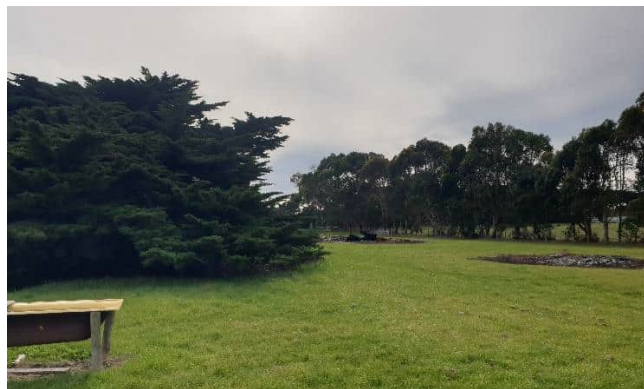
Photograph 88: View facing northeast into the northeastern portion of site. Two large burn off piles can be seen

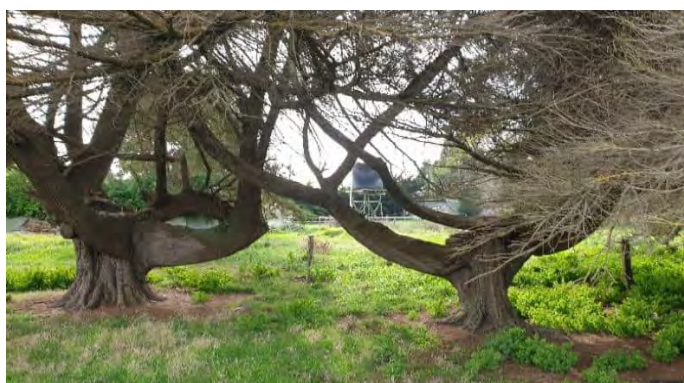
Photograph 89: View facing northeast into the northeastern portion of site. A shed and raised above ground tank are visible.

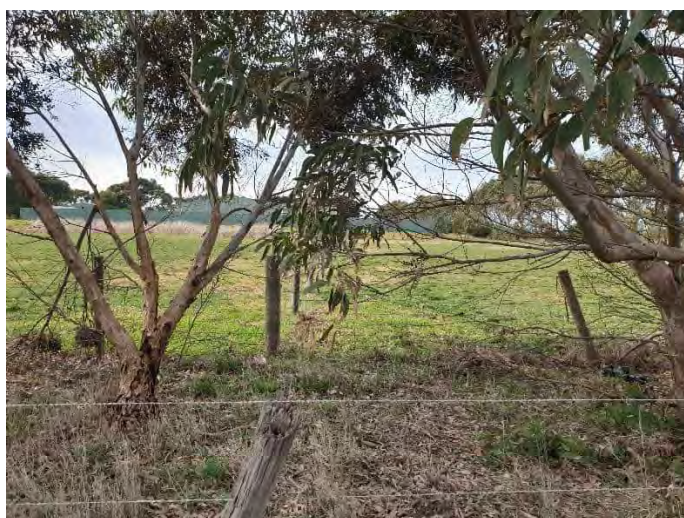
Photograph 90: View facing east from the western portion of site. A large shed and dam are visible.

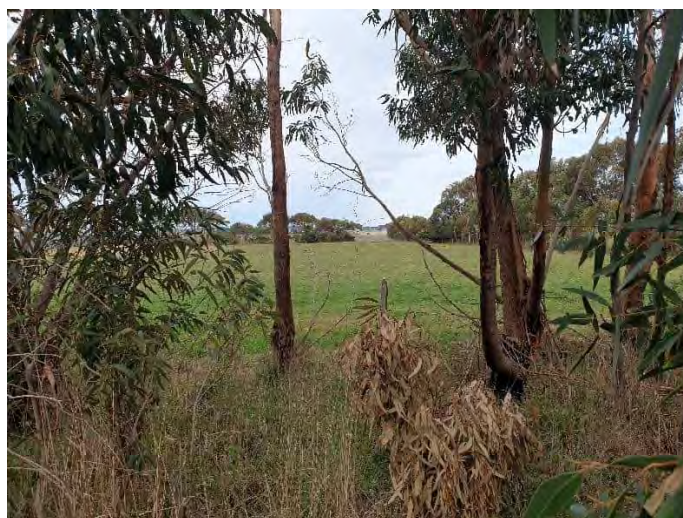
Photograph 91: View facing south from the northern boundary of site. The site is mostly grassed and predominantly flat.

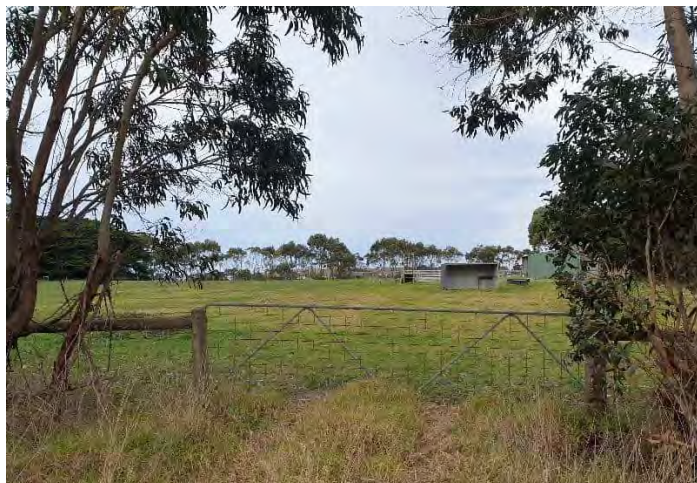
Photograph 92: View facing south from the northern boundary of site. A stockyards and barn can be seen in the right of image. The ground is undulating and has varied grass health, indicating potential filling

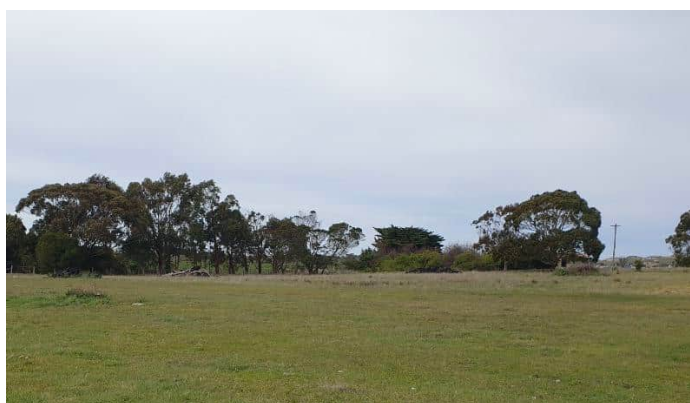
Photograph 93: View facing southeast from the northern boundary of site. The site is mostly flat and grassed, stockpiles of wood, tyres and hard waste are visible in the background of image.

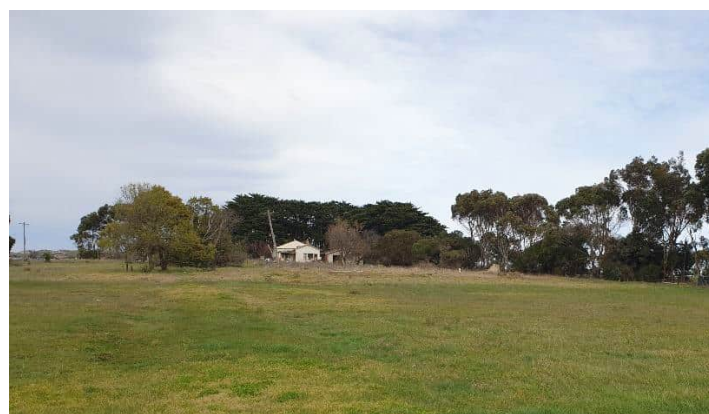
Photograph 94: View facing southwest from the northern boundary of site. A disused residence is visible in the background

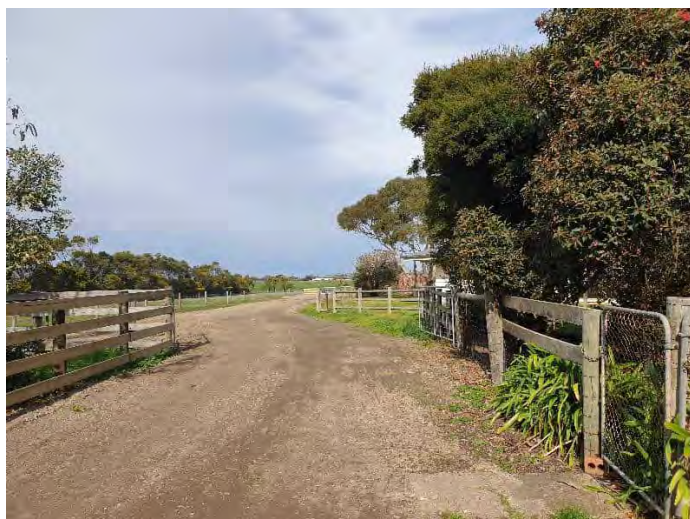
Photograph 95: View facing south from the northern boundary of site. A residence and shed are visible in the northern portion of site.

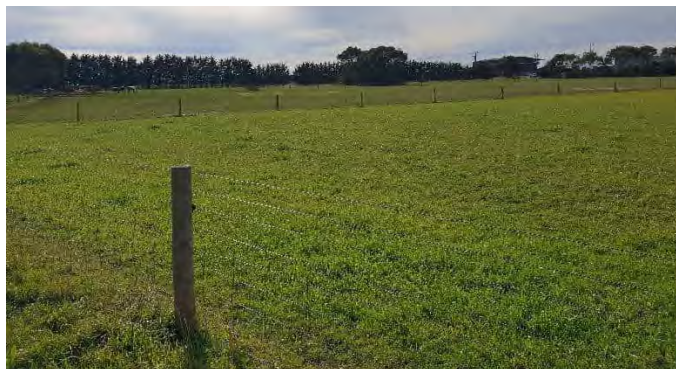
Photograph 96: View facing north from the southern boundary of site. The site is predominantly flat and grassed, used for grazing.

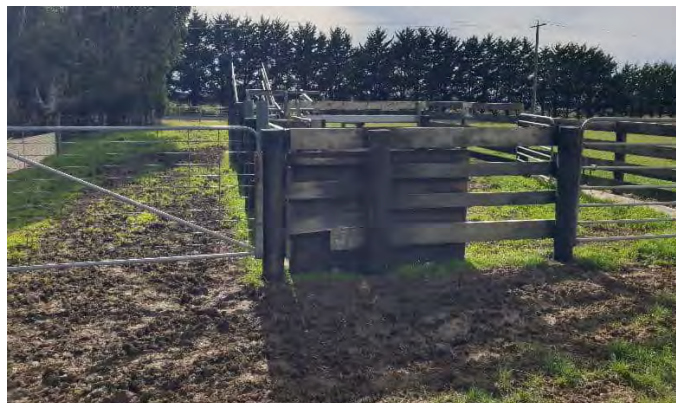
Photograph 97: View facing north of the stockyards in the northern portion of site.

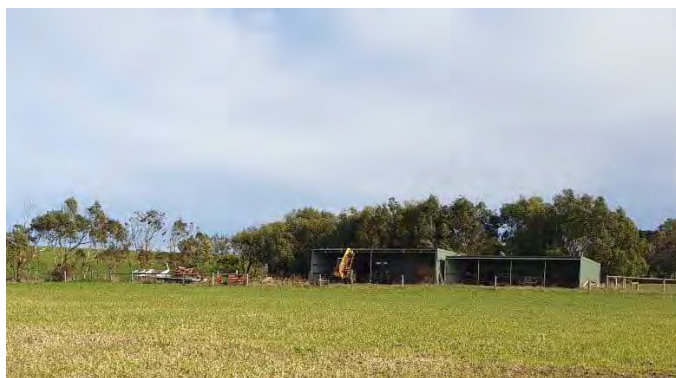
Photograph 98: View facing west of the southern portion of site. Two joined sheds are visible containing current and discarded farm equipment and vehicles

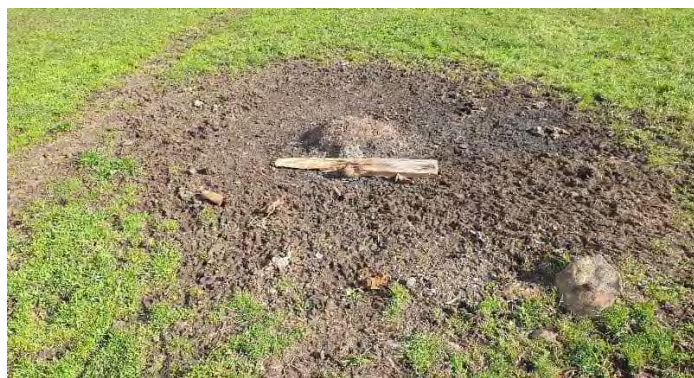
Photograph 99: View of the burn off pile in the centre portion of site. Inclusions of wood and metals (spray paint cans) were visible

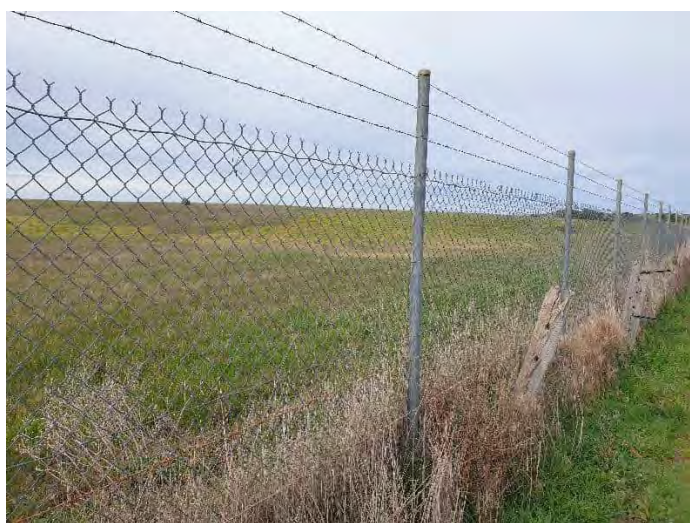
Photograph 100: View facing southeast from the northwestern boundary of site. The reservoirs are built up a couple meters above ground level.

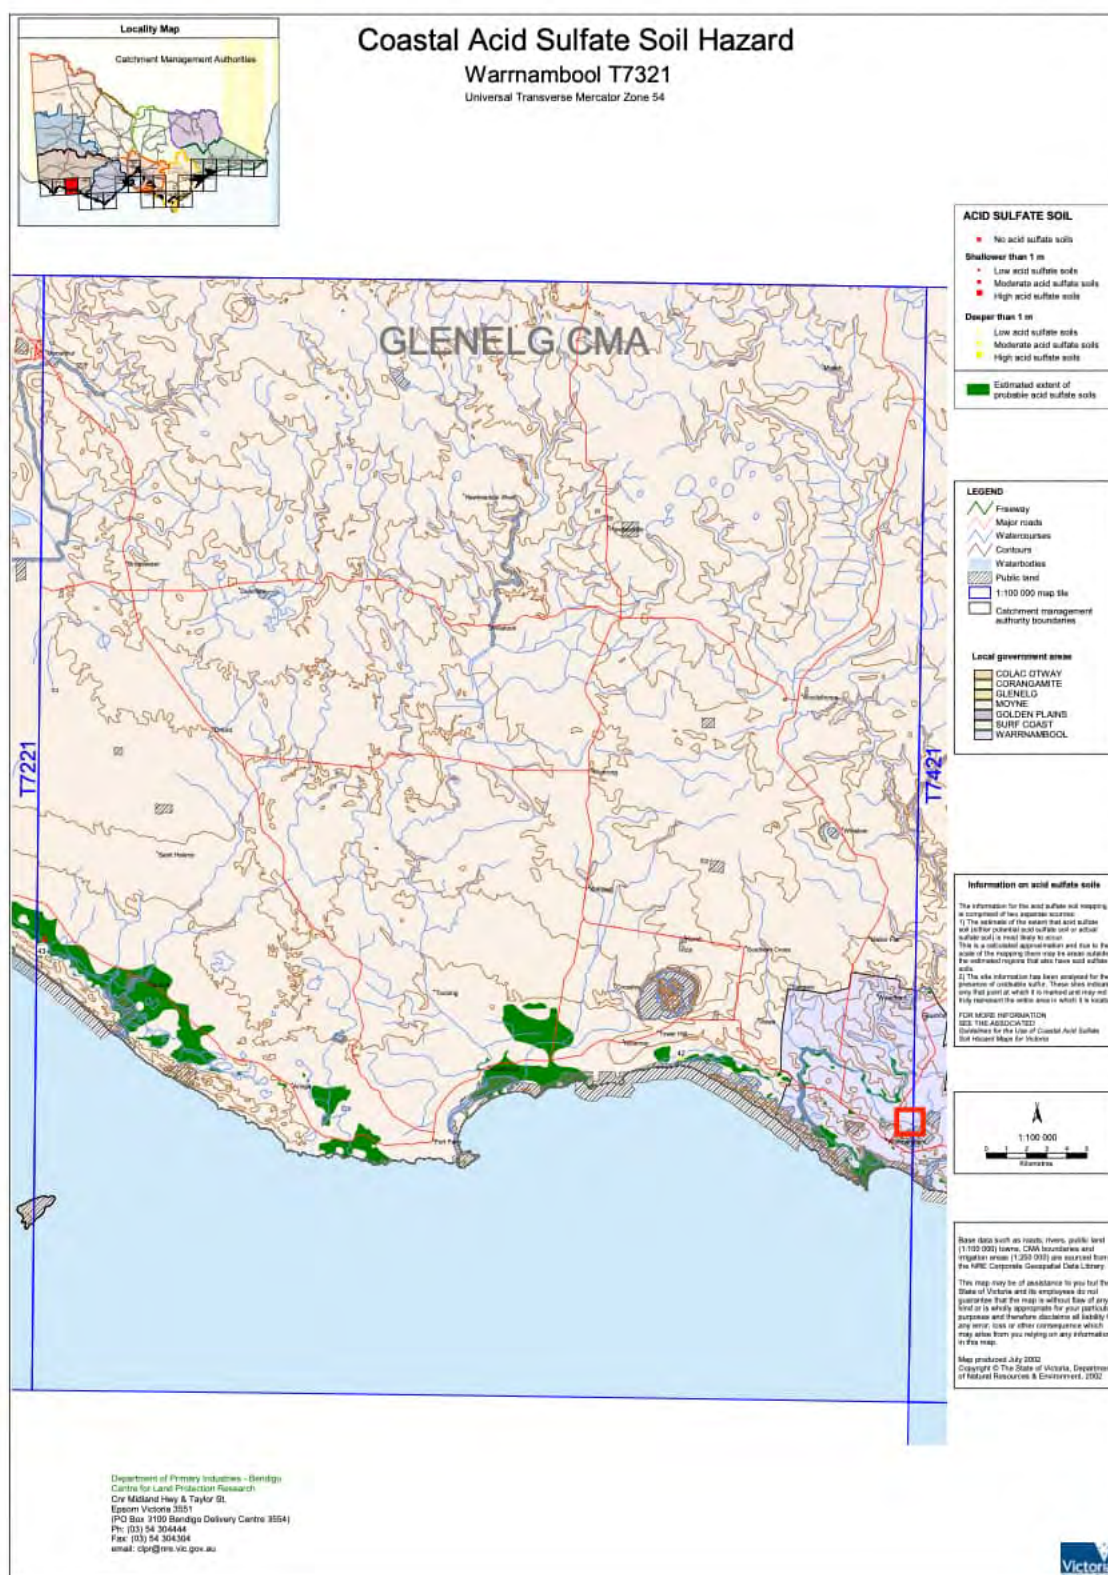
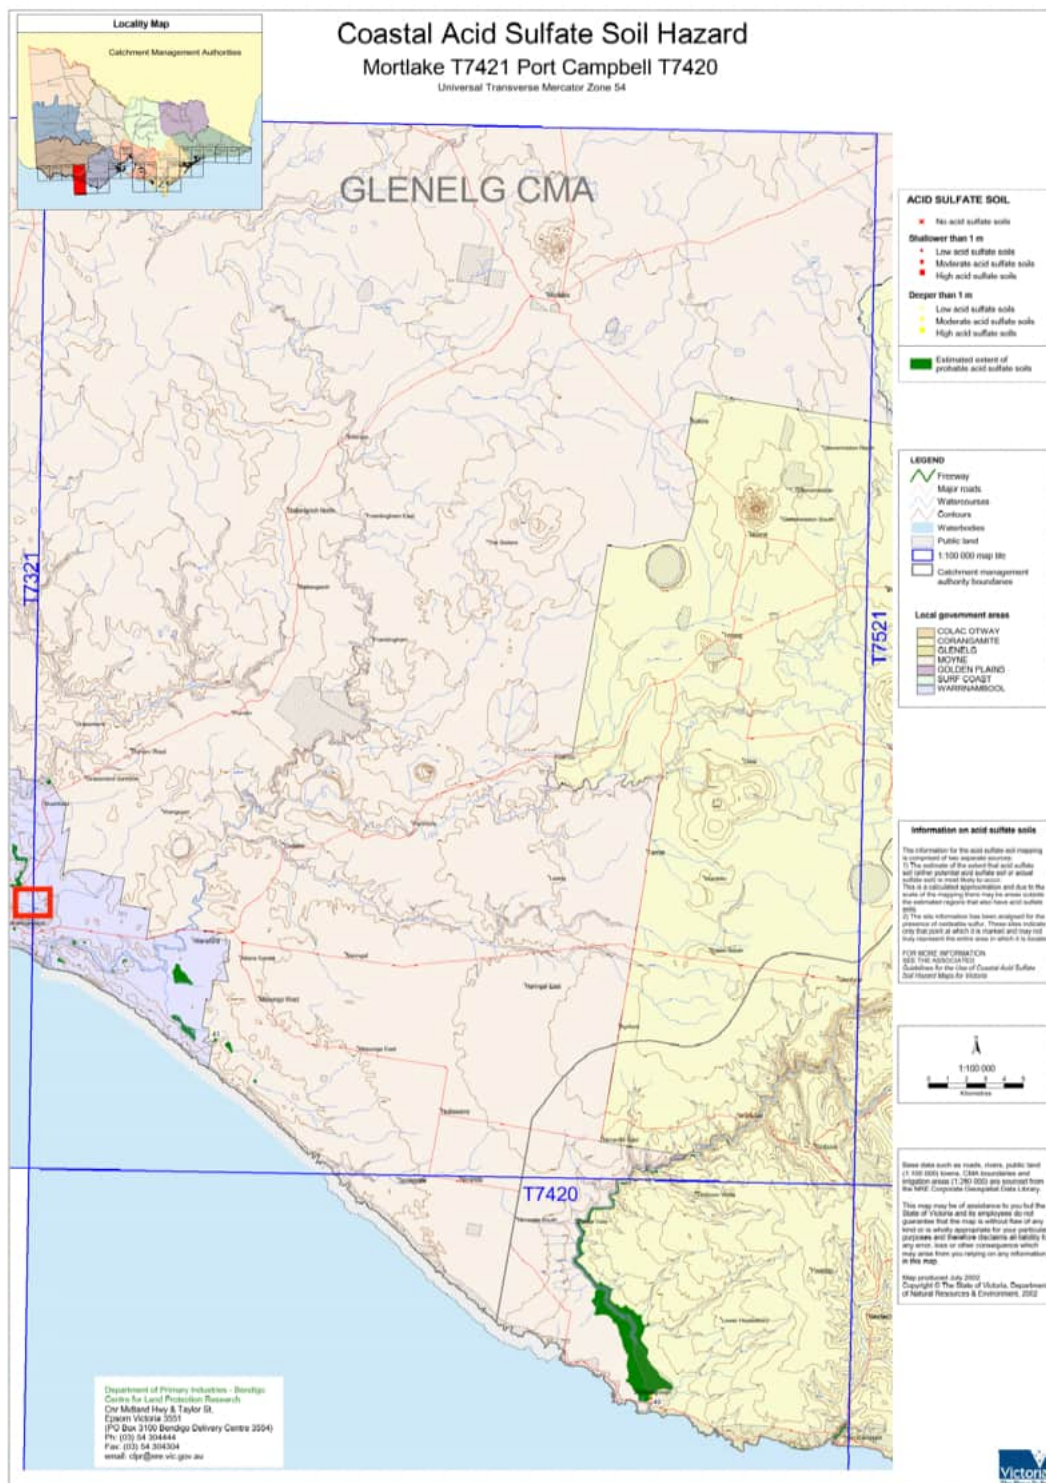
## Appendix 3 Coastal Acid Sulphate Soil Mapping

Referring to Coastal Acid Sulphate Soil Hazard Mapping Sheets for Warrnambool and Mortlake (Appendix 3), the study area and its surrounds is not mapped as likely to contain acid sulphate soils. Accordingly, groundwater acidification or potential acidification from this source is likely low.
