Amendment C205 to the Hume Planning Scheme – Lindum Vale PSP

Statement of Evidence

Satterley Property Group Pty Ltd

12 February 2018

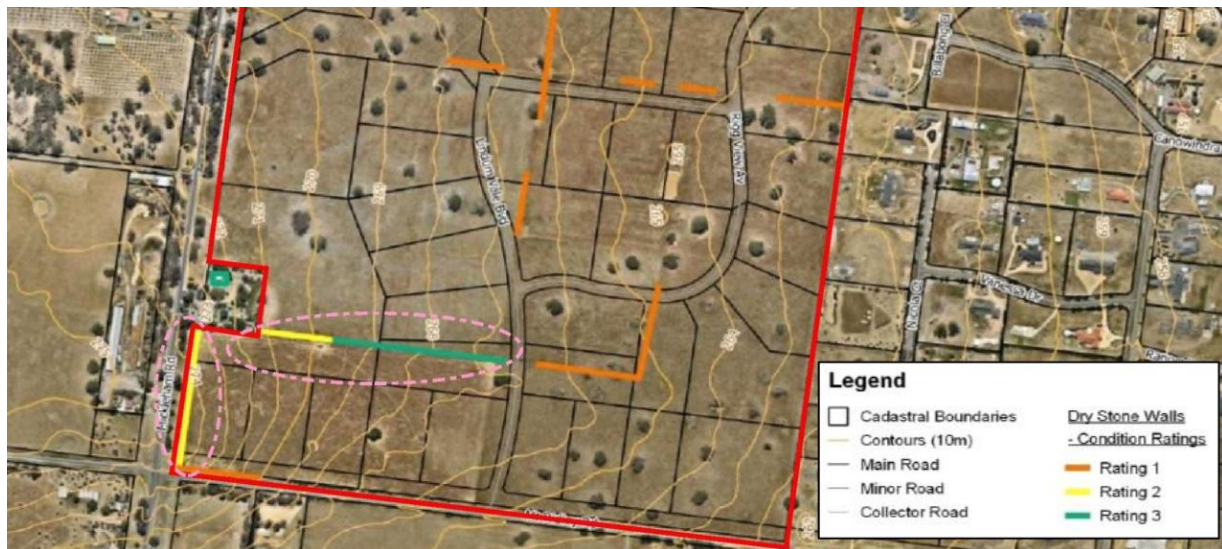
Figure 2 – Plan of the southern part of the PSP, showing the ratings of the subject dry stone walls (circled in pink). Note – the PSP layout shown in this plan is out of date. (Source: After Stevens 2015 & EHP 2017)

As can be seen from Table 1, the great majority of the dry stone walls in the PSP were categorised as being of Rating 1, i.e. of poorer condition. Figure 2 shows the location of all of the walls in the PSP which have been assigned a higher rating (Rating 2 or 3), and their assigned ratings are shown in Figure 2.

- DSW1 (recorded as including components DSW1-1 & DSW 1-2) – running east from the southeast corner of the adjacent Parnell's Inn property. This was categorised as Rating 2 by Stevens (2015);
- DSW2 (recorded as including components DSW2-1 & DSW2-2) – continuing eastwards from the east end of DSW1, but separated from it by a gate. This was categorised as Rating 3 by Stevens (2015); and
- DSW3 – running south, along Mickleham Road from the Parnell's Inn property. This was categorised as Rating 3 by Stevens (2015).

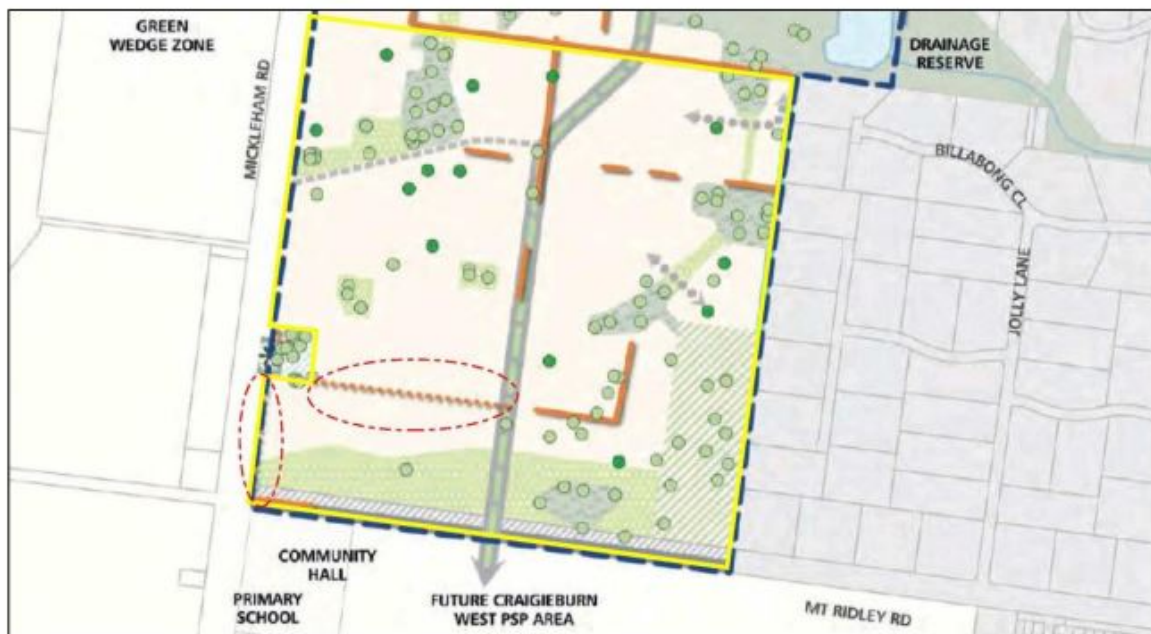
Figure 3 – Plan of the southern part of the PSP showing the subject dry stone walls (circled) in relation to the main spinal access road. Note – the detail of the PSP layout remains subject to revision. (Source: After EHP 2017)

Satterley is keen to ensure that any retained dry stone walls don't inhibit access to parts of the PSP, and this has been expressed as a concern in relation to the Amendment. This is a particular issue in relation to the directed retention of DSW2 that coincides with the proposed spinal thoroughfare through the PSP (see Figure 3). The retention of the east west aligned wall will present difficulties around connectivity in this part of the PSP, especially as the VPA has asserted that the creation of breaks in the wall for pedestrian and vehicle access should be kept to a minimum (Part A 2018).
