2 May 2018

155 Dore Road Pakenham tree assessment

Our ref: Matter 27511

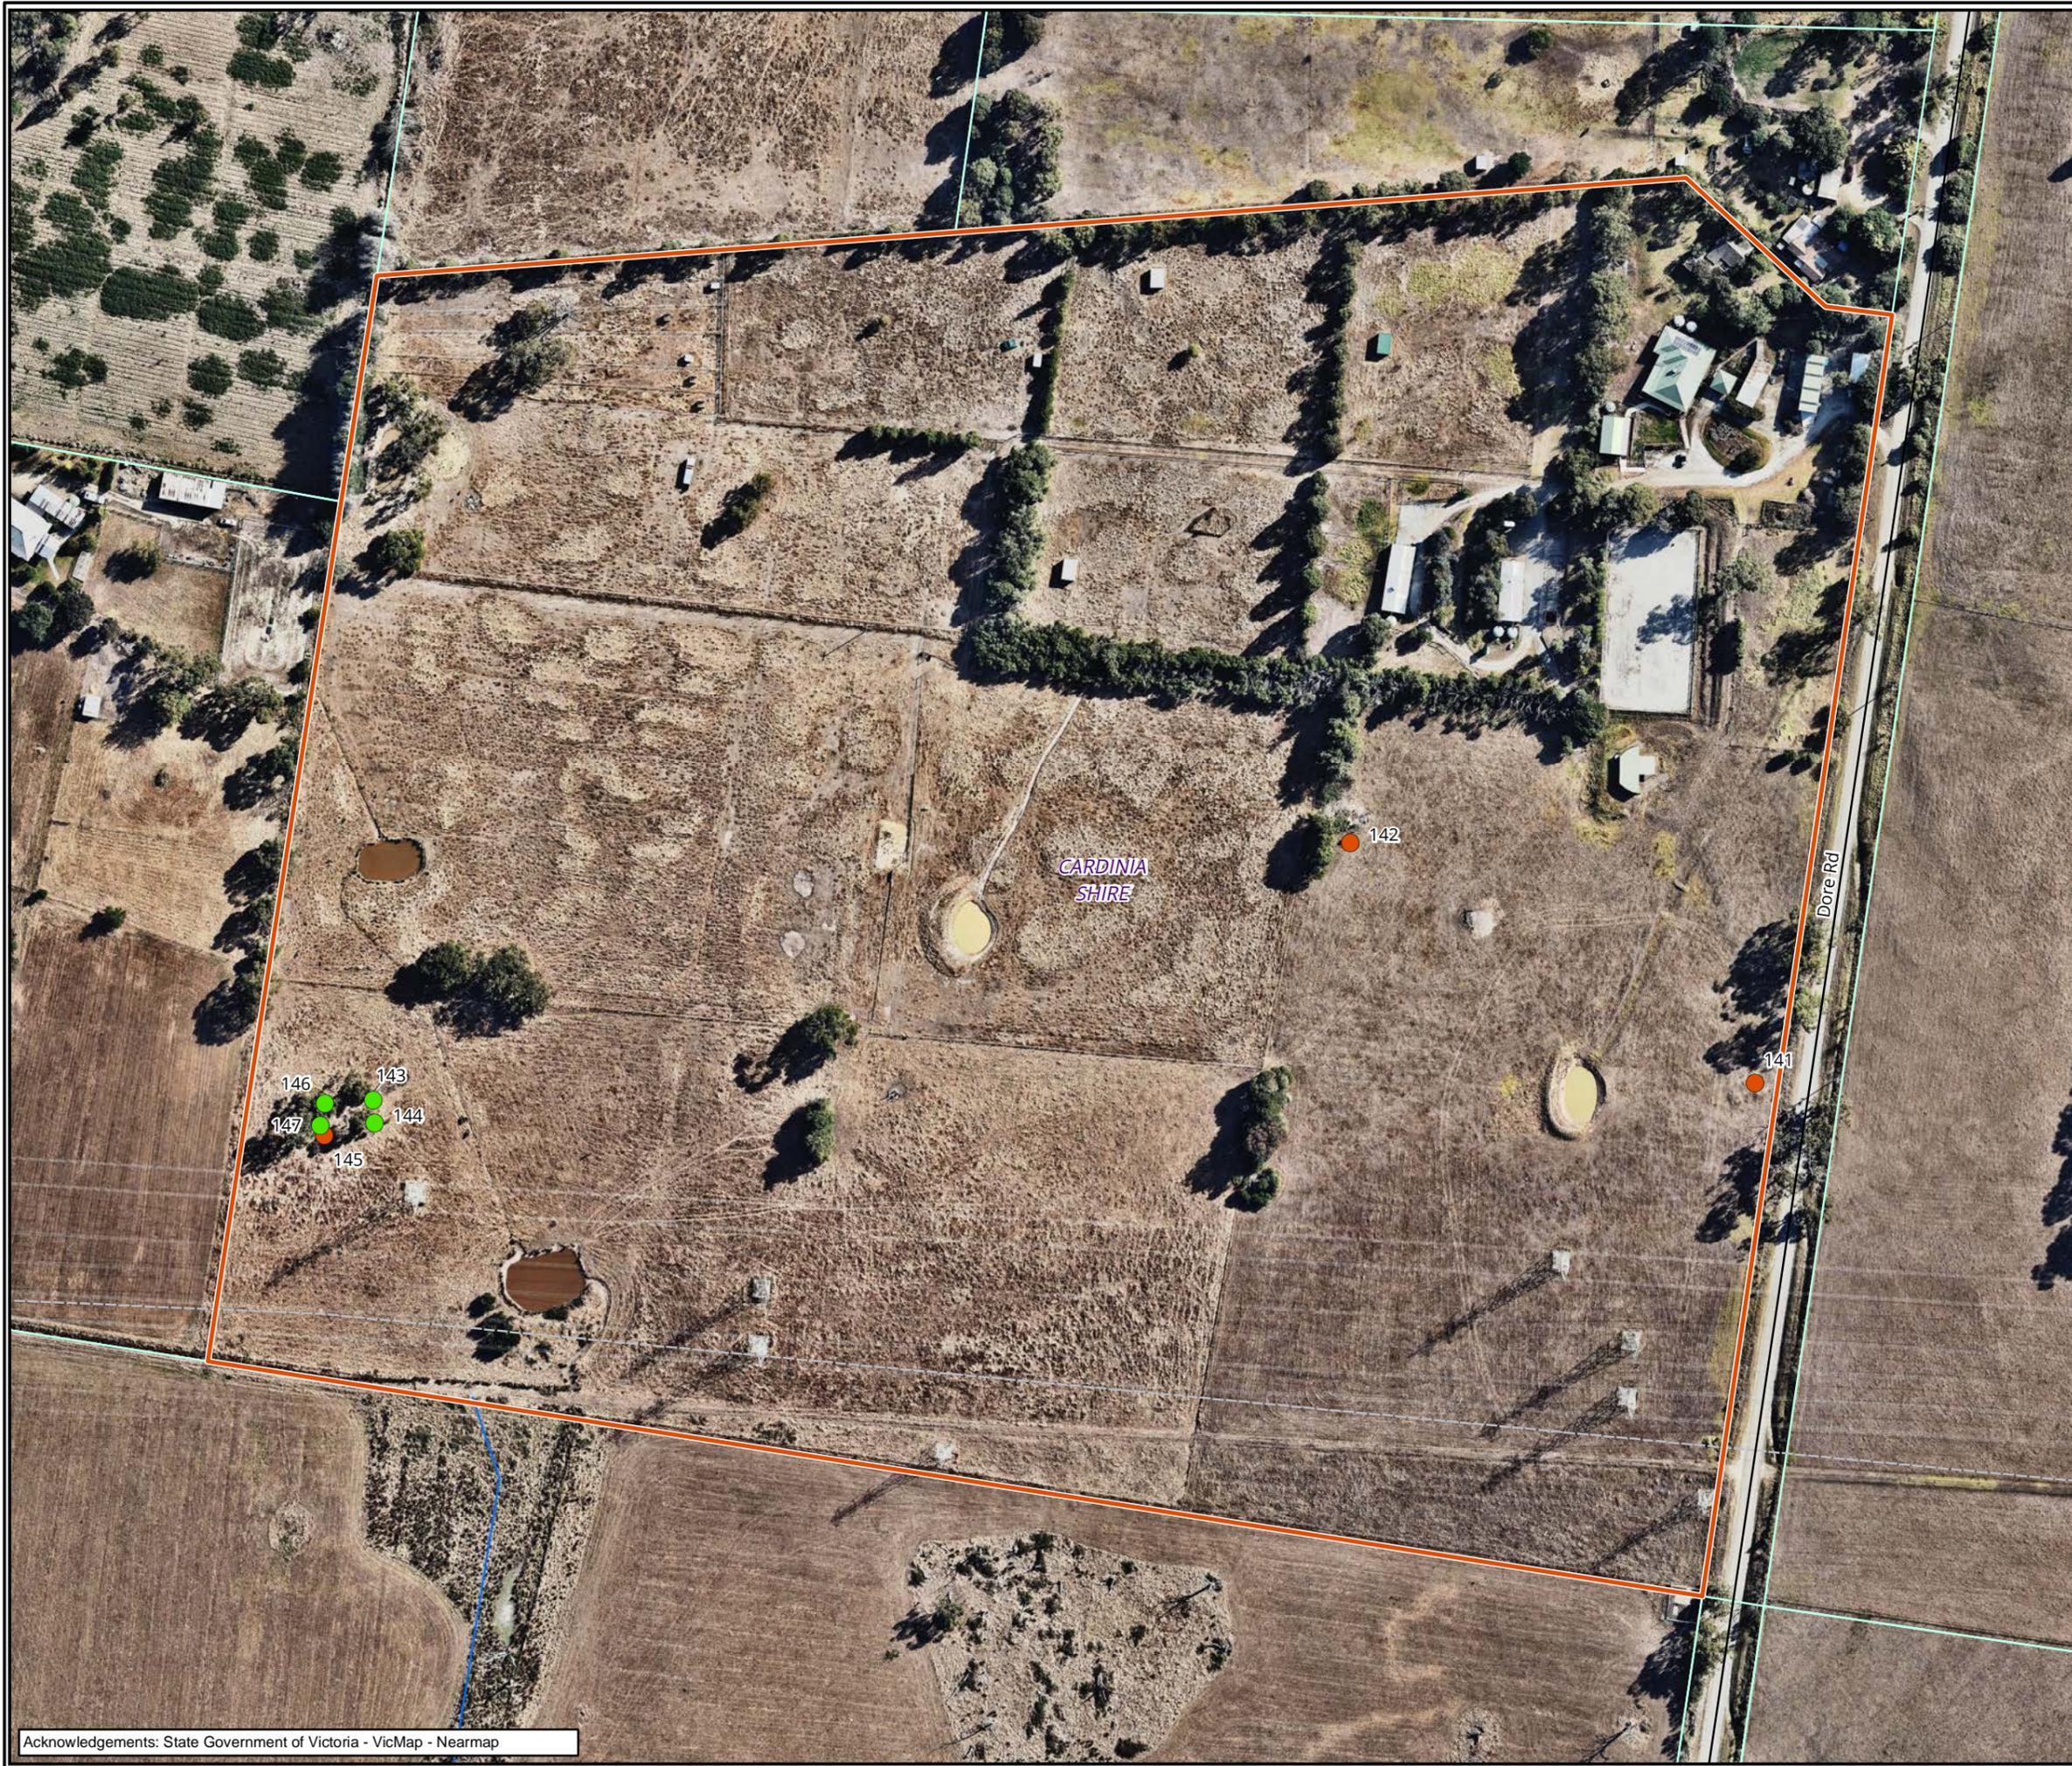
Figure 1: Location of trees to be retained under the NVPP, 155 Dore Road Pakenham

The study area was assessed on the 26 April 2018. Seven indigenous trees within the property identified to be retained within the NVPP (tree numbered 141-147) were assessed for their ecological value, potential for fauna habitat and current tree condition. The location of each tree assessed was based upon the location as displayed in Figure 2a of the NVPP as the written coordinates in Table 2 of the NVPP did not correspond with the figures.
