Arboricultural Assessment and Report

River Red Gum trees Kororoit Creek, Melton East PSP

Prepared for Victorian Planning Authority

5 May 2023

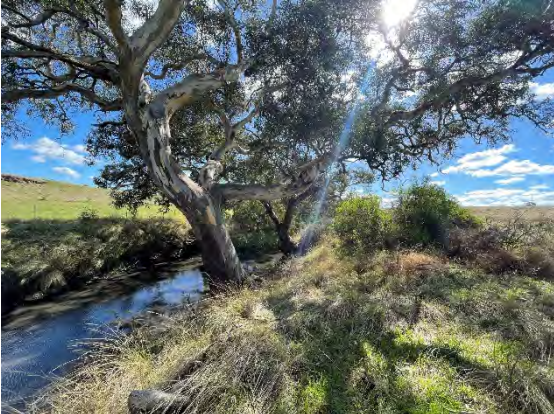
Tree ID: 21. *Eucalyptus camaldulensis* (River Red Gum), Maturing, Indigenous. Arb. Rating: High. Habitat hollows.
DBH: 105 cm. TPZ rad 12.6 m radius. Permit req'ment: ESO 2&5, 52.17.
Map ref: 1

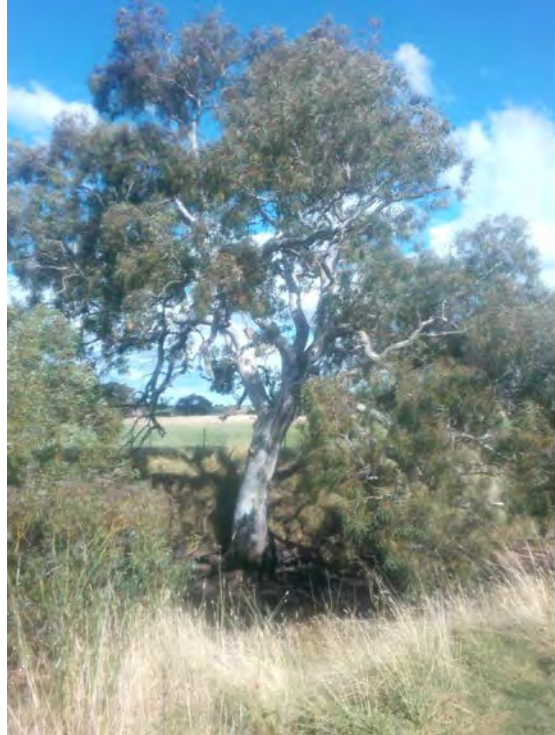
Tree ID: 31. *Eucalyptus camaldulensis* (River Red Gum), Maturing, Indigenous. Arb. Rating: High.
DBH: 90 cm. TPZ rad 10.8 m radius. Permit req'ment: ESO 2&5, 52.17.
Map ref: 1

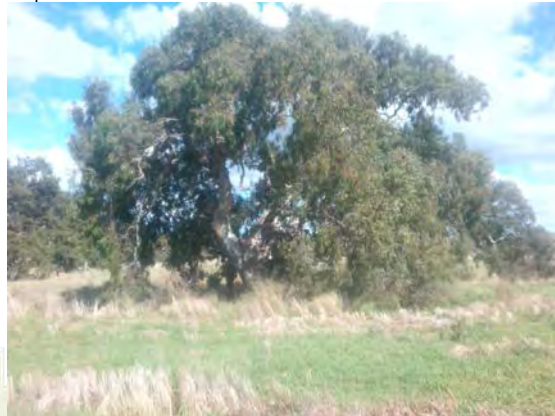
Tree ID: 33. *Eucalyptus camaldulensis* (River Red Gum), Maturing, Indigenous. Arb. Rating: High. Habitat hollows, past limb failure.
DBH: 127 cm. TPZ rad 15 m radius. Permit req'ment: ESO 2&5, 52.17.
Map ref: 1

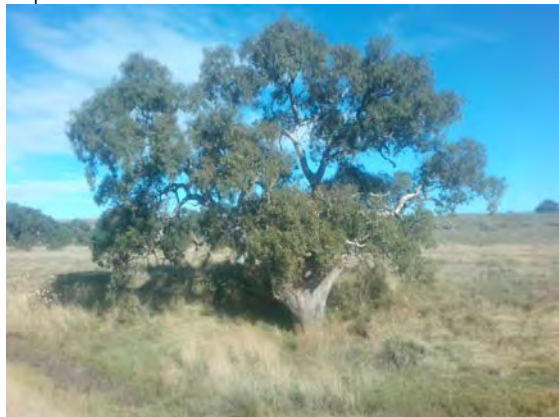
Tree ID: 45. *Eucalyptus camaldulensis* (River Red Gum), Maturing, Indigenous. Arb. Rating: High. Habitat hollows. DBH: 145 cm. TPZ rad 15 m radius. Permit req'ment: ESO 2&5, 52.17. Map ref: 2

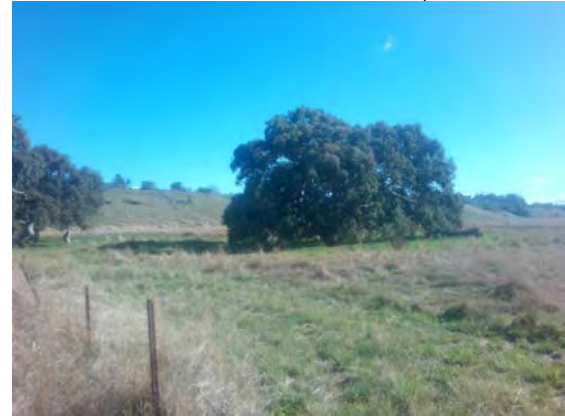
Tree ID: 49. *Eucalyptus camaldulensis* (River Red Gum), Maturing, Indigenous. Arb. Rating: High. Neighbour's tree. DBH: 95 cm. TPZ rad 11.4 m radius. Permit req'ment: 52.17. Map ref: 2

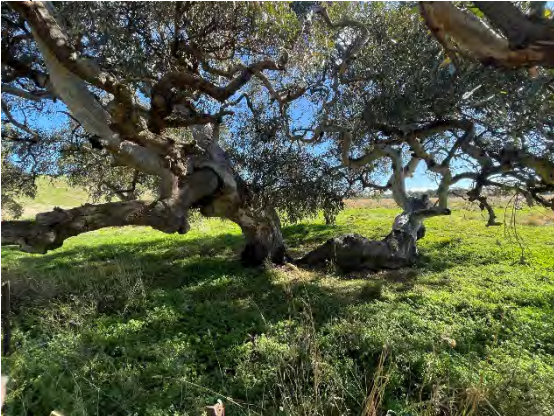
Tree ID: 51. *Eucalyptus camaldulensis* (River Red Gum), Maturing, Indigenous. Arb. Rating: High. Neighbour's tree. Two trunks. DBH: 110,90 cm. TPZ rad 15 m radius. Permit req'ment: ESO 2&5, 52.17. Map ref: 2

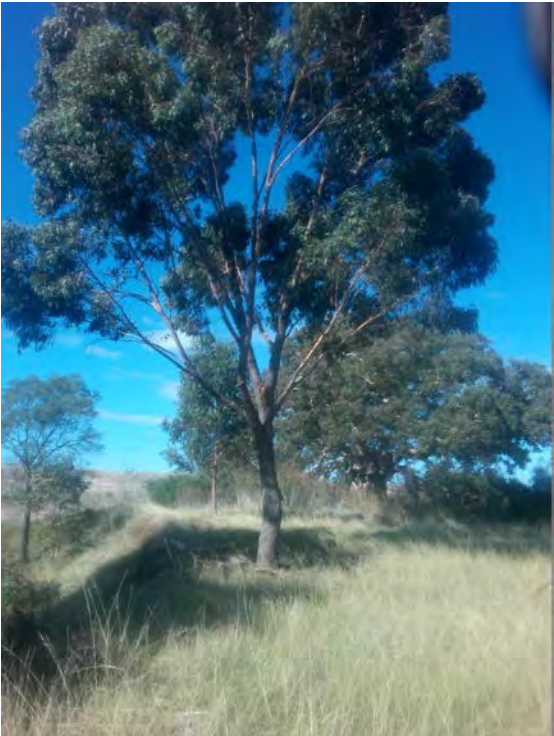
Tree ID: 57. *Eucalyptus melliodora* (Yellow Box), Semi-mature, Victorian native. Arb. Rating: Mod.B. DBH: 38 cm. TPZ rad 5 m radius. Permit req'ment: Exempt - planted. Map ref: 2

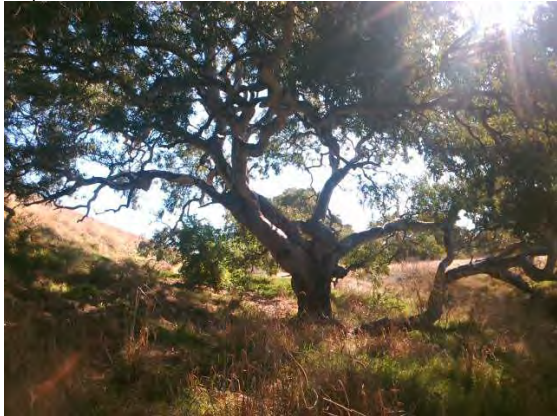
Tree ID: 69. *Eucalyptus camaldulensis* (River Red Gum), Maturing, Indigenous. Arb. Rating: Mod.A. Over-extended limbs.
 DBH: 129 cm. TPZ rad 15 m radius. Permit req'ment: ESO 2&5, 52.17.
 Map ref: 3

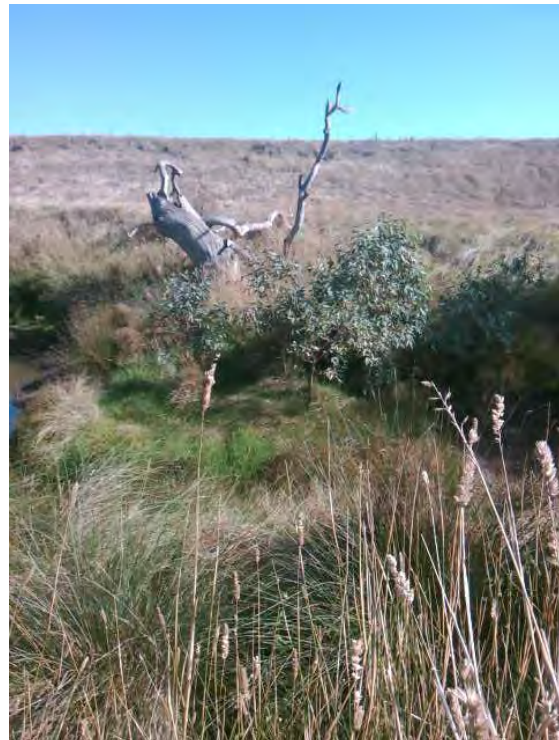
Tree ID: 77. *Eucalyptus camaldulensis* (River Red Gum), Over-mature, Indigenous. Arb. Rating: Low. Dead stag.
DBH: 76 cm. TPZ rad 9 m radius. Permit req'ment: ESO 2&5, 52.17. Map ref: 3

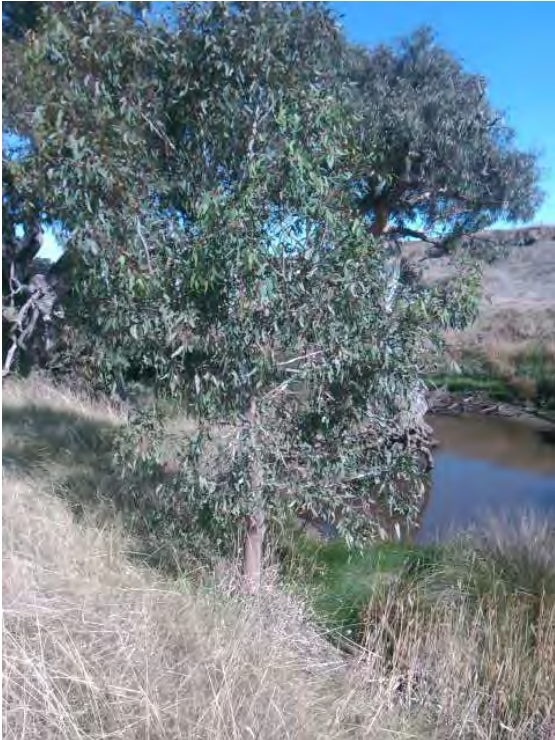
Tree ID: 78. *Eucalyptus camaldulensis* (River Red Gum), Semi-mature, Indigenous. Arb. Rating: Mod.B. DBH: 17 cm. TPZ rad 2 m radius. Permit req'ment: ESO 2&5, 52.17. Map ref: 3

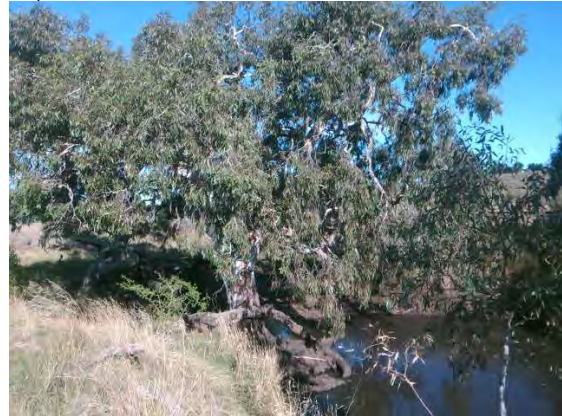
Tree ID: 111. *Eucalyptus camaldulensis* (River Red Gum), Maturing, Indigenous. Arb. Rating: High. Exposed roots. 1/2 in water. DBH: 120 cm. TPZ rad 14.4 m radius. Permit req'ment: ESO 2&5, 52.17. Map ref: 4

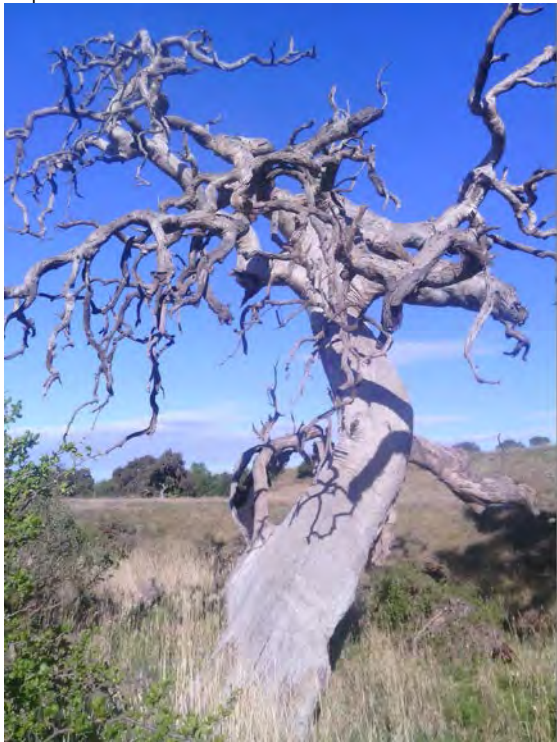
Tree ID: 119. *Eucalyptus camaldulensis* (River Red Gum), Over-mature, Indigenous. Arb. Rating: Low.
 DBH: 130 cm. TPZ rad 15 m radius. Permit req'ment: ESO 2&5, 52.17.
 Map ref: 4

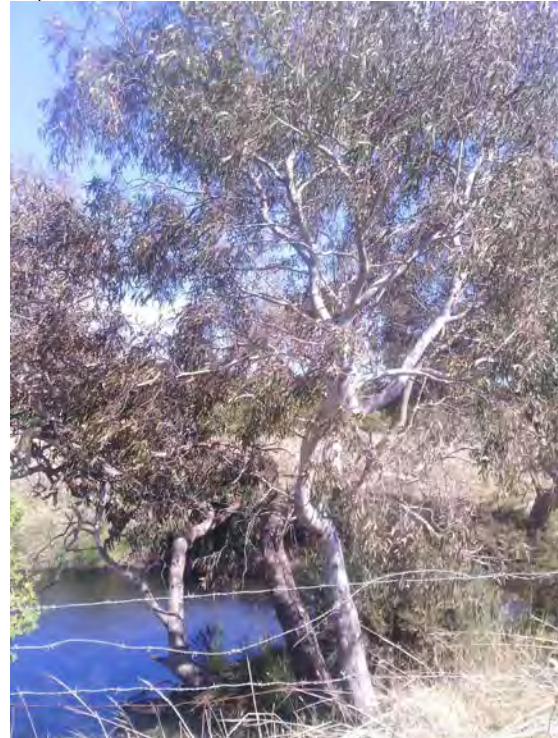
Tree ID: 140. *Eucalyptus camaldulensis* (River Red Gum), Maturing, Indigenous. Arb. Rating: Mod.A. Water edge, chlorotic foliage, exposed roots. DBH: 90 cm. TPZ rad 10.8 m radius. Permit req'ment: ESO 2&5, 52.17. Map ref: 5

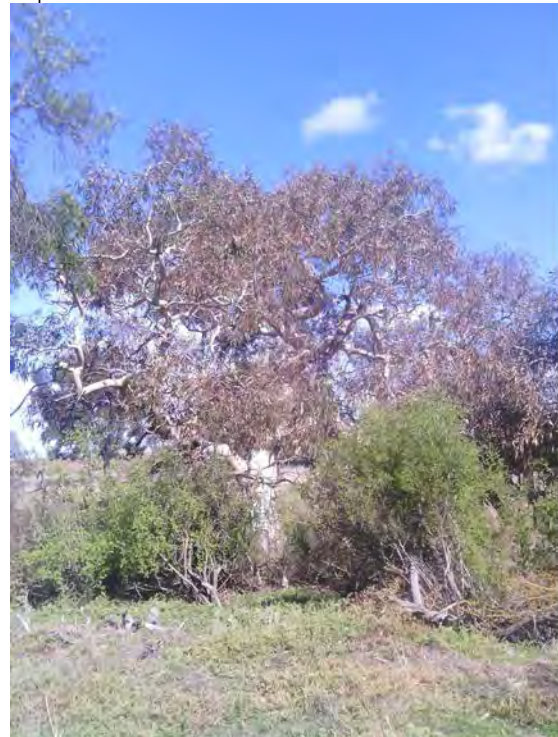
Tree ID: 145. *Eucalyptus camaldulensis* (River Red Gum), Maturing, Indigenous. Arb. Rating: Mod.A. Water edge, exposed roots, leaning trunk. DBH: 50 cm. TPZ rad 6 m radius. Permit req'ment: ESO 2&5, 52.17. Map ref: 5

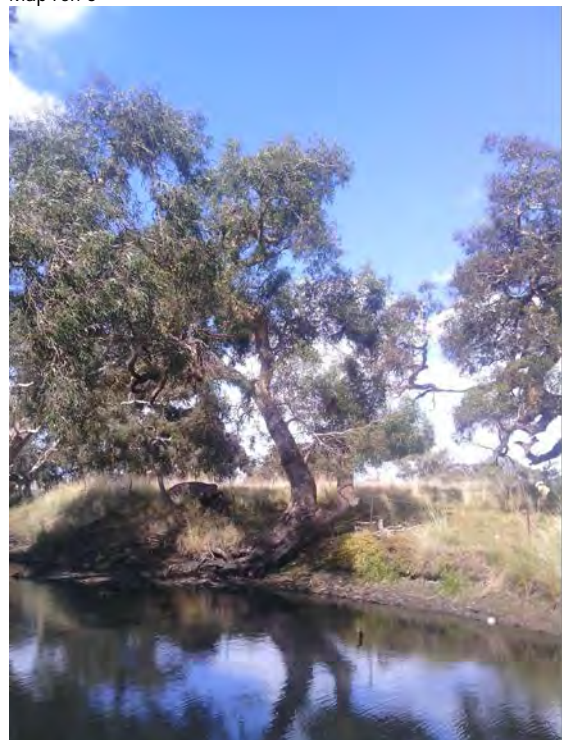
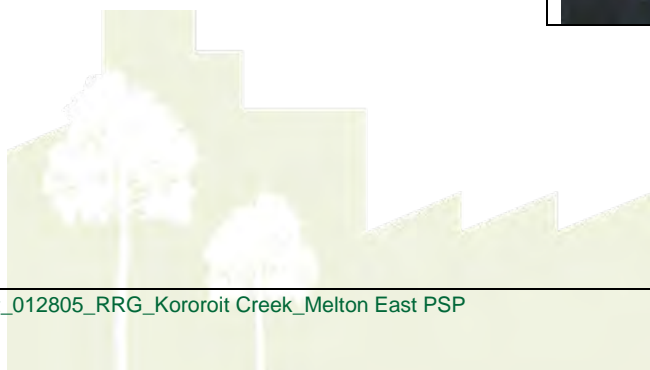
Tree ID: 149. *Eucalyptus camaldulensis* (River Red Gum), Maturing, Indigenous. Arb. Rating: Mod.A. Water edge, exposed roots, past branch failure. DBH: 50, 30 cm. TPZ rad 7 m radius. Permit req'ment: ESO 2&5, 52.17. Map ref: 5

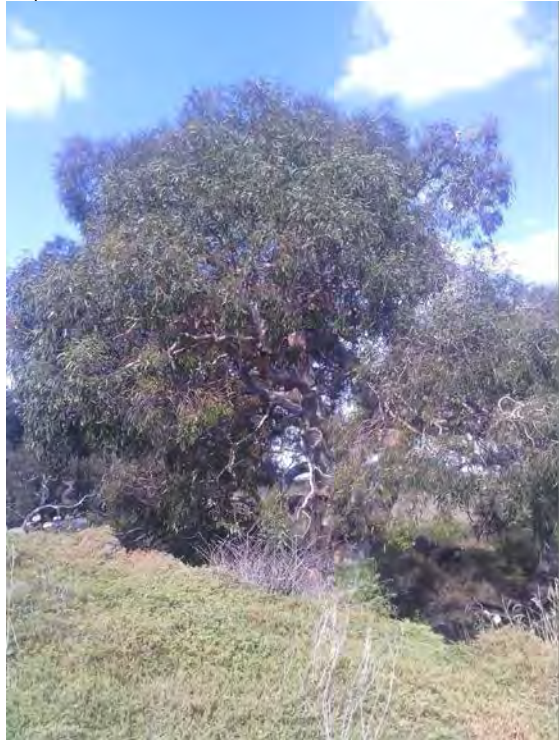
Tree ID: 154. *Eucalyptus camaldulensis* (River Red Gum), Early-mature, Indigenous. Arb. Rating: Mod.B. Waters edge, basal wounds. Trunk extends west over creek. DBH: 70 cm. TPZ rad 8.4 m radius. Permit req'ment: ESO 2&5, 52.17. Map ref: 5

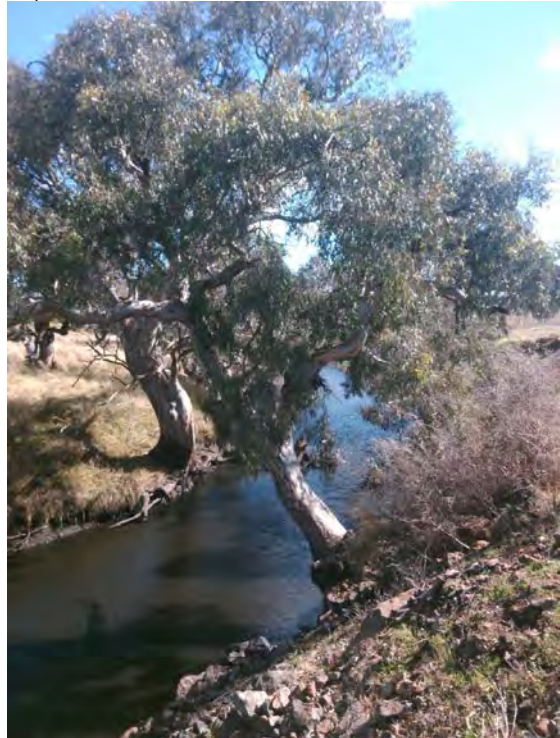
Tree ID: 153. *Eucalyptus camaldulensis* (River Red Gum), Maturing, Indigenous. Arb. Rating: Mod.A. Not accessed, waters edge, deadwood >50mm, trunk wounds. DBH: 90 cm. TPZ rad 10.8 m radius. Permit req'ment: ESO 2&5, 52.17. Map ref: 5

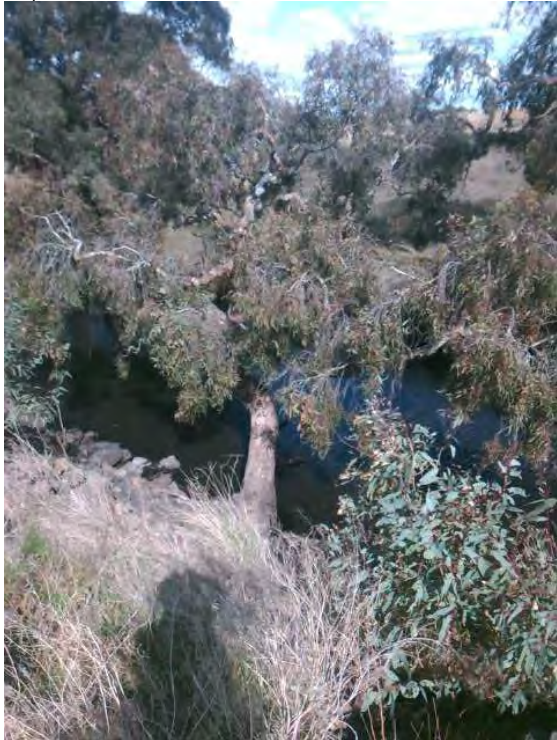
Tree ID: 158. *Eucalyptus camaldulensis* (River Red Gum), Early-mature, Indigenous. Arb. Rating: Mod.B. Waters edge, partly suppressed - crown bias se.
 DBH: 35 cm. TPZ rad 4.2 m radius. Permit req'ment: ESO 2&5, 52.17.
 Map ref: 5,6

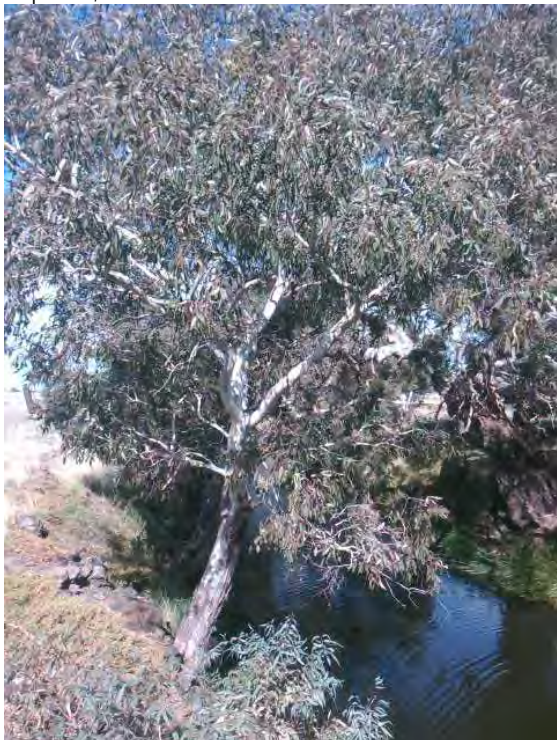
Tree ID: 159. *Eucalyptus camaldulensis* (River Red Gum), Maturing, Indigenous. Arb. Rating: Mod.A. Not accessed, waters edge, deadwood >50mm.
 DBH: 120 cm. TPZ rad 14.4 m radius. Permit req'ment: ESO 2&5, 52.17.
 Map ref: 5,6

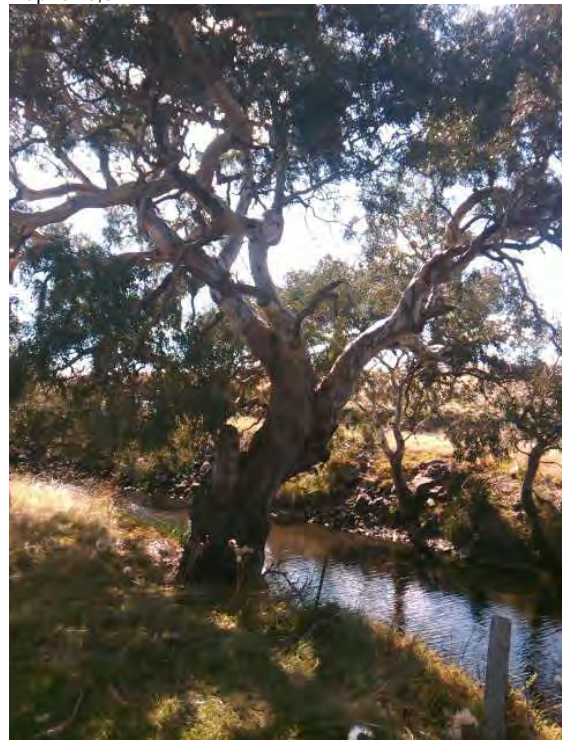
Tree ID: 160. *Eucalyptus camaldulensis* (River Red Gum), Early-mature, Indigenous. Arb. Rating: Mod.C. Leaning trunk. Trunk extending west over creek.
DBH: 27 cm. TPZ rad 3.2 m radius. Permit req'ment: ESO 2&5, 52.17. Map ref: 5,6

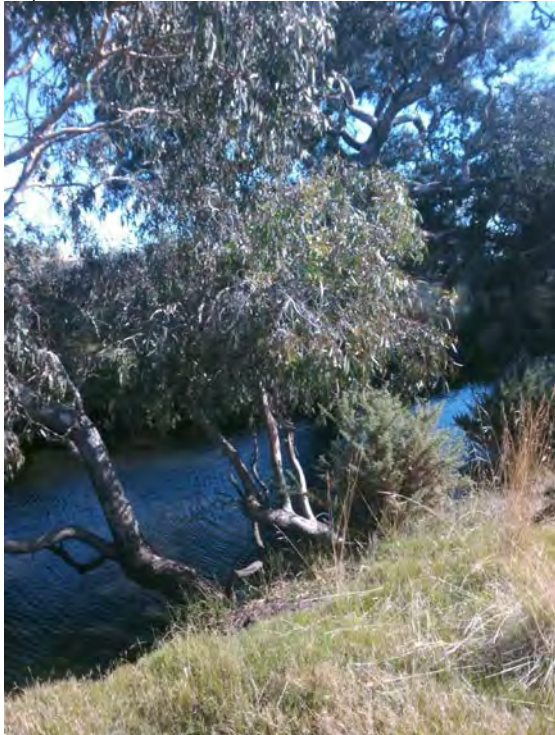
Tree ID: 162. *Eucalyptus camaldulensis* (River Red Gum), Maturing, Indigenous. Arb. Rating: High. Waters edge, deadwood >50mm. Remove wire constriction on trunk.
DBH: 75 cm. TPZ rad 9 m radius. Permit req'ment: ESO 2&5, 52.17. Map ref: 5,6

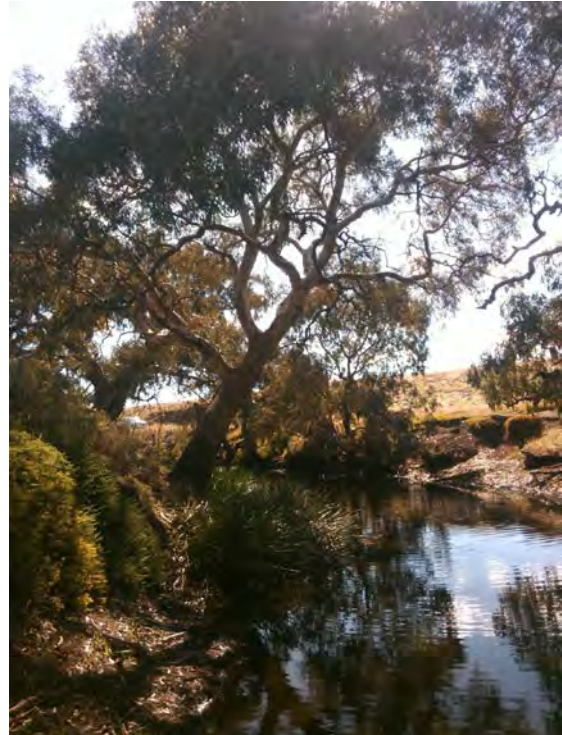
Tree ID: 161. *Eucalyptus camaldulensis* (River Red Gum), Early-mature, Indigenous. Arb. Rating: Mod.B. Abnormal lean. Trunk extending west over creek.
DBH: 38 cm. TPZ rad 4.6 m radius. Permit req'ment: ESO 2&5, 52.17. Map ref: 5,6

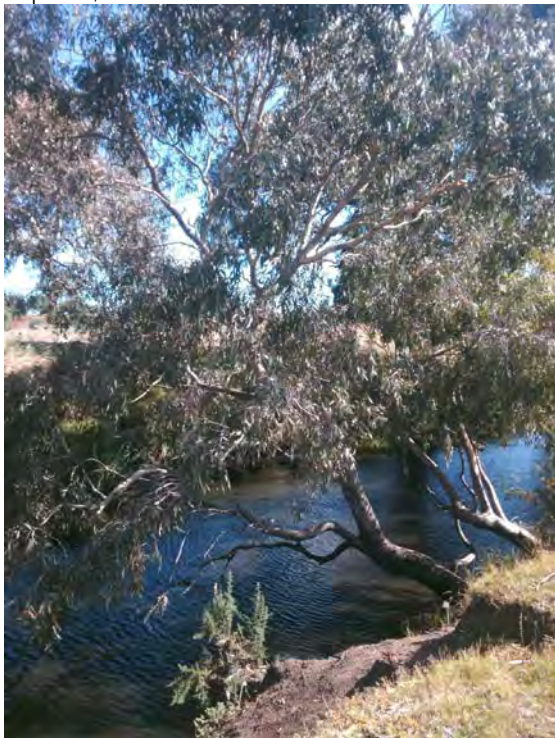
Tree ID: 163. *Eucalyptus camaldulensis* (River Red Gum), Maturing, Indigenous. Arb. Rating: Mod.A. Waters edge, deadwood >50mm. ~85cm trunk extending west over creek.
DBH: 90,95 cm. TPZ rad 15 m radius. Permit req'ment: ESO 2&5, 52.17. Map ref: 6

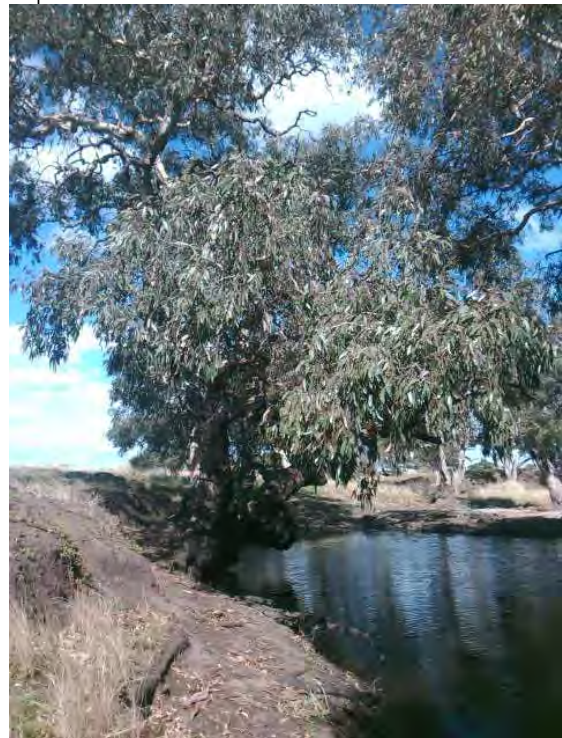
Tree ID: 164. *Eucalyptus camaldulensis* (River Red Gum), Early-mature, Indigenous. Arb. Rating: Mod.B. Waters edge, partly suppressed - crown bias se.
 DBH: 40 cm. TPZ rad 4.8 m radius. Permit req'ment: ESO 2&5, 52.17.
 Map ref: 6

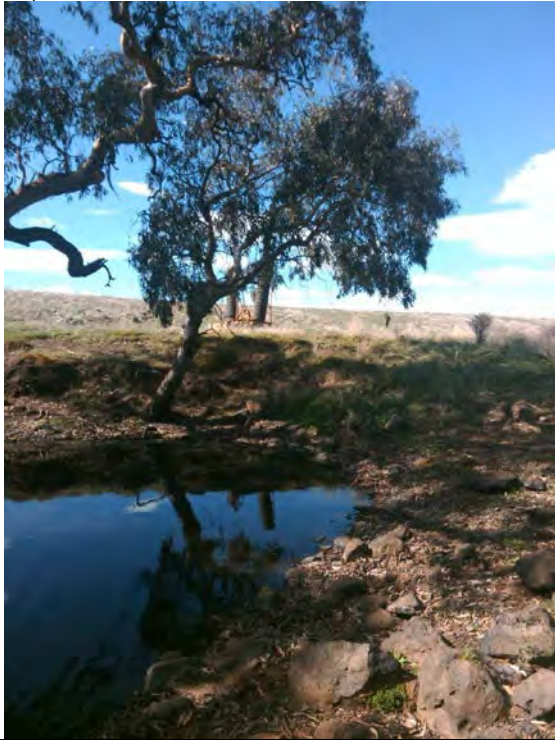
Tree ID: 166. *Eucalyptus camaldulensis* (River Red Gum), Early-mature, Indigenous. Arb. Rating: Mod.B. Basal wounds.
 DBH: 55 cm. TPZ rad 6.6 m radius. Permit req'ment: ESO 2&5, 52.17.
 Map ref: 5,6

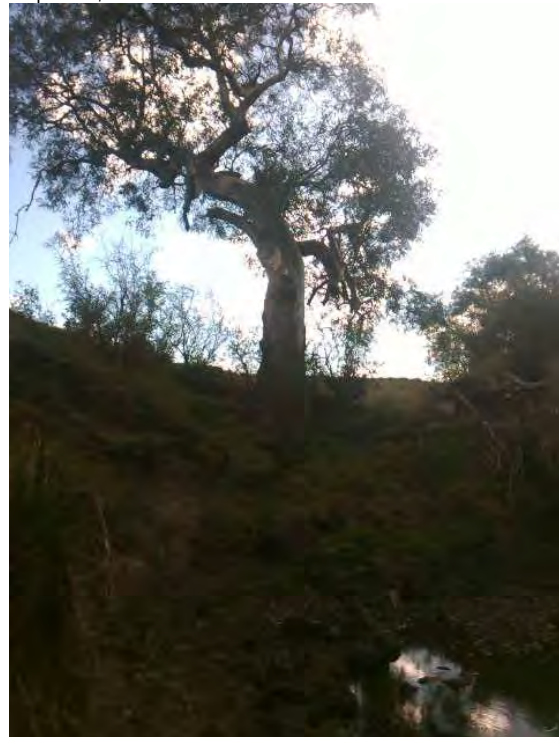
Tree ID: 168. *Schinus areira* (Peppercorn Tree), Early-mature, Exotic evergreen. Arb. Rating: Mod.B. Woody weed sp
DBH: 38 cm. TPZ rad 4.6 m radius. Permit req'ment: Exempt - weed. Map ref: 5,6

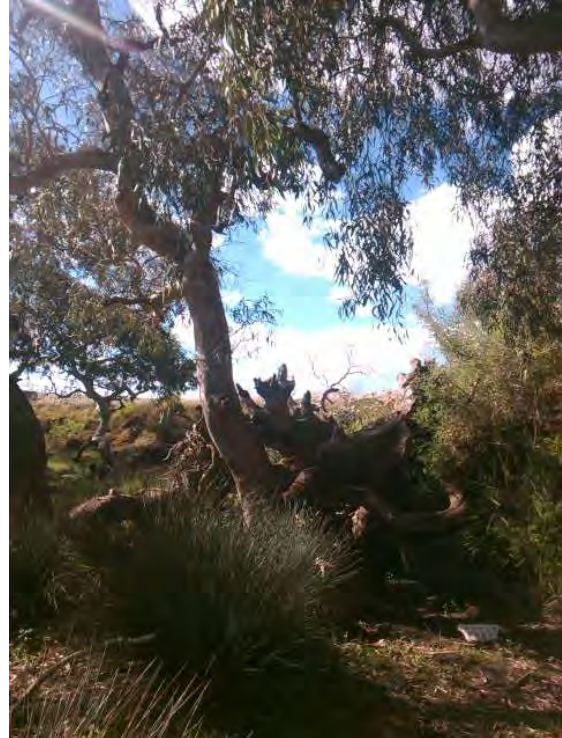
Tree ID: 174. *Eucalyptus camaldulensis* (River Red Gum), Early-mature, Indigenous. Arb. Rating: Mod.B. Waters edge, collapsed, exposed roots. Fallen into creek, growing on.
 DBH: 48 cm. TPZ rad 5.8 m radius. Permit req'ment: ESO 2&5, 52.17.
 Map ref: 6

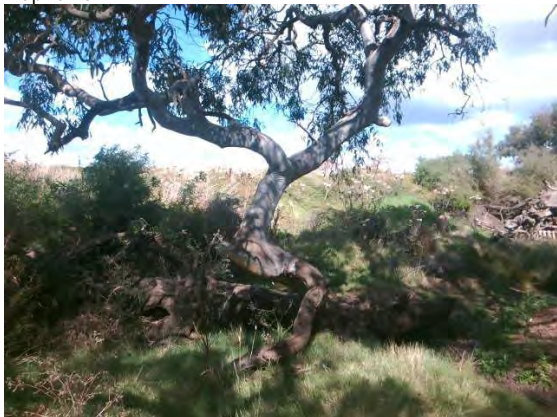
Tree ID: 176. *Eucalyptus camaldulensis* (River Red Gum), Over-mature, Indigenous. Arb. Rating: Low. Dead stag.
 DBH: 55 cm. TPZ rad 7 m radius. Permit req'ment: ESO 2&5, 52.17. Map ref: 6

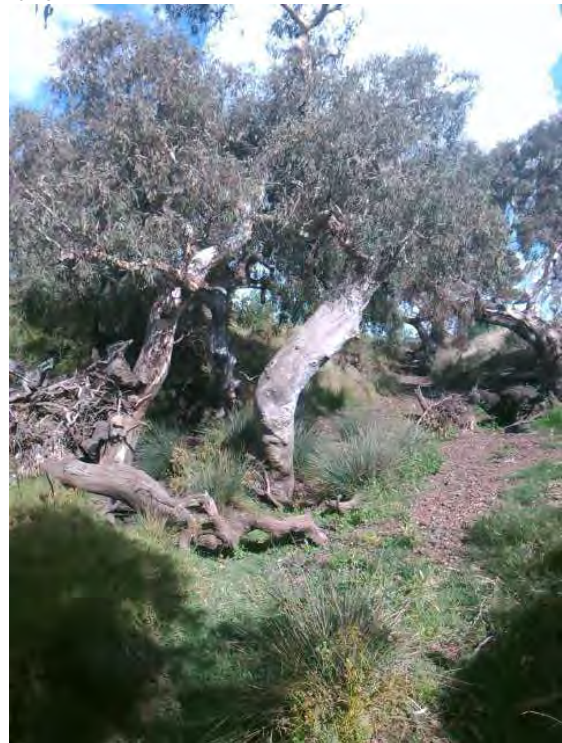
Tree ID: 177. *Eucalyptus camaldulensis* (River Red Gum), Early-mature, Indigenous. Arb. Rating: Mod.C. Waters edge, exposed roots, undermined by floods. Trunk extends W over creek.
DBH: 75 cm. TPZ rad 9 m radius. Permit req'ment: ESO 2&5, 52.17. Map ref: 6

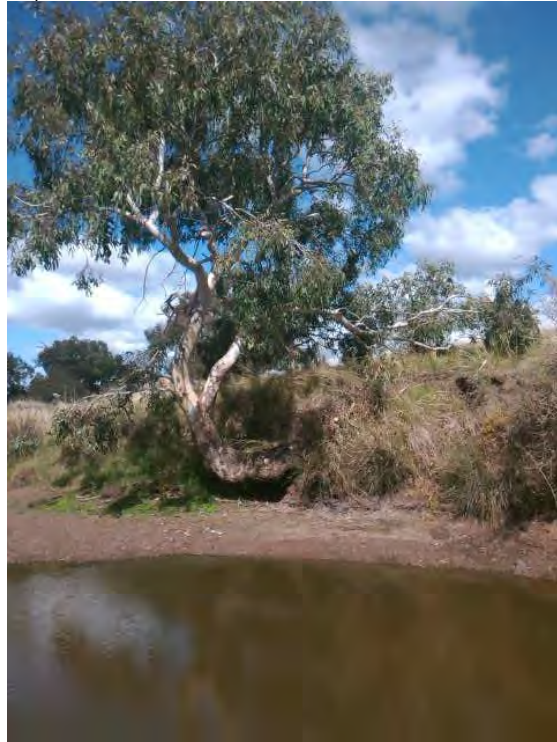
Tree ID: 182. *Eucalyptus camaldulensis* (River Red Gum), Early-mature, Indigenous. Arb. Rating: Mod.C. Waters edge, exposed roots. Undermined by floods.
 DBH: 30 cm. TPZ rad 3.6 m radius. Permit req'ment: ESO 2&5, 52.17. Map ref: 6

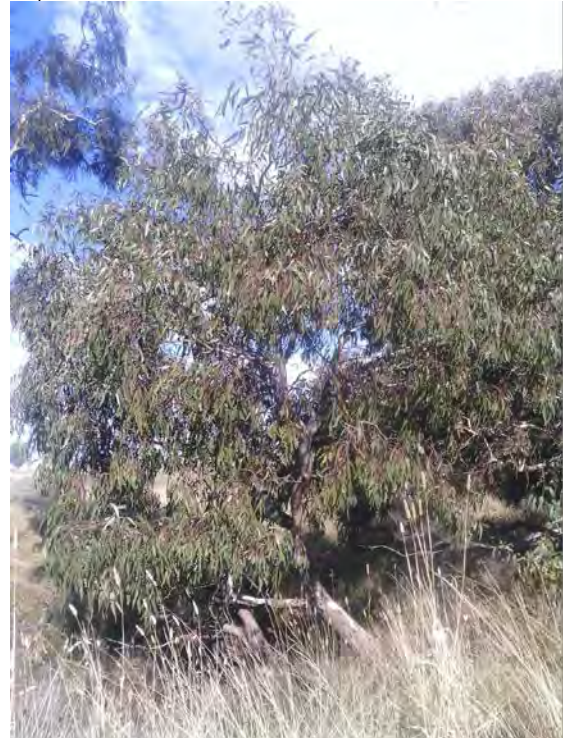
Tree ID: 211. *Eucalyptus camaldulensis* (River Red Gum), Maturing, Indigenous. Arb. Rating: Mod.A. Trunk wounds. DBH: 80 cm. TPZ rad 9.6 m radius. Permit req'ment: ESO 2&5, 52.17. Map ref: 8

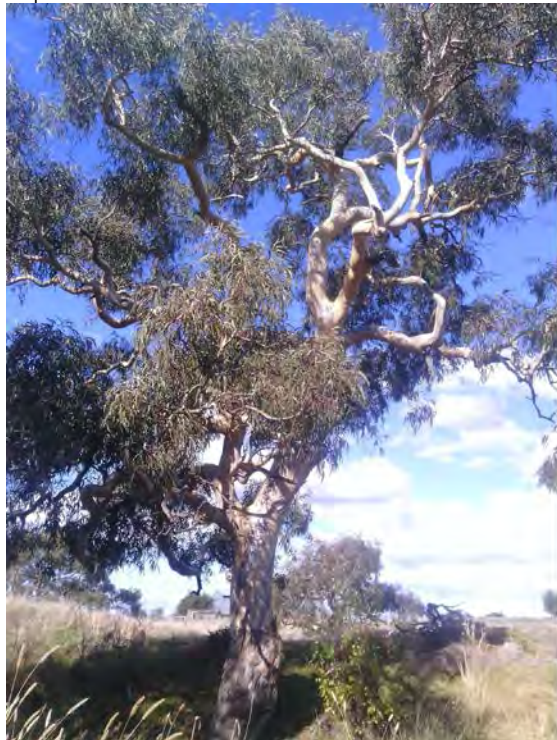
Tree ID: 213. *Eucalyptus camaldulensis* (River Red Gum), Semi-mature, Indigenous. Arb. Rating: Mod.B. Water edge, trunk cavity, trunk hollows. DBH: 75 cm. TPZ rad 9 m radius. Permit req'ment: ESO 2&5, 52.17. Map ref: 8

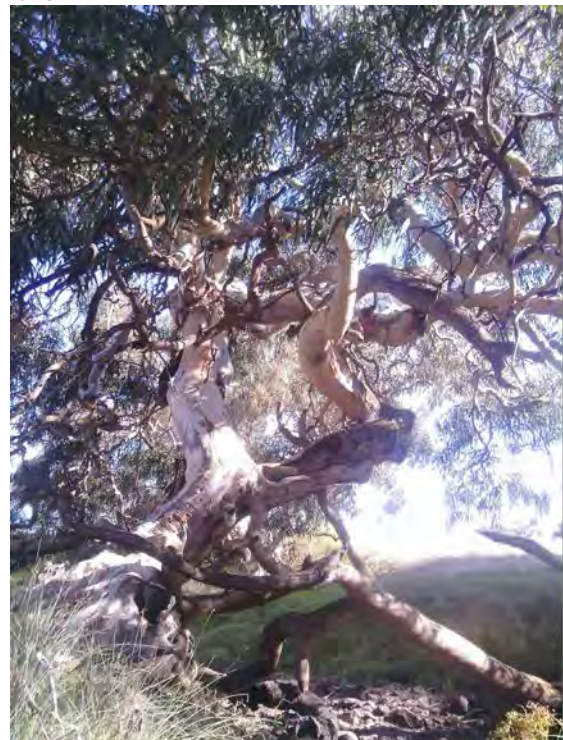
Tree ID: 220. *Eucalyptus camaldulensis* (River Red Gum), Maturing, Indigenous. Arb. Rating: Mod.B. Waters edge, exposed roots, undermined by floods.
DBH: 75 cm. TPZ rad 9 m radius. Permit req'ment: ESO 2&5, 52.17. Map ref: 8

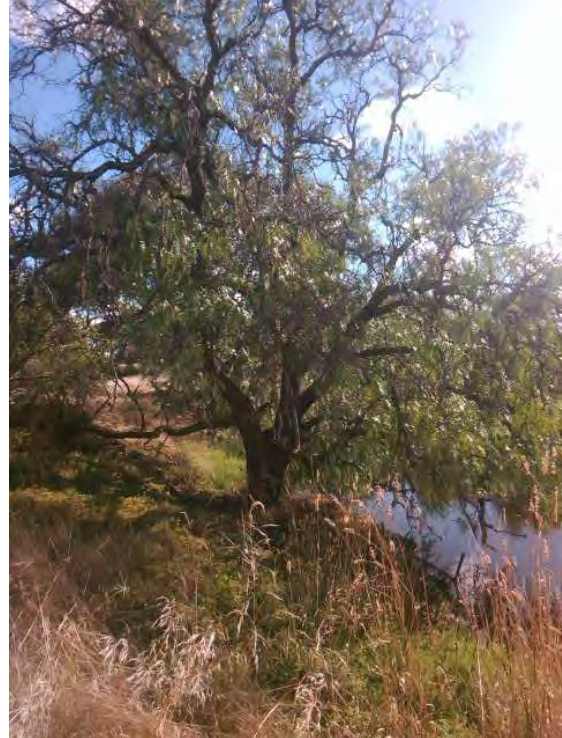
Tree ID: 221. *Eucalyptus camaldulensis* (River Red Gum), Maturing, Indigenous. Arb. Rating: Mod.B. Flood debris up against trunk.
DBH: 89 cm. TPZ rad 10.7 m radius. Permit req'ment: ESO 2&5, 52.17. Map ref: 8

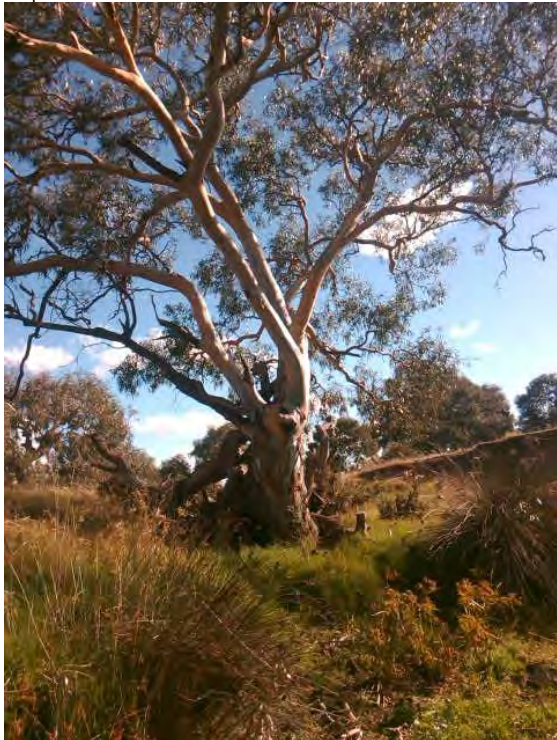
Tree ID: 223. *Eucalyptus camaldulensis* (River Red Gum), Early-mature, Indigenous. Arb. Rating: Mod.B. Trunk extends Sth over creek.
DBH: 44 cm. TPZ rad 5.3 m radius. Permit req'ment: ESO 2&5, 52.17. Map ref: 8

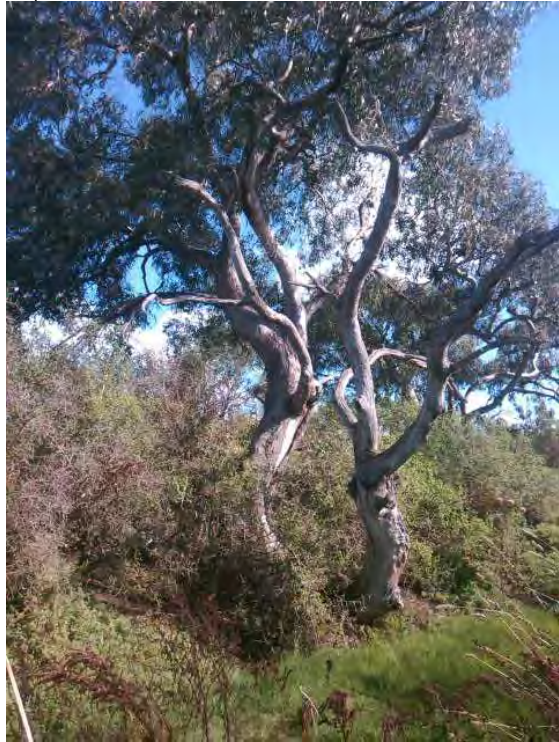
Tree ID: Grp 1. *Eucalyptus camaldulensis* (River Red Gum), Semi-mature, Indigenous. Arb. Rating: Mod.B. Group of 7 small trees
 DBH: 19 cm. TPZ rad 2.3 m radius. Permit req'ment: ESO 2&5, 52.17.
 Map ref: 4

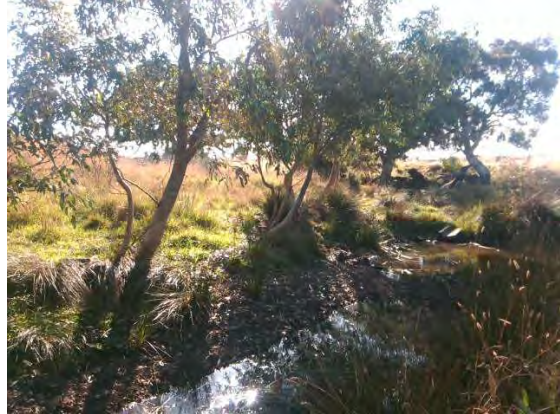
Tree ID: Grp 2. *Eucalyptus camaldulensis* (River Red Gum), Young, Indigenous. Arb. Rating: Mod.C. Group of 8 sapling trees
 DBH: 8 cm. TPZ rad 2 m radius. Permit req'ment: ESO 2&5, 52.18. Map ref: 4
