# **Growth Areas Authority**

Plumpton and Kororoit Precincts Land Capability Assessment

October 2013

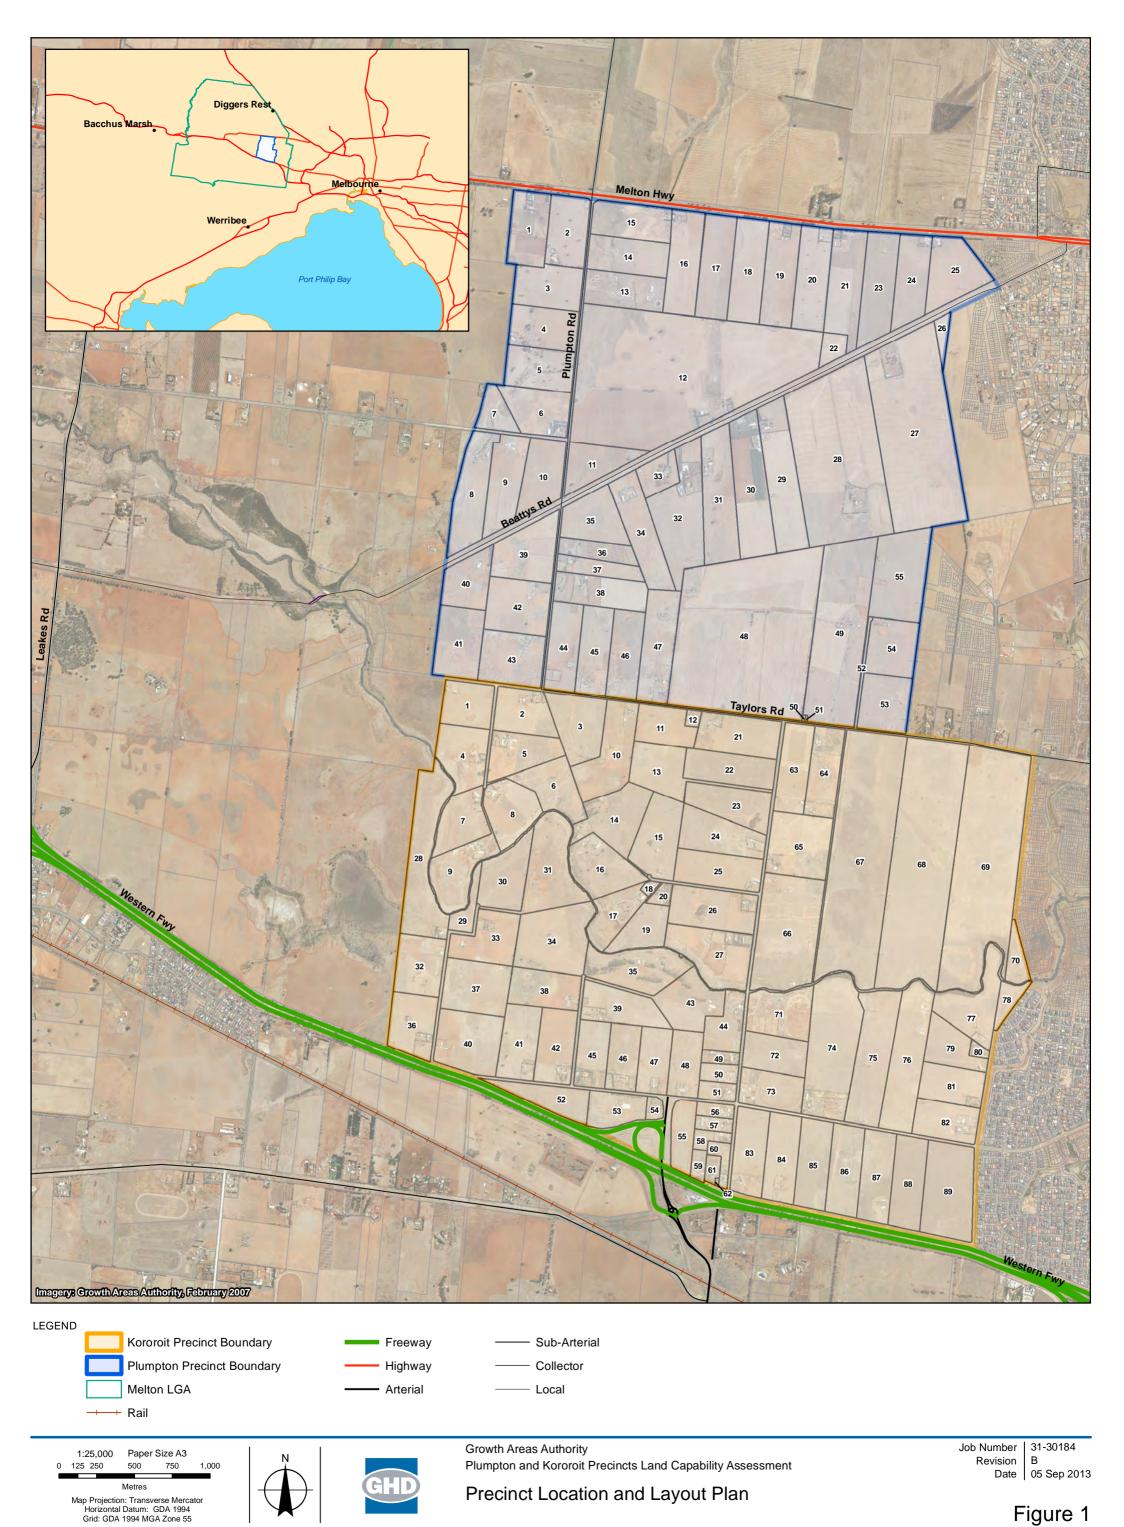
Both Precincts have been selected for future development as predominantly residential areas. A Precinct location and layout plan is provided as **Figure 1**.

A Precinct Location and Layout Plan, showing Property numbers is provided as Figure 1.

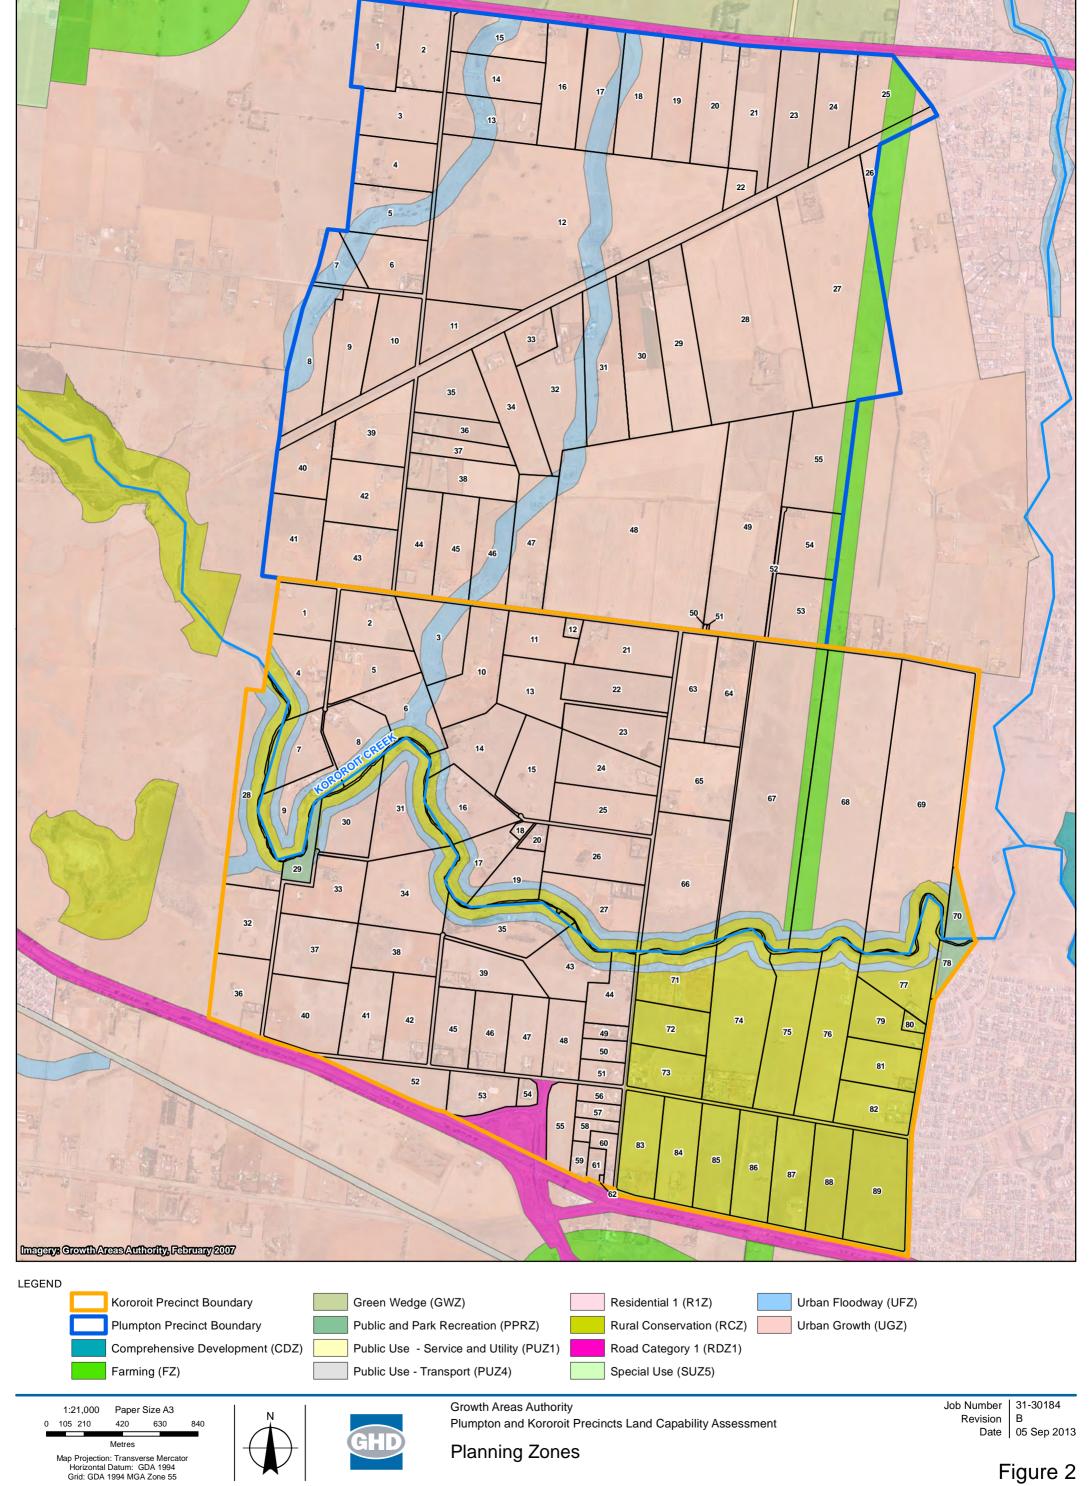
Figure 2 shows the Planning Zones for the both of the Precincts and surrounding areas.

The Precincts are located in an area that includes generally north-south oriented, low ridges associated with tributaries of Kororoit Creek, and Kororoit Creek itself which runs west-east through the centre of the Kororoit Precinct. The surface elevation of these small ridges ranges from 100 - 130 m Above Height Datum (mAHD) in the Plumpton Precinct and 80 - 100 mAHD in the Kororoit Precinct. Low lying areas associated with these watercourses, swamps and wetland areas throughout the Precincts, are prone to flooding. Some of these low lying areas are listed as being at risk of flooding by the Melton City Council Planning Scheme (hence the planning zones and overlays relating to inundation listed in **Section 2.1.2** and **2.1.3** and presented in **Figure 2** and **Figure 3**).

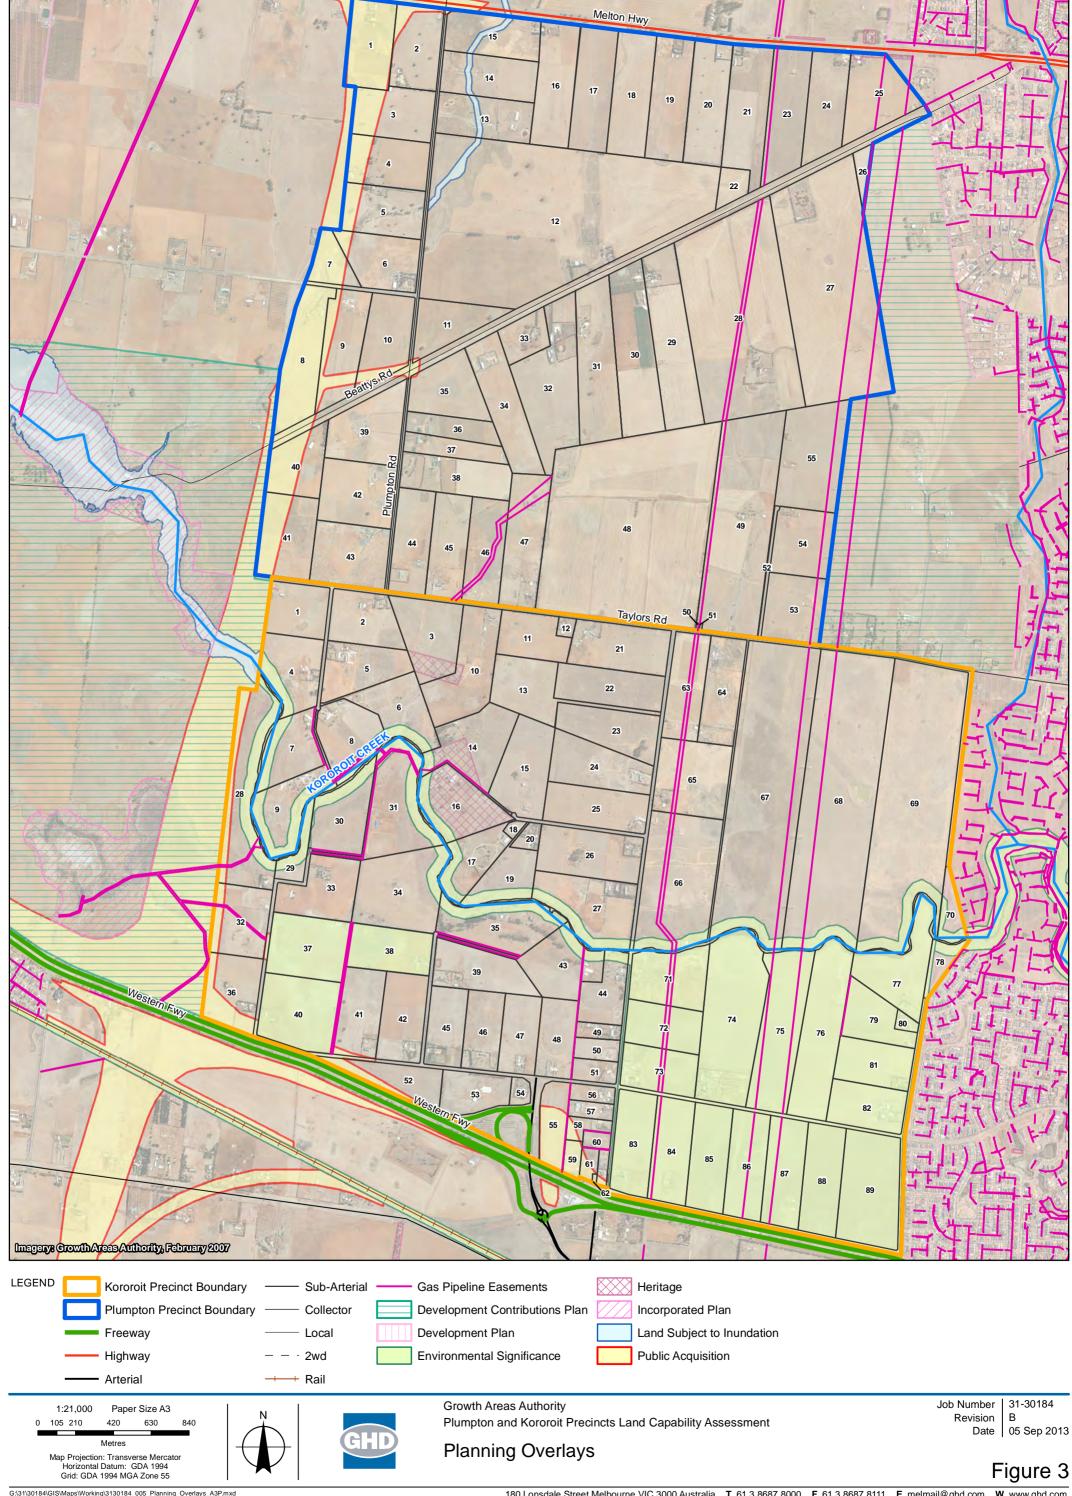
The planning scheme overlay information for the Precincts and surrounding areas are shown in **Figure 3**, including gas pipeline easements, which indicate where gas infrastructure throughout the Precincts is located.

<sup>&</sup>lt;sup>6</sup> **Figure 3** shows the gas pipeline alignments and easements in the Precincts and surrounding areas. This information was provided to GHD by GAA.

Earthworks associated with the transmission pressure gas pipeline which runs through the Precincts (extending north-south from Melton Highway to the Western Freeway) were noted in the 1979, 2001 and 2012 Kororoit aerial imagery (see **Figure 3** for location of gas pipeline). The works associated with this pipeline were undertaken over a number of years and may have involved multiple stages of work. The gas 'city gates' on Properties 50 and 51 in the Plumpton

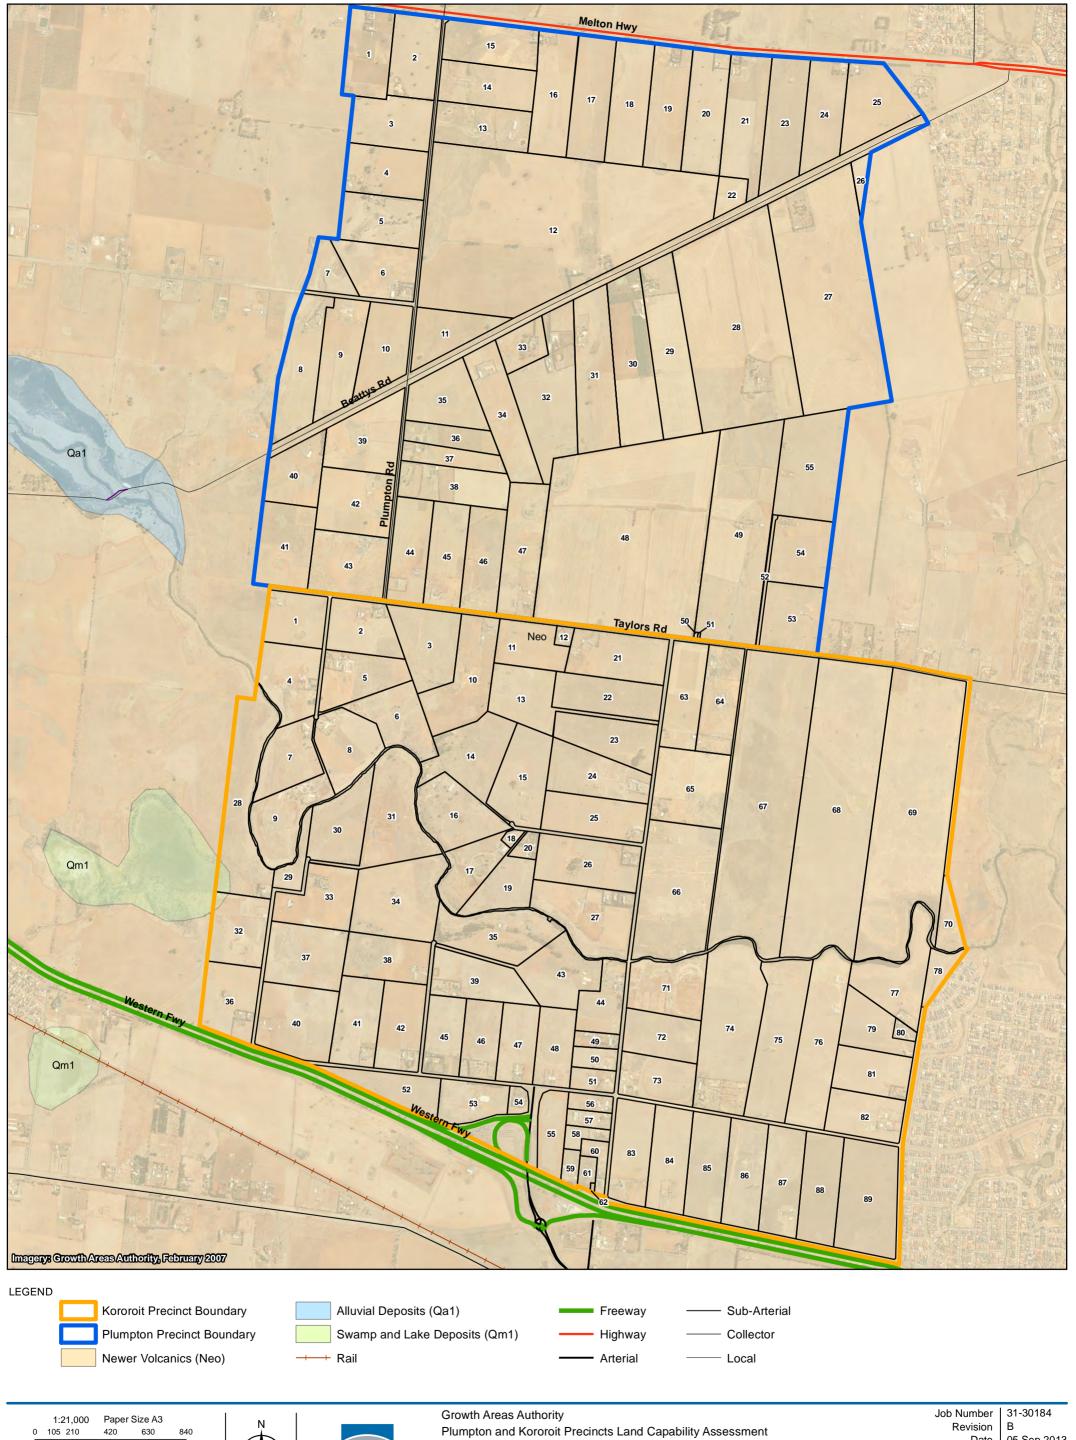
Figure 4 shows the geology underlying the Precincts and surrounding areas.

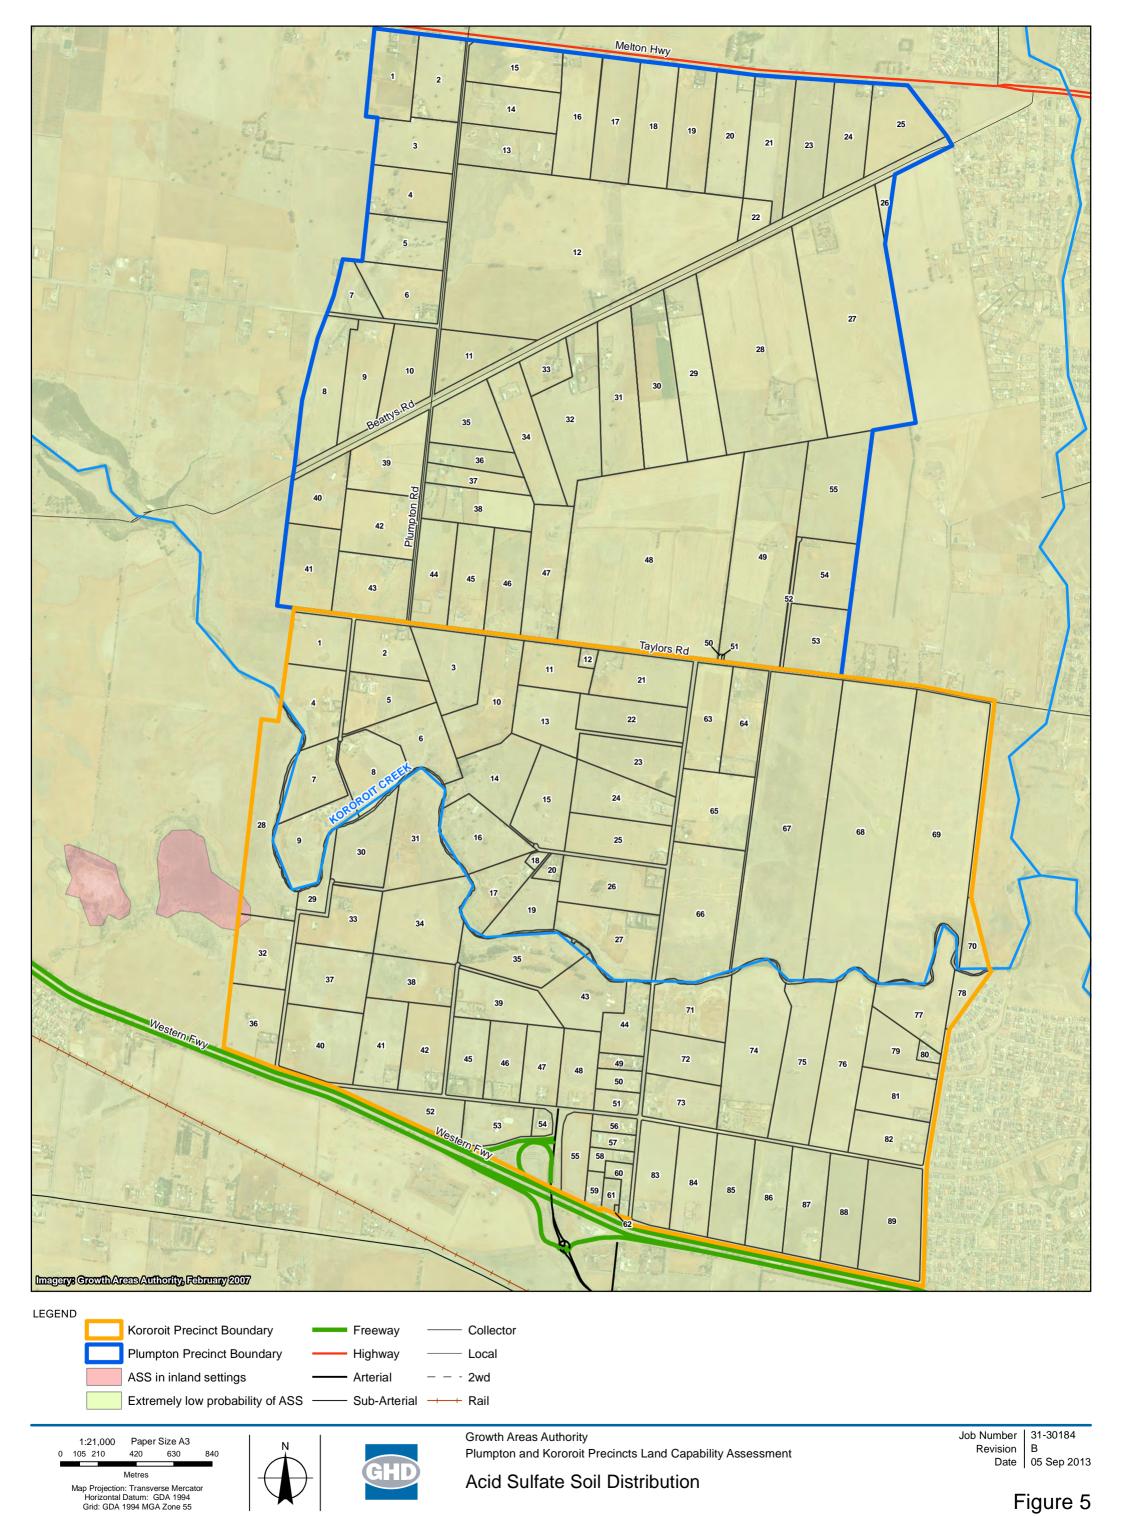
The review of available geological information on the DPI GeoVic website also identified that there is an area classified as potentially containing 'Acid Sulfate Soils (ASS) in an inland setting' located along the western boundary of the Kororoit Precinct associated with the low lying areas around Kororoit Creek (swamp and lake deposits). This area extends onto the western edges of Kororoit Precinct Properties 28 and 32 and indicates the potential for ASS to be present on these Properties. The distribution of ASS in the Precincts and surrounding area is shown in **Figure 5**.
